## **Pre-Demolition Limited Regulated Hazardous Materials Survey Report**

**Residential Home, Arlington County  
1212 S. Irving Street  
Arlington, VA 22204**

**November 28, 2020**

**JSK Project Number JSK-2020-86**

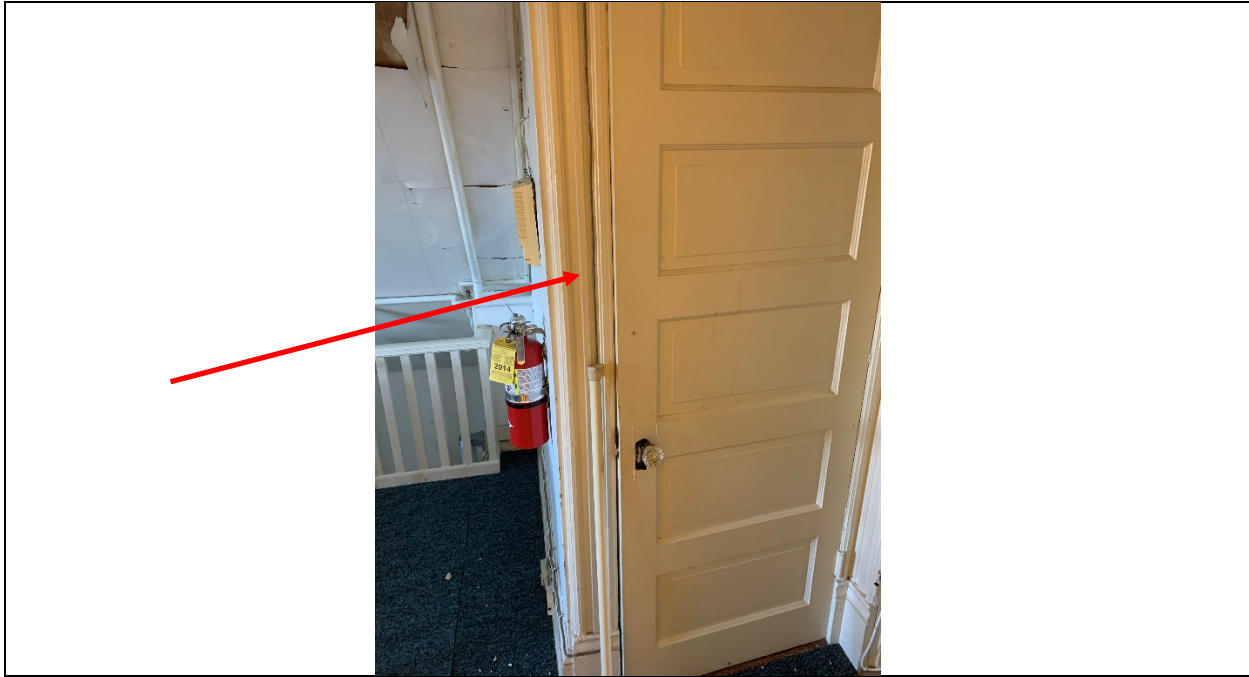
LBP-11: Lead-Based Paint on Closet Door Casing, Landing on 3<sup>rd</sup> Floor

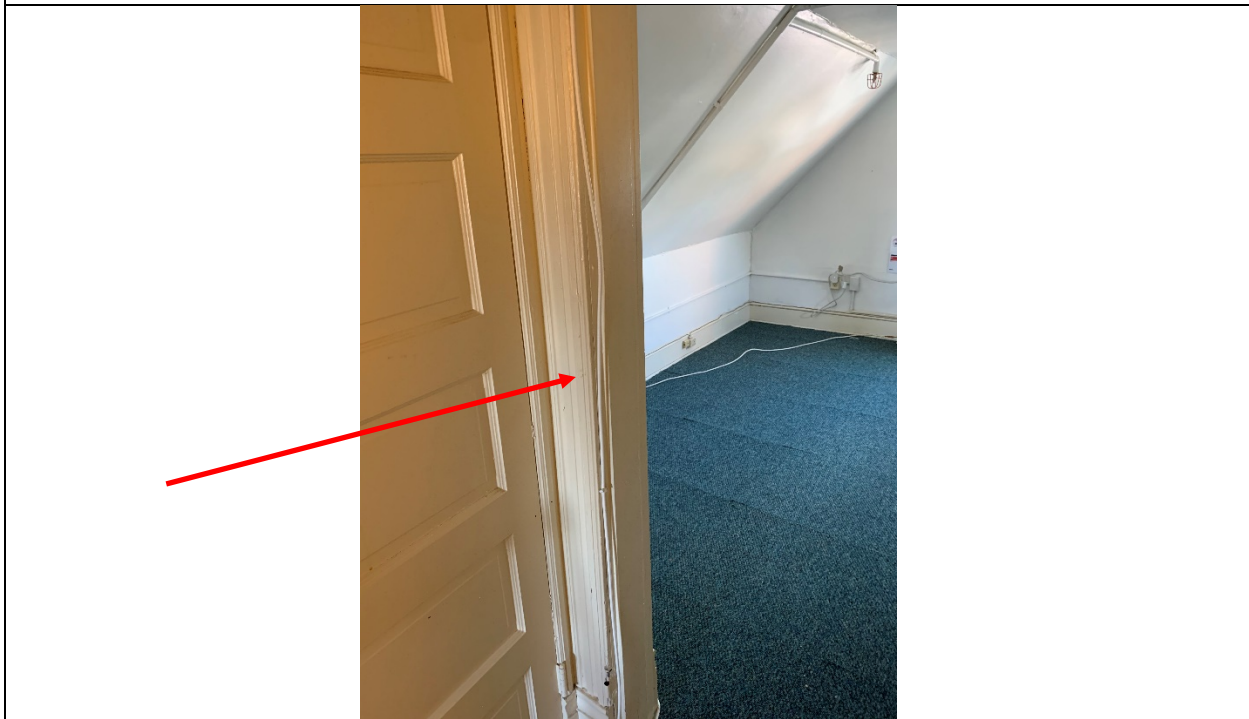
LBP-12: Lead-Based Paint on Door Casing Leading to Bedroom 3-1 on 3<sup>rd</sup> Floor

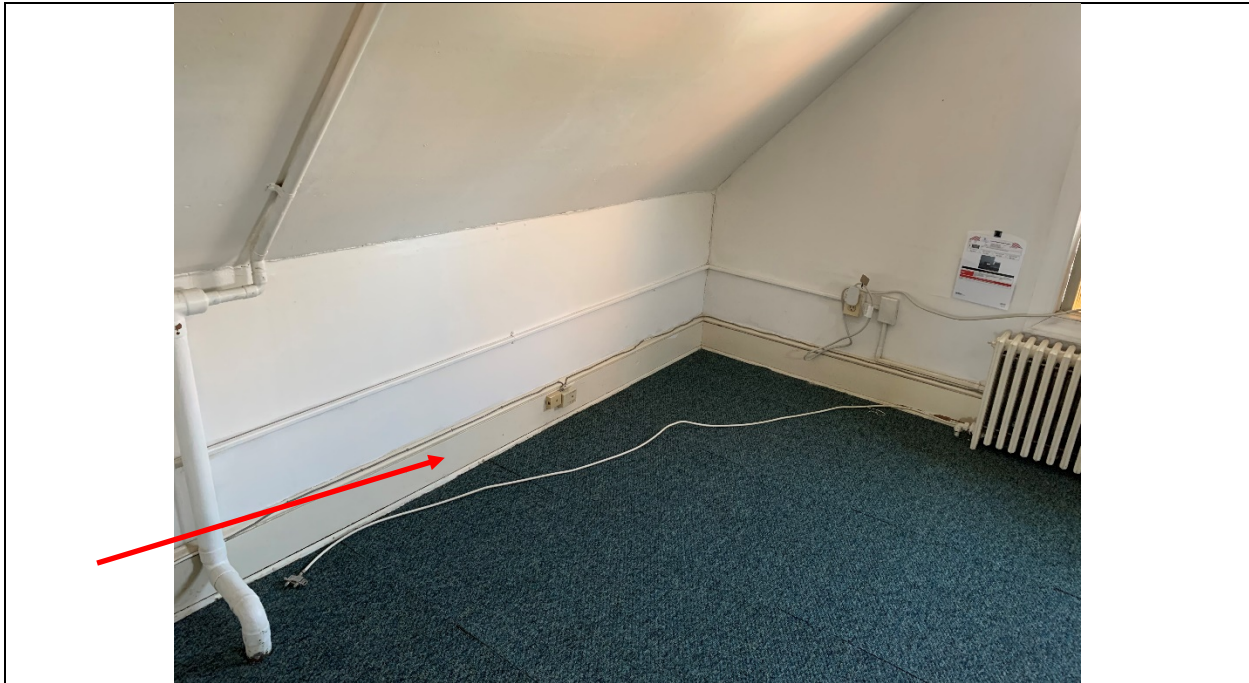
LBP-13: Lead-Based Paint on Baseboard in Bedroom 3-1 on 3<sup>rd</sup> Floor

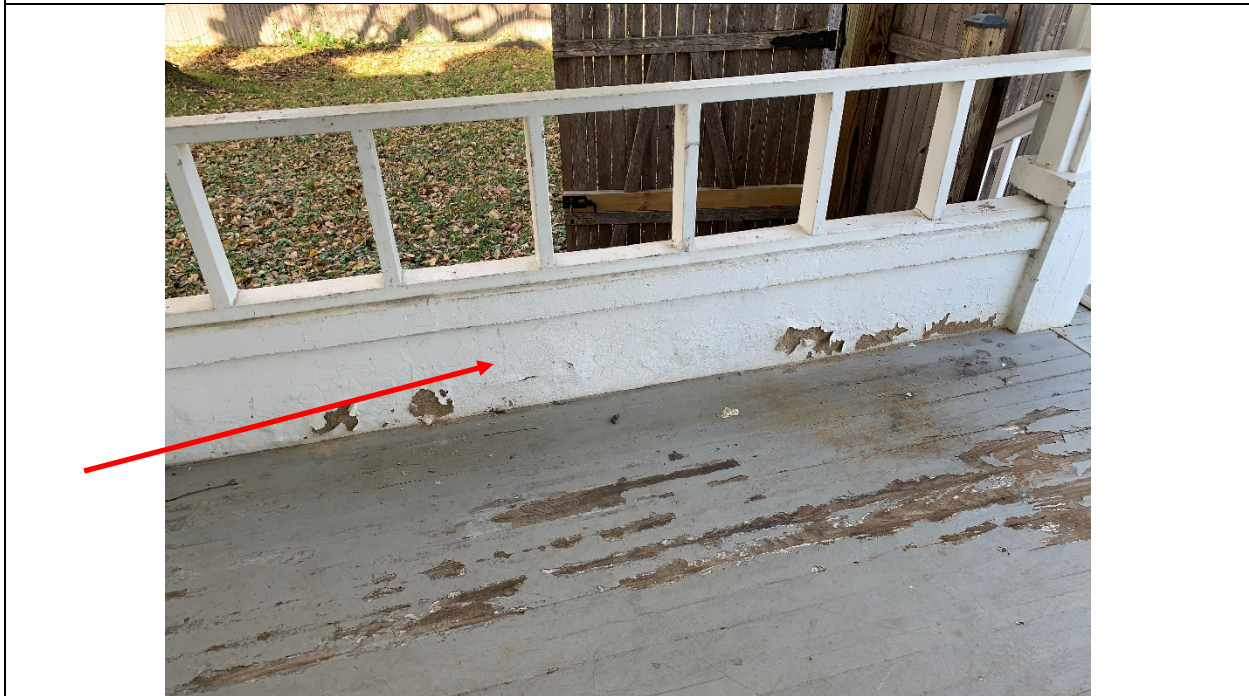
- White Concrete Knee Wall in the Landing area at the Entrance to Building: Reading of 7.3 mg/cm<sup>2</sup>. The paint on this was about 10% damaged.

- White Concrete Knee Wall in the Landing area at the Entrance to Building: Reading of 7.3  $\text{mg}/\text{cm}^2$ . The paint on this was about 10% damaged.

LBP-14: Lead-Based Paint on Concrete Knee Wall in Landing Area of Entrance to Property

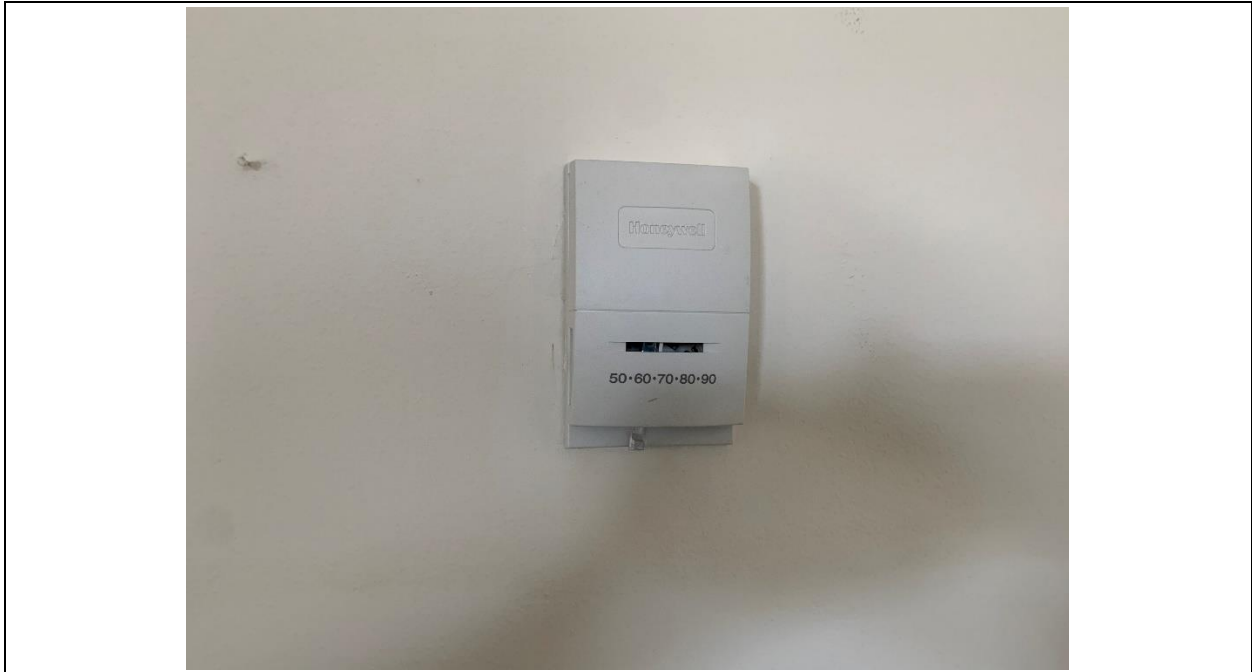
Mercury Thermostat in Living Room

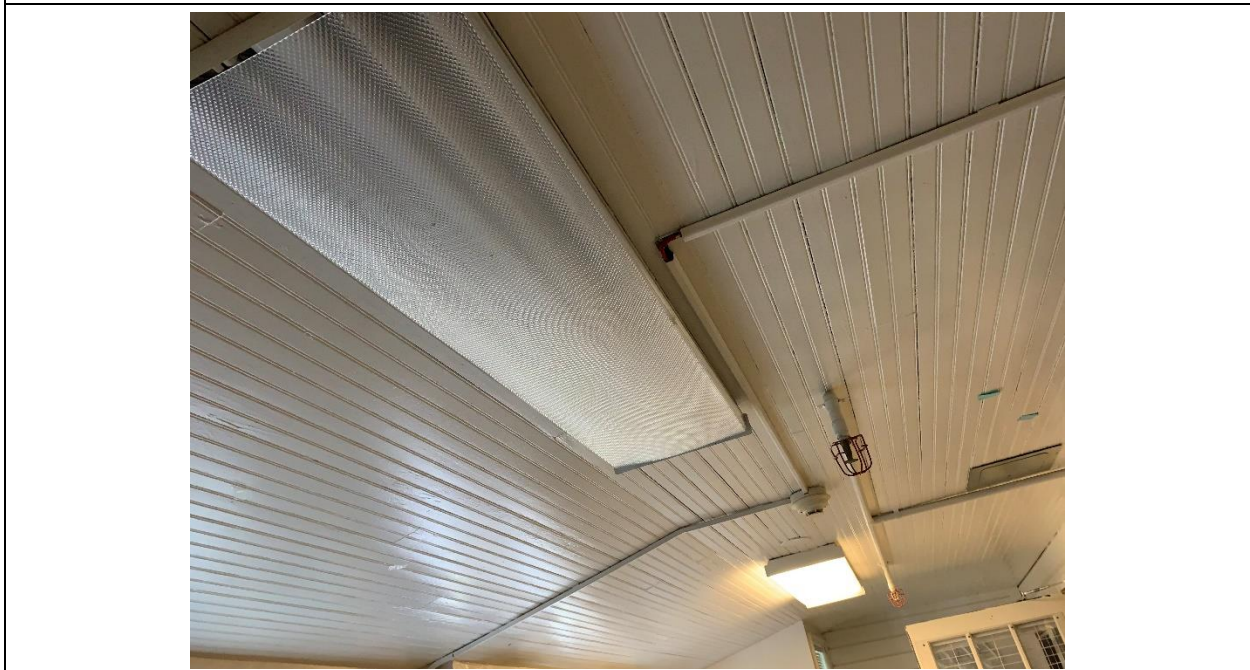
Typical Fluorescent Lighting with non-PCB Electronic Ballasts in the Office & Kitchen of the Subject Property
