# Project Summary

<b>Project Name:</b>	Crestview Main St Mobility Implementation Plan SUE
<b>Client Name:</b>	Matrix Design Group, Inc
<b>Client Contact:</b>	Jason Rutt
<b>Project Manager:</b>	Chris Crawford
<b>Project Number:</b>	21.1165.004
<b>Date:</b>	July 20, 2022
<b>Period:</b>	Through July 20, 2022

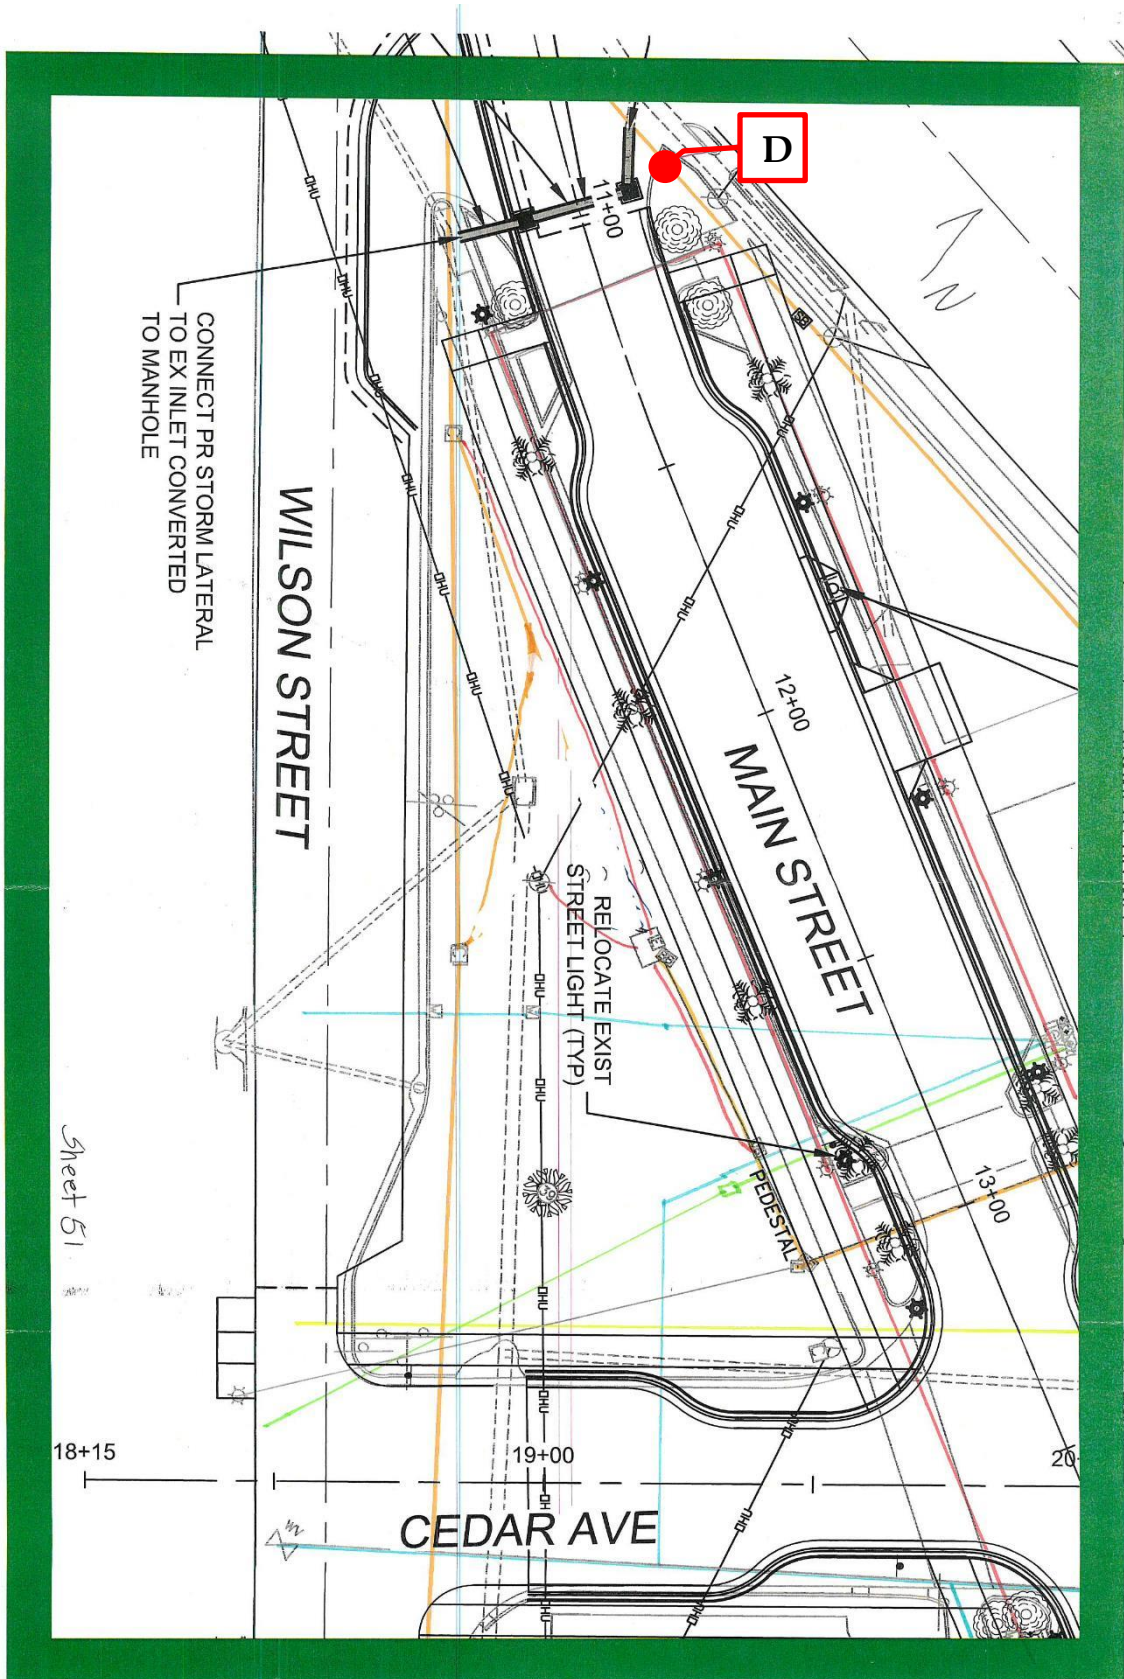
Figure 1. UT01 Field Sketch - Part 1

Level B locates were performed in the triangle area of Main St between the intersection of Cedar Ave and US 90, along Cedar Ave and the eastern right-of-way of Wilson St. Utilities located within these boundaries included gas, power, fiber, sewer force main, water and communications (Fig. 1, pg. 4). A conflict with the storm design was identified near US 90 and a Level A locate was performed approximately five feet from the conflict site to avoid traffic interruption, labeled Site D (Fig. 1A, pg. 5). This was determined to be a bundle of 1.5" conduits of different colors. Our experience along US 90 has shown there are generally six (6) of these bundled together; However, due to their close proximity, only four (4) adjacent conduits were verified within the bundle.

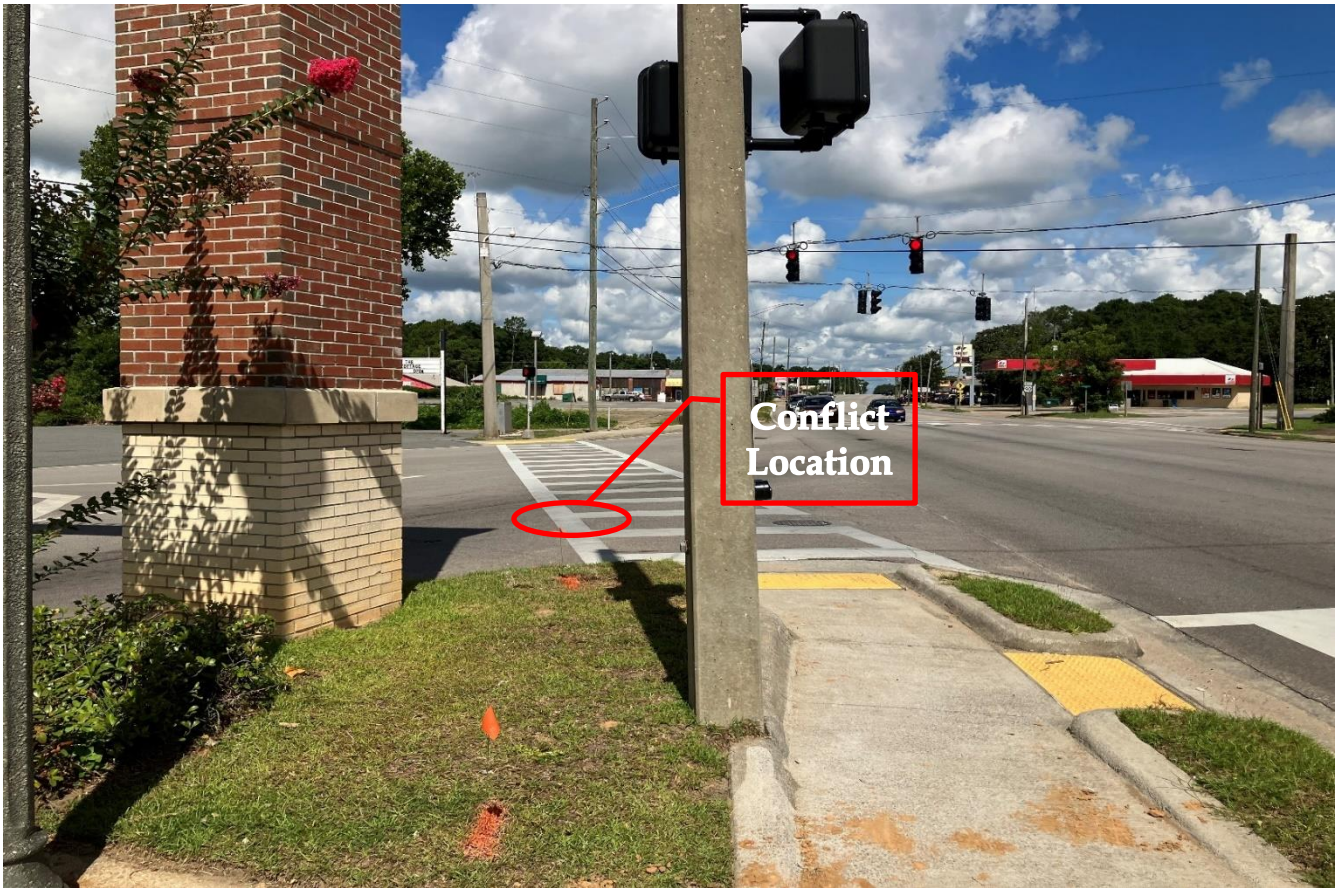
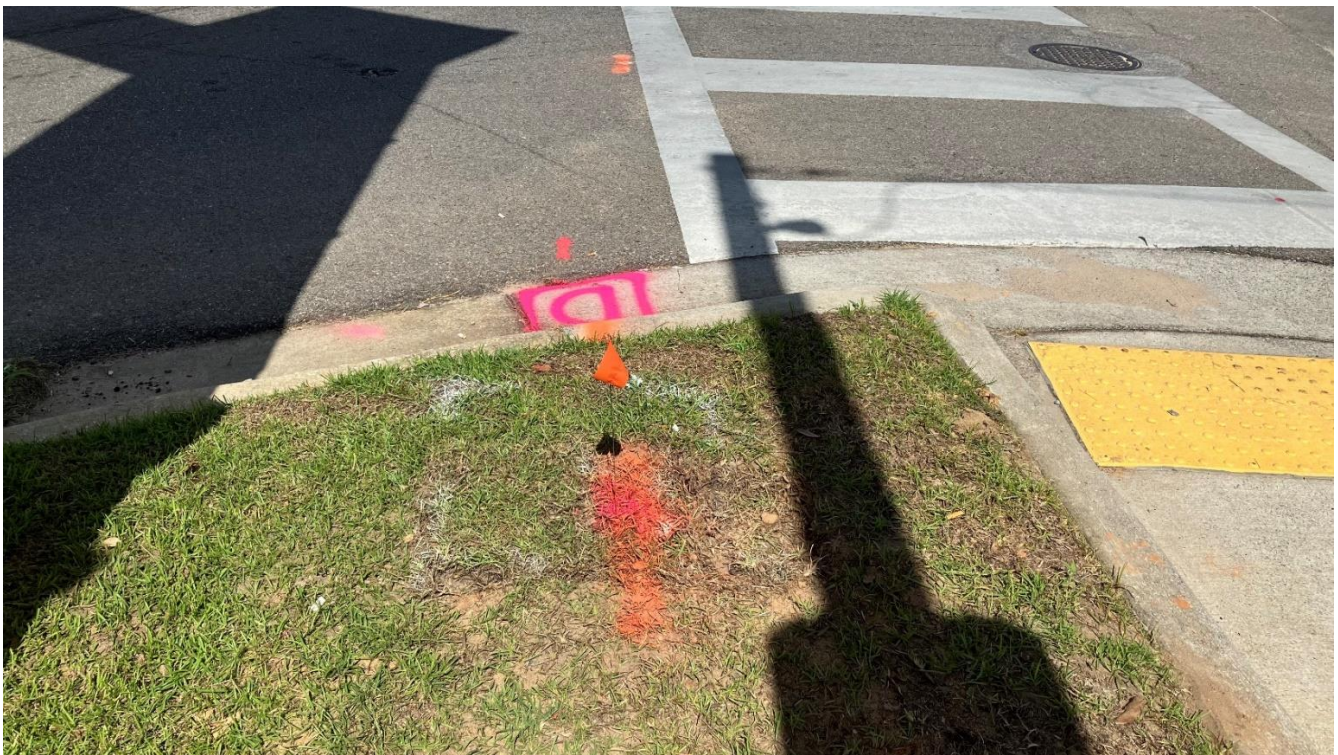
Figure 1A. Level A Pictures - US 90 & Main St

The Level A site was located under grass and immediately backfilled after identification using original spoils. The corresponding label was painted on the adjacent concrete surface for use by GCT.

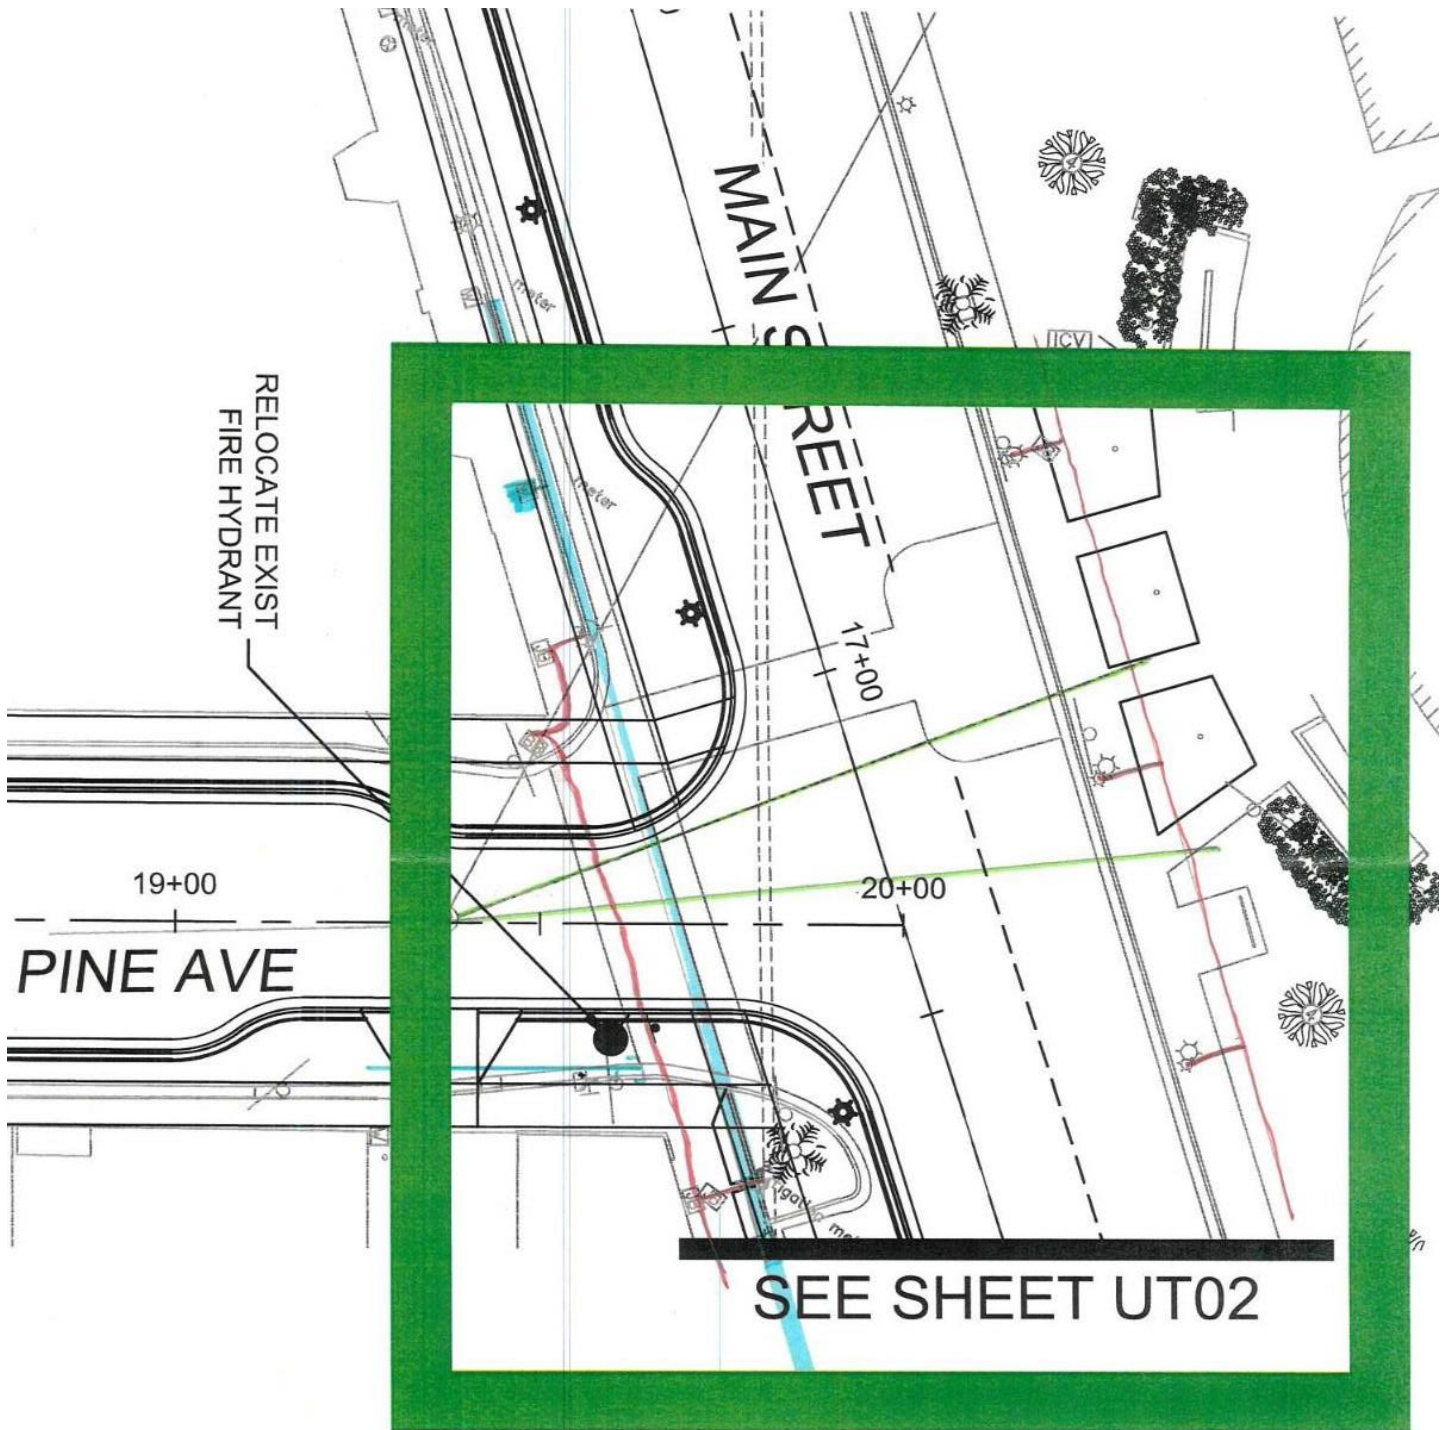
Figure 2. UT01 Field Sketch - Part 2

Level B locates were also performed along Main St at the intersection with Pine Ave. Utilities located included power, water, and gravity sewer (Fig. 2, pg. 6). No conflicts with storm design were determined and no Level A was performed at this site.

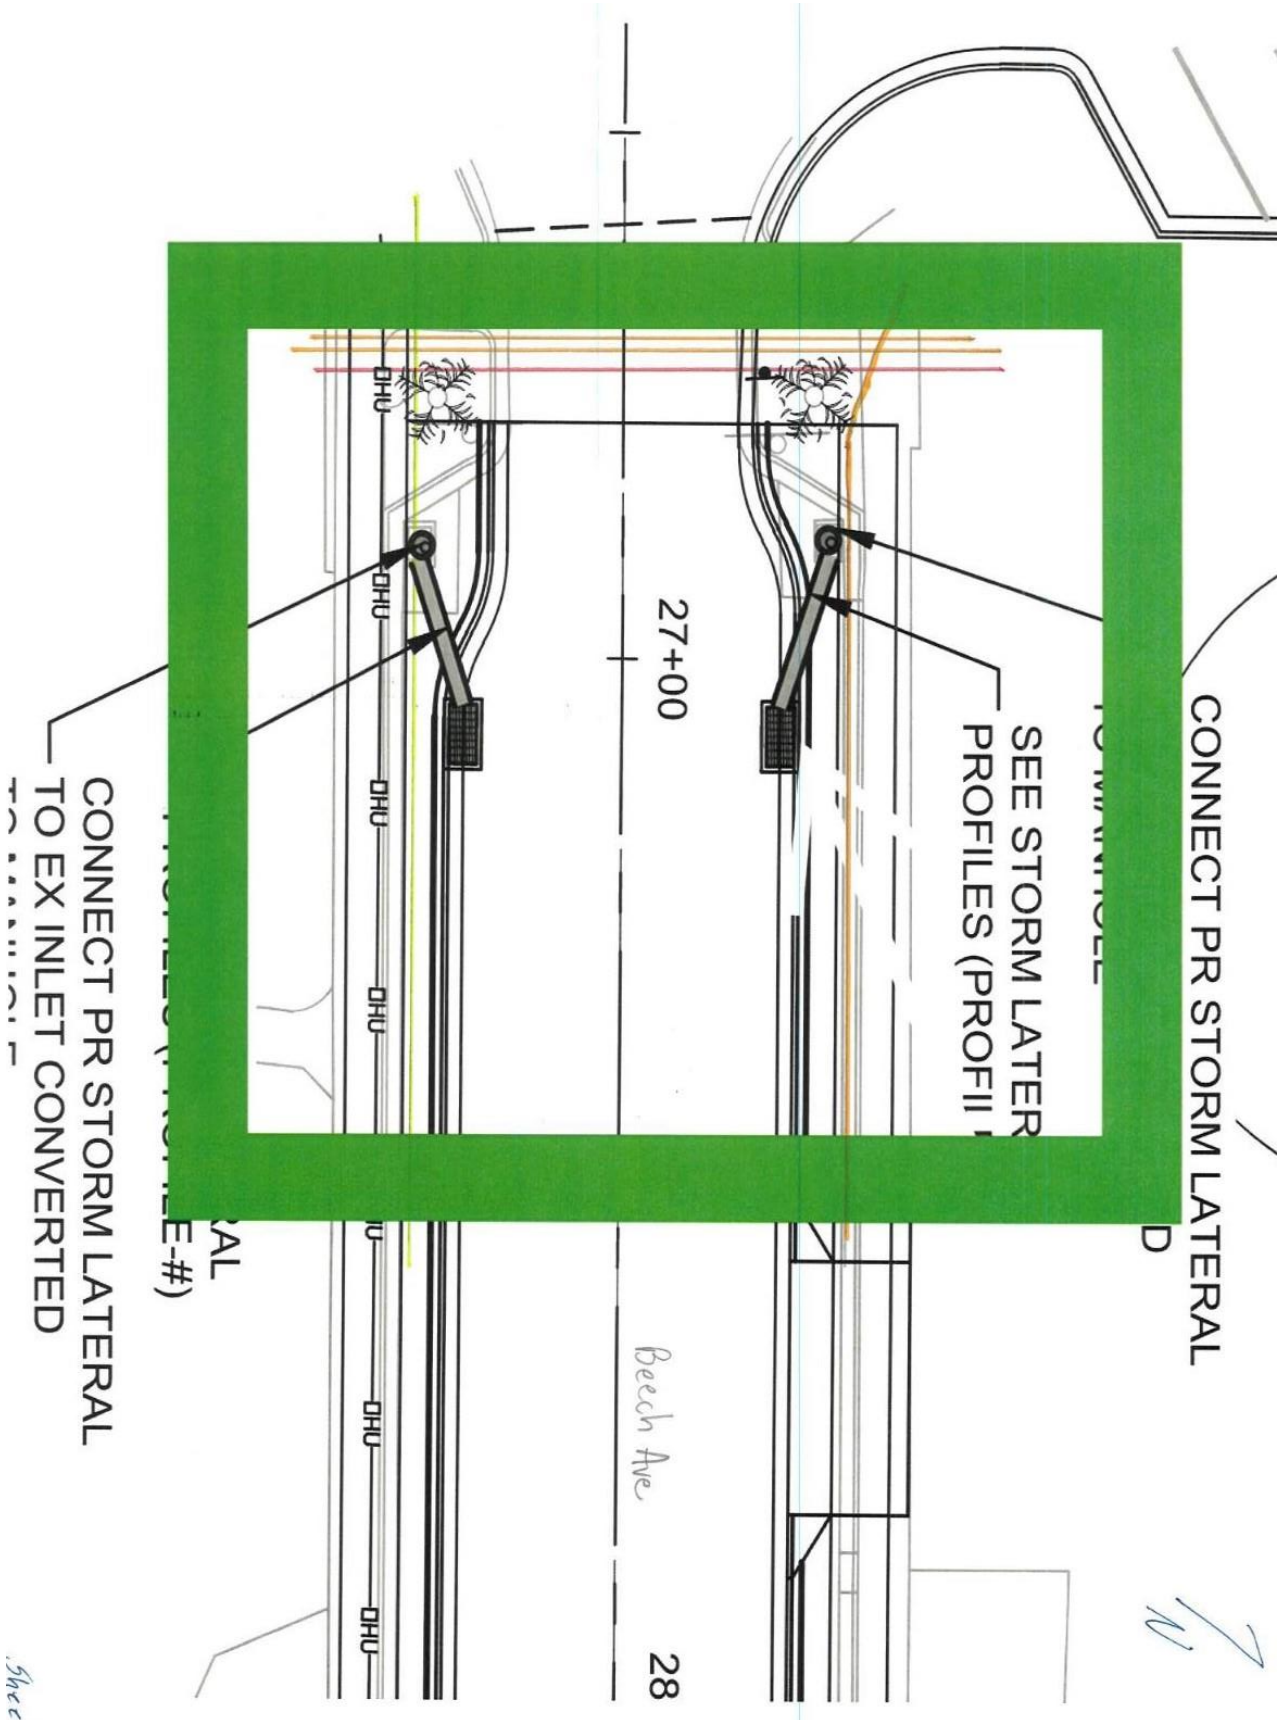
Figure 3. UT02 Field Sketch - Part 1

Level B locates were performed on Beech Ave at the intersection with Wilson St. Utilities located included communications, power and gas (Fig. 3, pg. 7). The gas line was newly installed via directional drilling below the storm inlet catch basin. No Level A was performed at this location.

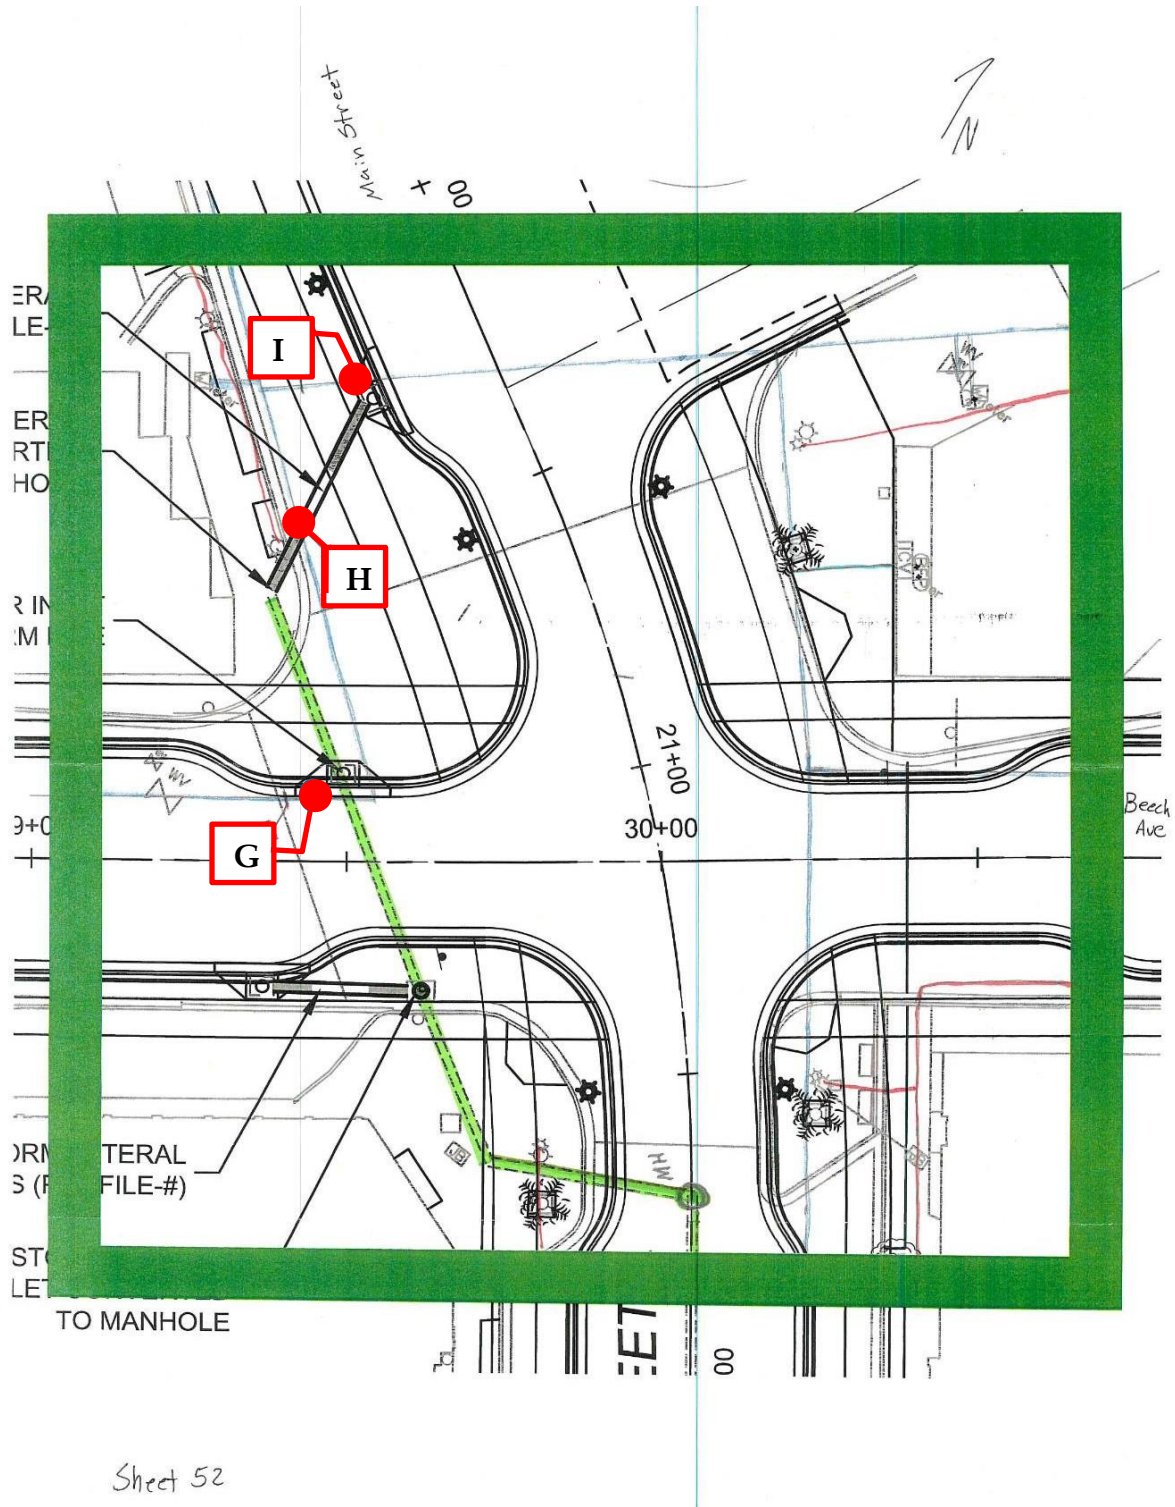
Figure 4. UT02 Field Sketch - Part 2

Level B locates were performed at the intersection of Main St and Beech Ave. Utilities located included water, power and storm (Fig. 4, pg. 8). Three conflict locations were identified and excavation was performed at the sites labeled G, H and I (Fig. 4A, pgs. 9-10). All conflicts were identified as 2" Cast Iron water lines.

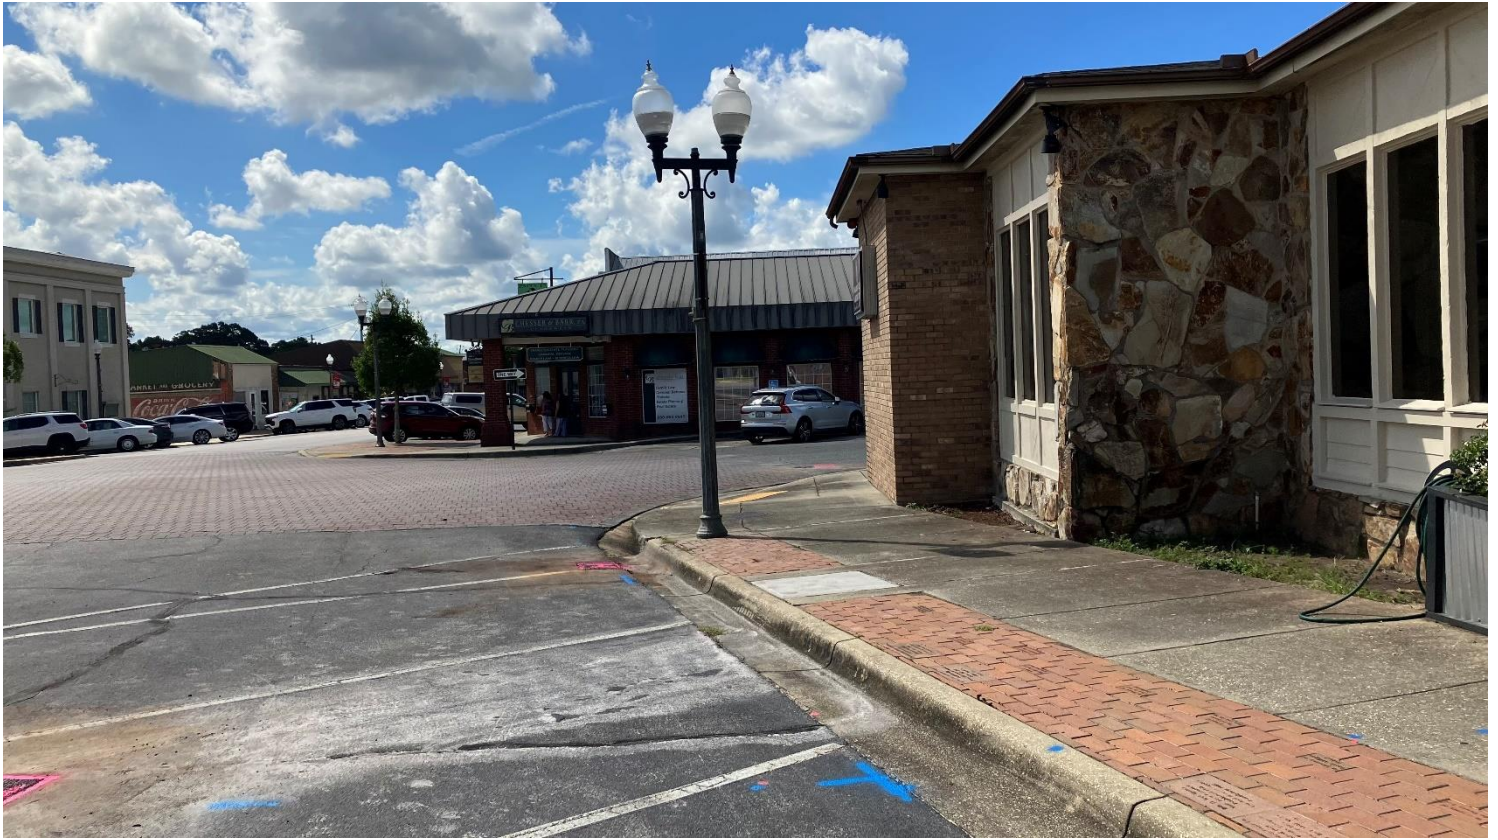
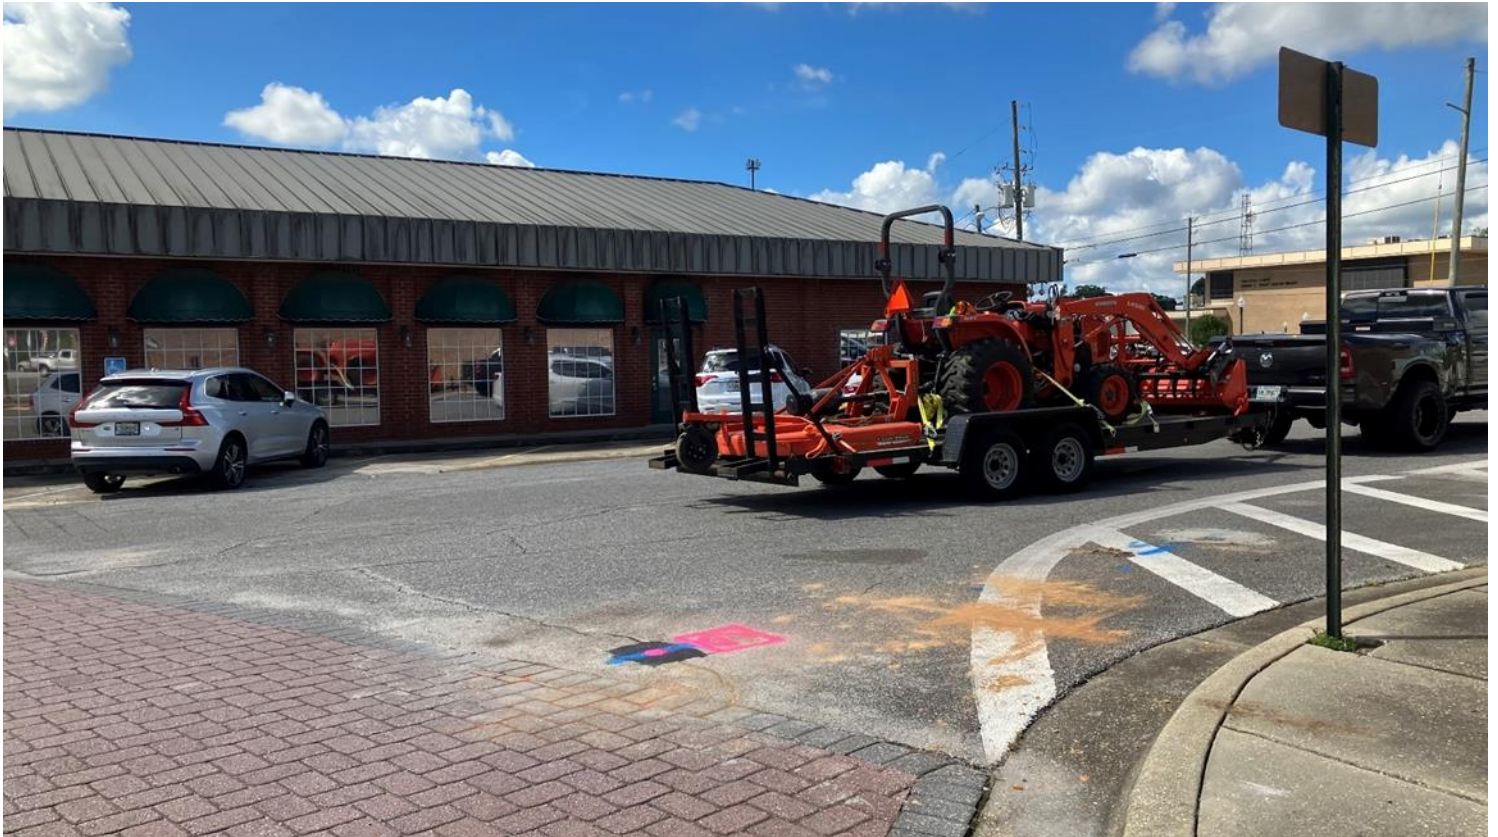
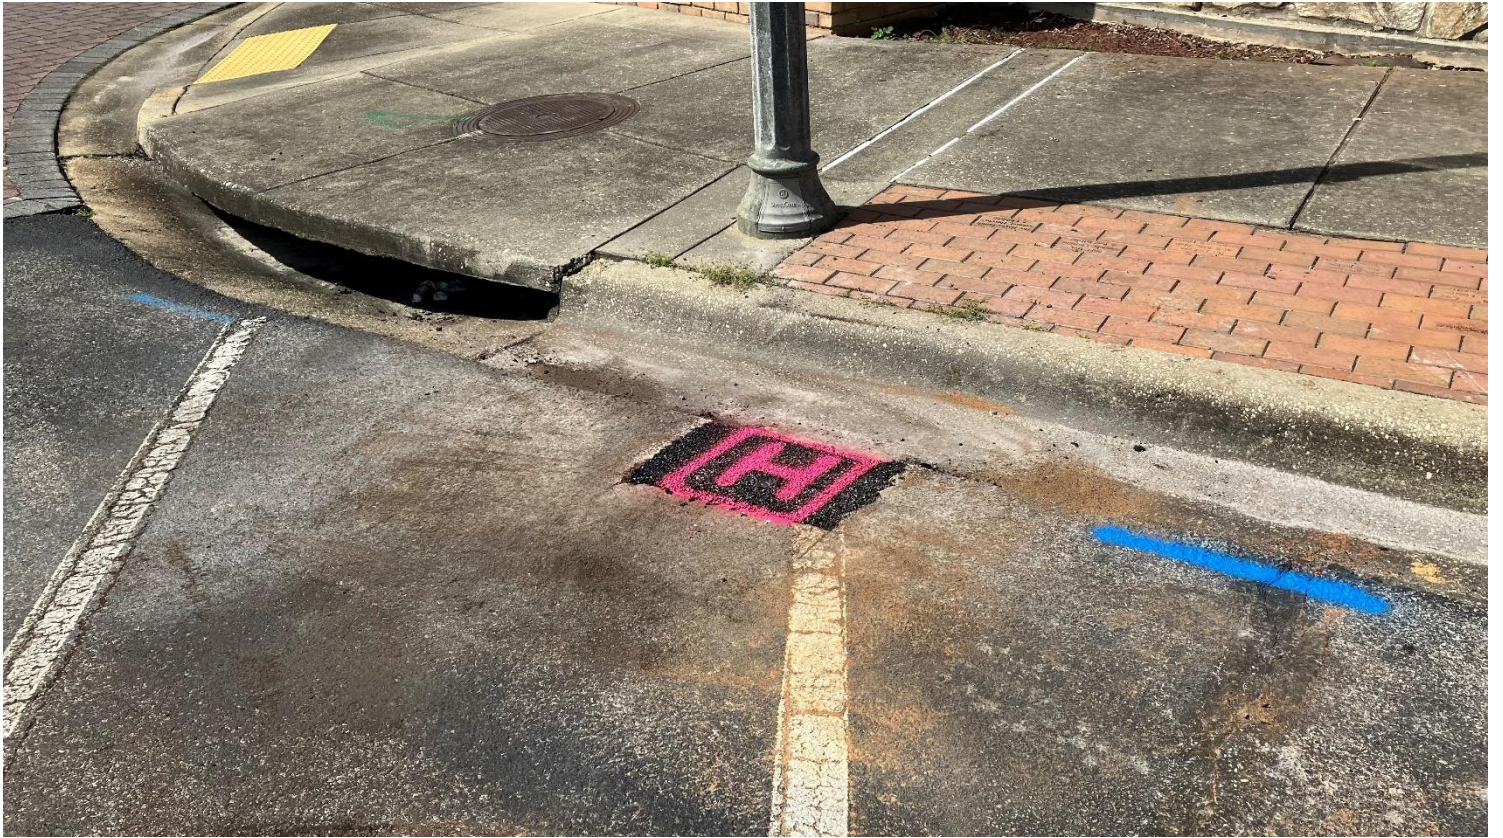
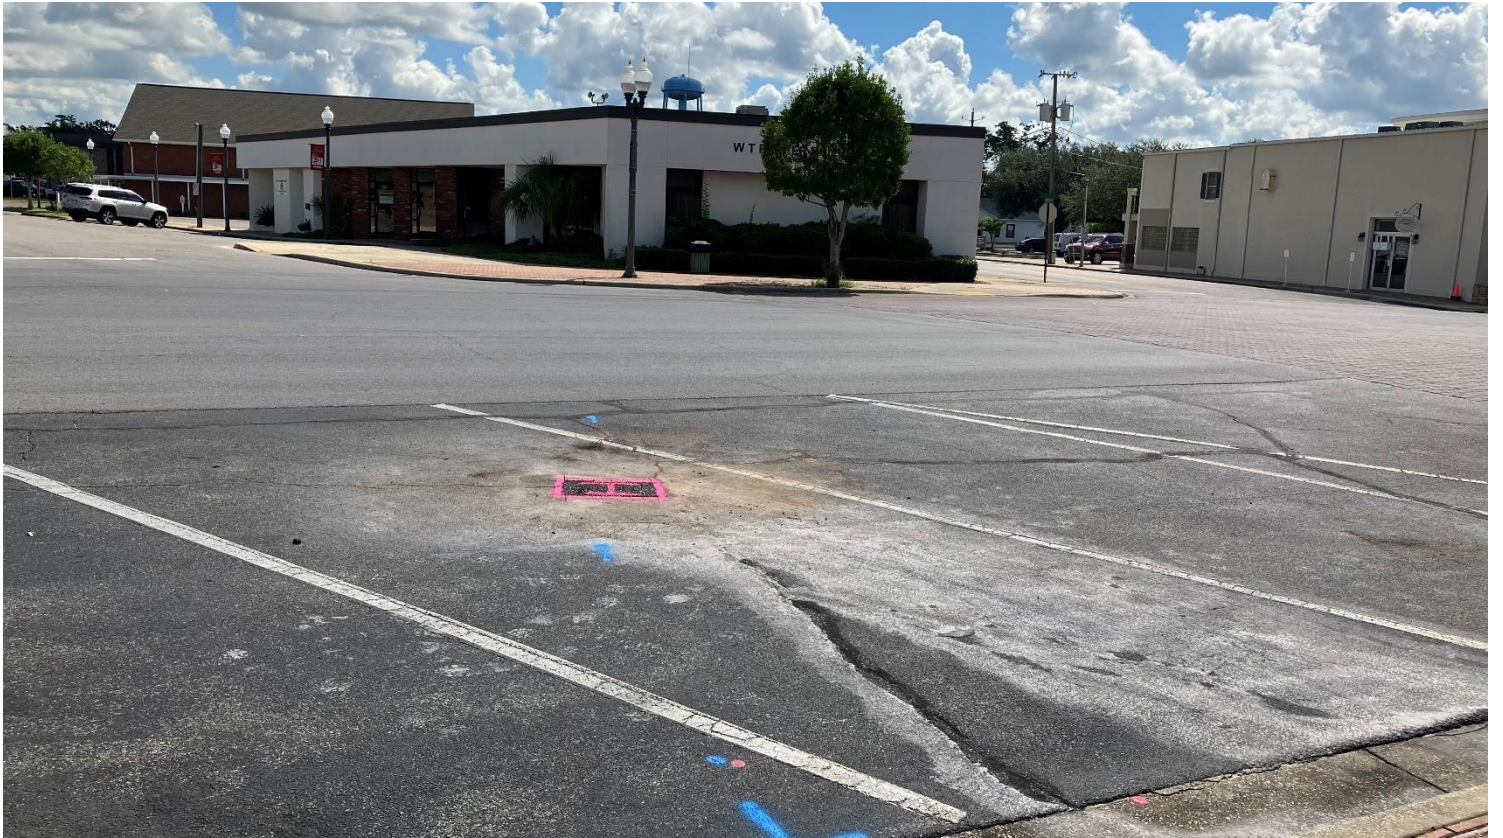
Figure 4A. Level A Pictures – Okloosa Title & Abstract - 402 Main St

The Level A sites were all located under asphalt pavement of varying thickness (Fig. 8, pg. 17) requiring the use of a cutoff saw and a jackhammer. The asphalt repair was made immediately after identification using QPR asphalt patching and the corresponding labels were painted on the surface for use by GCT.

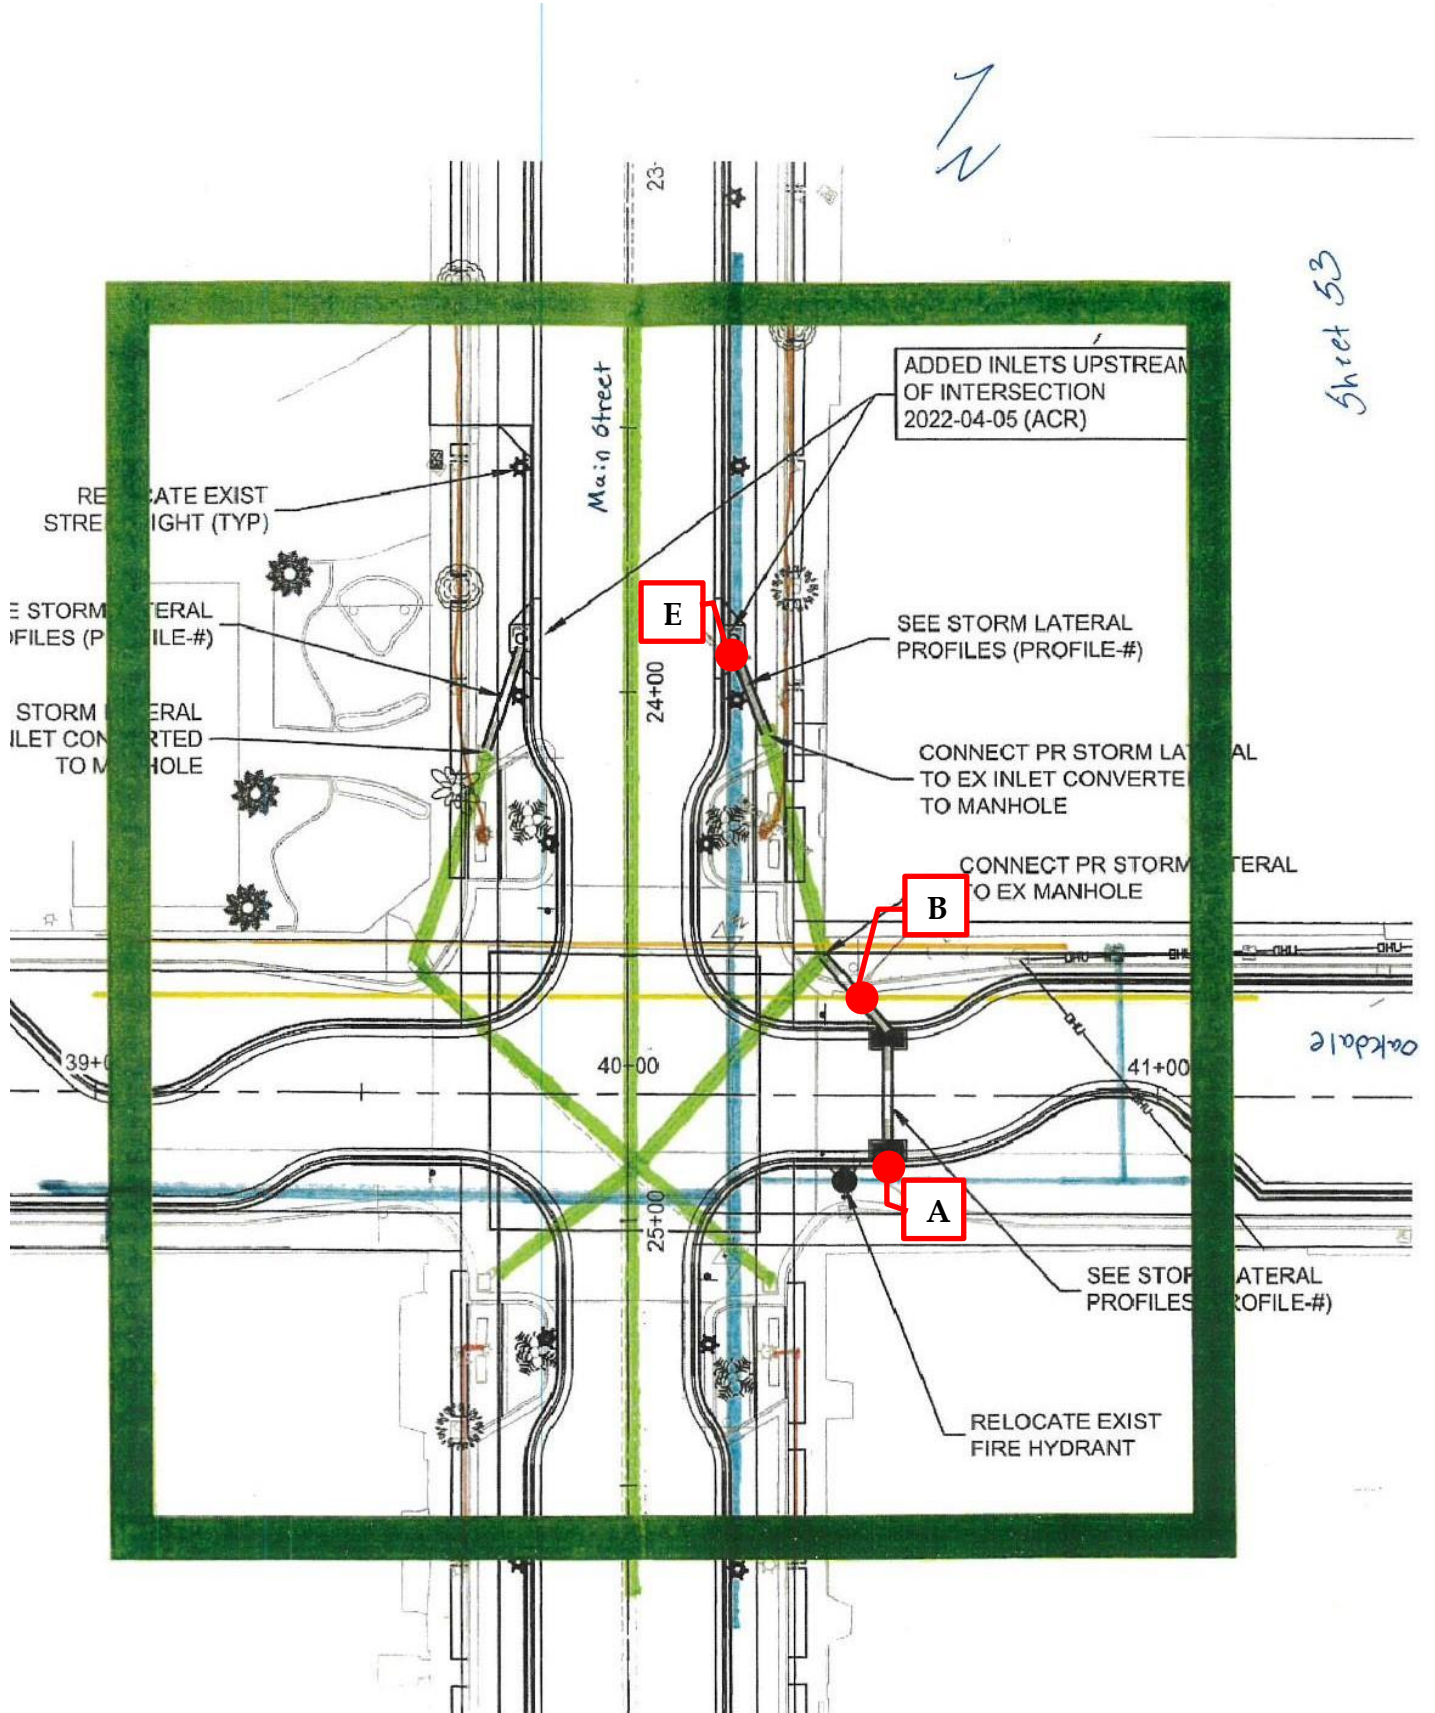
Figure 5. UT03 Field Sketch

Level B locates were performed at the intersection of Main St and Oakdale Ave. Utilities identified during the GPR investigation included gas, power, water storm and communications (Fig. 5, pg. 11). Three (3) conflicts with the storm design were identified and Level A utility verification was performed at sites labeled A, B and E (Figs. 5A, 5B & 5C, pgs. 12-13). Conflict A was identified as an 8" Cast Iron water main. Conflict site B was the newly installed 4" PE gas main and conflict site E was identified as a 6" Cast Iron water main.

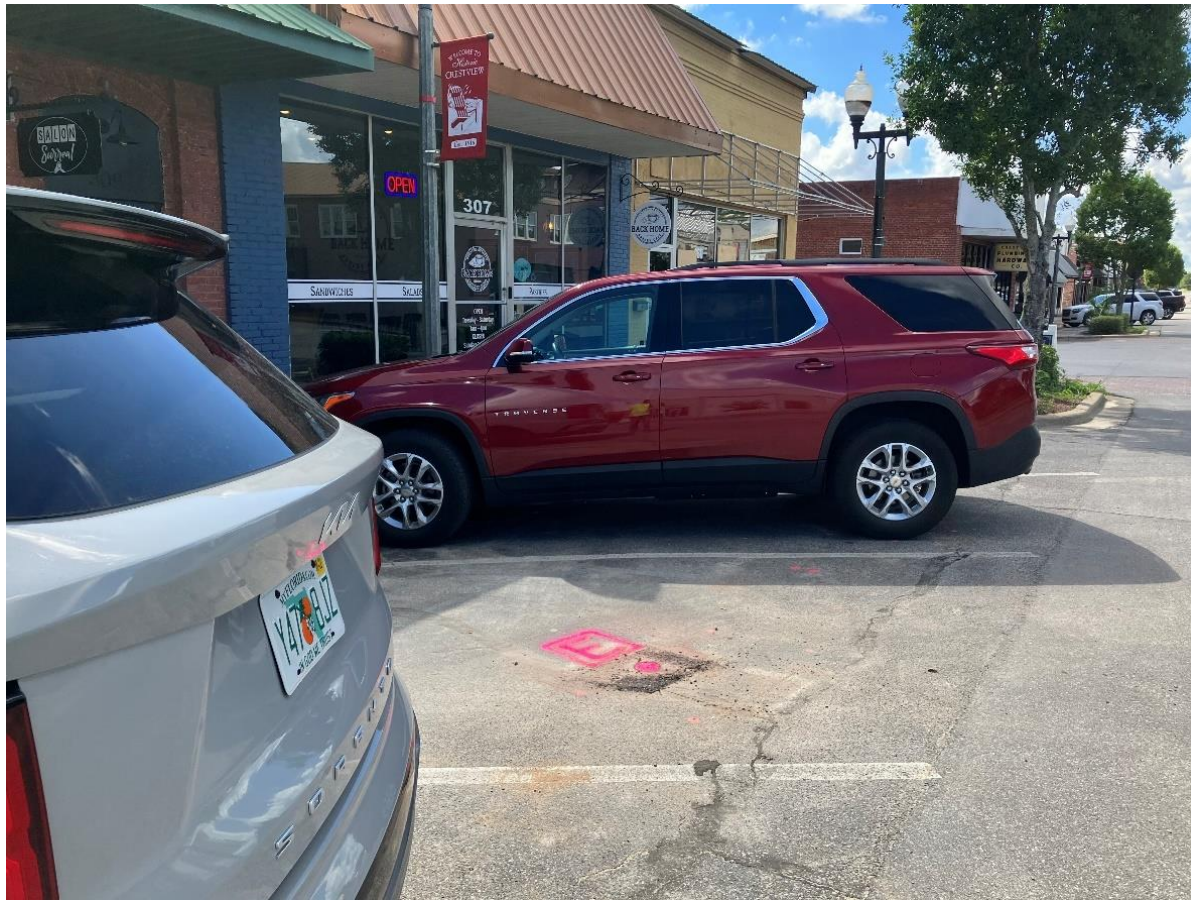
*Figure 5A. Location E – Salon Surreal - 309 Main St*

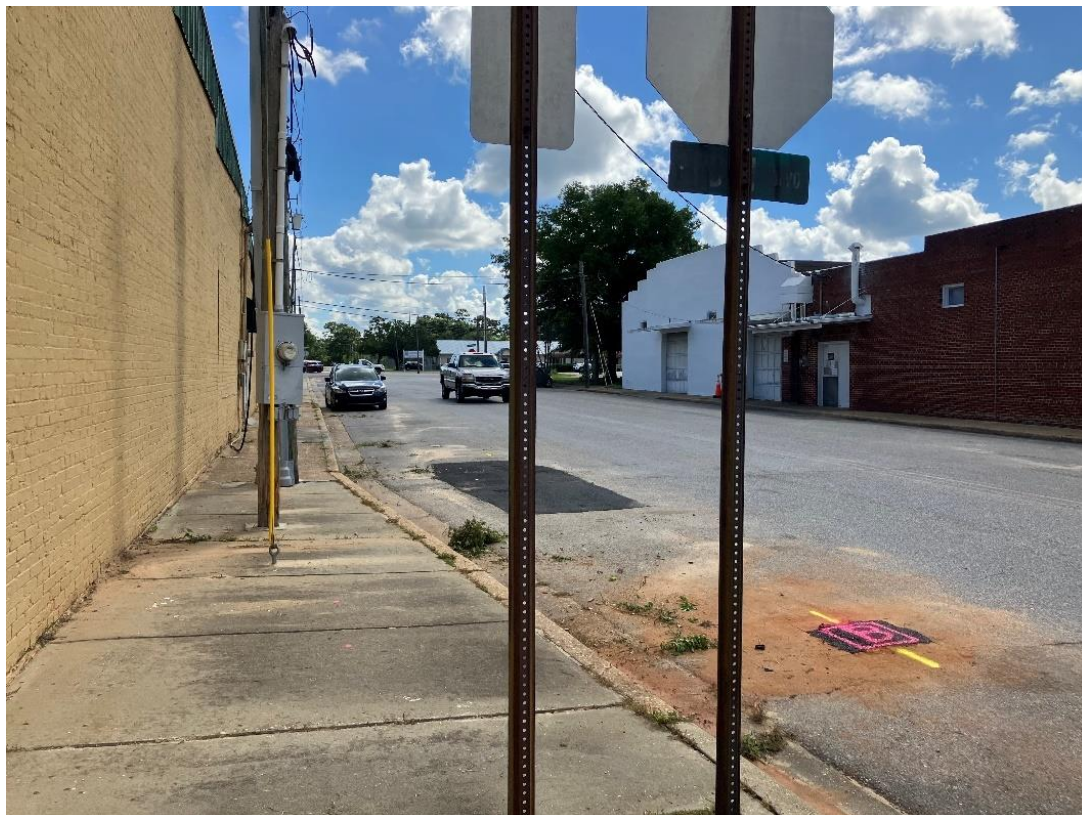
*Figure 5B. Location B – Oakdale Ave side of Rollin EZ - 301 Main St*

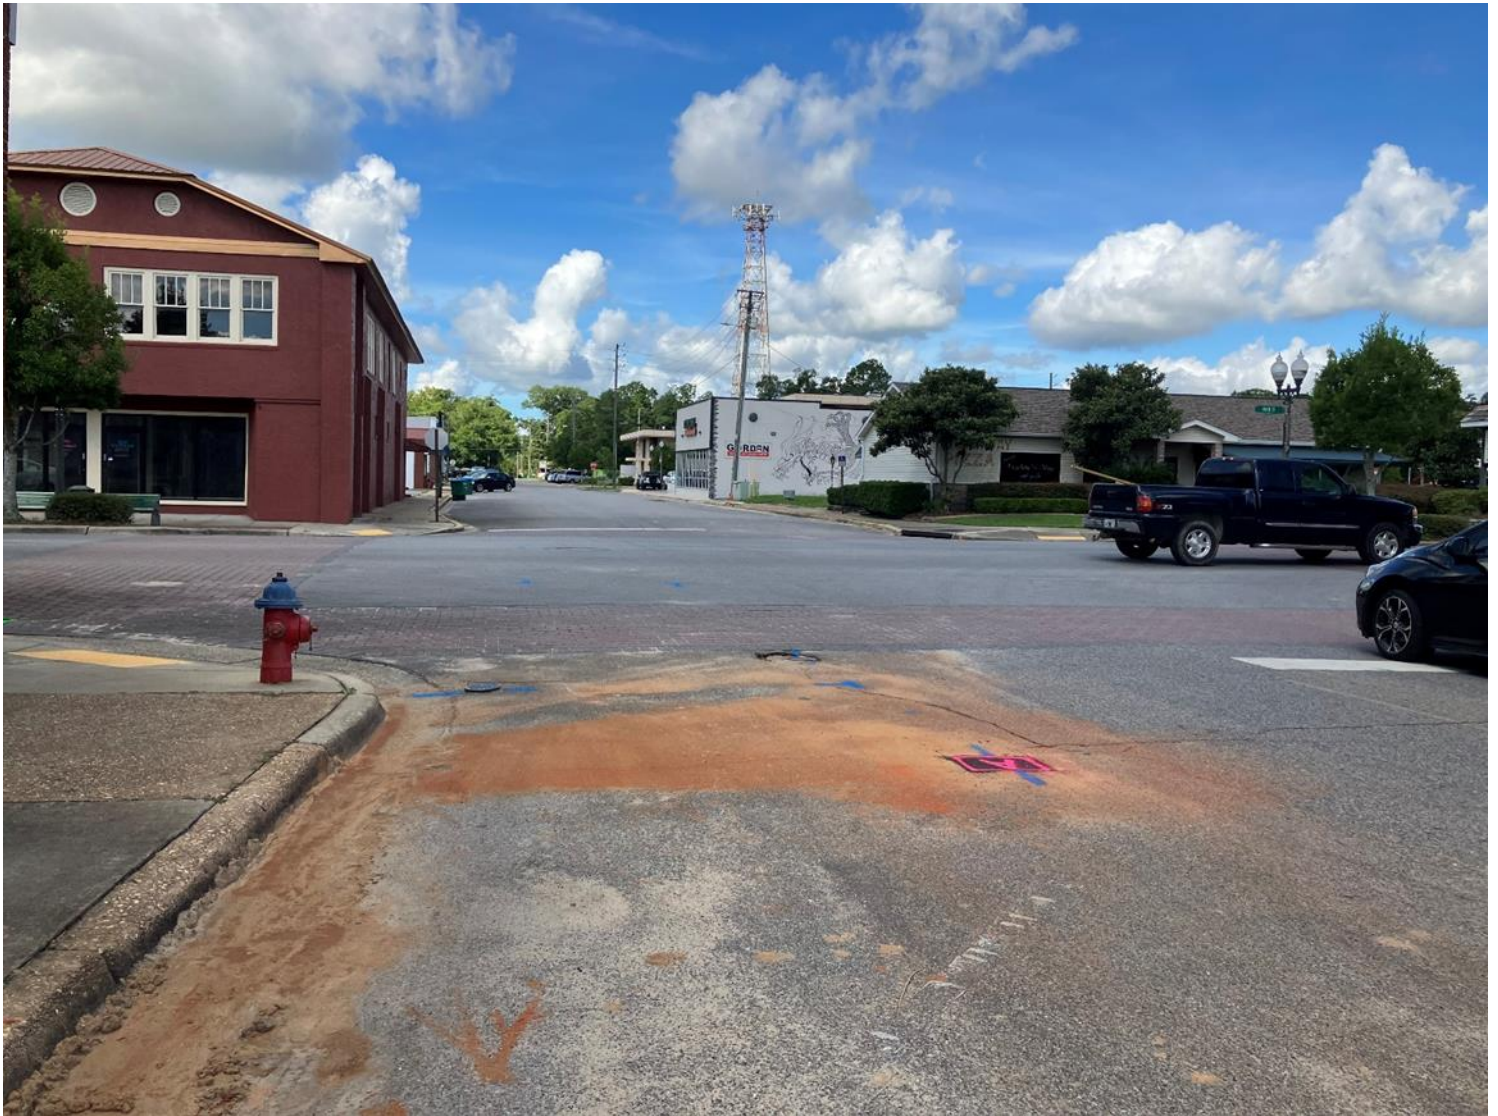
*Figure 5C. Location A - Oakdale Ave side of Crestview Plumbing & Hardware - 297 Main St*
