# Project Summary

<b>Project Name:</b>	Crestview Main St Mobility Implementation Plan SUE
<b>Client Name:</b>	Matrix Design Group, Inc
<b>Client Contact:</b>	Jason Rutt
<b>Project Manager:</b>	Chris Crawford
<b>Project Number:</b>	21.1165.004
<b>Date:</b>	July 20, 2022
<b>Period:</b>	Through July 20, 2022

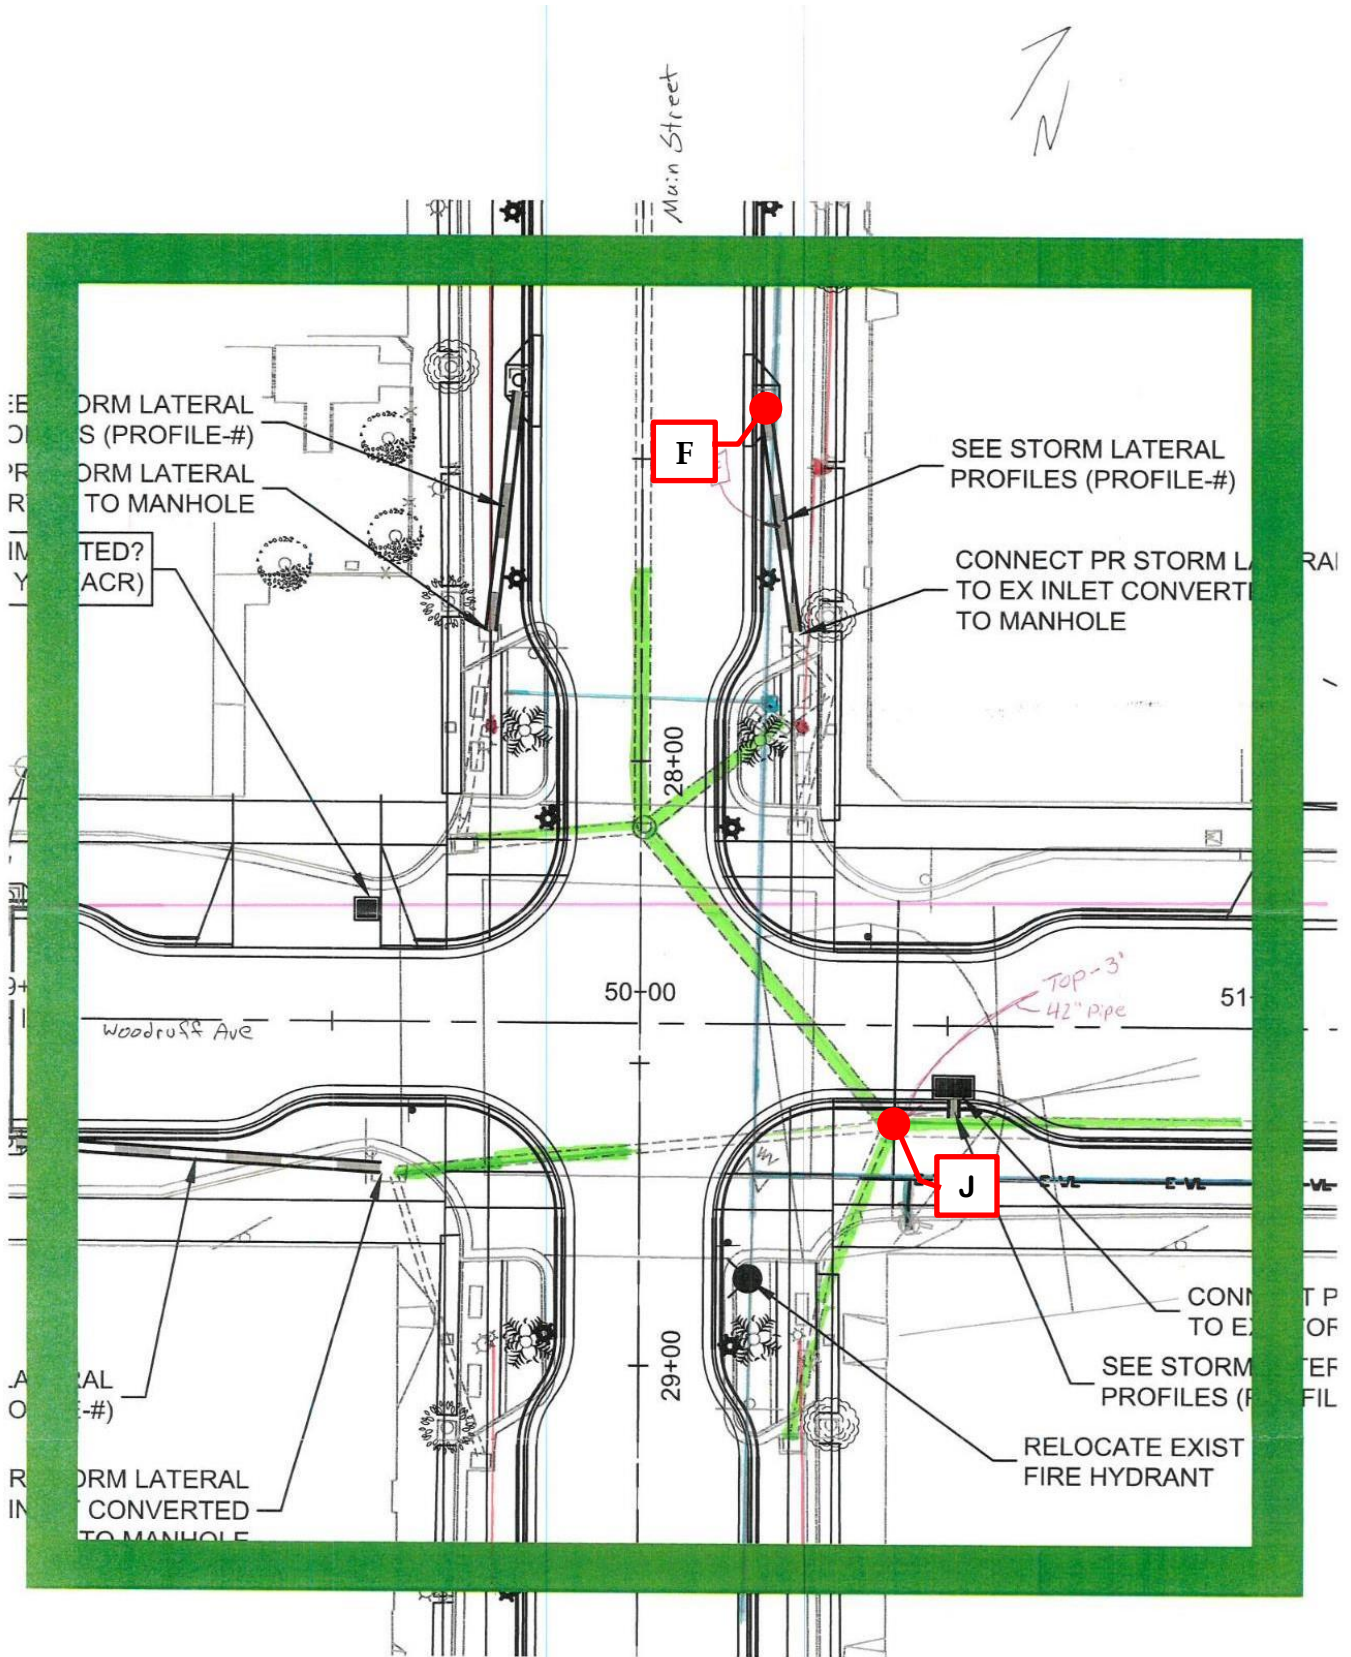
Figure 6. UT04 Field Sketch - Part 1

Level B locates were performed at the intersection of Main St and Woodruff Ave. Utilities marked included water, power, storm and an unknown utility (Fig 6, pg. 14). Two storm design conflicts were identified and Level A excavation was performed at one conflict site labeled F (Fig. 6A, pg. 16). This was identified as a 6" Cast Iron water main. The other conflict, the existing 42" RCP storm where design calls for a PR Inlet to be installed, was verified by visual inspection of the manhole access cover. The unknown utility was not identifiable via surface features and was not excavated since it was not in conflict with the storm design.

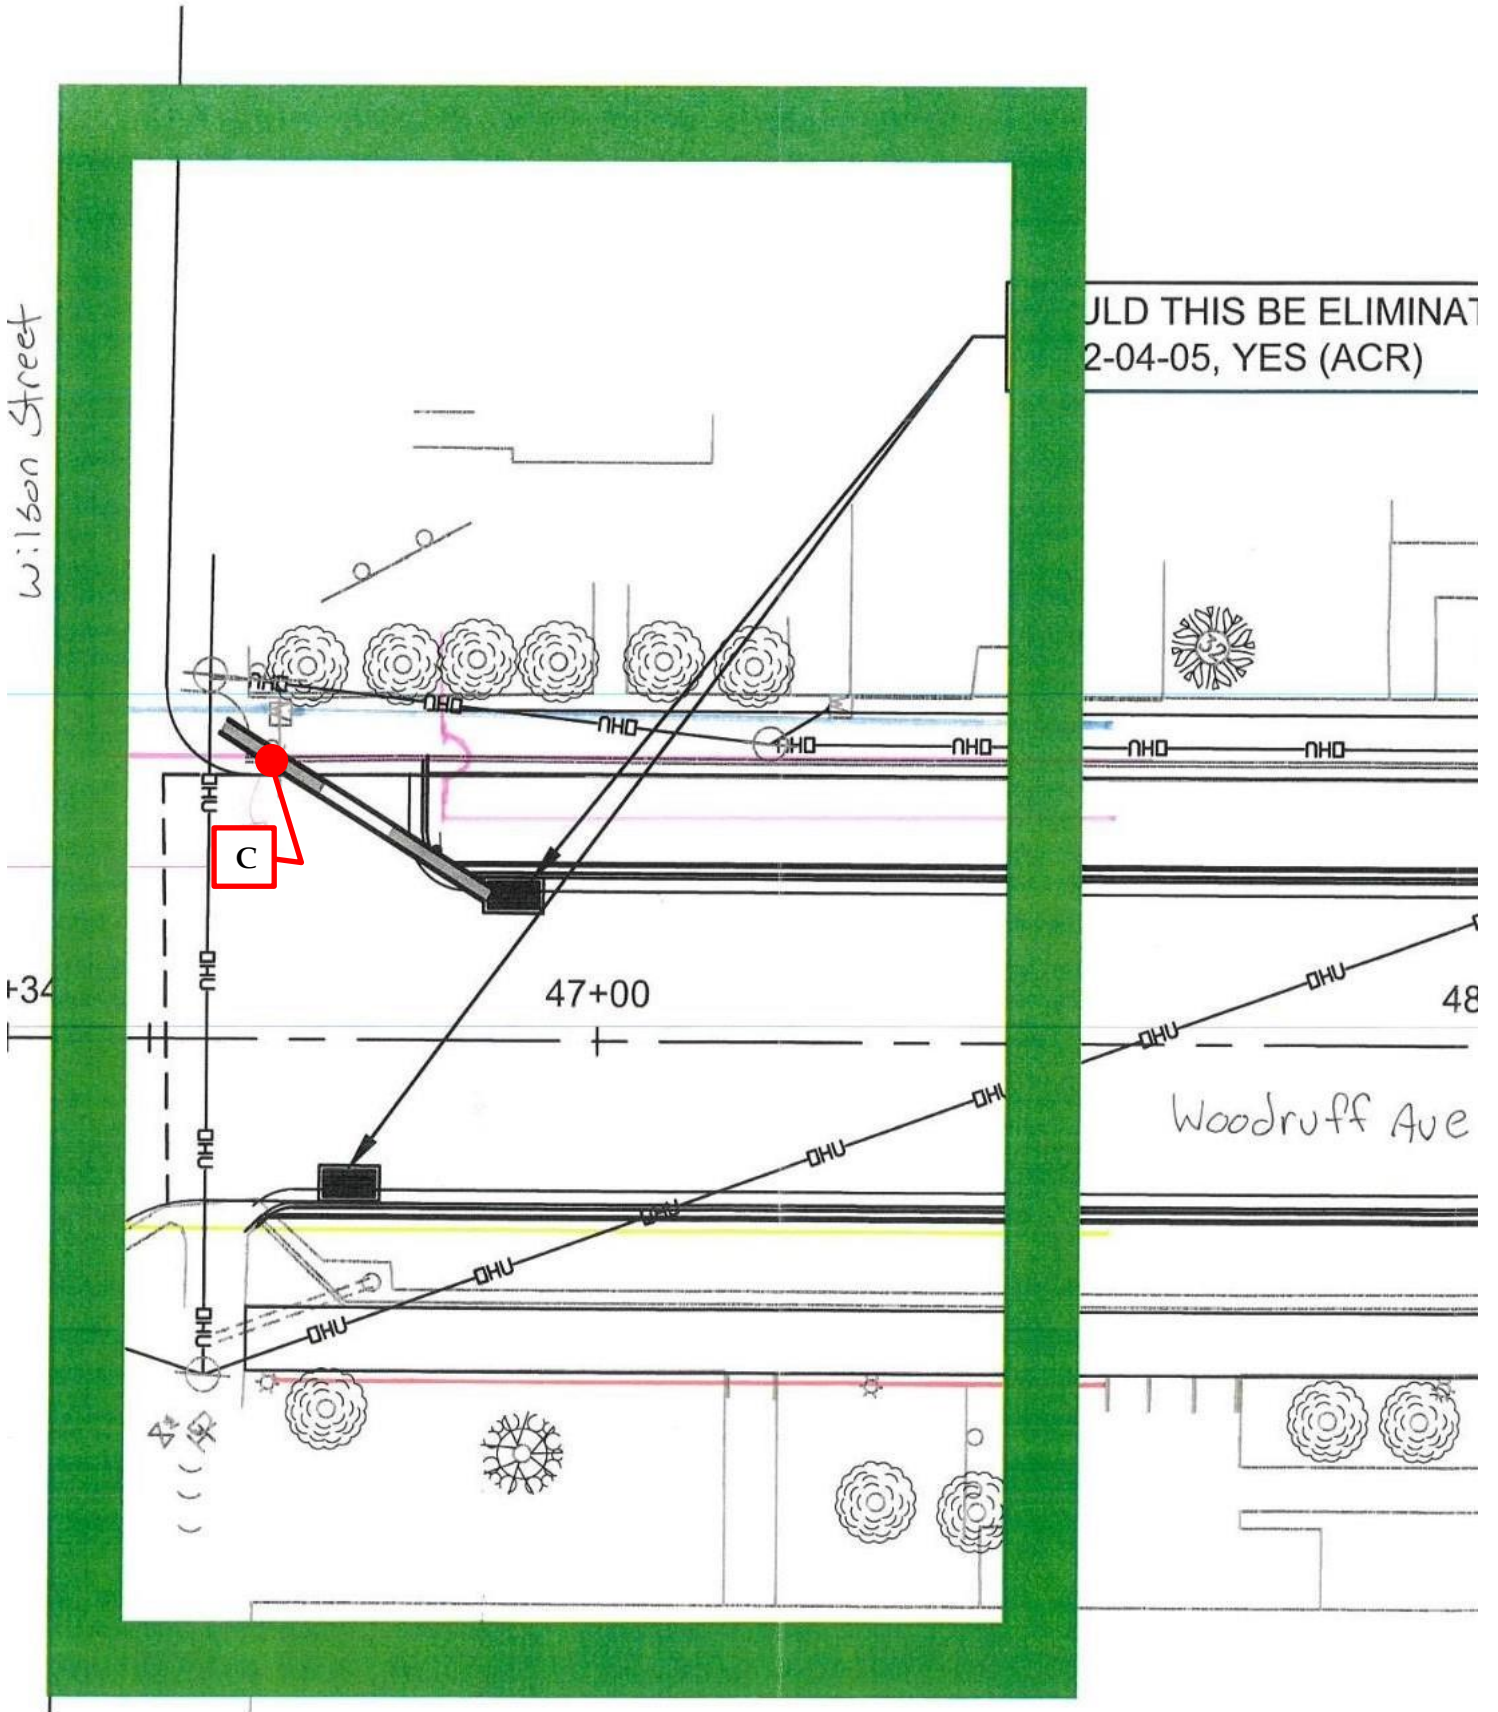
Figure 7. UT04 Field Sketch - Part 2

Level B locates were also performed at the intersection of Wilson St and Woodruff Ave. Utilities marked included gas, power and two unknown utilities (Fig.7, pg. 15). One design conflict was identified and Level A excavation was performed at site labeled C (Fig 7A, pg. 16). This was identified as a 15" VCP, but use was not able to be determined. The other unknown was

possibly sewer or storm, but it was not a conflict utility; Therefore, no Level A was performed and a determination was not able to be reached.

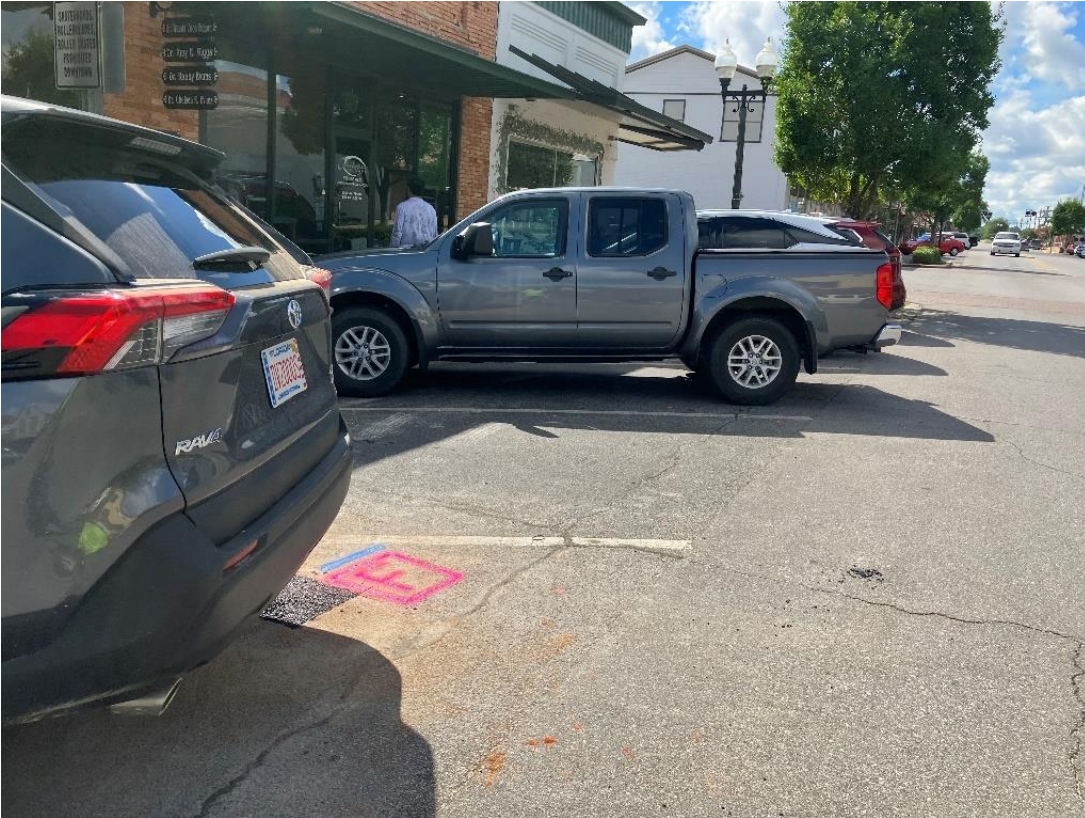
*Figure 6A. Location F – Okaloosa Eye Care - 207 Main St*

The Level A sites were located under asphalt and/or concrete curbing requiring the use of a cutoff saw and a jackhammer. The concrete repair was made immediately after identification using Quikrete fast-setting concrete mix and the corresponding label was painted on the surface for use by GCT.

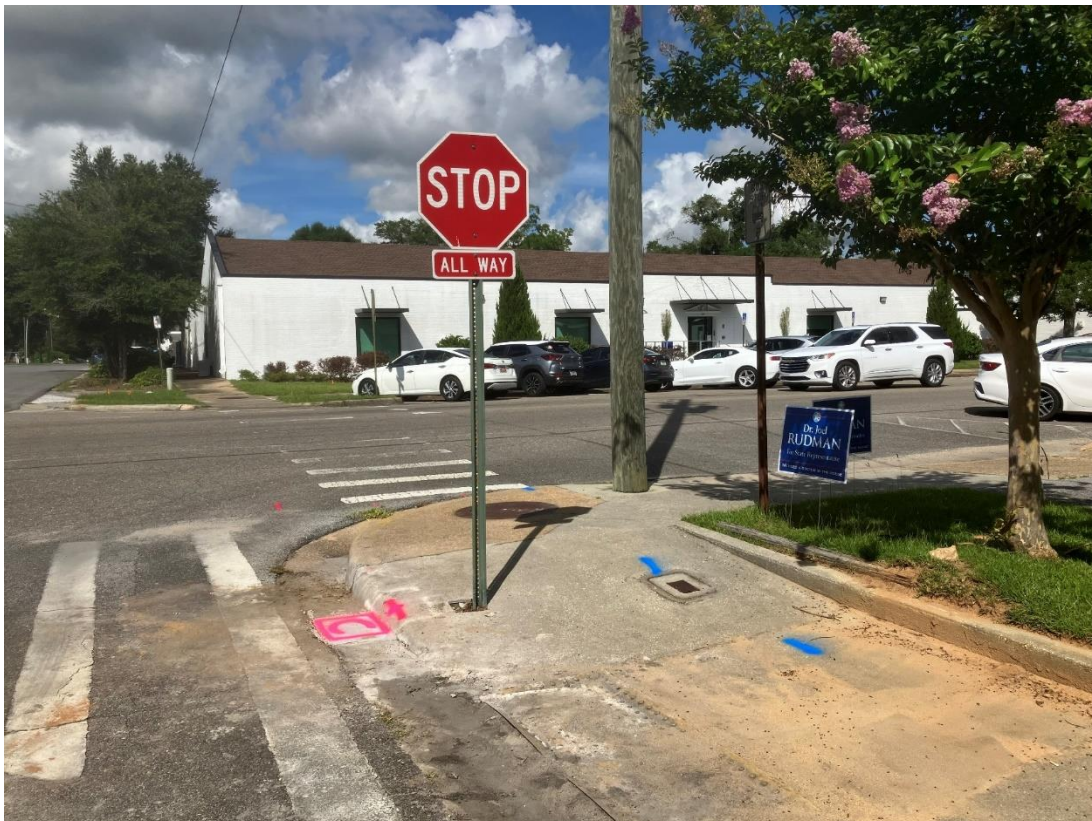
*Figure 7A. Location C – The Holloway Agency – 168 W Woodruff Ave*

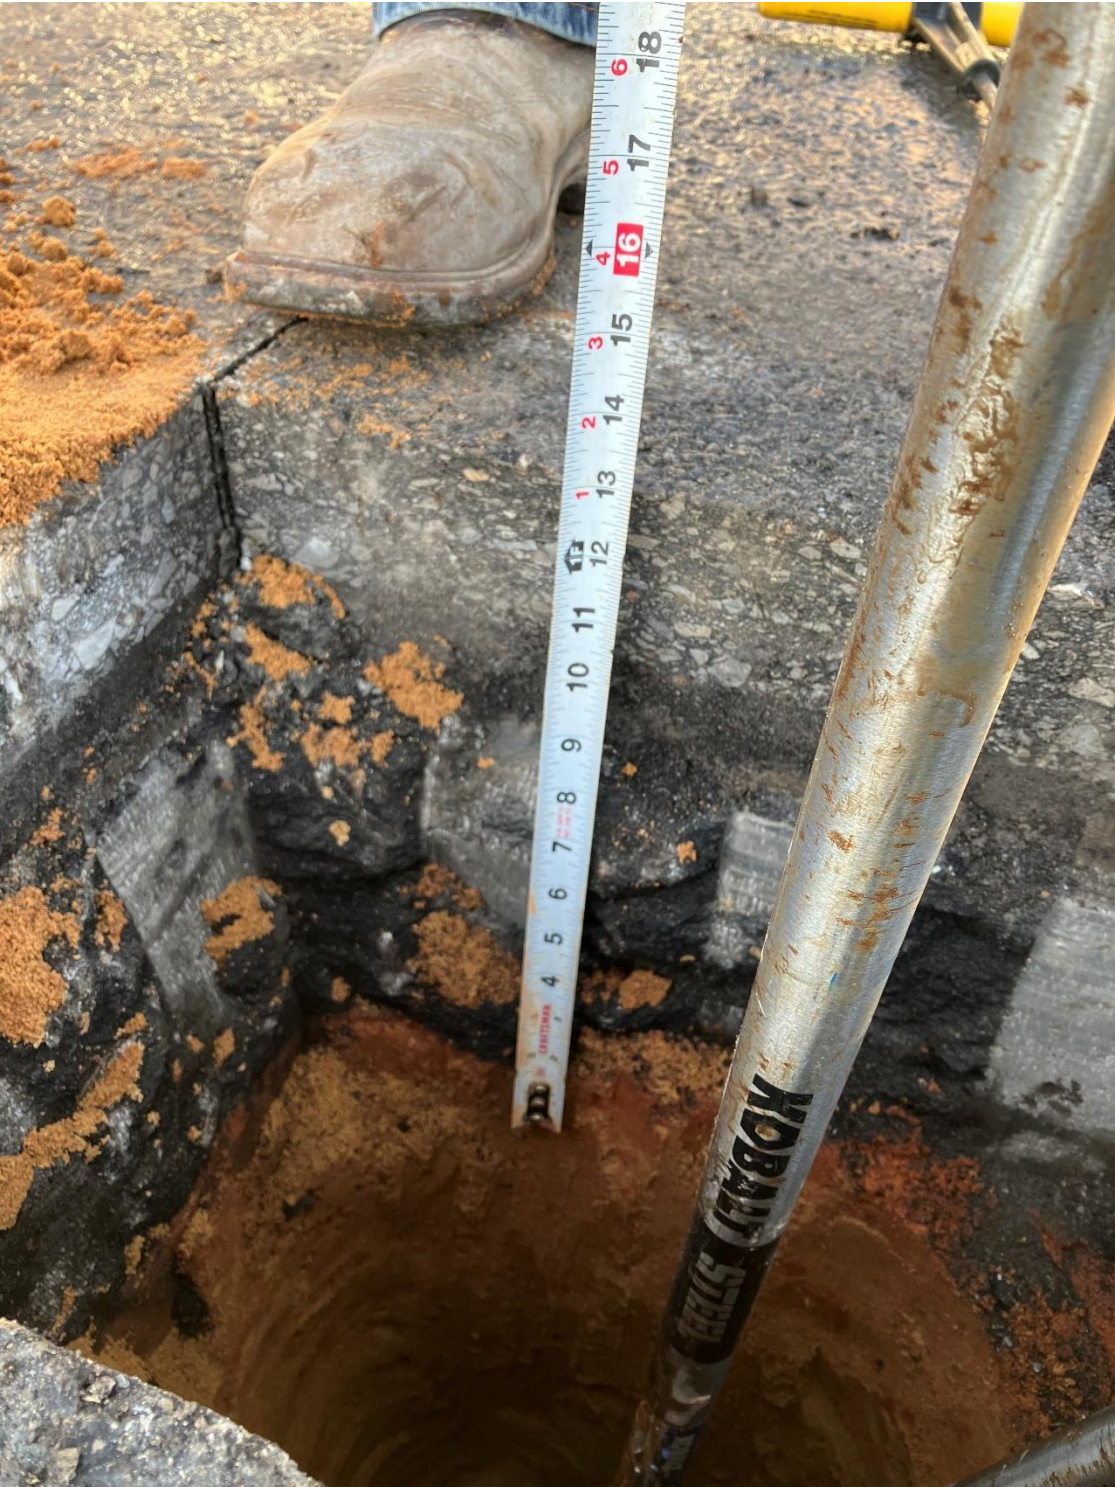
Figure 8. Main St Asphalt Thickness (Typ)

The Level A sites were all located under asphalt pavement of varying thickness (Fig. 8, pg. 17) requiring the use of a cutoff saw and a jackhammer. The asphalt repair was made immediately after identification using QPR asphalt patching and the corresponding labels were painted on the surface for use by GCT.
