LIMITED ASBESTOS AND LEAD-BASED PAINT INSPECTION REPORT
KAMINSKI HOUSE BATHROOMS

Georgetown, South Carolina

Asbestos Inspections, LLC Project # 2017-253

Inspection Completed On – December 18, 2017
Report Prepared On – December 21, 2017

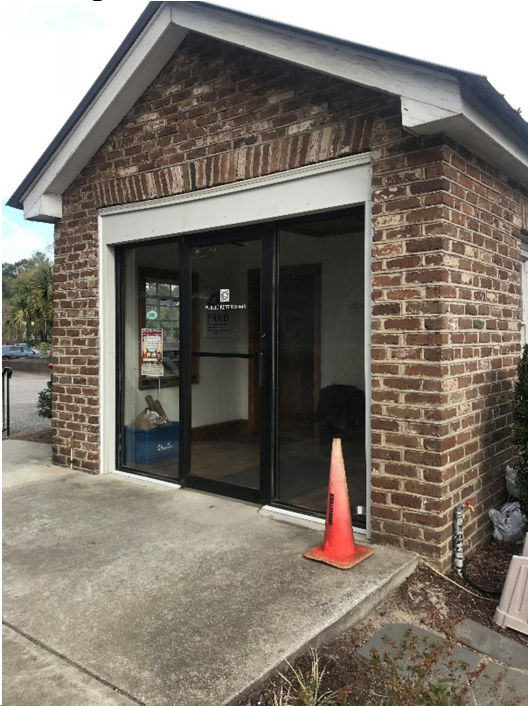
Building Exterior

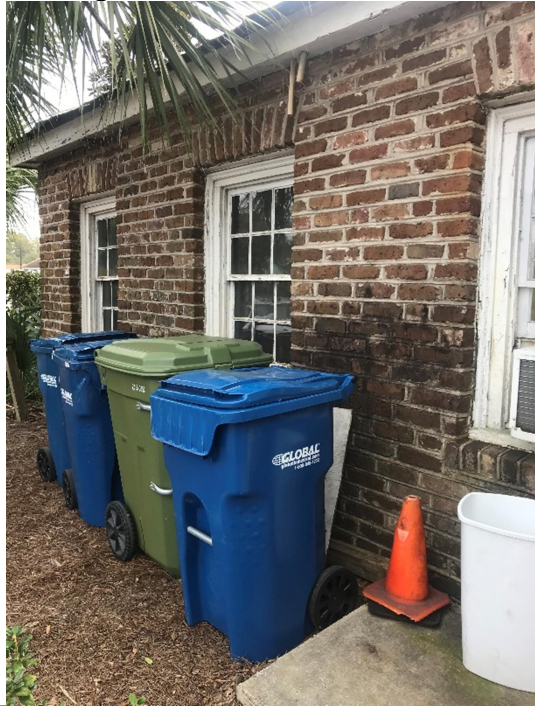
Building Exterior

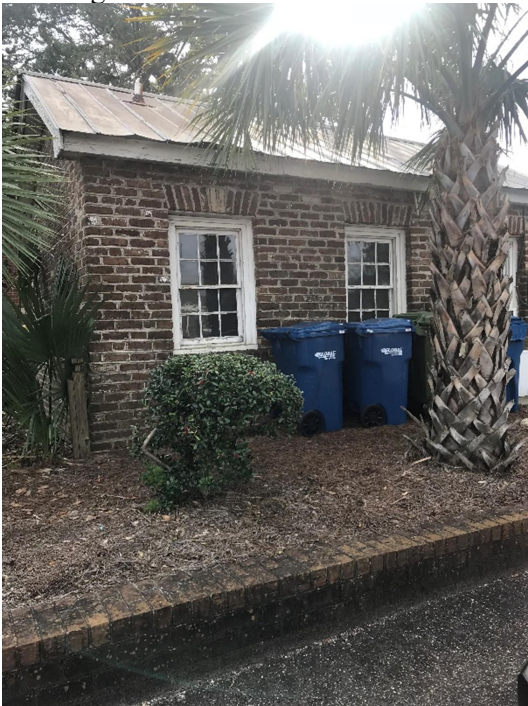
Building Exterior

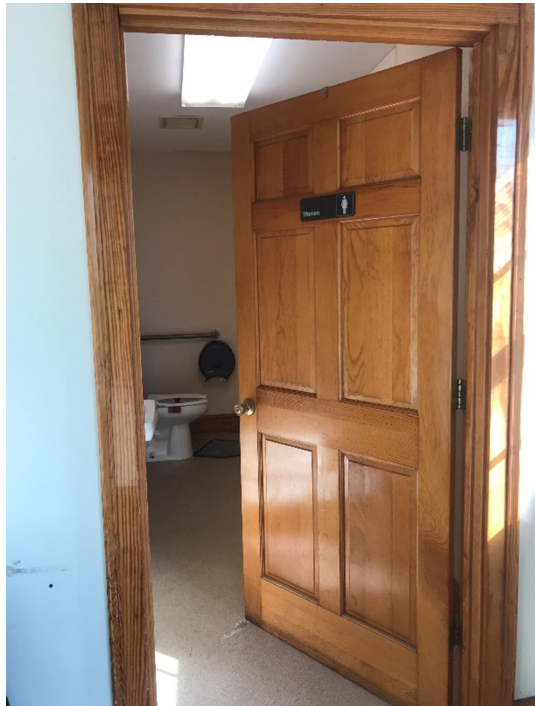
Women's Restroom
