**EVALUATION AND DESIGN CRITERIA REPORT
REVISION 3
DSA BACKCHECK**

BERKELEY CITY COLLEGE

**2118 Milvia Street
Berkeley, CA**

KPW Project No 16C129
DSA APPLICATION #01REH-10075

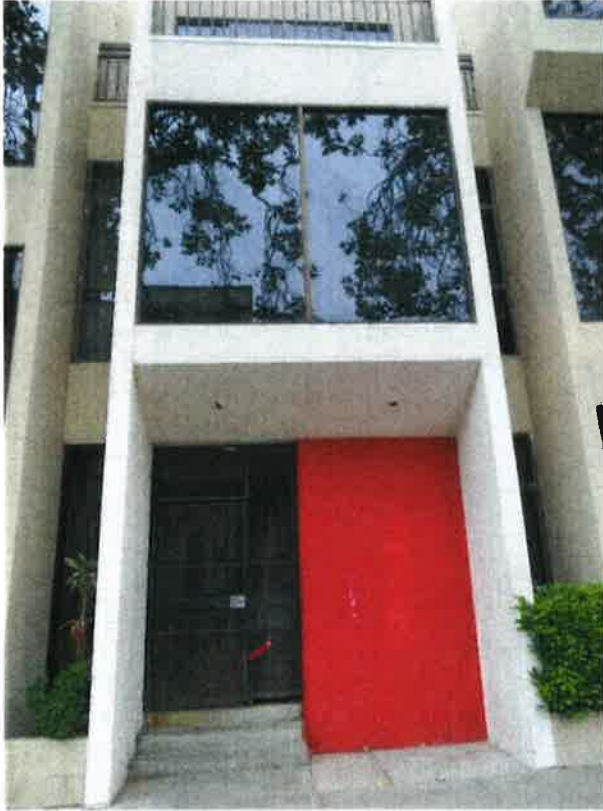
2118 Milvia Street – existing entry at south elevation, proposed egress only

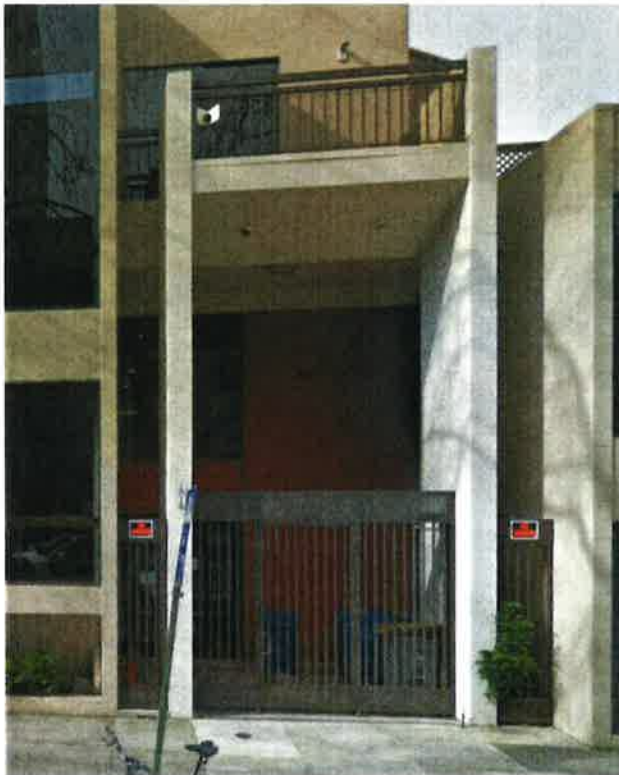
2118 Milvia Street – existing entry at east elevation, proposed egress only

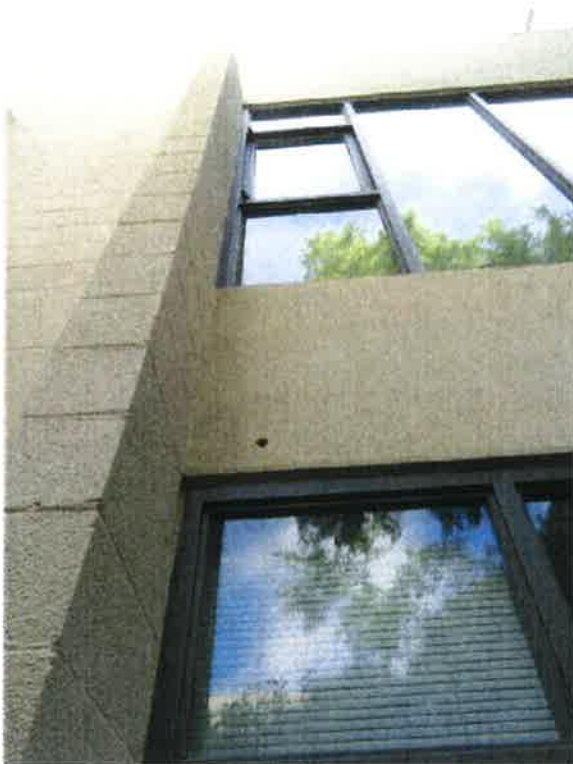
2118 Milvia Street – existing wire glass in steel frames at north elevation to be replaced

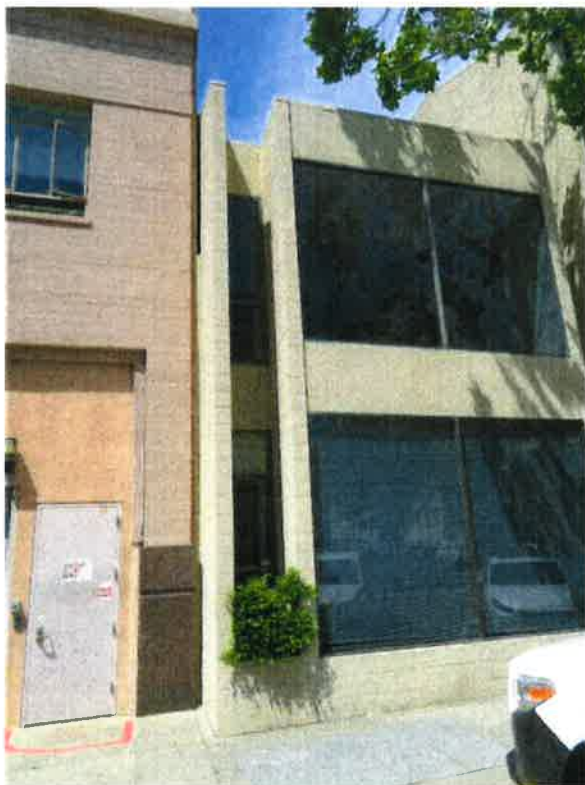
2118 Milvia Street – joint between west wall and adjoining building (1947 Center Street)

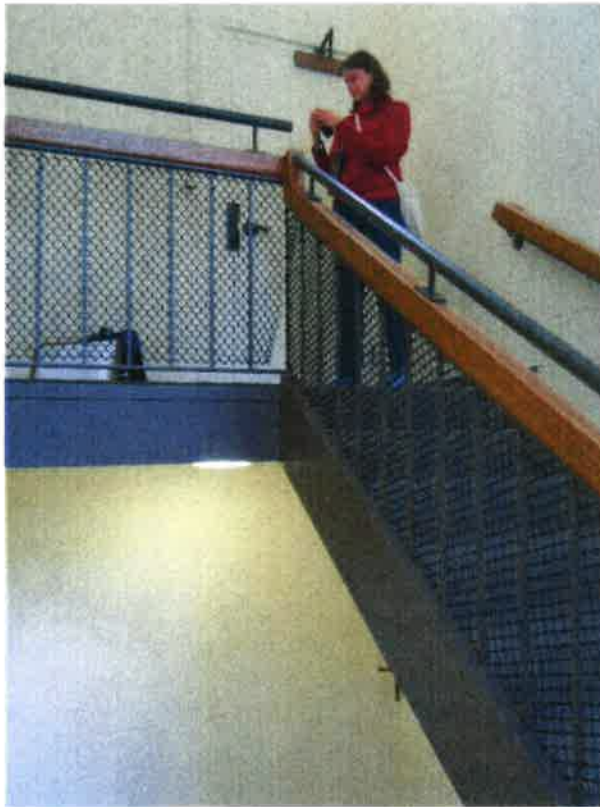
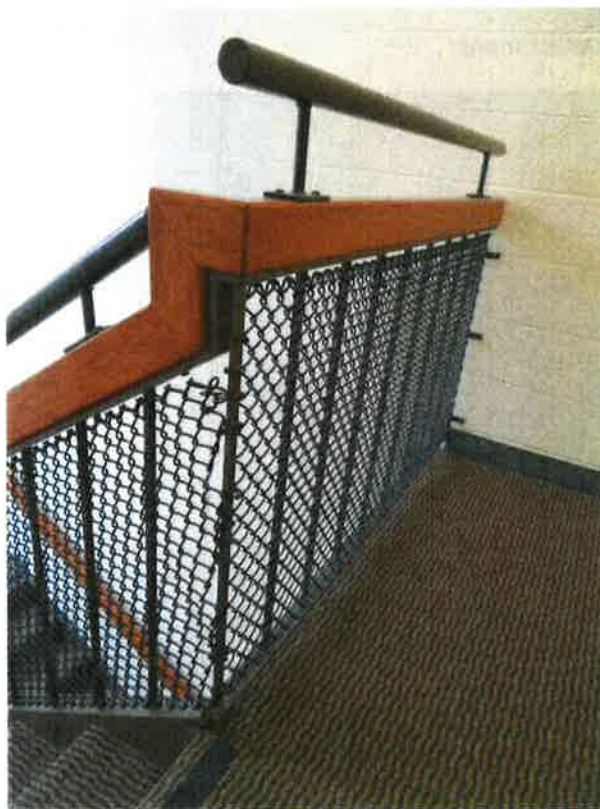
2118 Milvia Street – existing steel and concrete filled metal pan stair – guardrail to be replaced

Stair handrails and guardrails do not meet current code requirements for height. The railings will be replaced with new or modified to meet current CBC requirements.

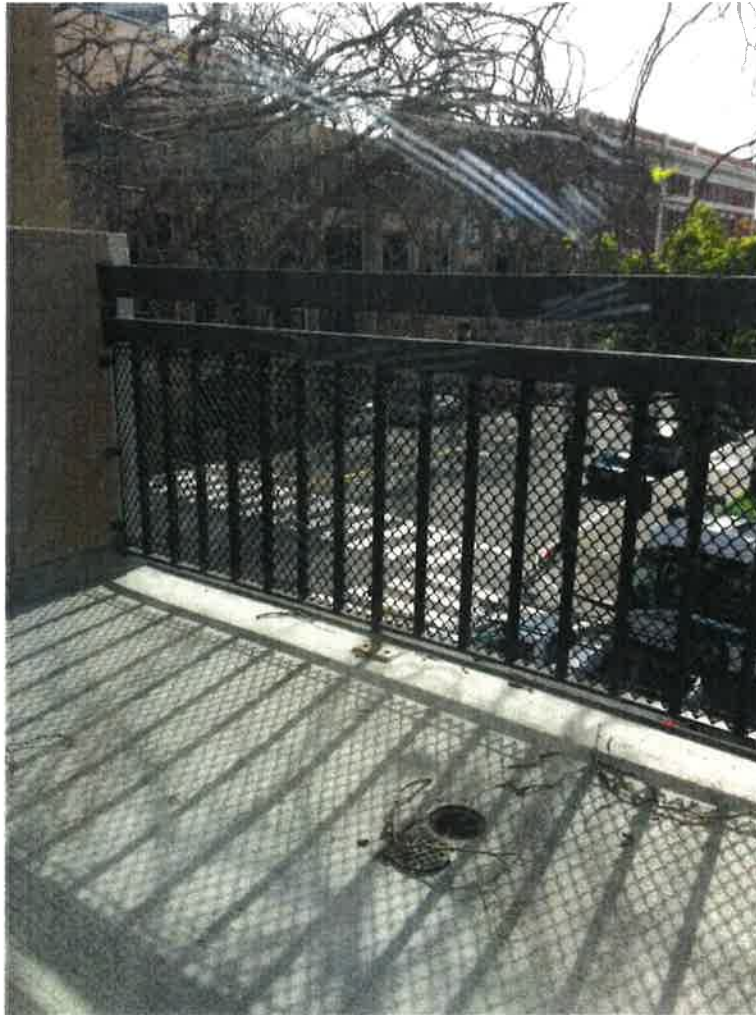
2118 Milvia Street – existing deck – guardrail to be modified or replaced

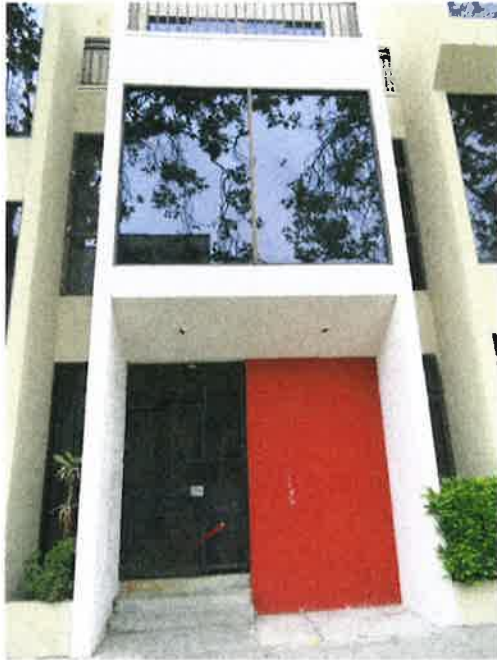
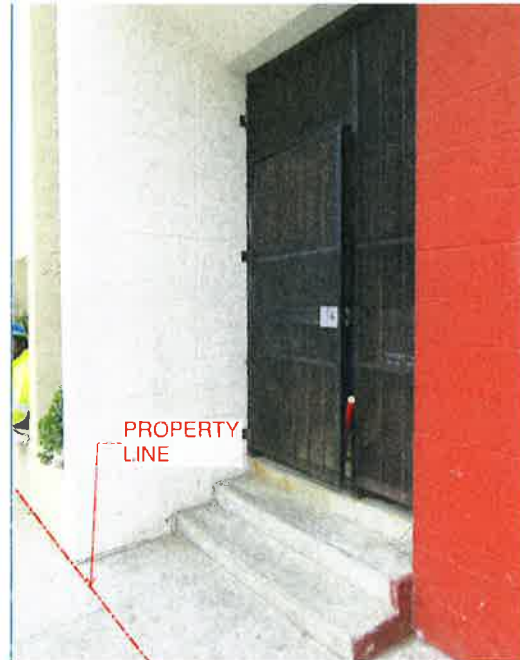
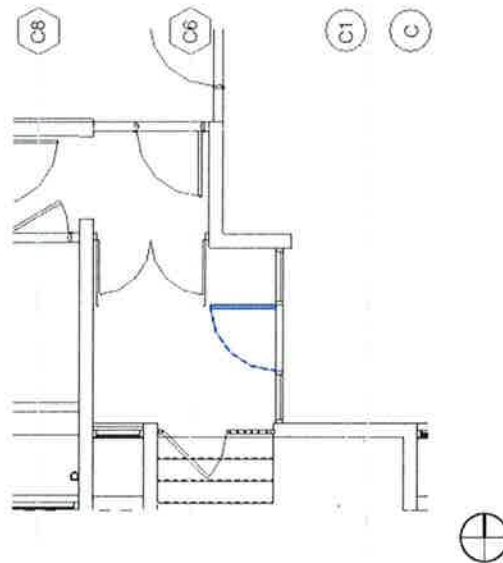
The exit on Center Street is approximately 18 inches above the sidewalk to finish floor level. This project proposes to reconfigure the existing stairs, railings, and security gates to meet Chapter 10, exiting. It will not be possible to make this a wheelchair accessible entrance due to property line and public sidewalk constraints, however, the two entries on Milvia will be wheelchair accessible. The public entrance to the building is at the corner of Center and Milvia, which is approximately 70 feet from the exit on Center Street.

2118 Milvia Street – existing entry at south elevation (Center Street)
photographs and plan

The existing building is constructed right to the property line/back of sidewalk and there is no room to configure the new steps out beyond the property line. As shown in the proposed plan on page 3 of this document, this project provides a 40" wide stair between the CMU building wall and the property line. In addition, the top handrail extension will encroach into the security gate clearance.

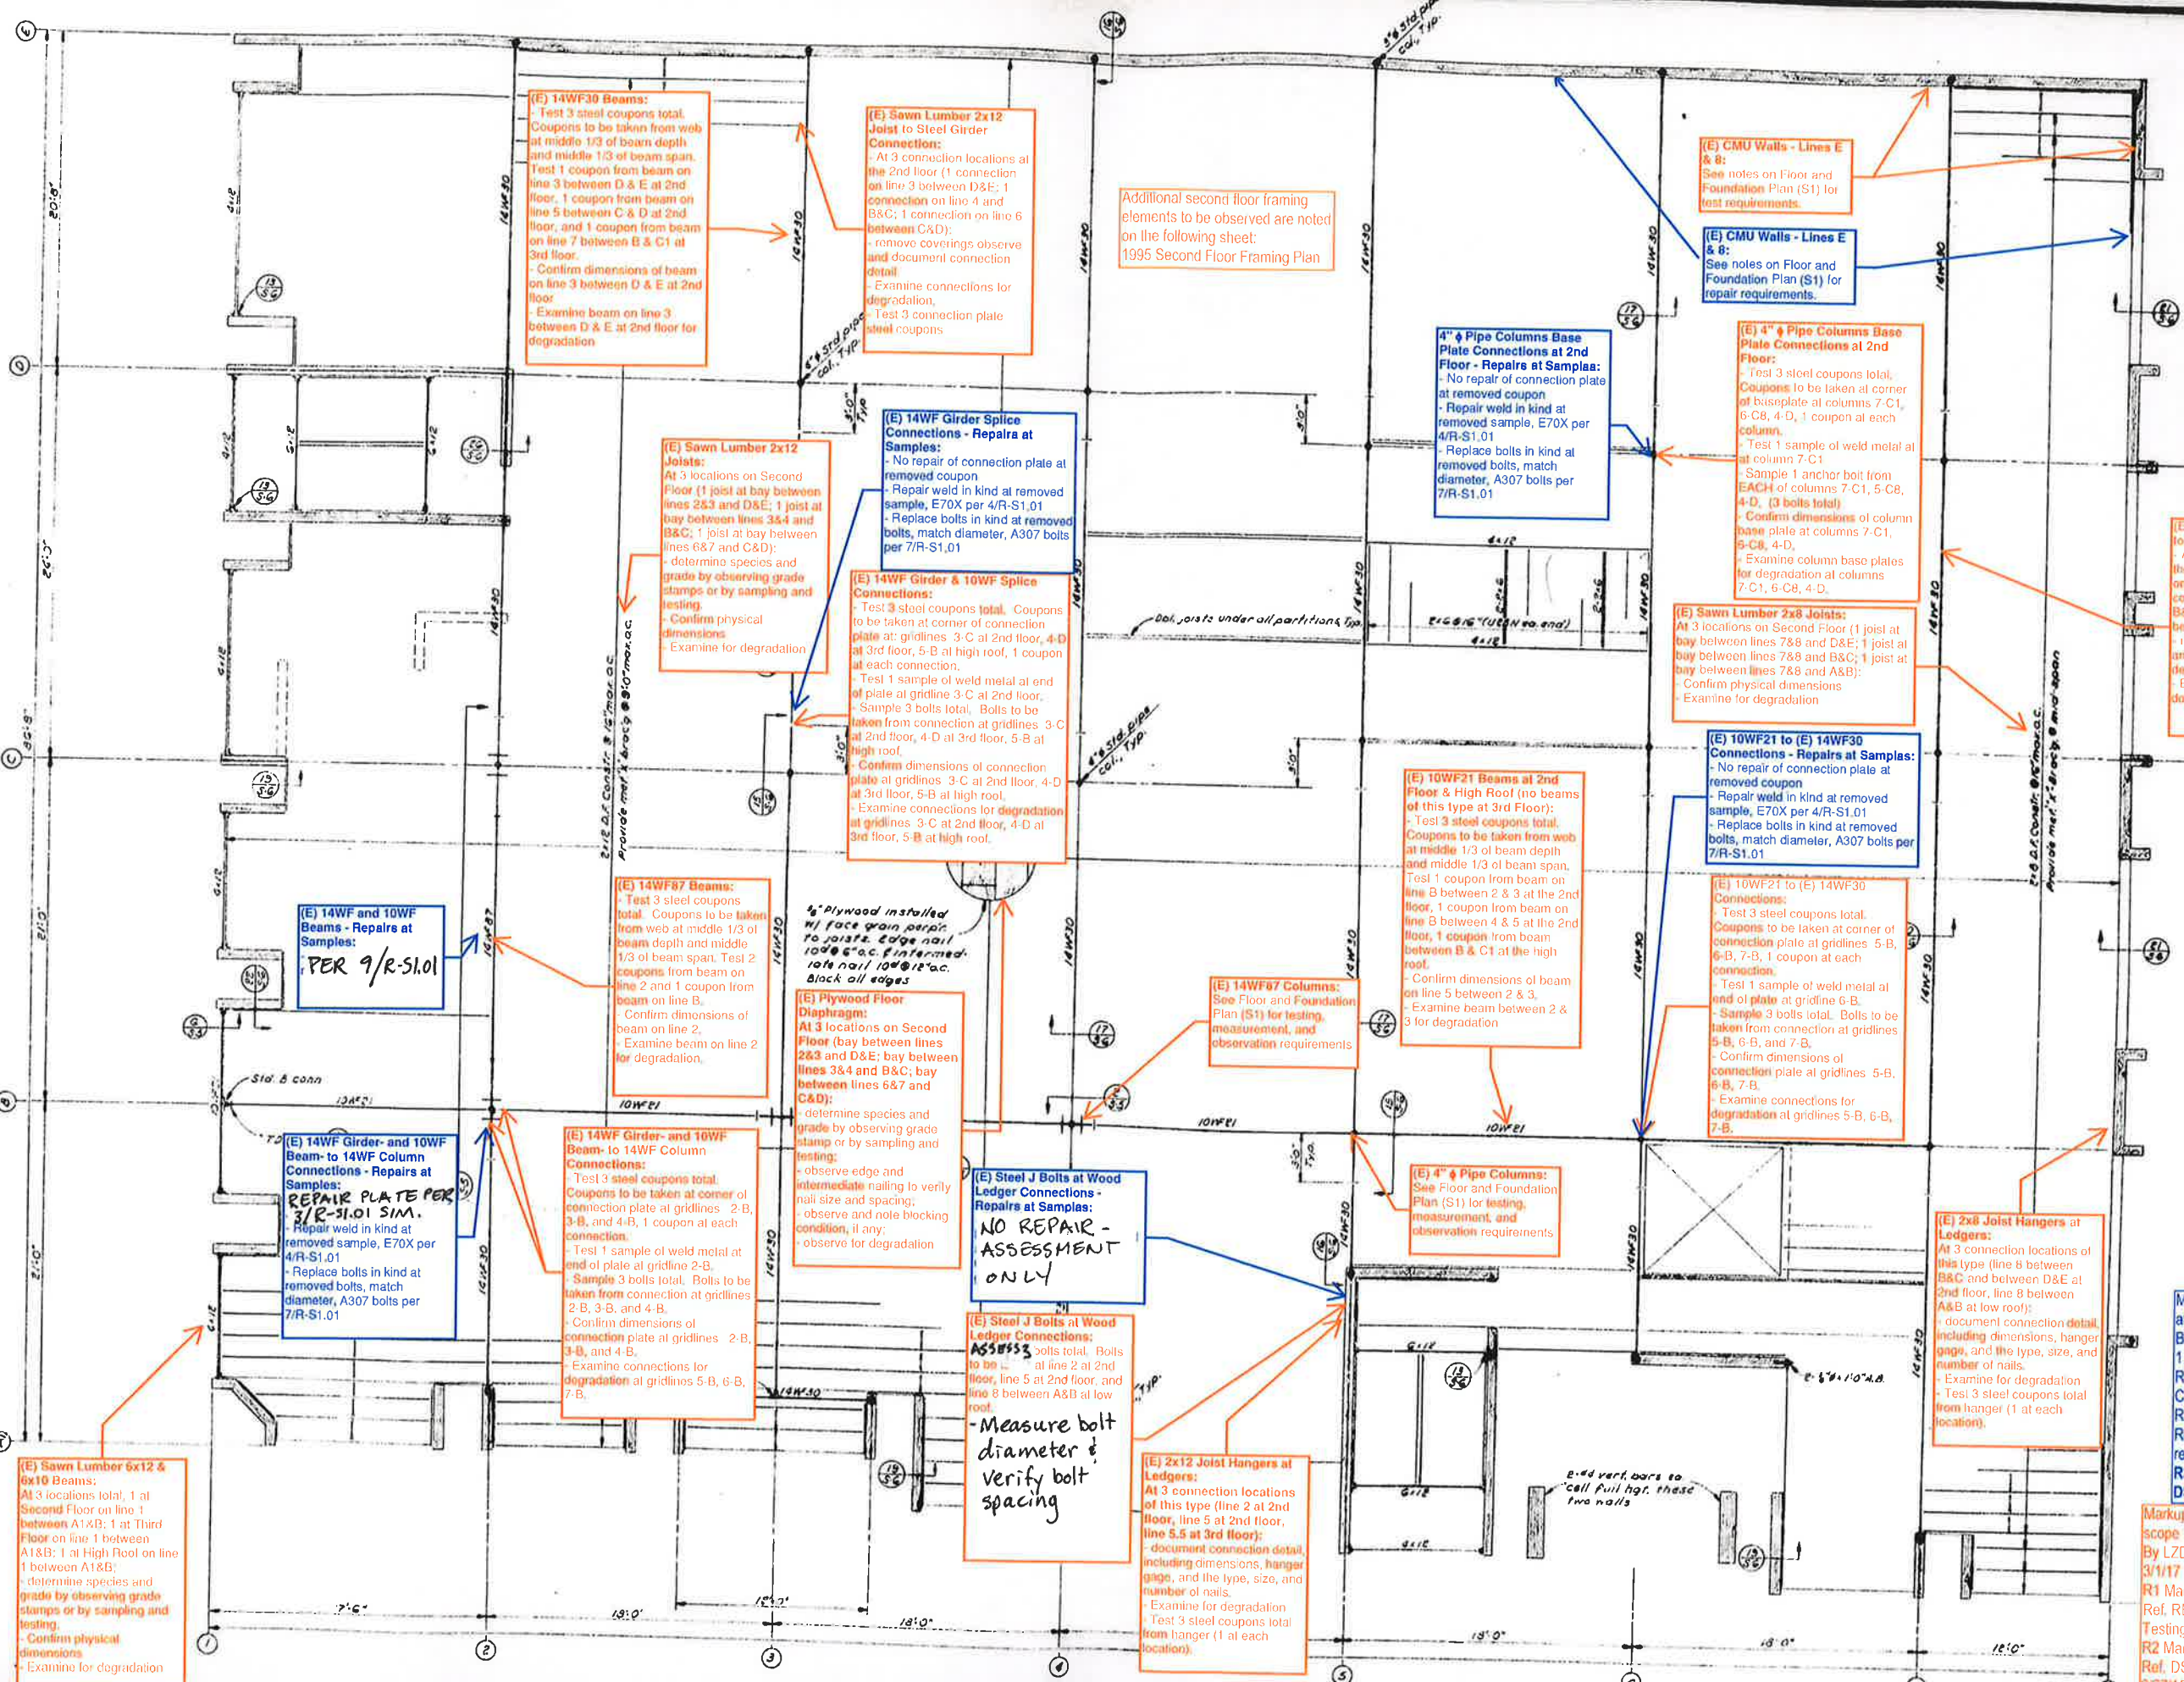
(E) 14WF30 Beams:
- Test 3 steel coupons total. Coupons to be taken from web at middle 1/3 of beam depth and middle 1/3 of beam span.
- Test 1 coupon from beam on line 3 between D & E at 2nd floor, 1 coupon from beam on line 5 between C & D at 2nd floor, and 1 coupon from beam on line 7 between B & C at 3rd floor.
- Confirm dimensions of beam on line 3 between D & E at 2nd floor.
- Examine beam on line 3 between D & E at 2nd floor for degradation.

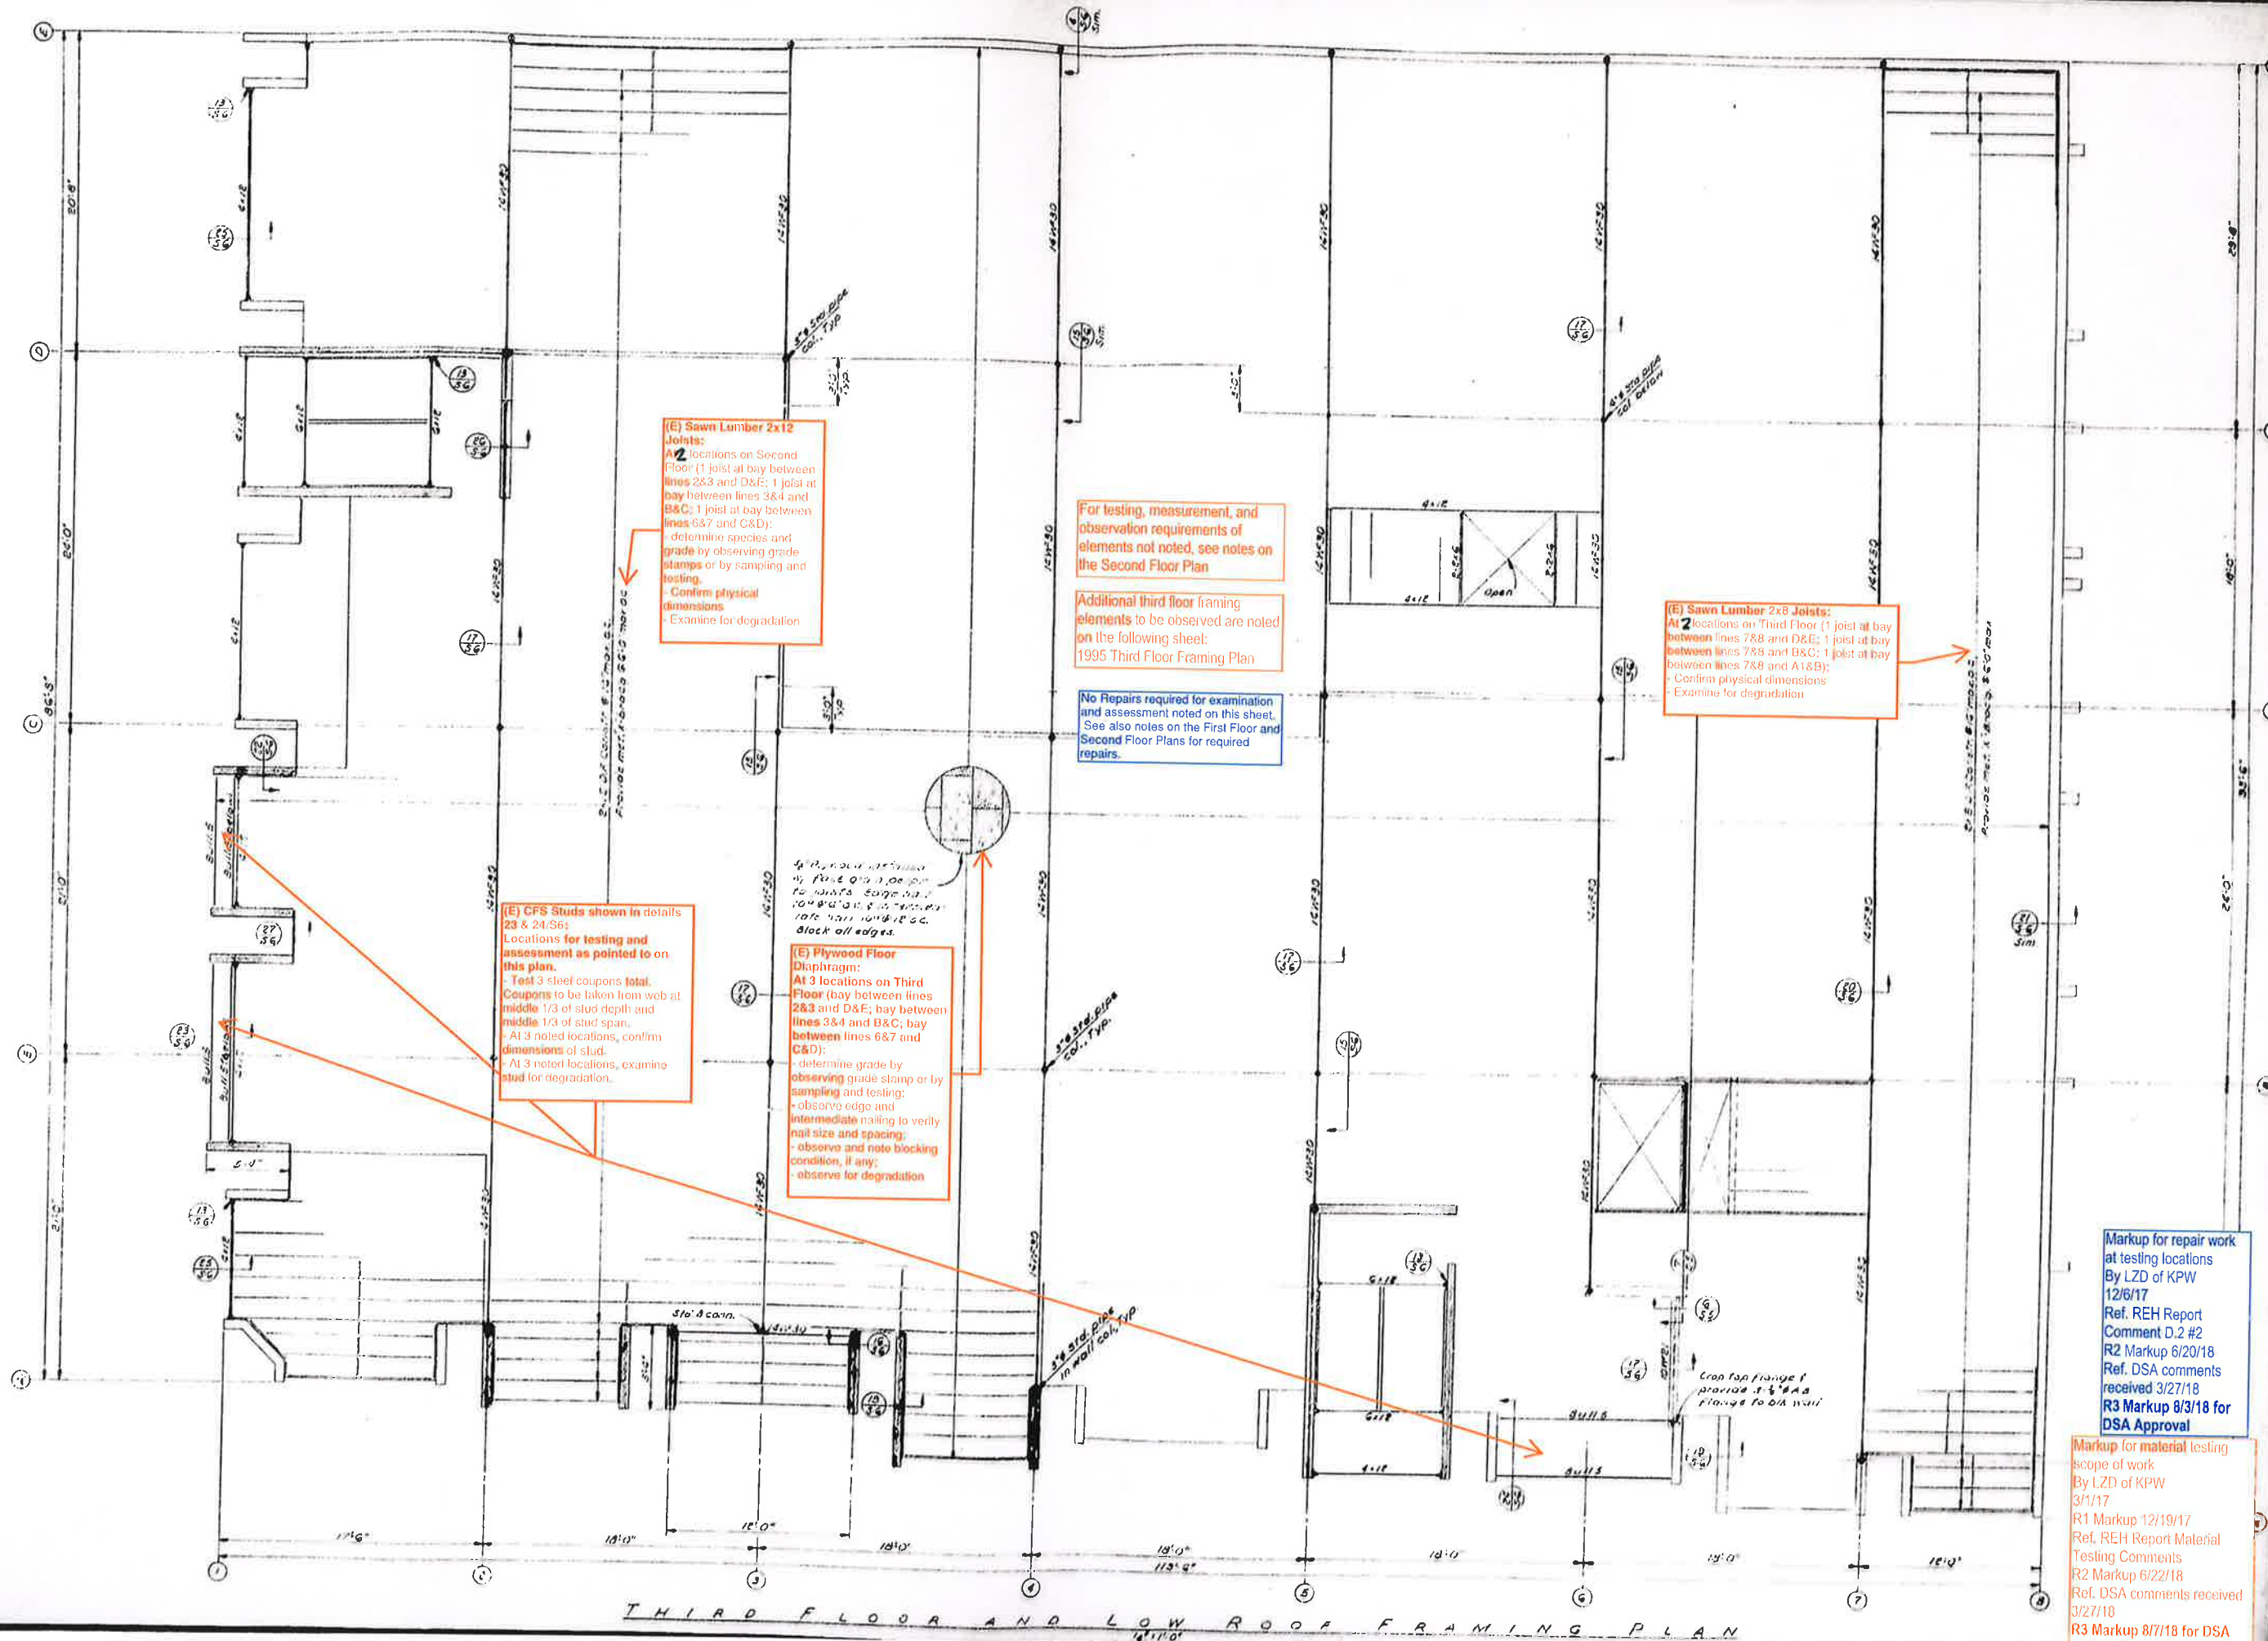
(E) Sawn Lumber 2x12 Joists:
At 2 locations on Second Floor (1 joist at bay between lines 283 and D&E; 1 joist at bay between lines 3&4 and B&C; 1 joist at bay between lines 6&7 and C&D);
- determine species and grade by observing grade stamps or by sampling and testing;
- Confirm physical dimensions;
- Examine for degradation
