Asbestos & Lead Based Paint Assessment

City of Spartanburg
770 Hart Street
Spartanburg, South Carolina 29306

Project Number: 0122-17

February 17, 2022

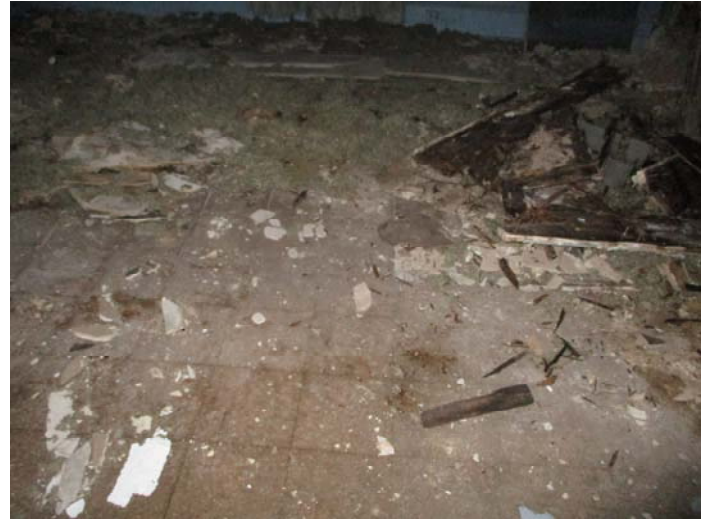
Photo 2 – 9"x9" brown streaked floor tile & mastic in the front left bedroom

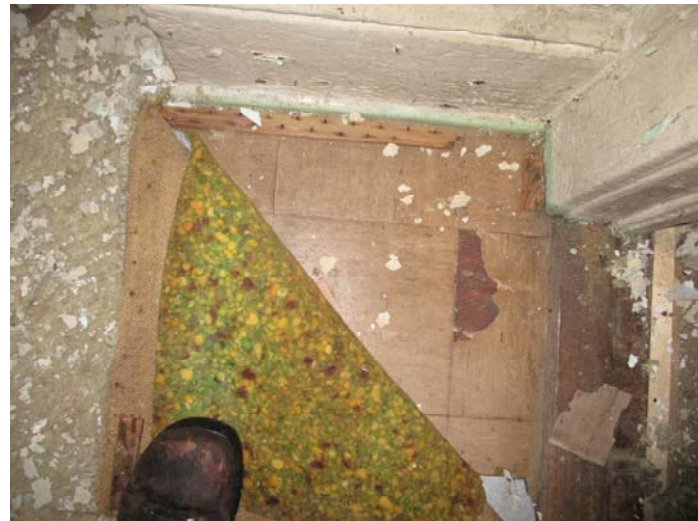
Photo 3 – 9"x9" brown streaked floor tile & mastic under carpet in the living room & hallway

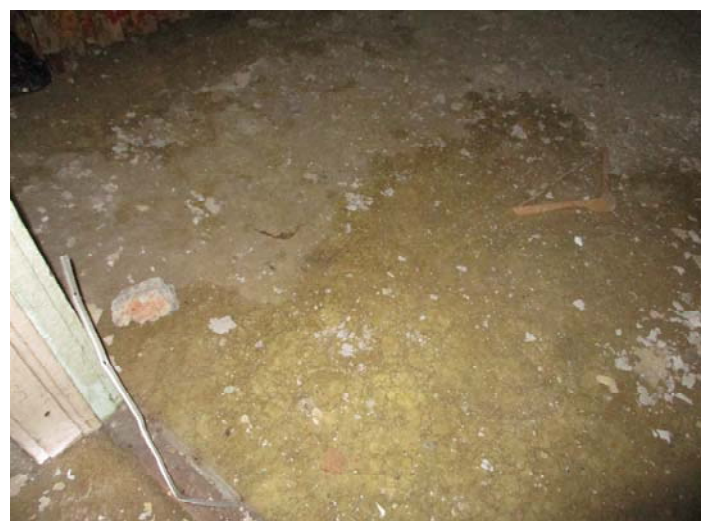
Photo 4 – Tan rock fissure pattern roll vinyl floor over 4 layers of vinyl floors & adhesives in the dining room

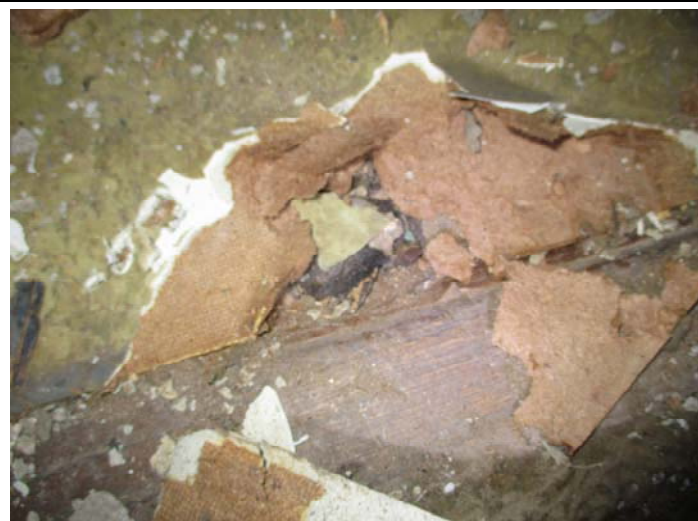
Photo 5 – Tan rock fissure pattern roll vinyl floor over 4 layers of vinyl floors & adhesives in the dining room

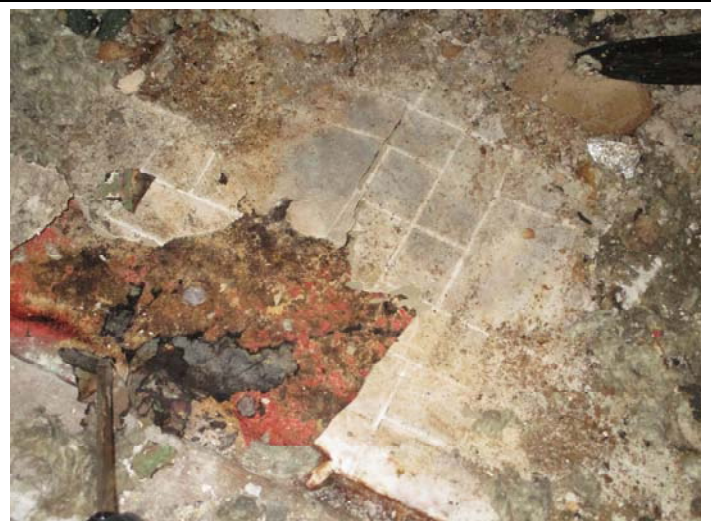
Photo 6 – Tan & gray pattern roll vinyl floor over 5 layers of vinyl floors & adhesives in the kitchen

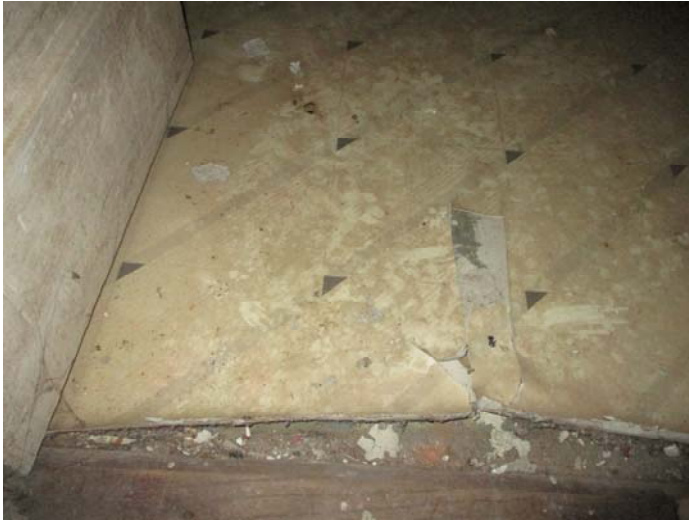
Photo 7 – Tan with gray stripes roll vinyl floor with backing & adhesive in the bathroom

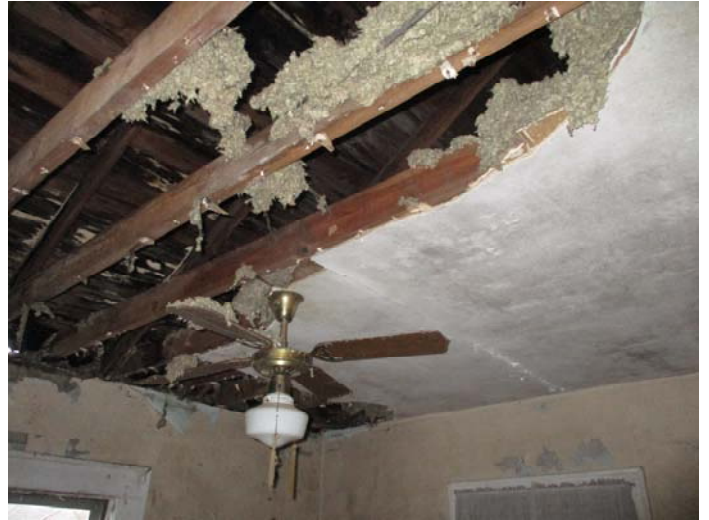
Photo 8 – Typical view of plaster with finish walls & ceilings throughout the residence

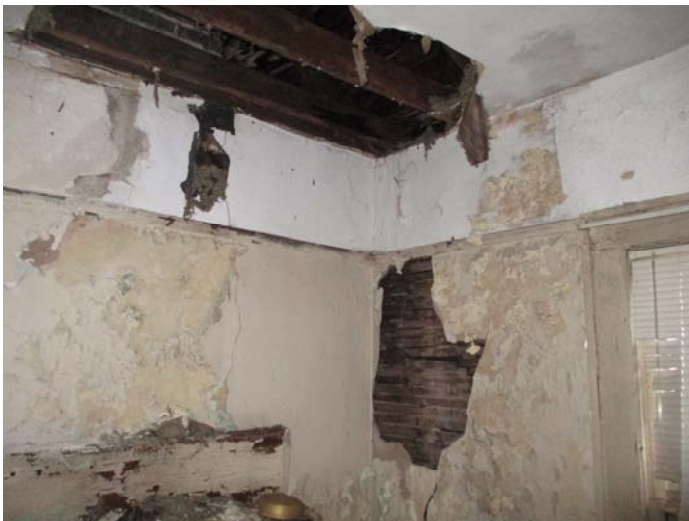
Photo 9 – Typical view of plaster with finish walls & ceilings throughout the residence

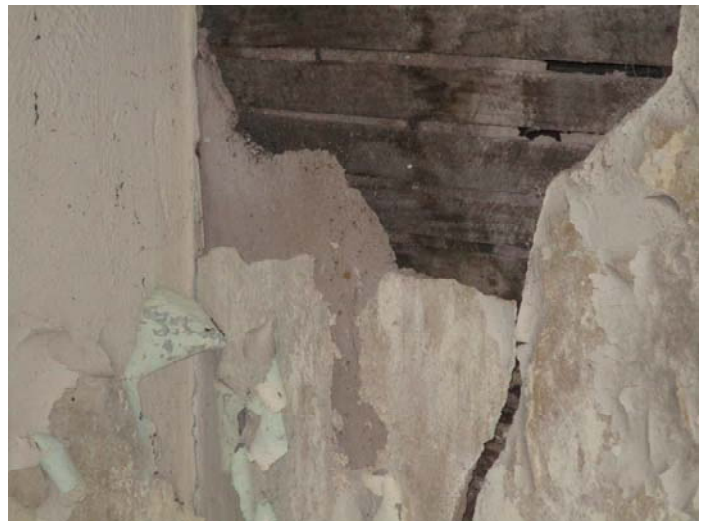
Photo 10 – Typical view of plaster with finish walls & ceilings throughout the residence

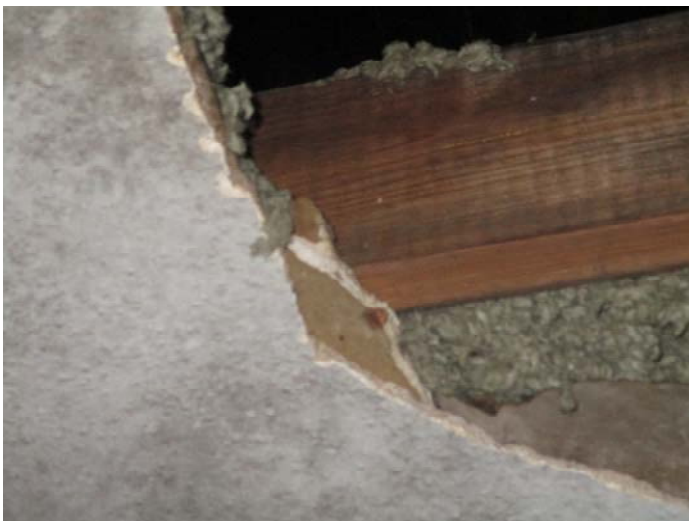
Photo 11 – Unfinished drywall beneath plaster scattered throughout the residence

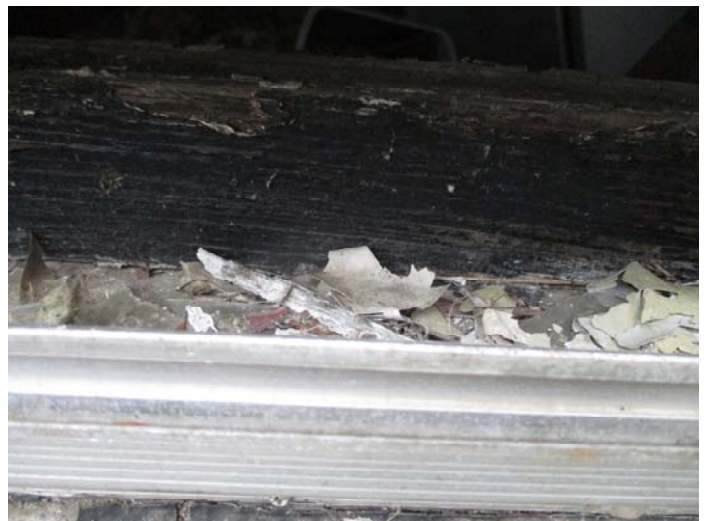
Photo 12 – Wooden window glazing

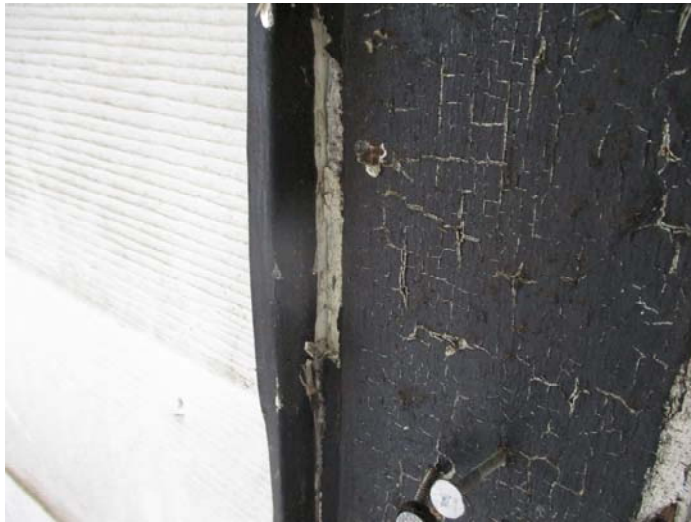
Photo 13 – Hard white caulk on wooden window & door casings

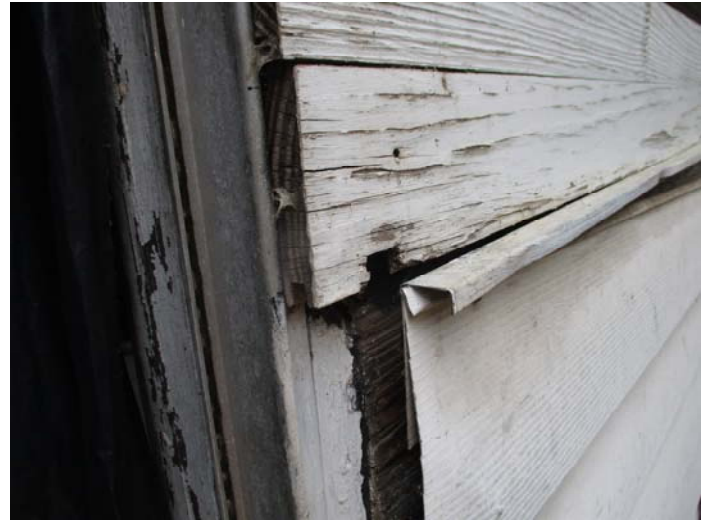
Photo 14 – White filler material in wooden siding in the back door area

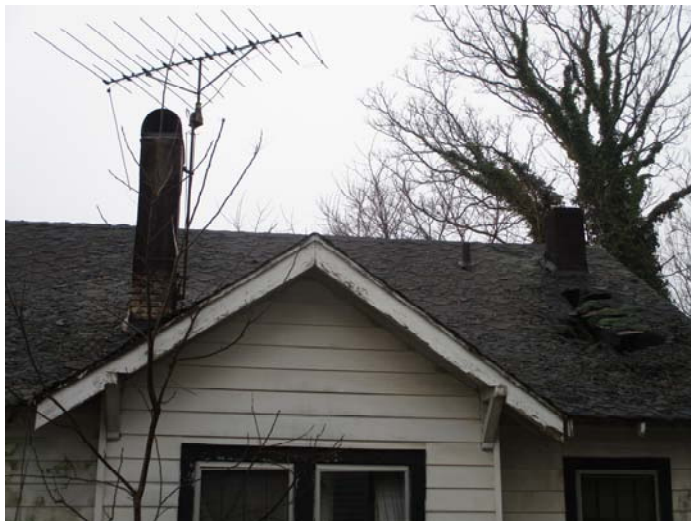
Photo 15 – Typical view of house roof with 2 chimneys with tar that are presumed positive for asbestos

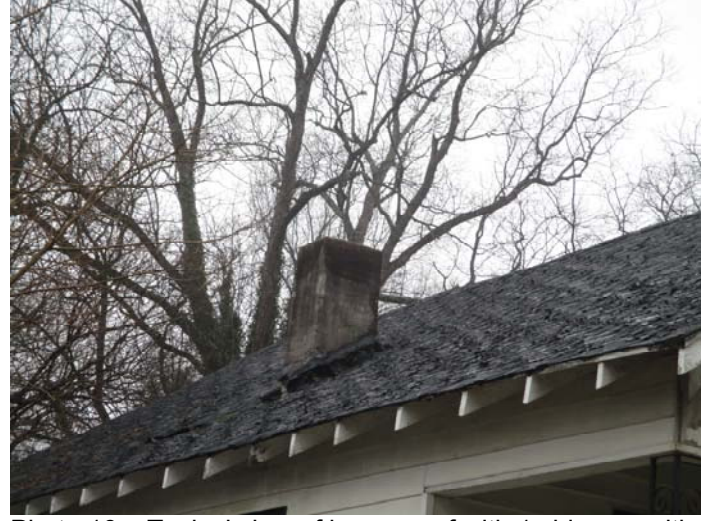
Photo 16 – Typical view of house roof with 1 chimney with tar that are presumed positive for asbestos

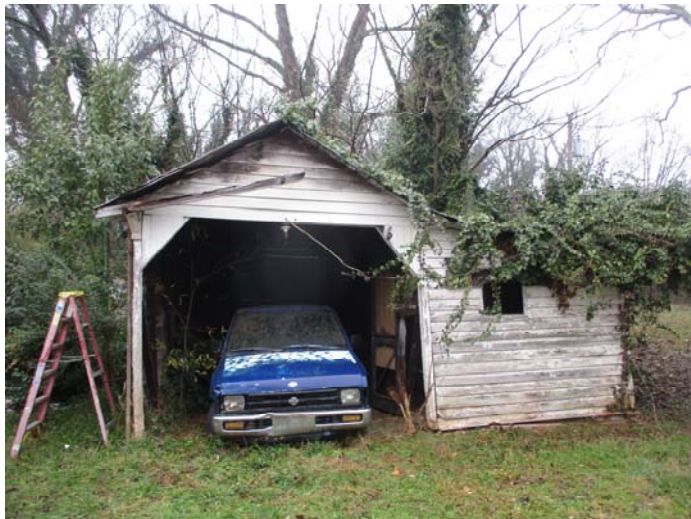
Photo 17 – Front shed with wooden construction & silver sealant on the metal roof

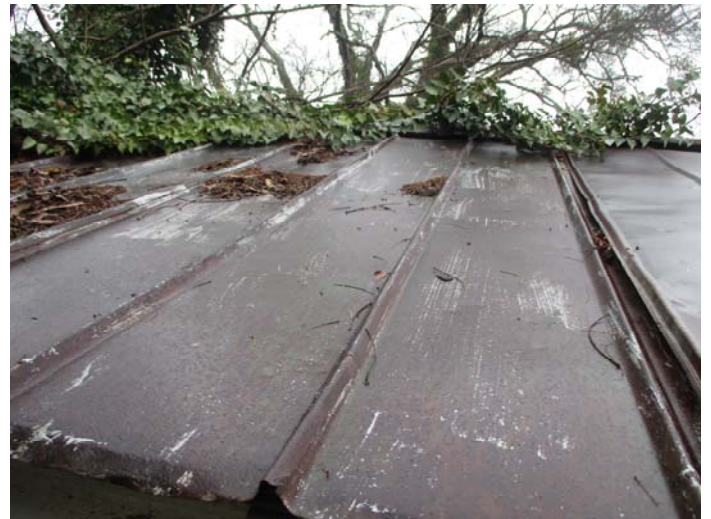
Photo 18 – Front shed with silver sealant on the metal roof

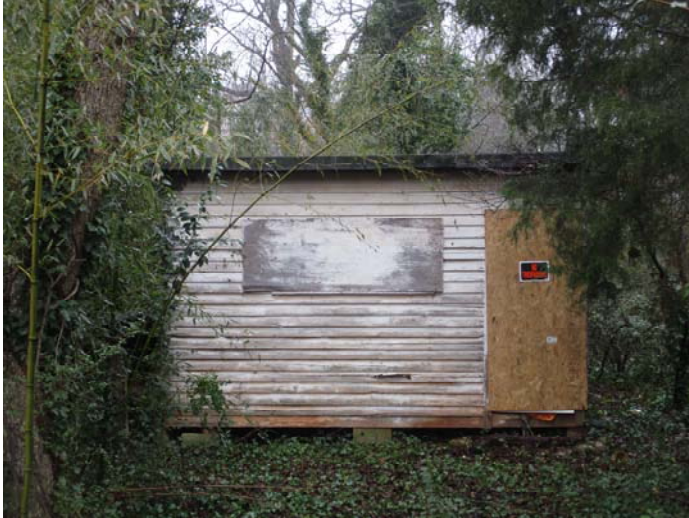
Photo 19 – Back shed with wooden construction & shingle and felt on the roof

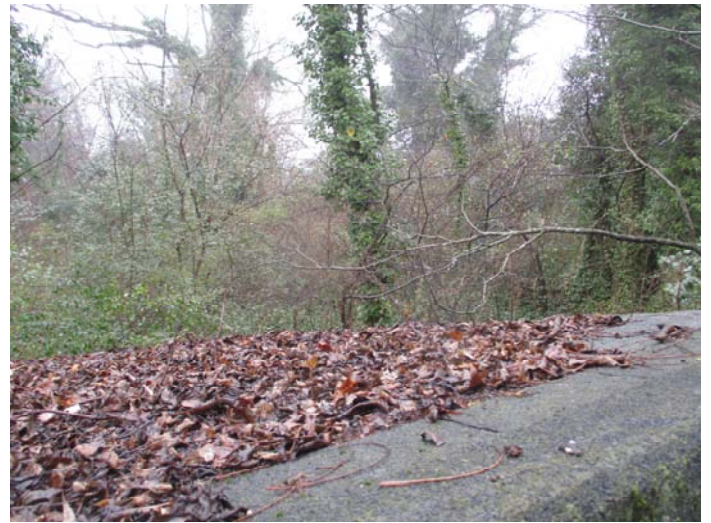
Photo 20 – Back shed with shingle and felt on the roof
