## **Asbestos & Lead Based Paint Assessment**

100 Prospect Street  
Spartanburg, South Carolina 29306

Project Number: 0118-14

August 14, 2017

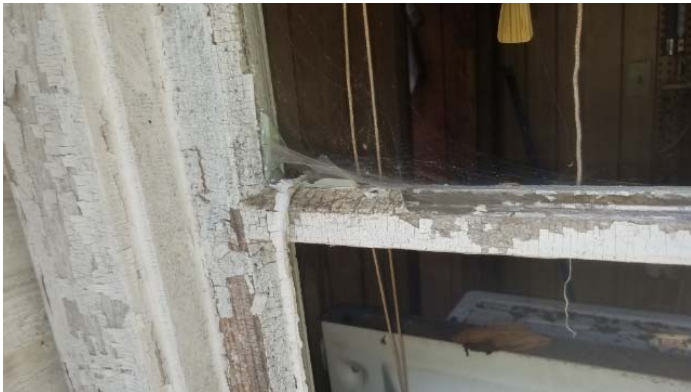
Photo 3 – Window caulk and glaze.

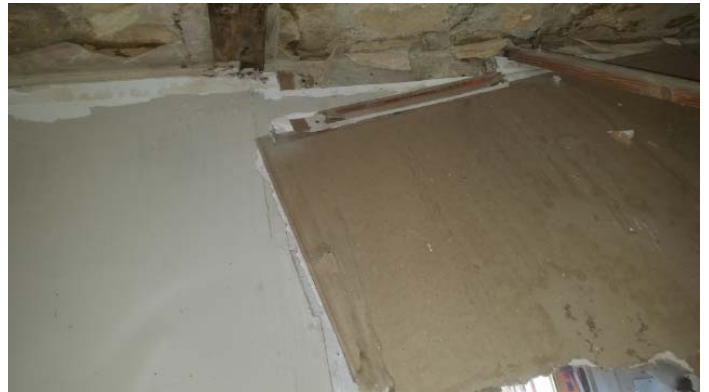
Photo 4 – Dry wall.

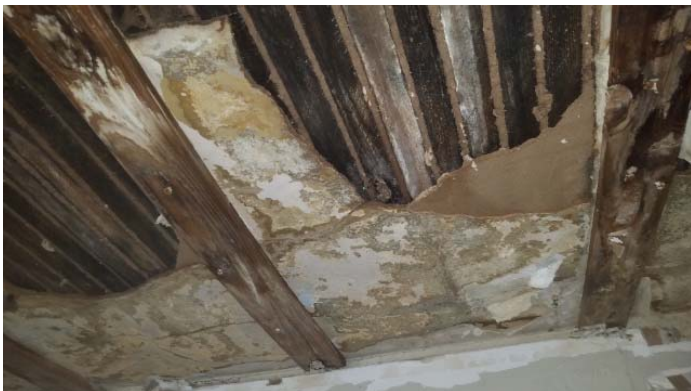
Photo 5 – Ceiling plaster.

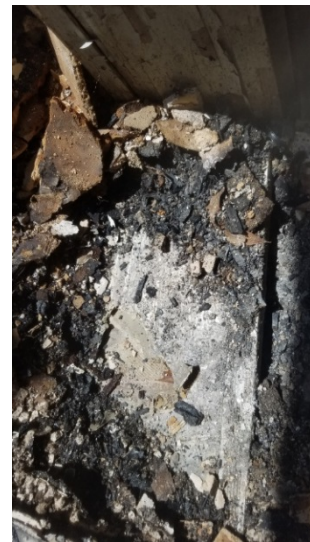
Photo 6 – Bathroom flooring in the addition.

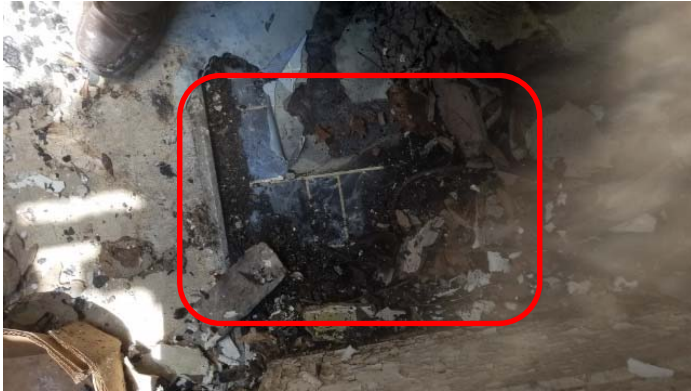
- Kitchen self-adhesive tile – 10% Chrysotile – 120 SF

Photo 7 – Kitchen self-stick flooring.

1. Abate the asbestos containing materials in the structure prior to renovation or demolition.
2. Follow applicable asbestos regulations during renovation or demolition of the structure. You should be aware that stringent requirements are imposed upon anyone renovating or demolishing a structure in which ACM will be disturbed. This work must be performed in accordance with OSHA asbestos regulations, 29 CFR 1910 & 1926, and NESHAP asbestos regulations 40 CFR 61, subpart M. South Carolina regulations require the accreditation of personnel who work in the asbestos field and notification and permitting fees for asbestos removal projects. There is a 10 working day notification period required prior to abatement

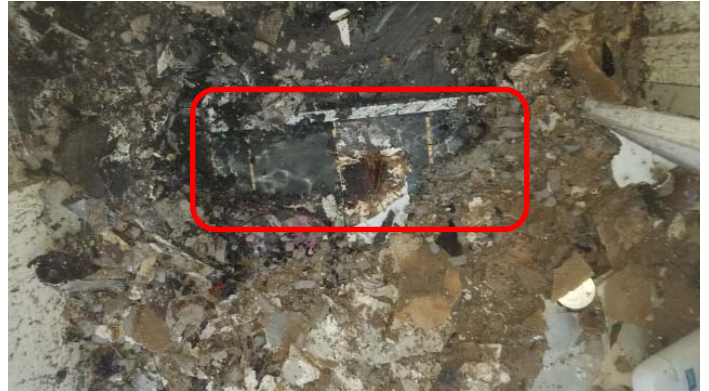
Photo 8 – Hall bath self-stick flooring.

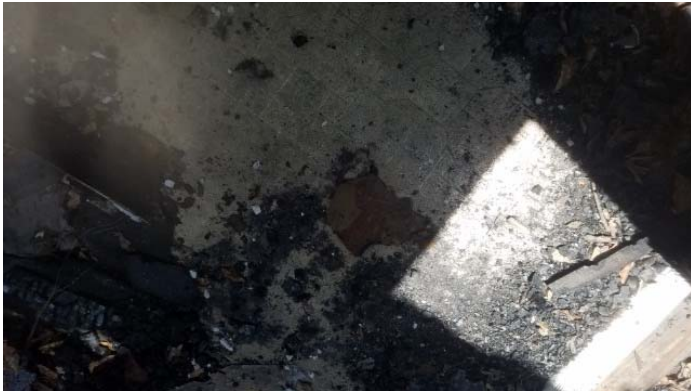
Photo 9 – Tan flooring at rear entrance.

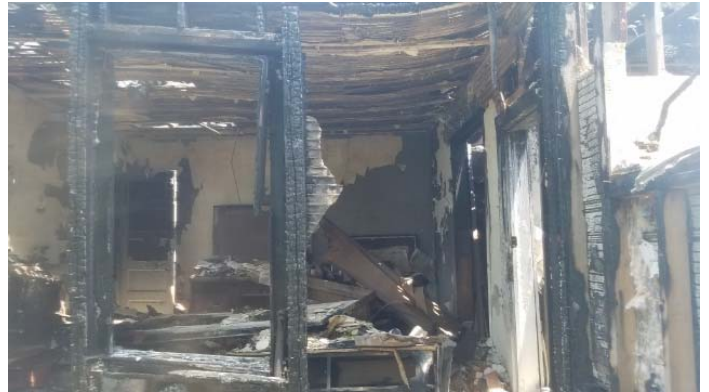
Photo 10 – Exterior view through burnt wall.
