Asbestos & Lead Based Paint Assessment

112 Owens Street
Spartanburg, South Carolina 29306

Project Number: 0118-14

August 14, 2017

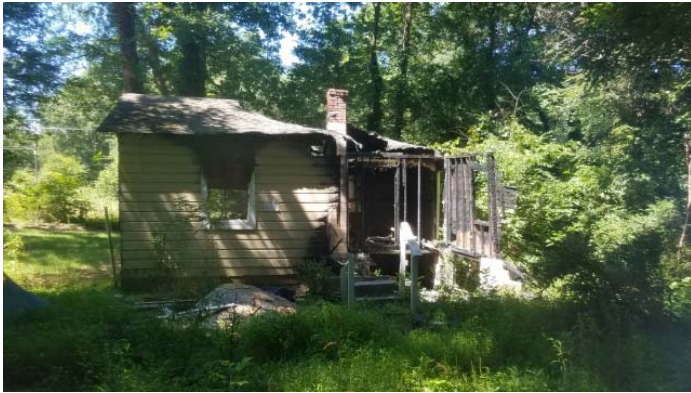
Photo 1 – 112 Owens Street in Spartanburg, South Carolina.

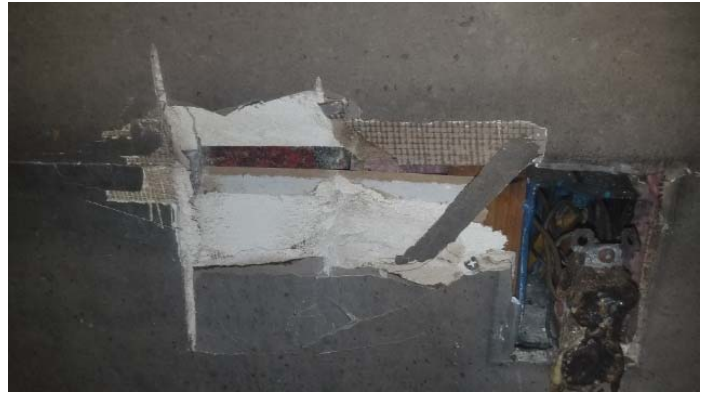
Photo 2 – Drywall, joint compound and tape.

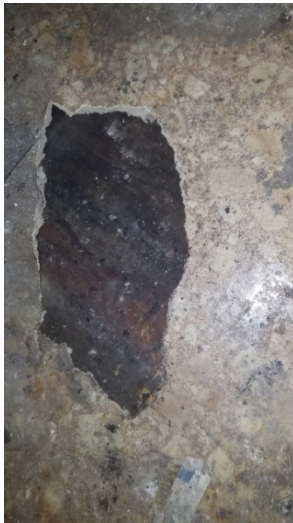
Photo 3 – Kitchen flooring.

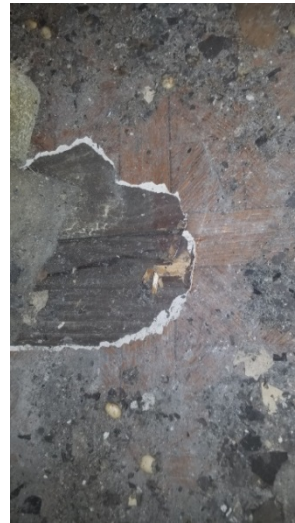
Photo 4 – Pantry flooring.

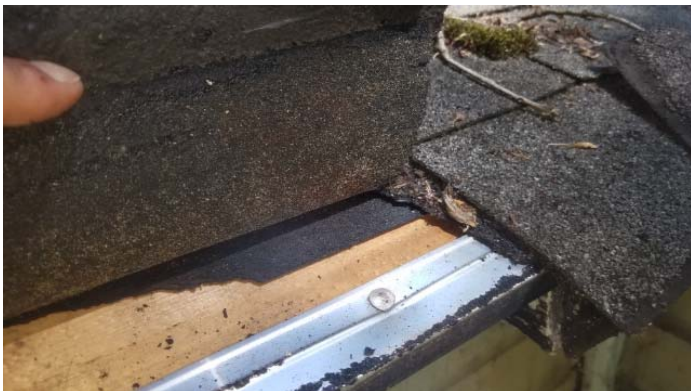
Photo 5 – Roof shingle and felt.

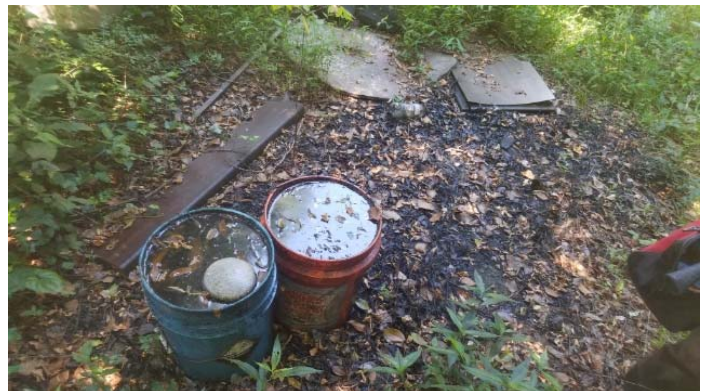
Photo 6 – Buckets of oil in front yard.
