Asbestos & Lead Based Paint Assessment

279 Ernest L. Collins Street
Spartanburg, South Carolina 29306

Project Number: 0118-14

August 14, 2017

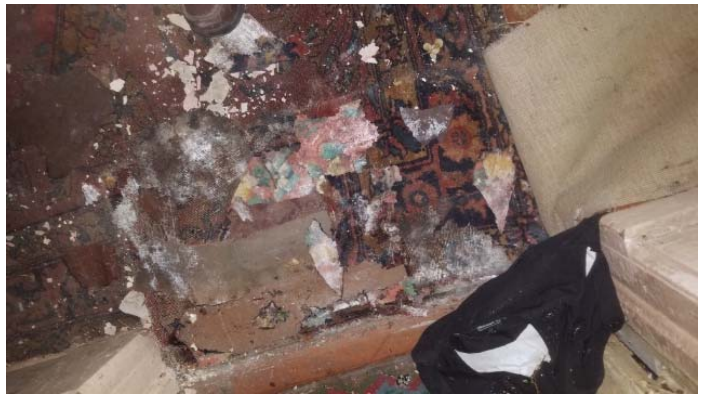
Photo 2 – Felt flooring in foyer.

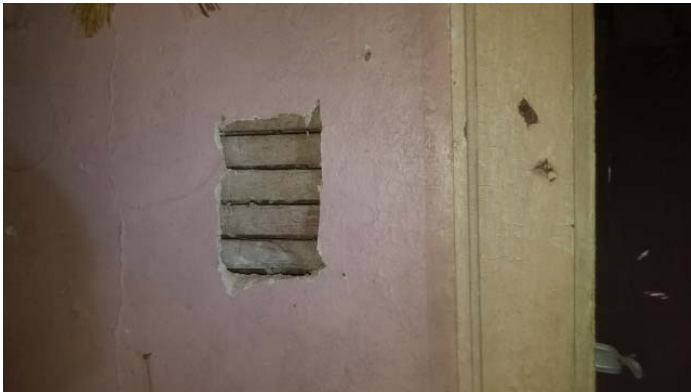
Photo 3 – Plaster wall.

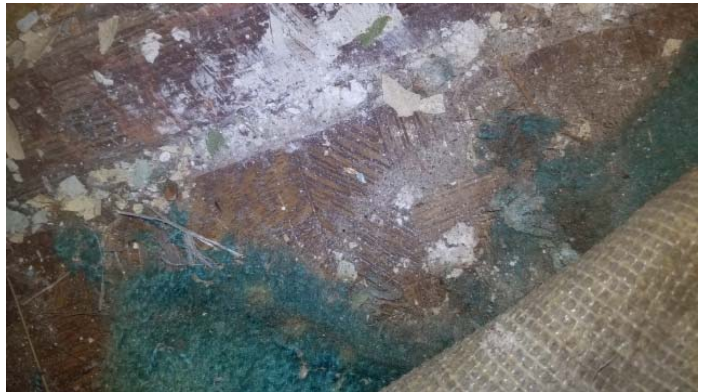
Photo 4 – Wood pattern flooring in living room.

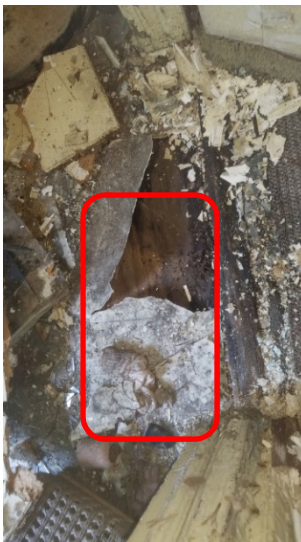
Photo 5 – Back porch grey flooring.

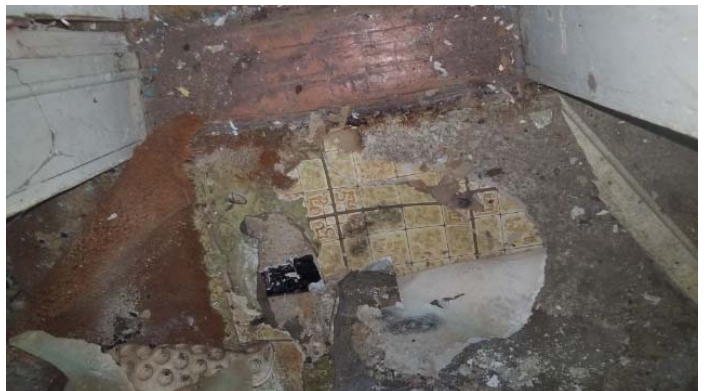
- Bathroom flooring – Tan - 15% Chrysotile – 60 SF
- Bathroom floor tile – Grey – 2% Chrysotile – 60 SF
- Bathroom floor mastic – Black – 4% Chrysotile – 60 SF
- Assumed chimney mastic

Sample No.	Location	Sample Description	Analytical Results	Friable/Non Friable	Condition	Quantity
20	Bathroom	4 layers of vinyl floors	PLM- 2% to 15% chrysotile (vinyl floors); 4% chrysotile (bottom mastic)	Non-Friable	Good	60 SF
21						
22

Photo 6 – Bathroom flooring.

1. Abate the asbestos containing materials in the structure prior to renovation or demolition.
2. Follow applicable asbestos regulations during renovation or demolition of the structure. You should be aware that stringent requirements are imposed upon anyone renovating or

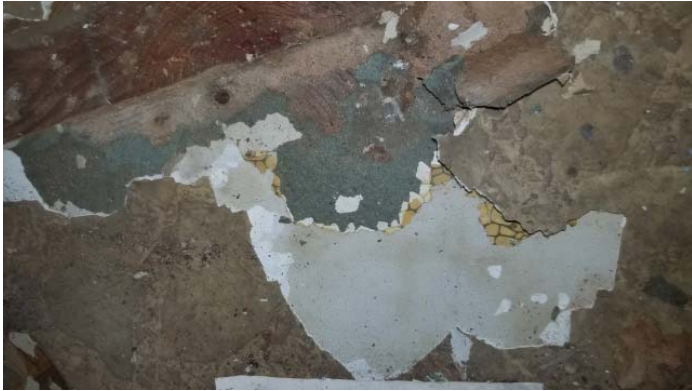
Photo 7 – Kitchen flooring.

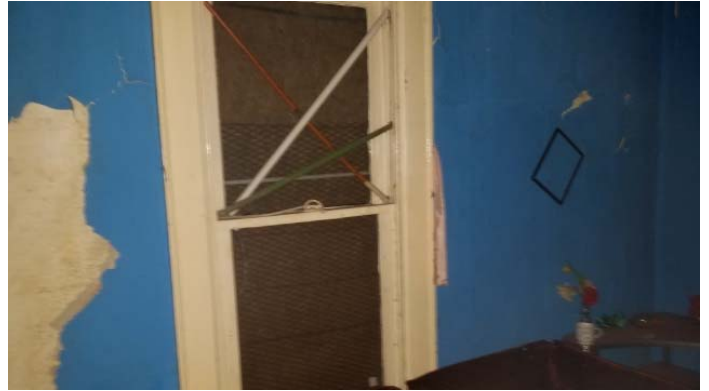
Photo 8 – Window glaze.

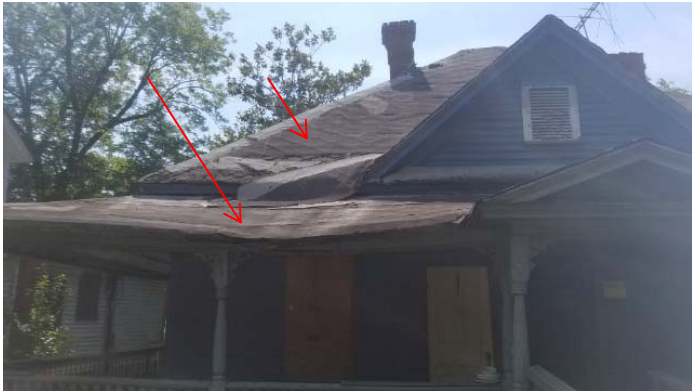
Photo 9 – Main and porch roofs.
