Asbestos & Lead Based Paint Assessment

City of Spartanburg
431 Hunt Street
Spartanburg, South Carolina 29301

Project Number: 0118-14

May 17, 2017

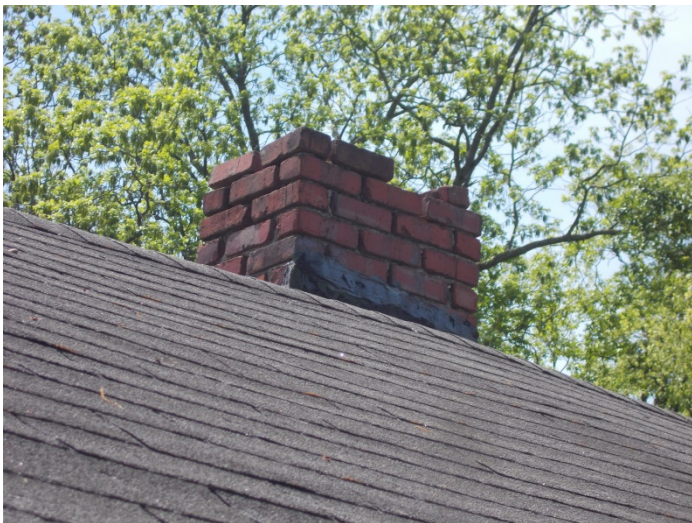
Photo 3 – 1 chimney with mastic/tar in middle of roof

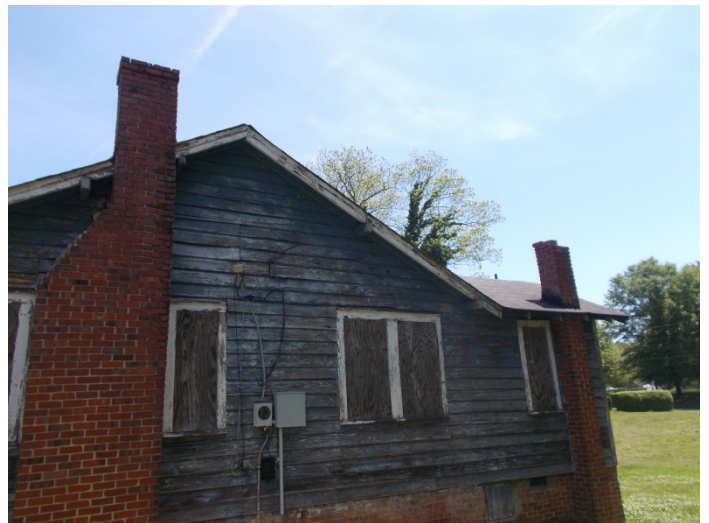
- Approximately 75 LF of exterior caulk on 2 chimneys on the right side of the house and adjacent siding.
- Approximately 18 LF of mastic/tar on 3 chimneys.
- Approximately 100 SF of 9" x 9" brown speckled floor tile in kitchen.

Photo 4 – 3 chimneys with mastic/tar & caulk on the right side of house

1. Abate the asbestos containing materials in the structure prior to renovation or demolition.

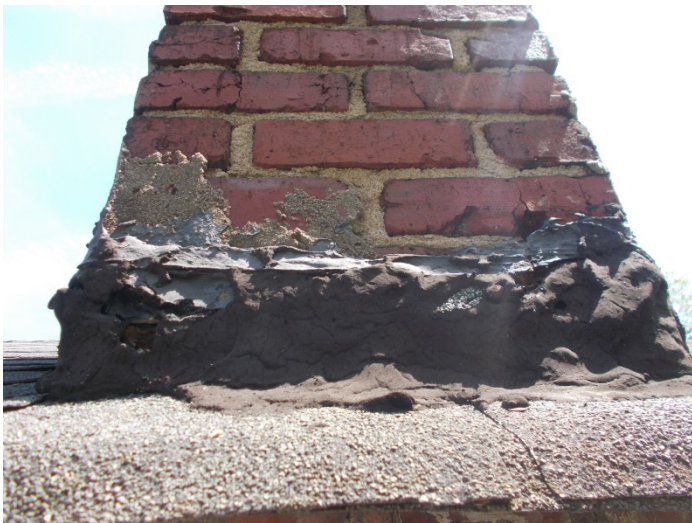
Photo 5 – mastic/tar on chimney

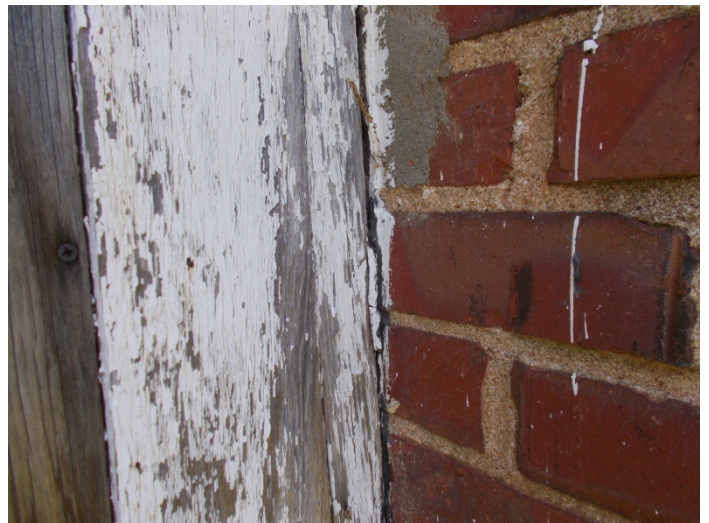
Photo 6 – caulk on 2 chimneys & adjacent siding on the right side of the house

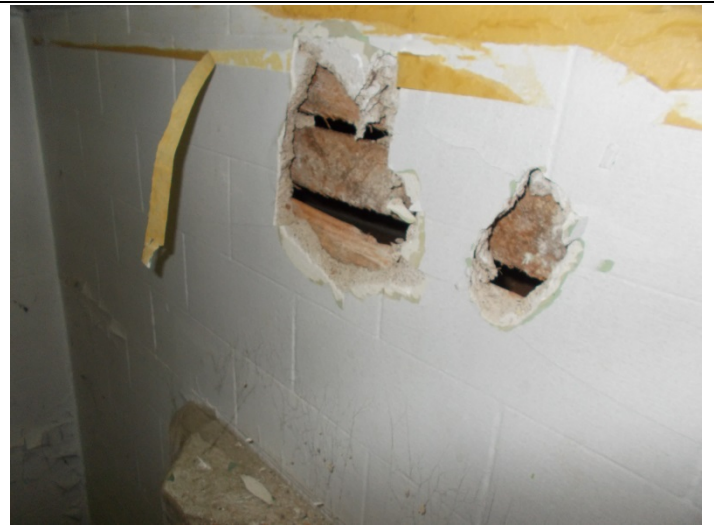
- Lower $\frac{1}{2}$ of the plaster wall in the bathroom.
- Brown wooden door frames.
- White wooden window systems, chair rails & base boards.

Photo 8 – Brick pattern plaster with finish in the bathroom lower 1/2 of walls

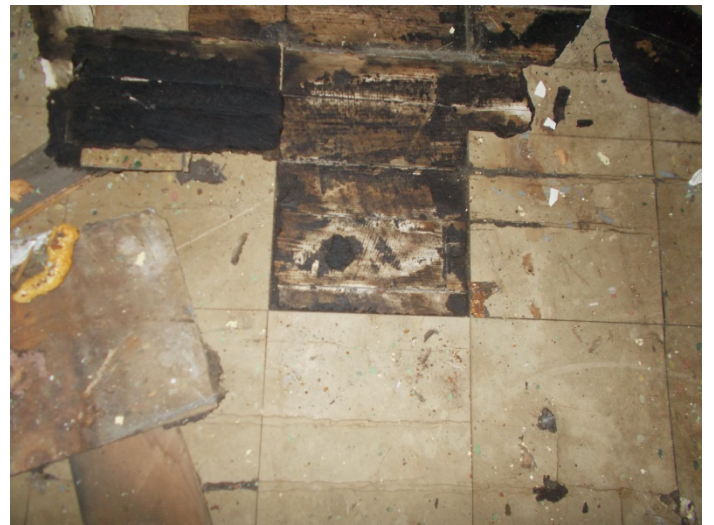
Photo 10 – 9" x 9" brown speckled floor tile & felt in the kitchen
