Asbestos & Lead Based Paint Assessment

City of Spartanburg
620 South Irwin Avenue
Spartanburg, South Carolina 29306

Project Number: 0118-14

May 17, 2017

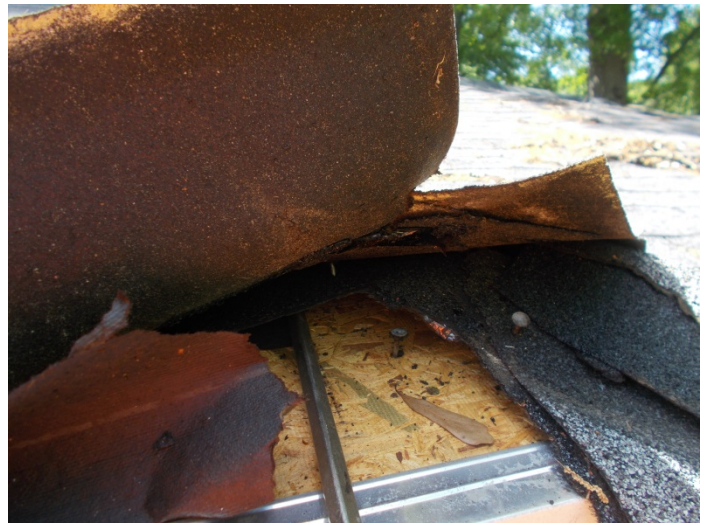
Photo 2 – Roof shingles and felt

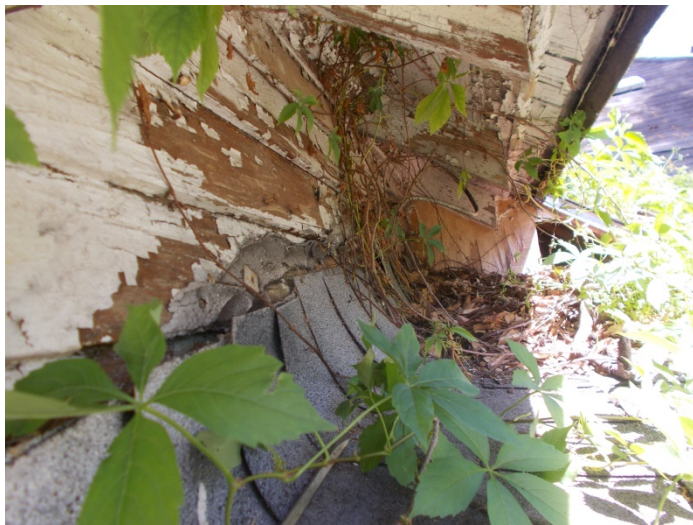
- Approximately 50 LF of mastic/tar on roof flashing.
- Approximately 13 wooden windows with glazing.
- Approximately 40 SF of yellow square pattern vinyl floor & mastic (2nd layer) under wood in the back entry hallway.
- Approximately 12 LF of mastic/tar on 2 chimneys – assumed positive.

Photo 3 – Roof flashing with mastic/tar

1. Abate the asbestos containing materials in the structure prior to renovation or demolition.
2. Follow applicable asbestos regulations during renovation or demolition of the structure. You should be aware that stringent requirements are imposed upon anyone renovating or demolishing a structure in which ACM will be disturbed. This work must be performed in accordance with OSHA asbestos regulations, 29 CFR 1910 & 1926, and NESHAP asbestos regulations 40 CFR 61, subpart M. South Carolina regulations require the accreditation of personnel who work in the asbestos field and notification and permitting fees for asbestos removal projects. There is a 10 working day notification period required prior to abatement of asbestos in a facility. Failure to take proper precautions and actions to protect human

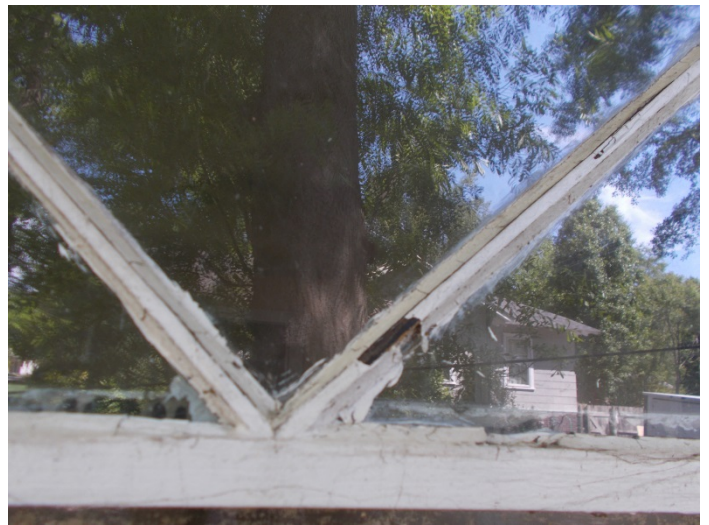
Photo 4 – Wooden window glazing

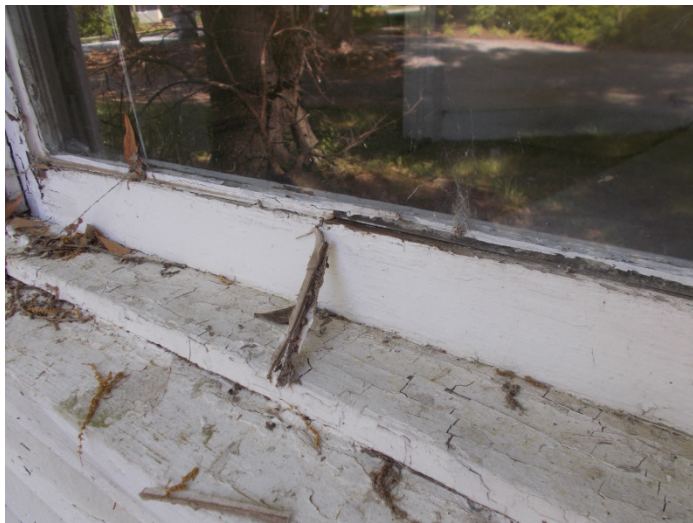
Photo 5 – Wooden window caulk

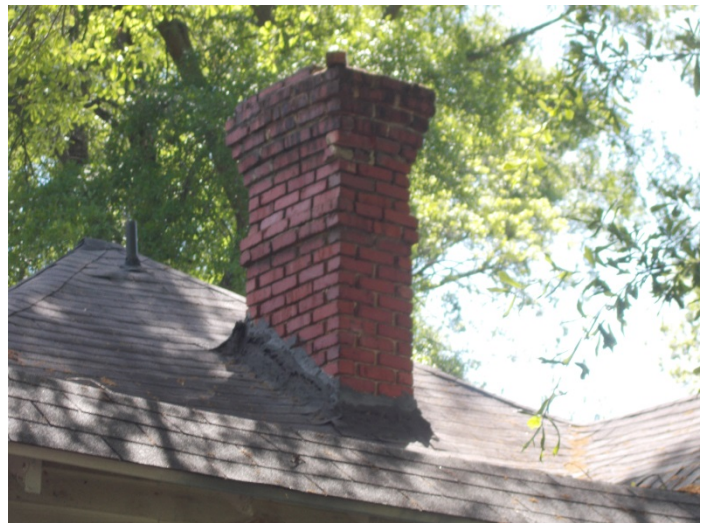
Photo 6 – mastic/tar on 2 chimneys – assumed positive.

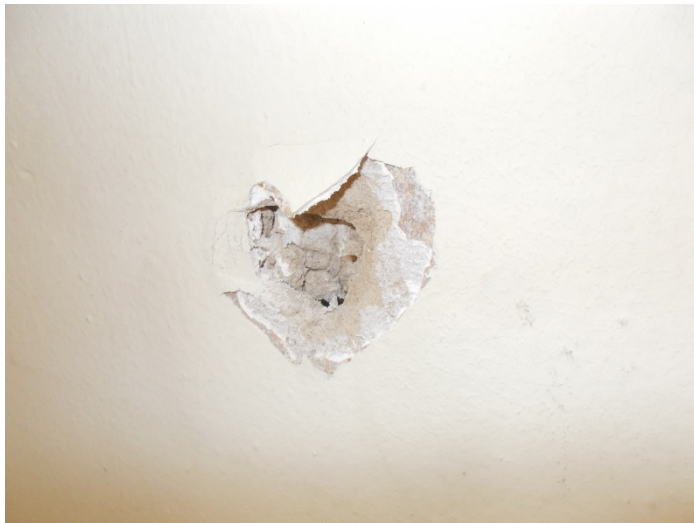
Photo 7 – Plaster with finish throughout

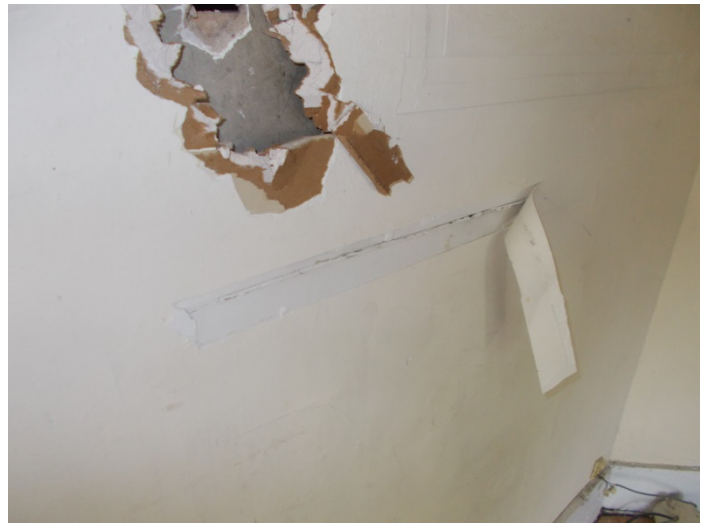
Photo 8 – Drywall with joint compound & tape throughout

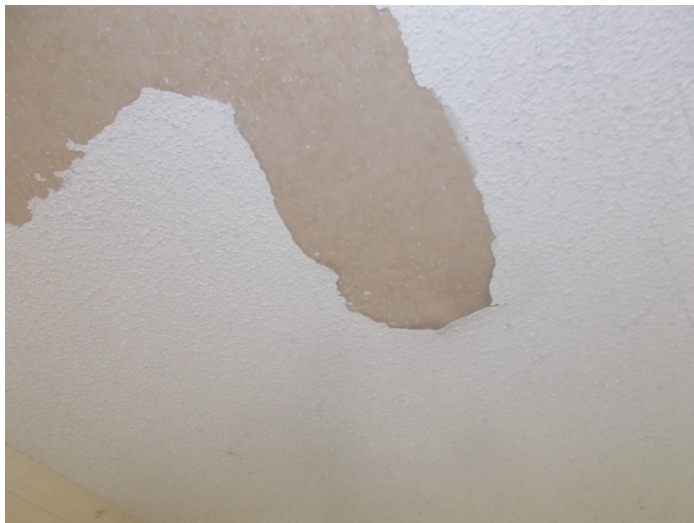
Photo 9 – Popcorn ceiling texture in the front left room, living room, dining room, kitchen, front bathroom & back-middle left bedroom

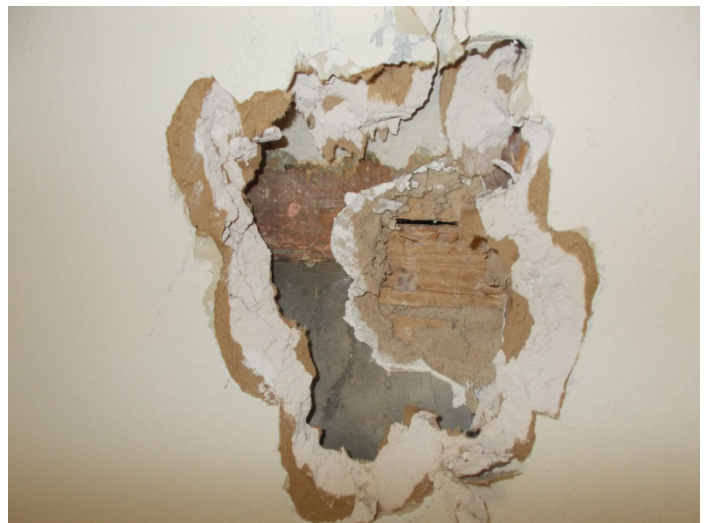
Photo 10 – Drywall over plaster

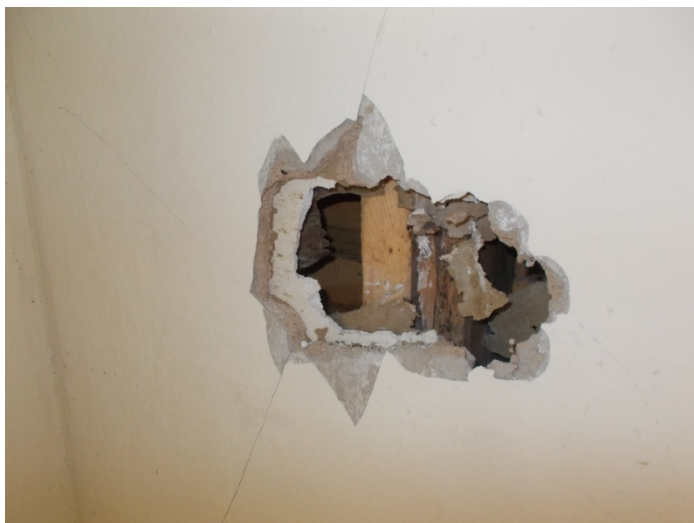
Photo 11 – Plaster over drywall

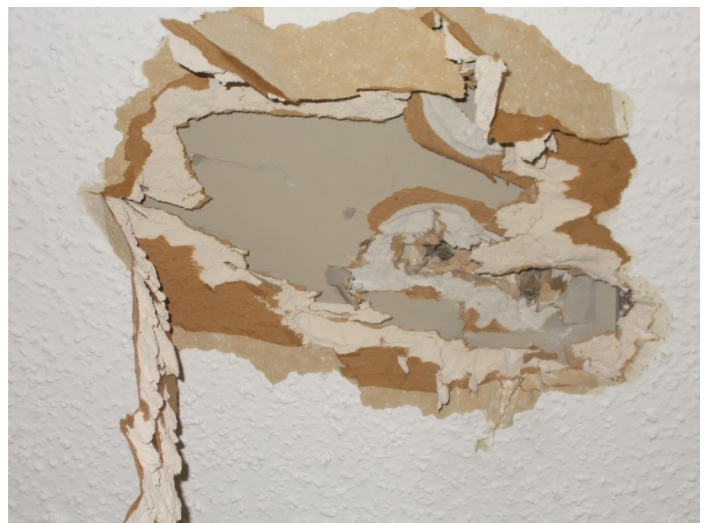
Photo 12 – Drywall over plaster

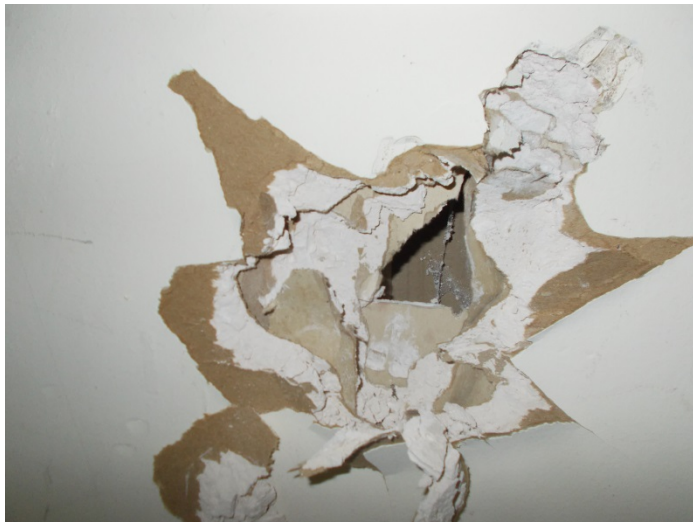
Photo 13 – Double layer drywall

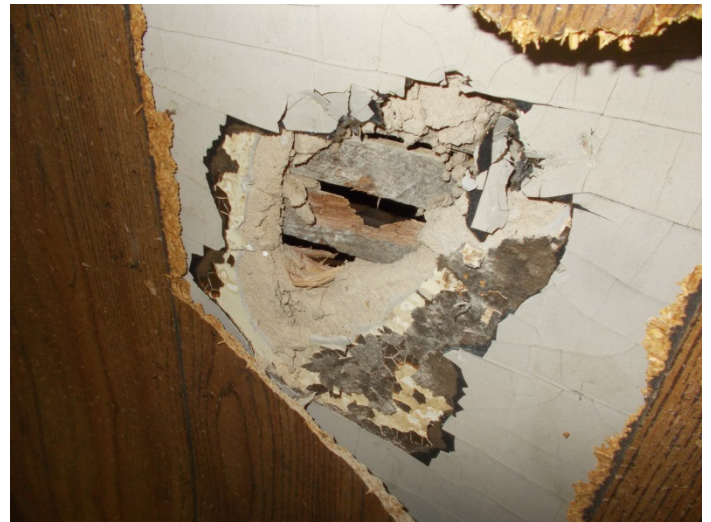
Photo 14 – Wall material with felt over plaster in the kitchen

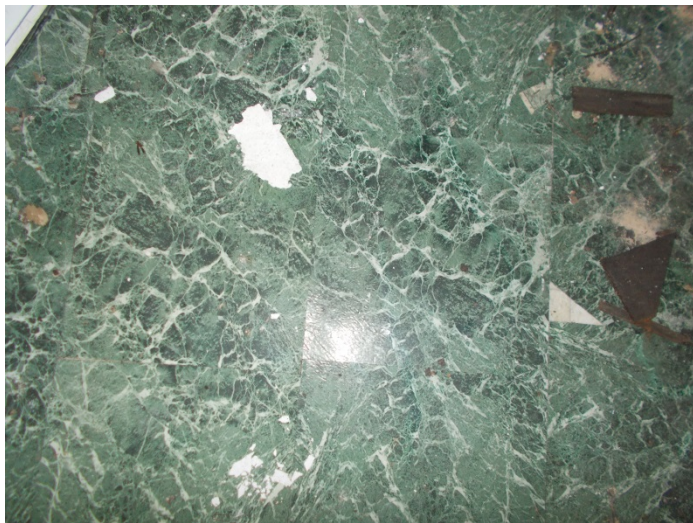
Photo 15 – 12" x 12" green marble pattern self-stick floor tile & mastic in the front bathroom (top layer)

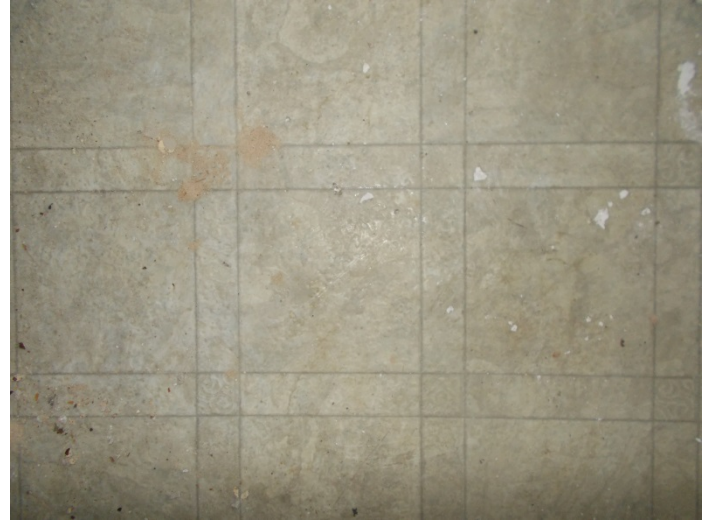
Photo 16 – Beige square pattern vinyl floor with no mastic in the front bathroom (2nd layer); kitchen (top layer) & back bathroom (top layer)

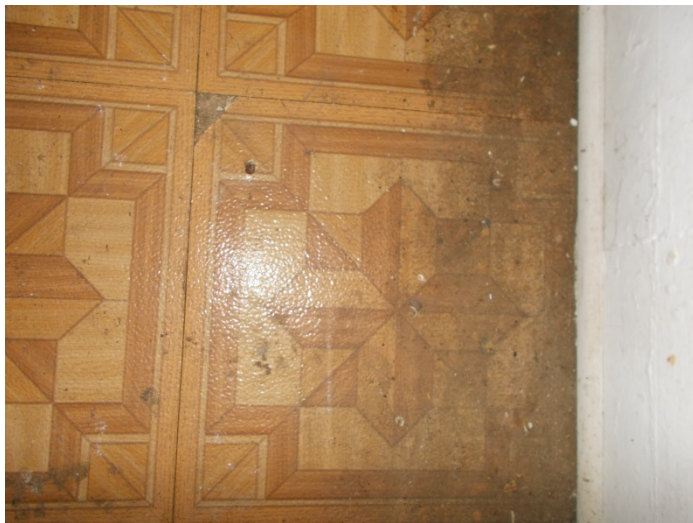
Photo 17 – 12" x 12" wooden pattern self-stick floor tile & mastic in the Kitchen (2nd layer); back entry (2nd layer) & back entry hallway

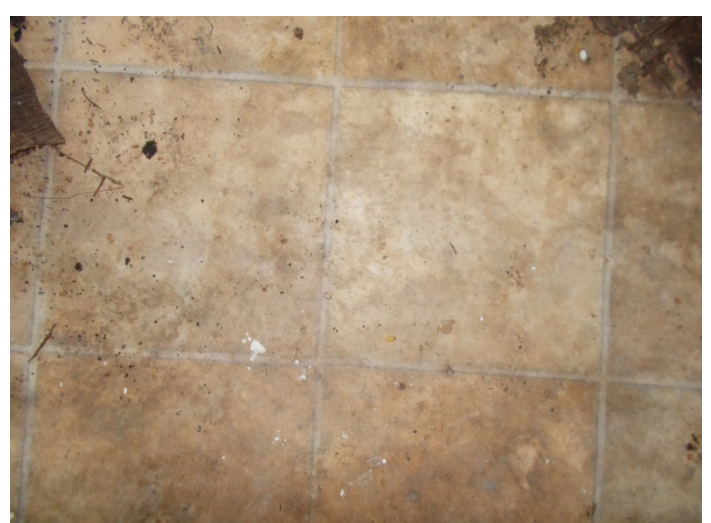
Photo 18 – Brown square pattern vinyl floor with no mastic in the back entry (top layer)

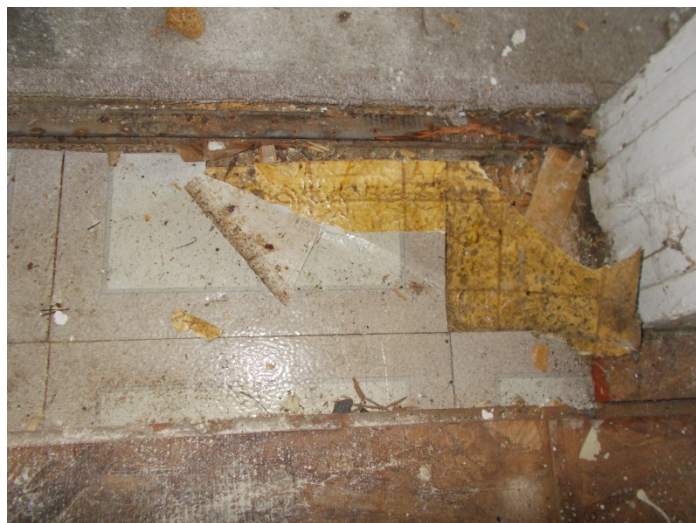
Photo 19 – 12" x 12" grey pattern self-stick floor tile & mastic over yellow square pattern vinyl floor & mastic in the back entry hallway (under wood)

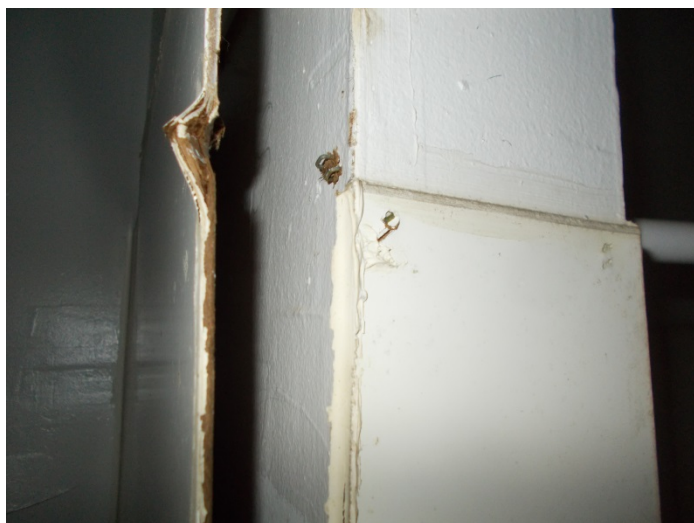
Photo 20 – Tub/shower surround caulk in the front & back bathrooms
