ASBESTOS ASSESSMENT

DWELLING DEMOLITION

224 SHAMROCK DRIVE
SUMMERVILLE, SOUTH CAROLINA 29483

ECS PROJECT NO. 49:11848

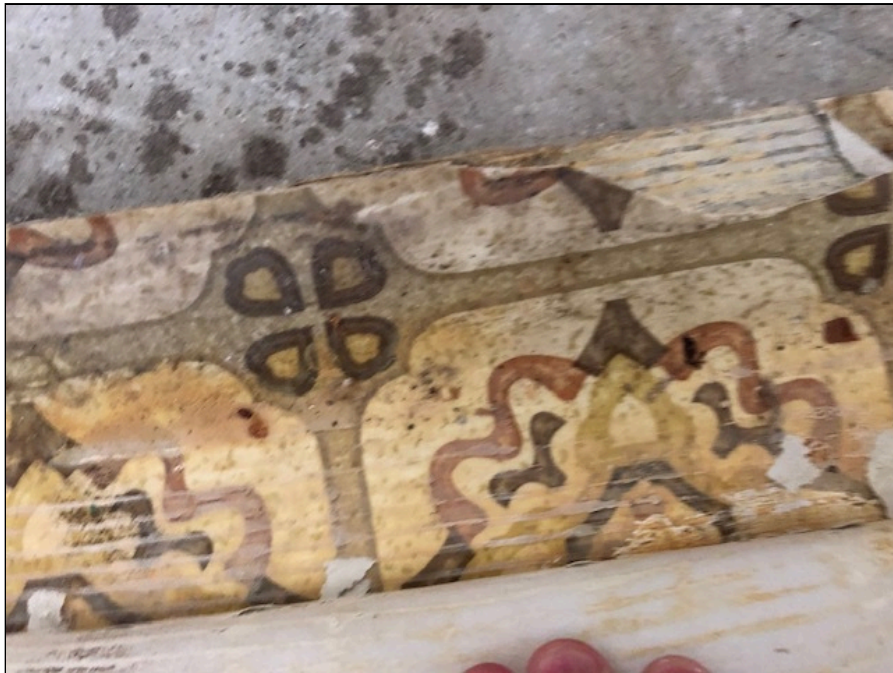
- **Beige Patterned Linoleum & Mastic: (Sample ID 03-01,02,03)**
- **White Under Sink Coating: (Sample ID 04-01,02,03)**

2 - Image of beige patterned linoleum & mastic: (Sample ID 03-01,02,03)

NESHAP requires the identification of friable ACM and non-friable ACM likely to become friable during demolition and/or renovation activities. NESHAP requires that the identified ACM be removed prior to initiating activities likely to disturb the ACM. Notification to the SC-DHEC is required for demolitions including move-off of a facility and the intentional burning of a facility within South Carolina. Notification is also required for renovations that include the disturbing or removal of regulated quantities of RACM; it is also required for planned renovations to occur at the same facility or project during a year's time. Each structure or facility must have a separate notification. Notification is required for facilities which do not contain asbestos as well. The starting date for demolition or renovation must be at least 10 working days from the date of submission of a complete notification to SCDHEC. ECS recommends abating asbestos containing materials in the structure prior to disturbance. Based on the square footage of friable asbestos containing material, the SCDHEC will require a project design for this abatement project.

ECS recommends that a project specification be prepared to delineate and quantify known and suspect hazardous and regulated materials in the buildings and to outline proper procedures for the abatement. This will help protect the owner's liability in better defining the scope of work and contractors' roles and responsibilities in the abatement process and holding the contractor accountable for the performance of the project. The specification typically defines the Contractor's scope of work and outline requirements and procedures that must be followed for the project. The intent of the specification is to give performance requirements for the Contractor so that the project can be completed safely and in compliance with applicable federal and state regulations. Typically, the specification document serves as part of the site owner's contract with the contractor.

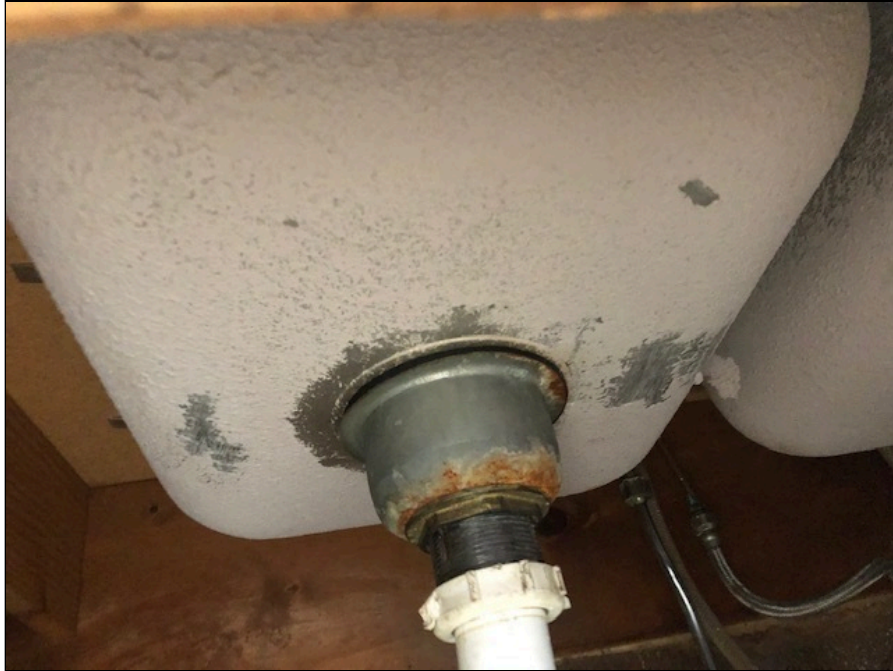
3 - Image of white under sink coating: (Sample ID 04-01,02,03)

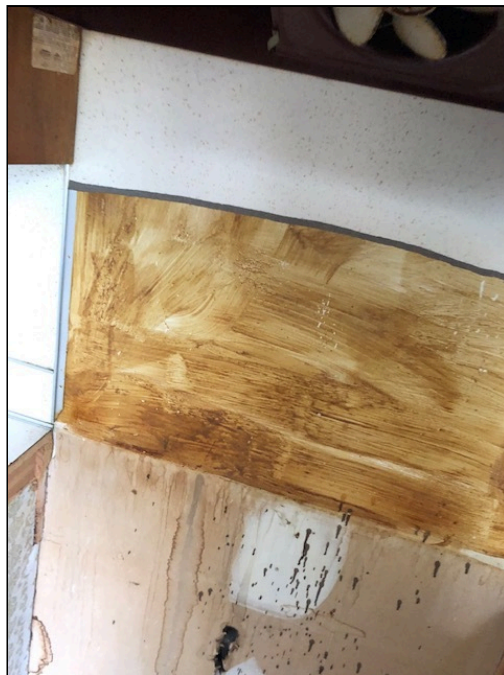
- **Kitchen Wall Panel Mastic: (Sample ID 10-01,02,03)**

4 - Image of beige kitchen wall panel mastic: (Sample ID 10-01,02,03)

A trace amount of asbestos ($\leq 1\%$) was detected in the bulk samples of (Sample ID: 10-01,02,03) analyzed by the laboratory. Although materials that contain trace amounts of asbestos are not subject to U.S. EPA or South Carolina regulations for the handling and disposal of asbestos, OSHA still regulates any work which will disturb materials identified with trace amounts of asbestos (reference the November 24, 2003 OSHA Interpretation document - Compliance Requirements For Renovation Work Involving Materials Containing Less Than 1% Asbestos). Therefore, any Contractors disturbing these materials will need to comply with components of 29 CFR 1926.1101, as detailed in the 2003 OSHA Interpretation document.

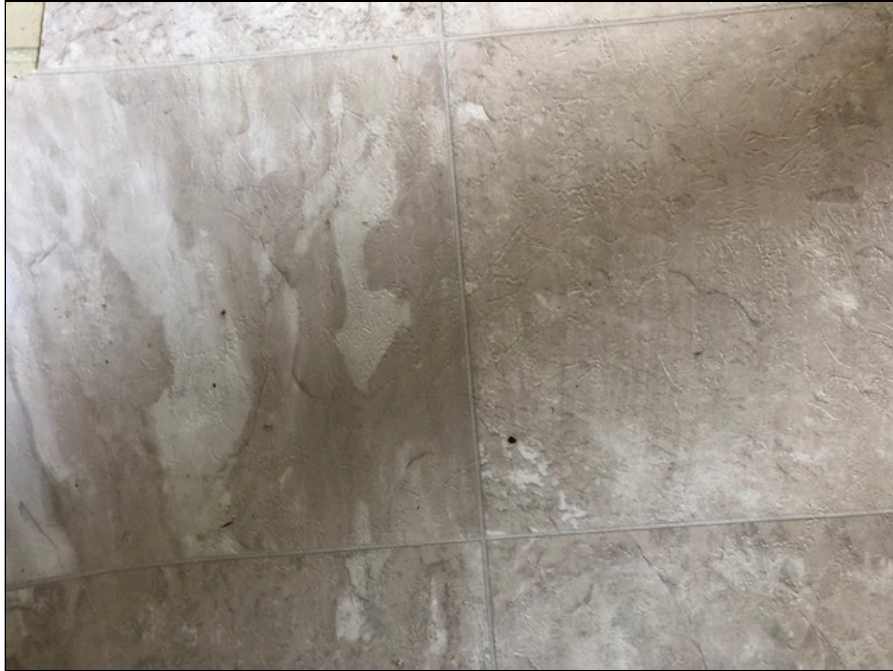
5 - Image of grey 12" x 12" linoleum

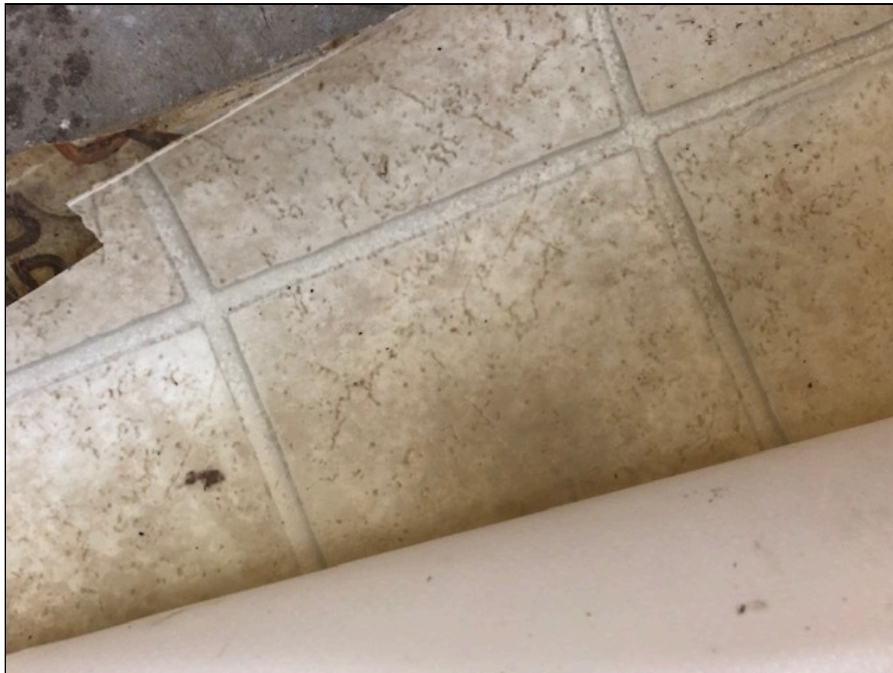
6 - Image of white 6" x 6" patterned linoleum & mastic

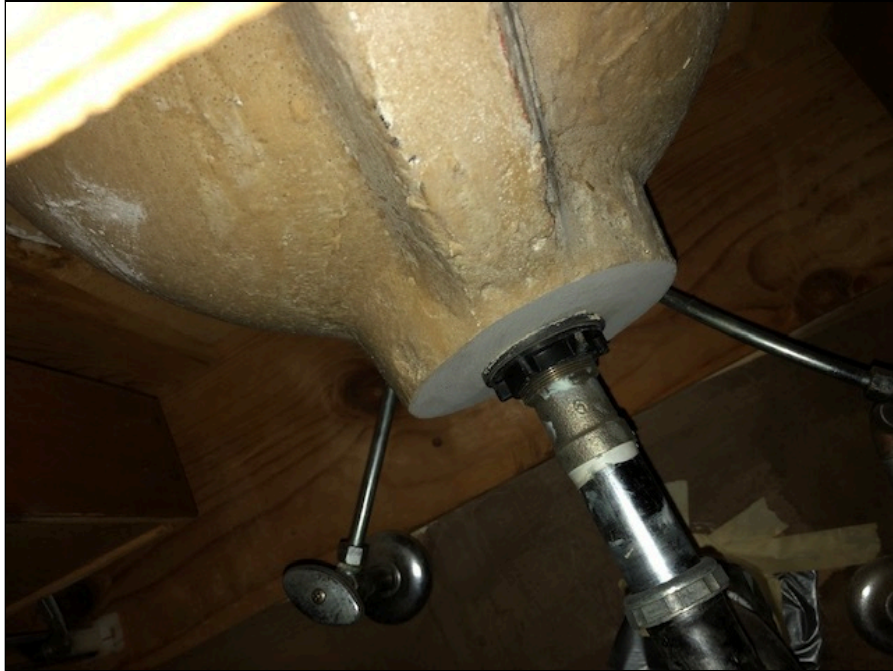
7 - Image of beige under sink coating

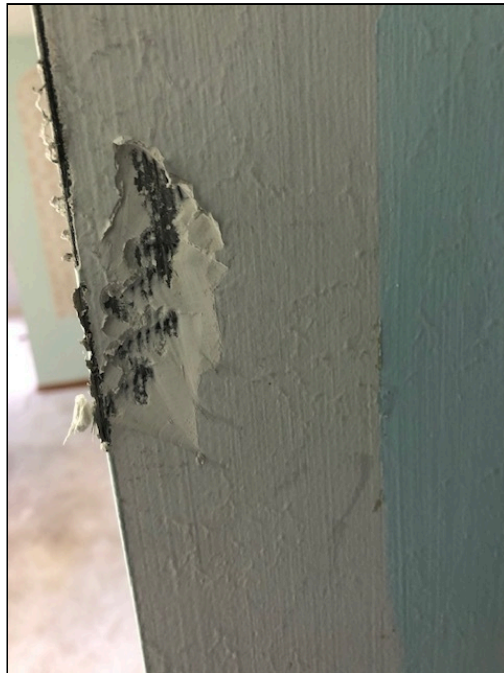
8 - Image of joint compound sample

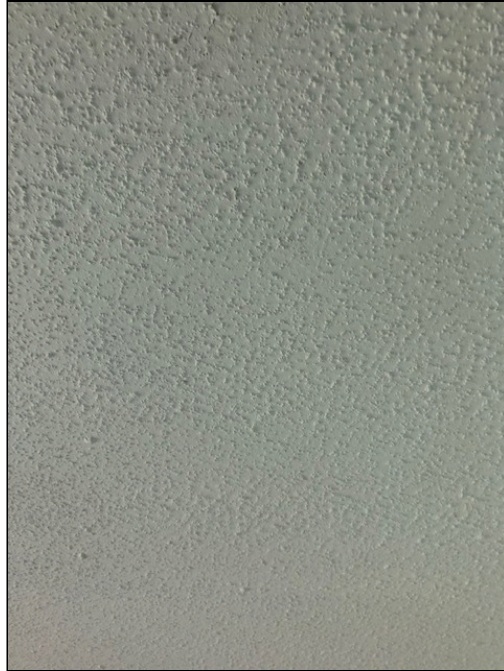
9 - Image of white textured ceiling

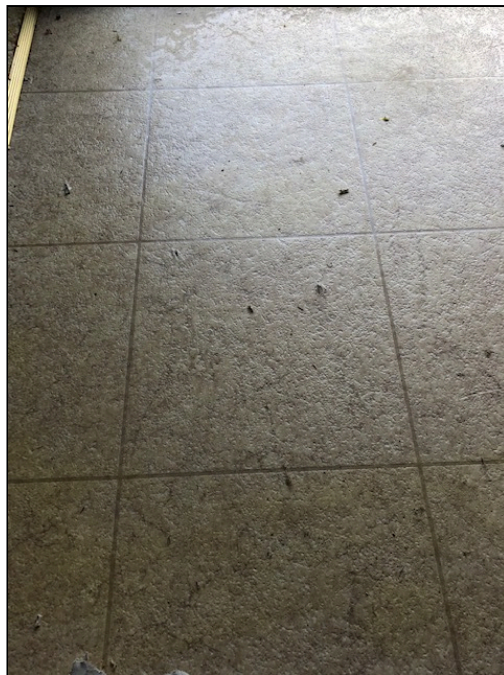
10 - Image of light beige square pattern linoleum & mastic

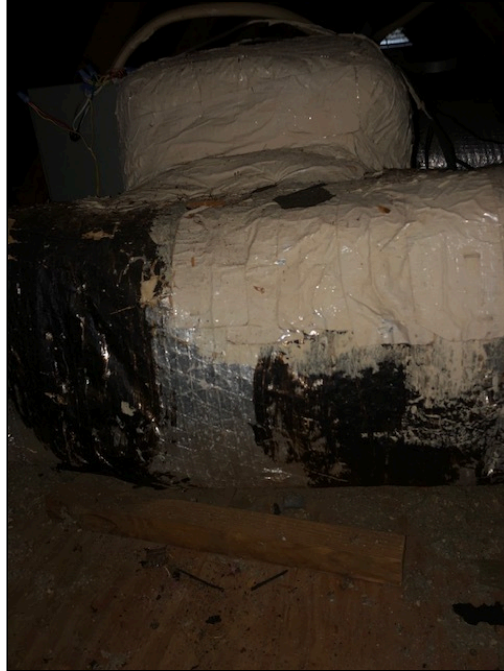
11 - Image of white & black duct mastic

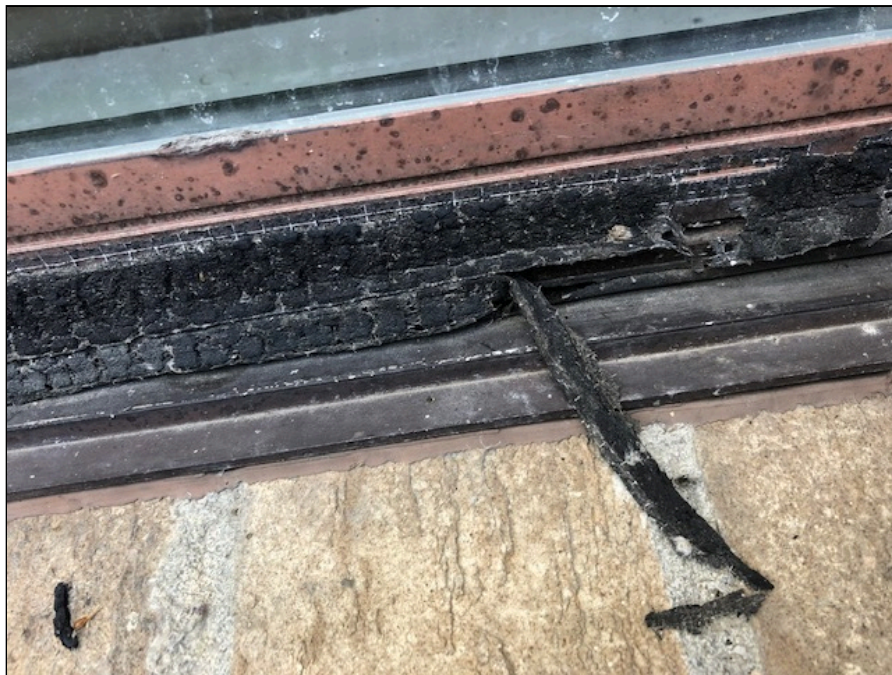
12 - Image of black window liner

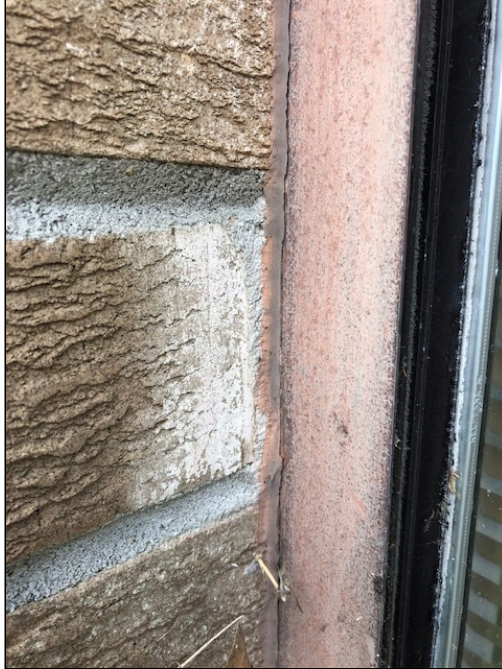
13 - Image of white window & door caulking

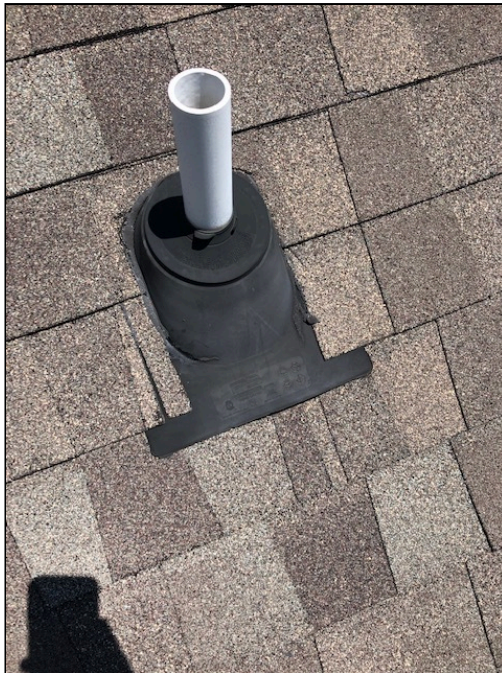
14 - Image of black roof tar
