HAZARDOUS MATERIALS INVESTIGATION REPORT

**FOR THE BUILDING
LOCATED AT
1425 NORTH QUINCY STREET
ARLINGTON, VIRGINIA 22207**

Aerosol Monitoring & Analysis, Inc.

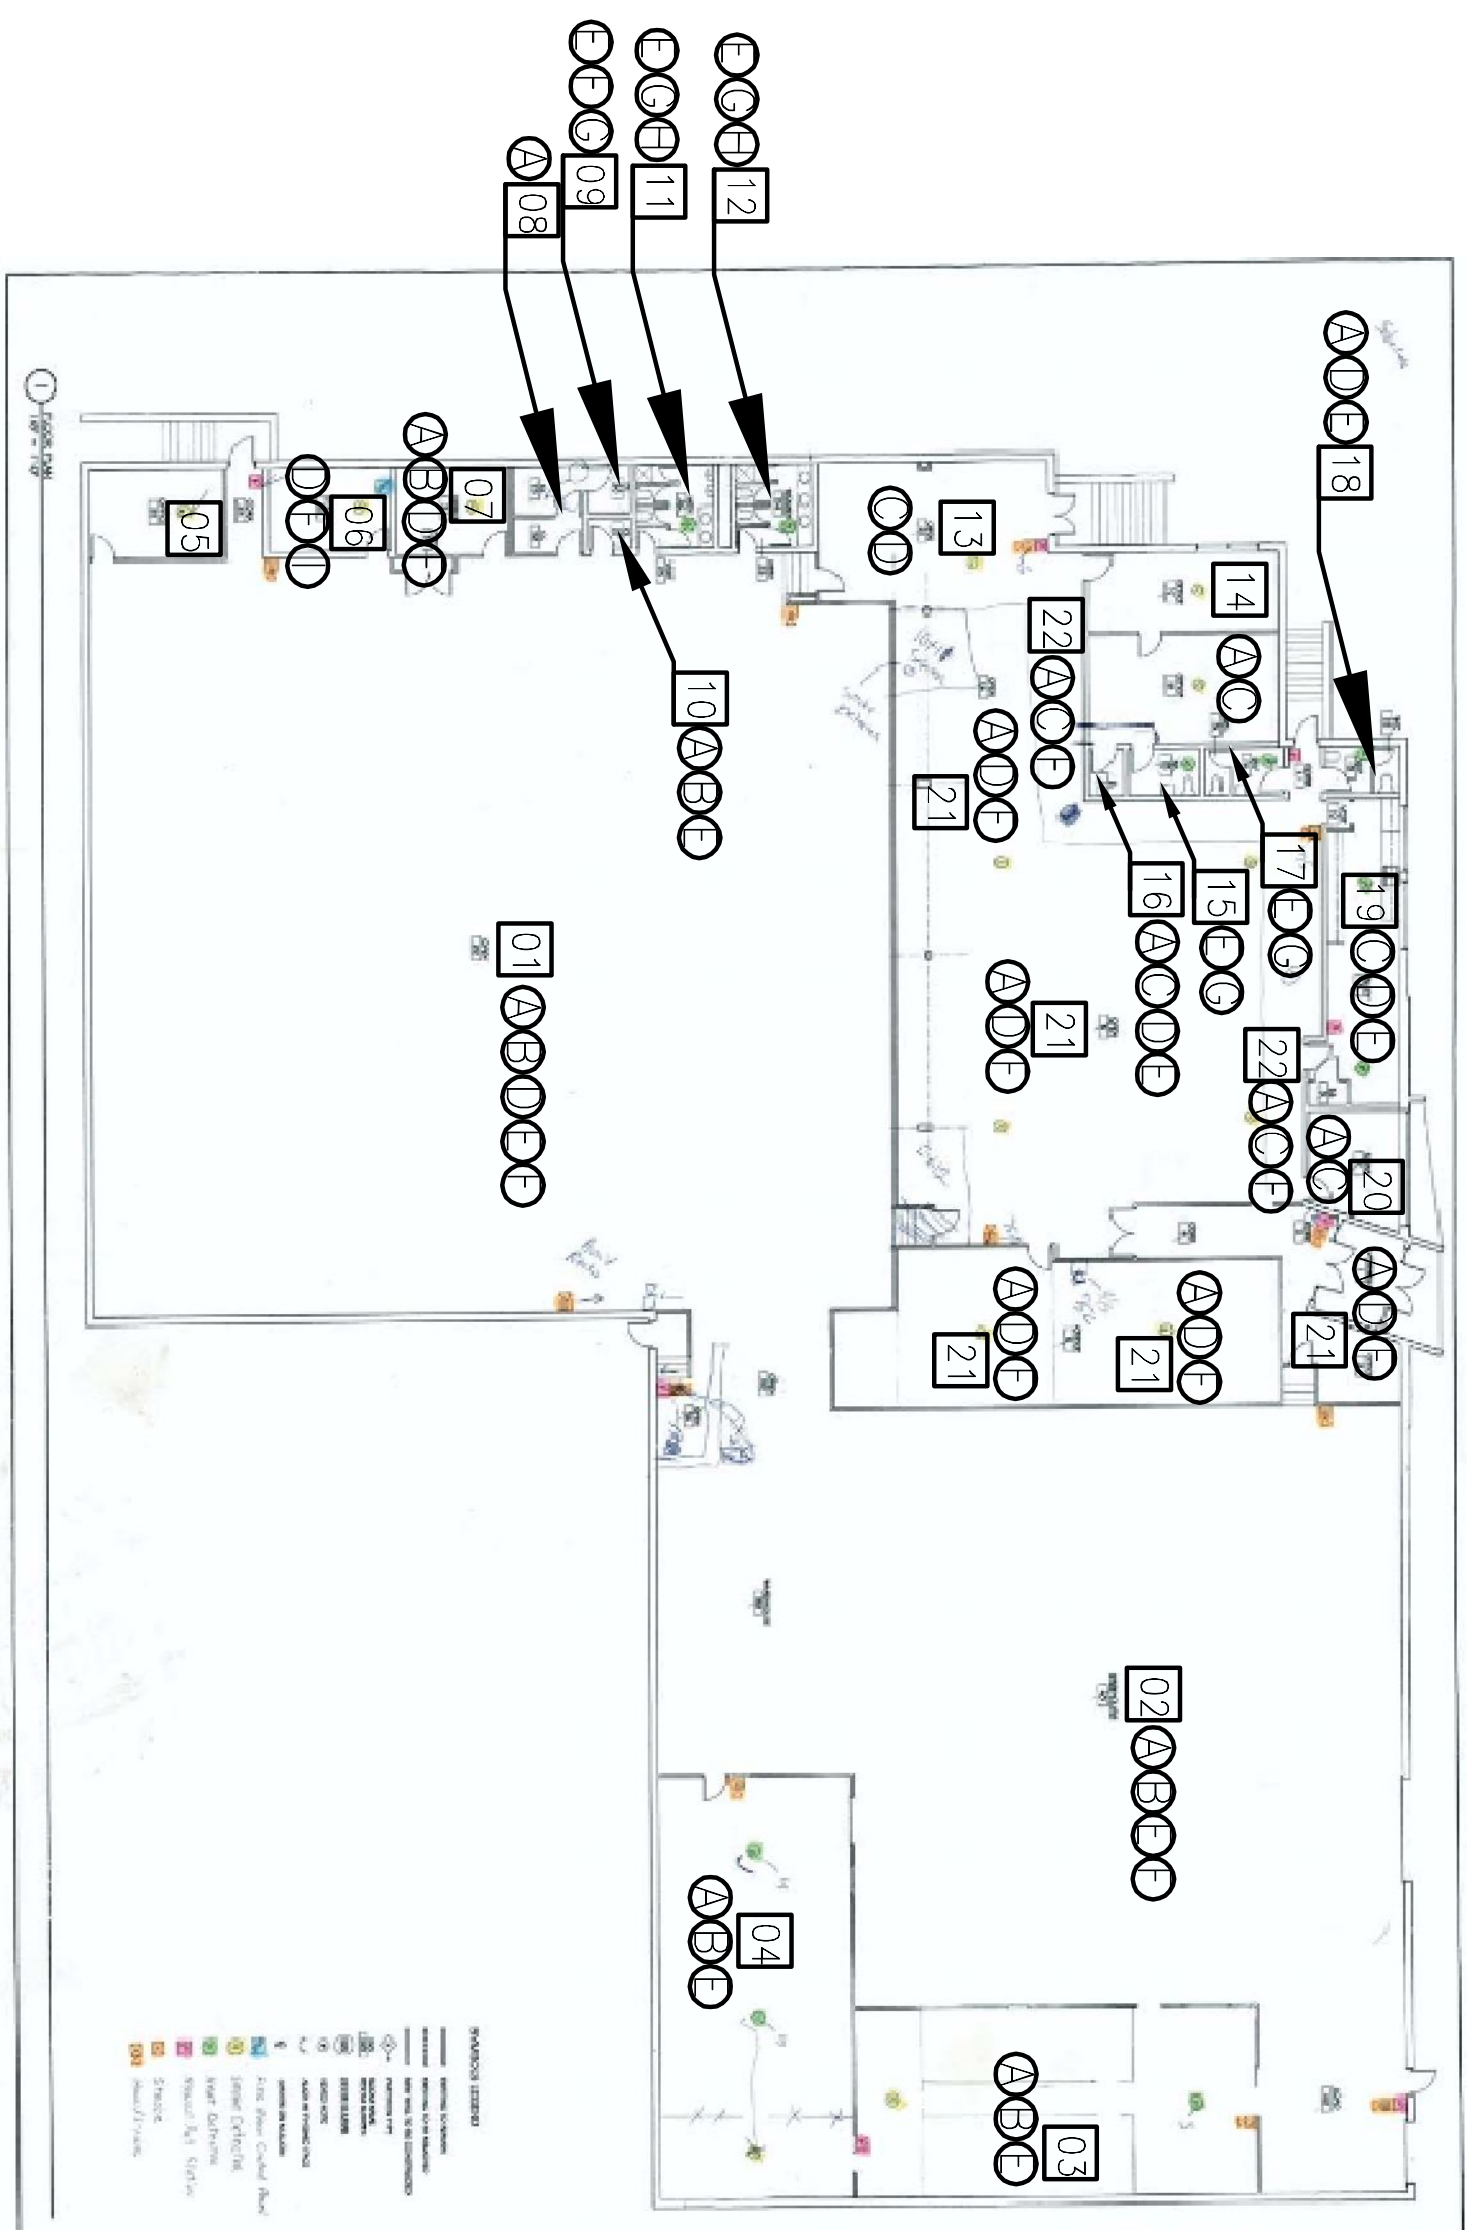
ACM LOCATION DRAWING
 1425 NORTH QUINCY STREET
 ARLINGTON, VIRGINIA 22207

ASBESTOS CONTAINING MATERIALS:
