**BOTKINS LANE BRIDGE  
ABUTMENT REPAIR \***

SCOUR REMEDIATION  
EXHIBITS  
MASONRY ABUTMENT

# SMALL STRUCTURE INSPECTION REPORT

STRUCTURE NAME: Botkins Lane Bridge  
INSPECTED BY: J. Agler 12/11/2022

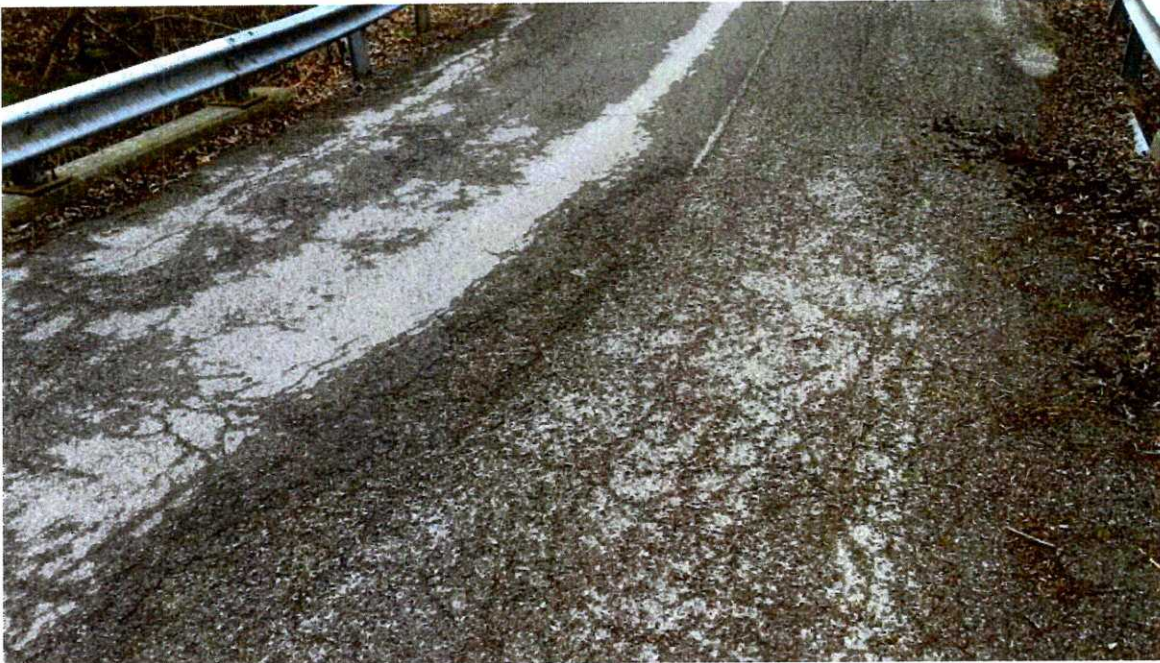
The deck is covered in asphalt overlay. Asphalt shows slight wear and minor cracking.

Photo 03. Asphalt Overlay - Minor Cracking

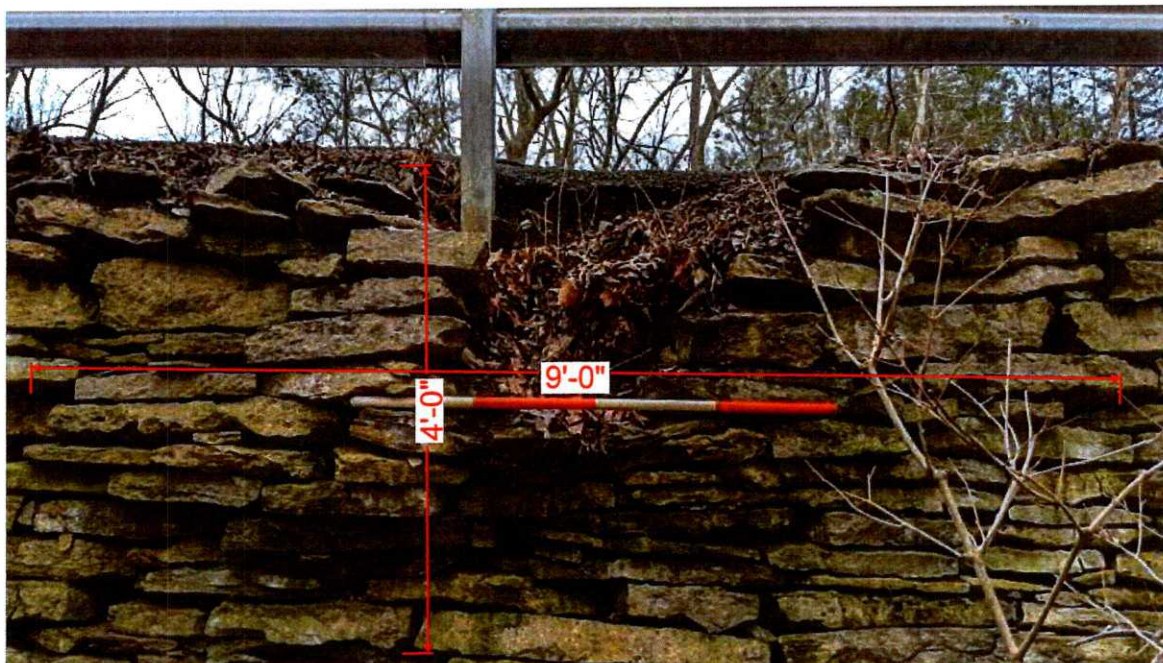
The asphalt has minor wear with smooth transitions. Drop offs with little to no shoulder. The NE wing has a 9' wide by 4' tall area of failing stone at the top of the wall (See Photos 10 and 11) which is allowing partial collapse of the approach road. The horizontal displacement is approximately 8" (See Photo 11).

Photo 10. Masonry Wall Embankment at Northeast Quadrant Failing

Replace bridge railing, transitions, approach rail, and end treatments to meet standards. Patch curb ends.  
Repair and mortar northeast wing section and repair failing road shoulder.  
Pour 2' concrete footers along base of concrete abutments and full-height facing on masonry.  
Post bridge for 9 Ton gross capacity in eastbound direction.  
Consider for replacement.

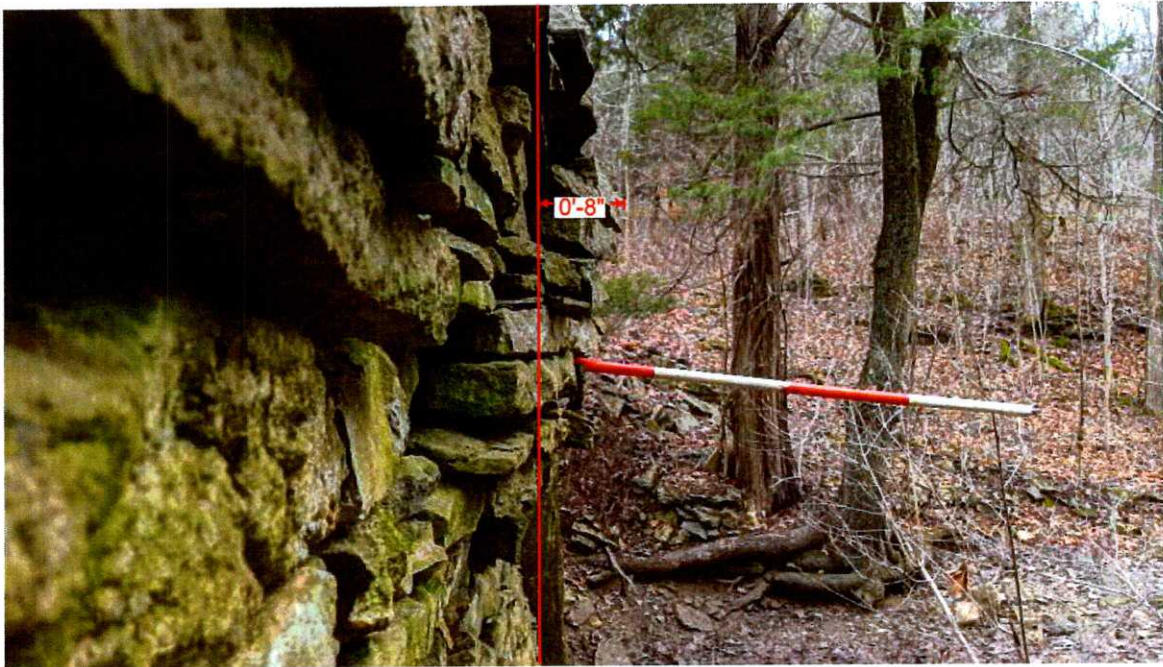
Photo 11. Masonry Wall Embankment at Northeast Quadrant Failing, Looking West Along Face of Wall.

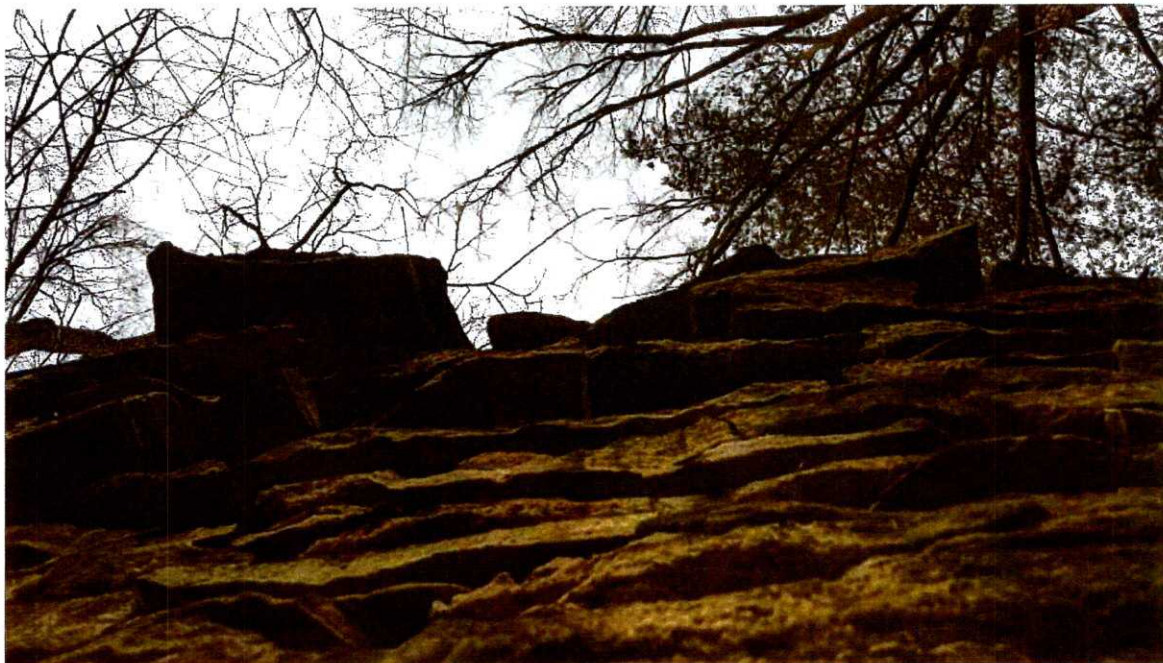
Photo 12. Masonry Wall Embankment at Northeast Quadrant Failing, Looking Up Along Face of Wall, Closer to Bridge Than Photos 10 and 11.

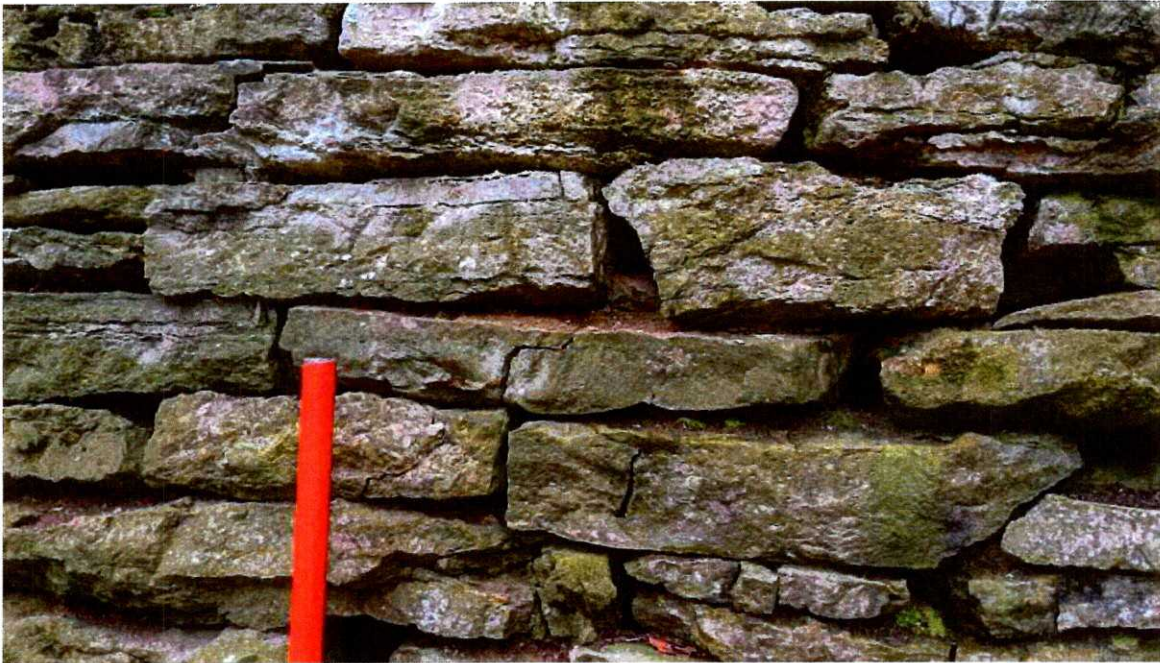
Photo 13. Cracking of Masonry Stones at Northwest Wall

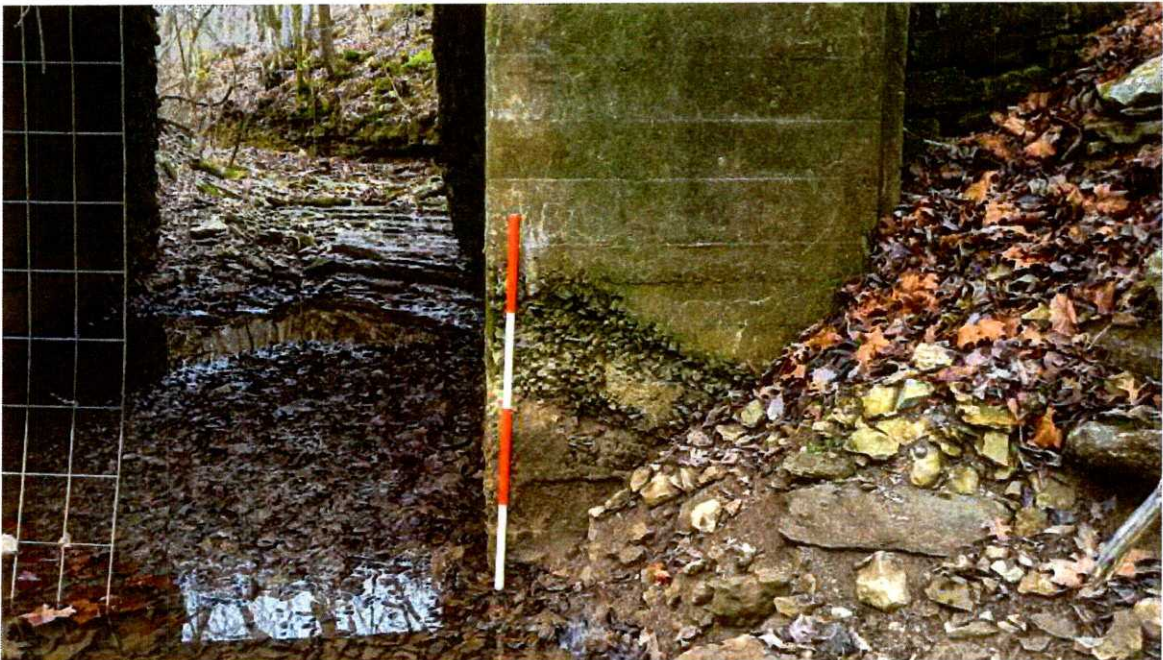
The deck soffit and fascia has cracking with efflorescence and areas of honeycombing.

Photo 16. Honeycombing at North Face of West Abutment

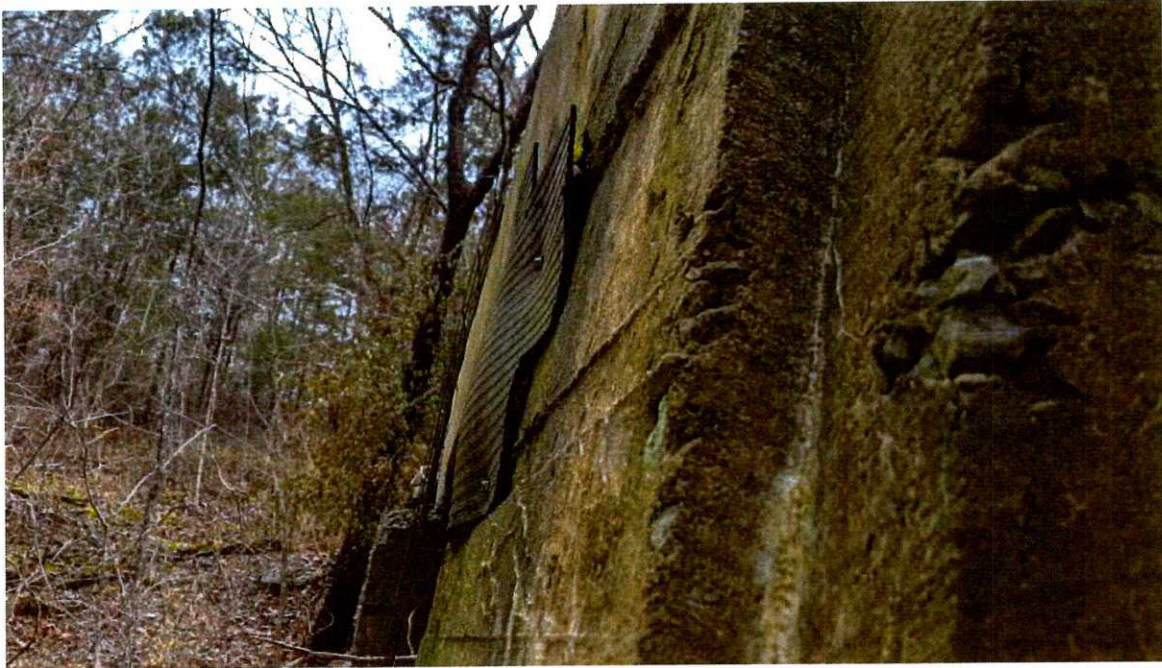
The turned back masonry wings on the north quadrants and the SW quadrant are dry laid stone. The previously noted (2016 inspection) large hole in the NW abutment outer face has been patched with formwork left in place and appears to be bulging out from the concrete patch (no change from 11/2021 inspection). Concrete portion of abutments generally have spalling and cracks with efflorescence and honeycombing, more significantly in the west abutment. The west end of the middle bracing W-section of the abutment is corroded with section loss and has a vertical crack leading to it. The masonry portion of the abutments have vertical cracks through stones (see Photos 20-22 for cracked stones at west abutment). The noted full height cracks from the 2016 inspection have been repaired, but the vertical cracking through stones remain.

Photo 17. Patch Formwork Left in Place at North Face of West Abutment

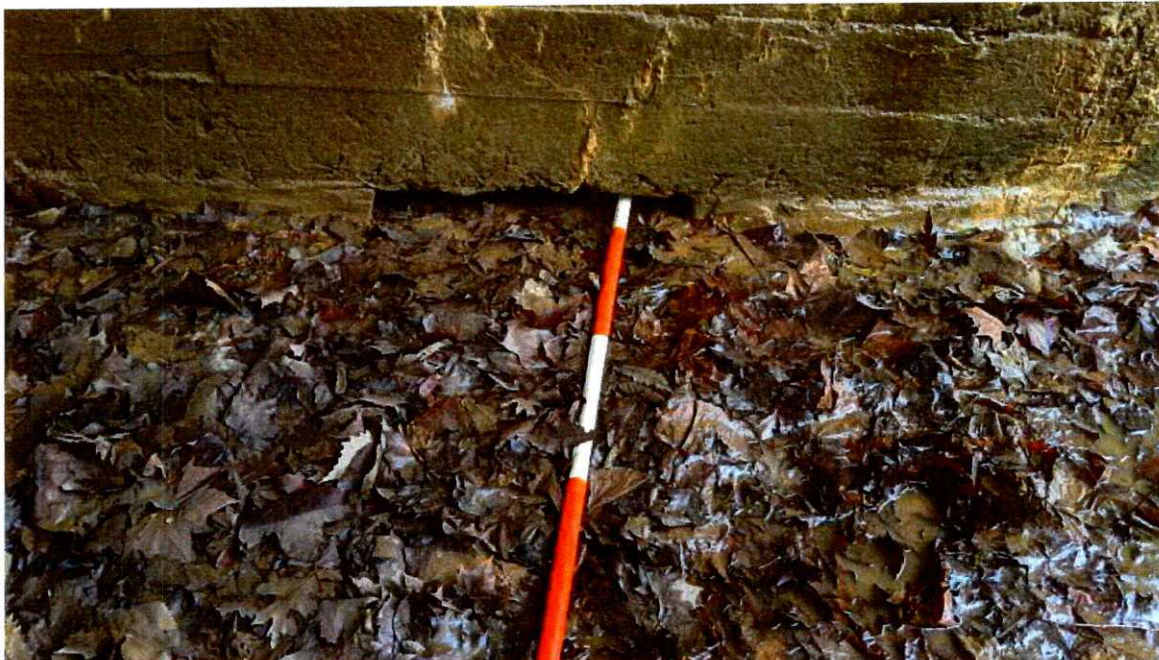
Both abutments have sections of undermining of up to 12" (see Photos 18 and 19).

**No change in NBI Item 60 rating is warranted since local failures of the substructure are not probable and deterioration does not appear to be progressing significantly based on conditions seen in the previous inspection, dated 11/2021. Bridge should continue to be posted at 9 Tons in each direction.**

Photo 18. Section of Undermining Near North End of West Abutment, Up to 12"

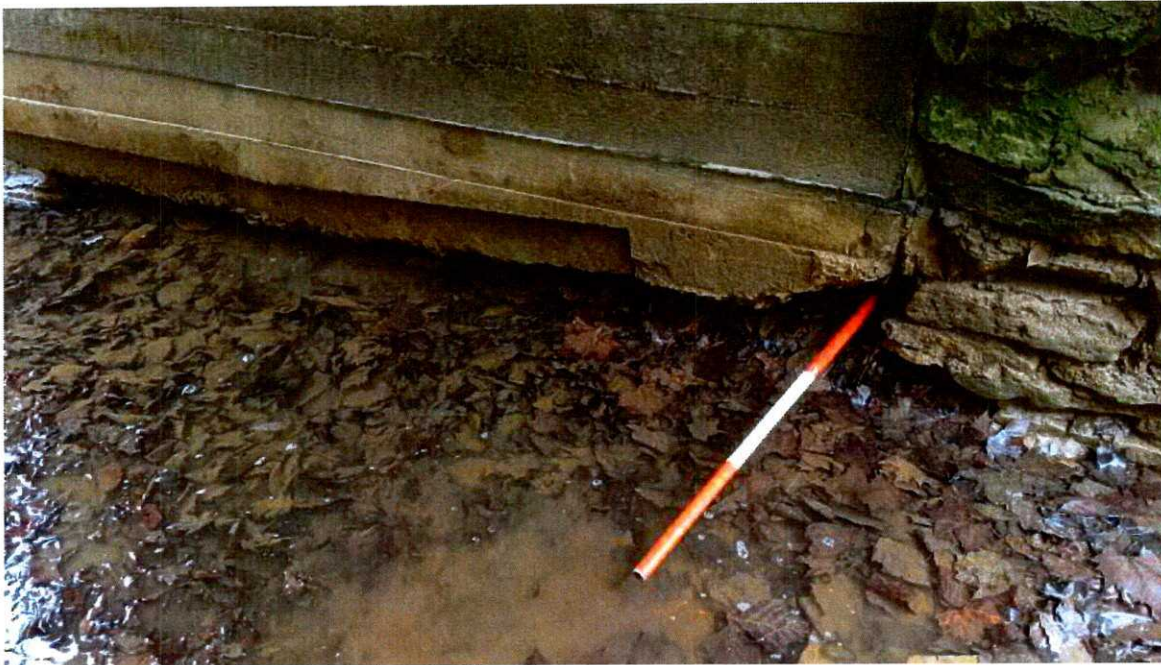
Photo 19. Undermining Along East Abutment, Up to 12" Along Section

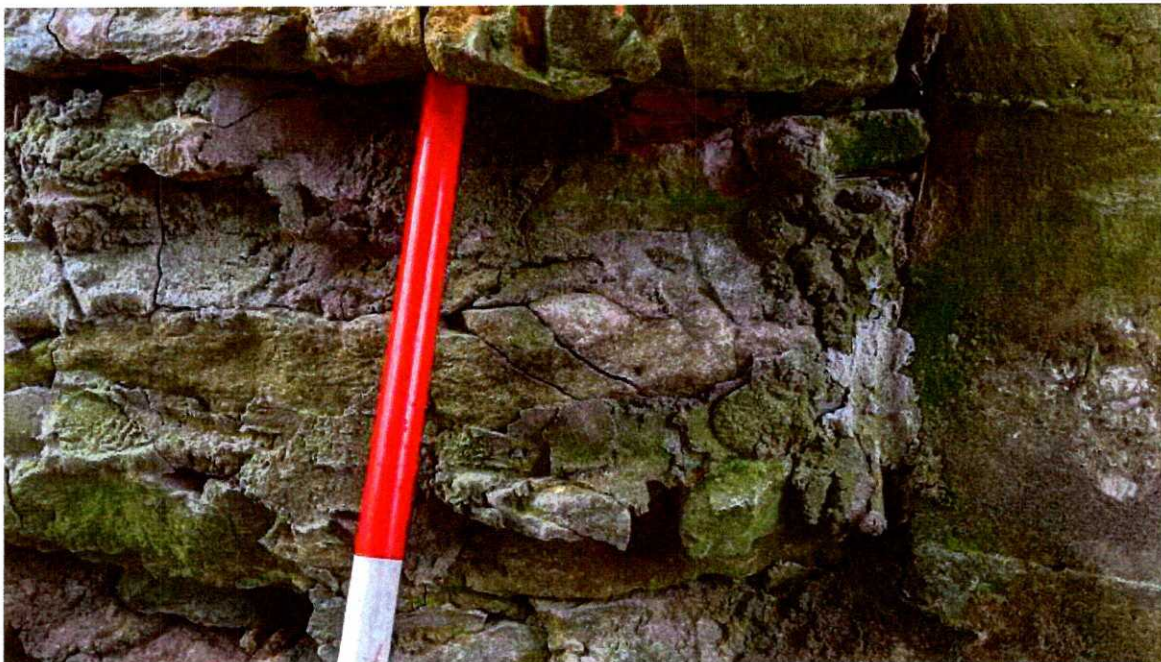
Photo 20. Cracking Through of Stones at South End of West Abutment

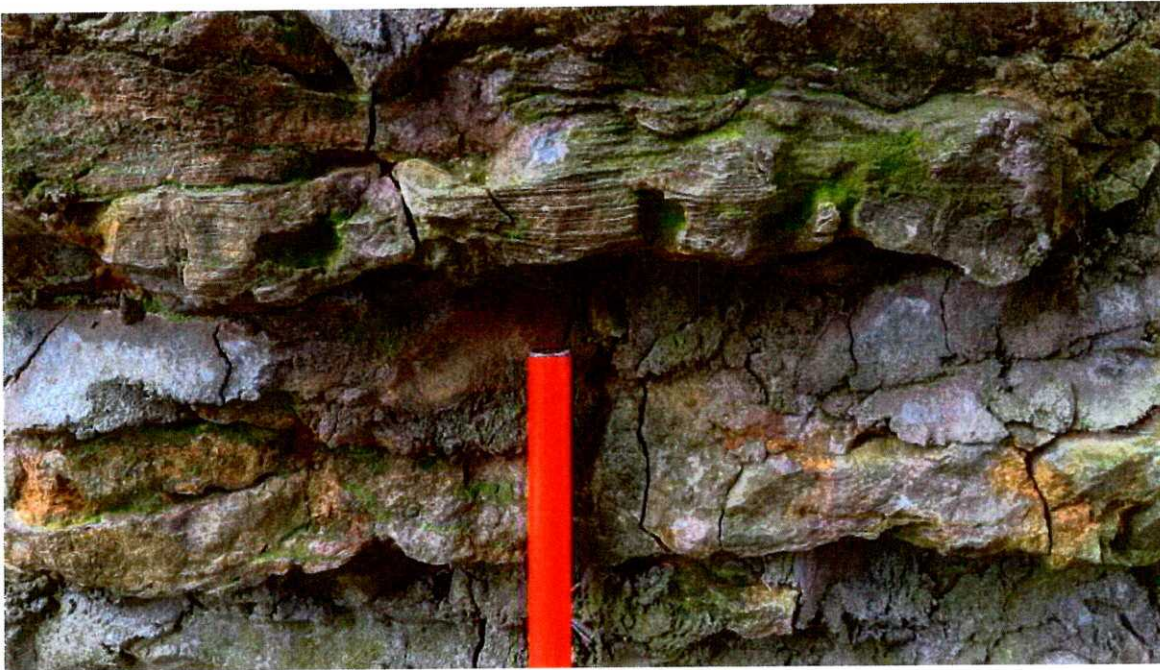
Photo 21. Cracking Through of Stones and Grout at South End of West Abutment

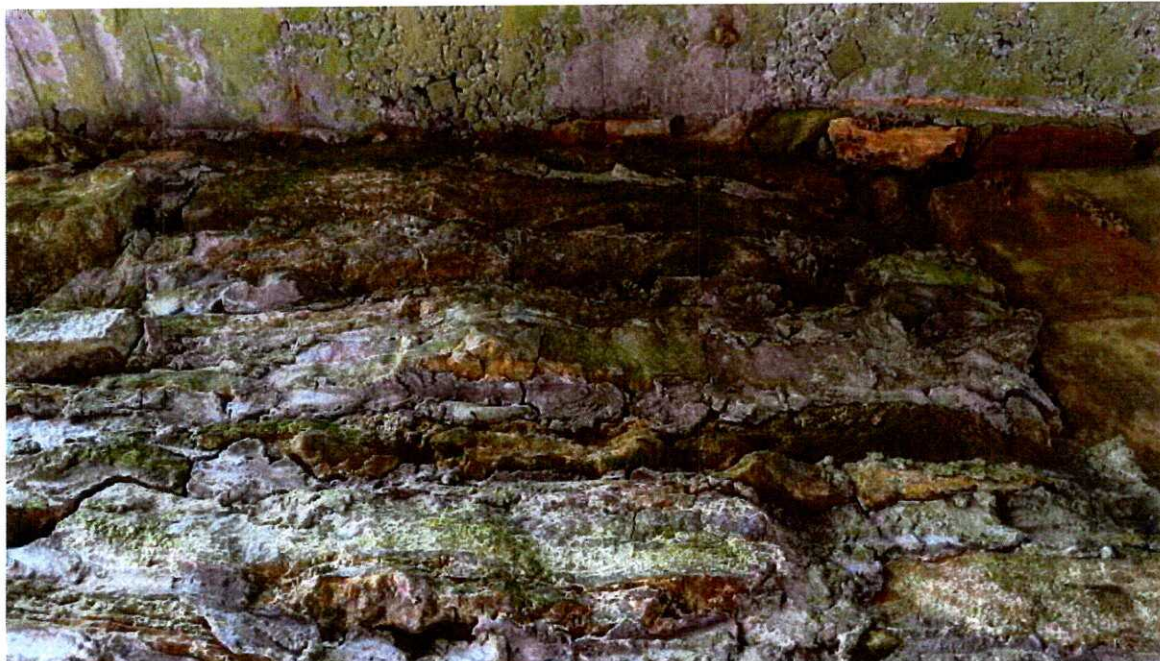
Photo 22. Cracking Through of Stones and Grout at South End of West Abutment, Looking Up

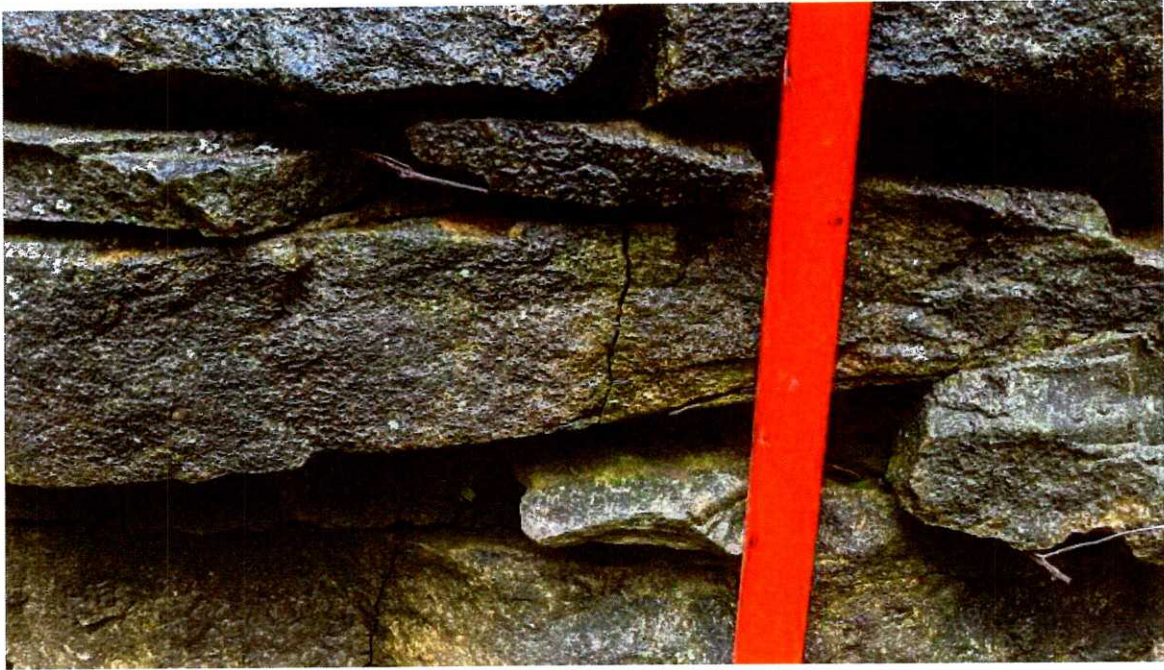
Photo 23. Stones Cracking at Southeast Quadrant. Wall also has sections of grout falling out.

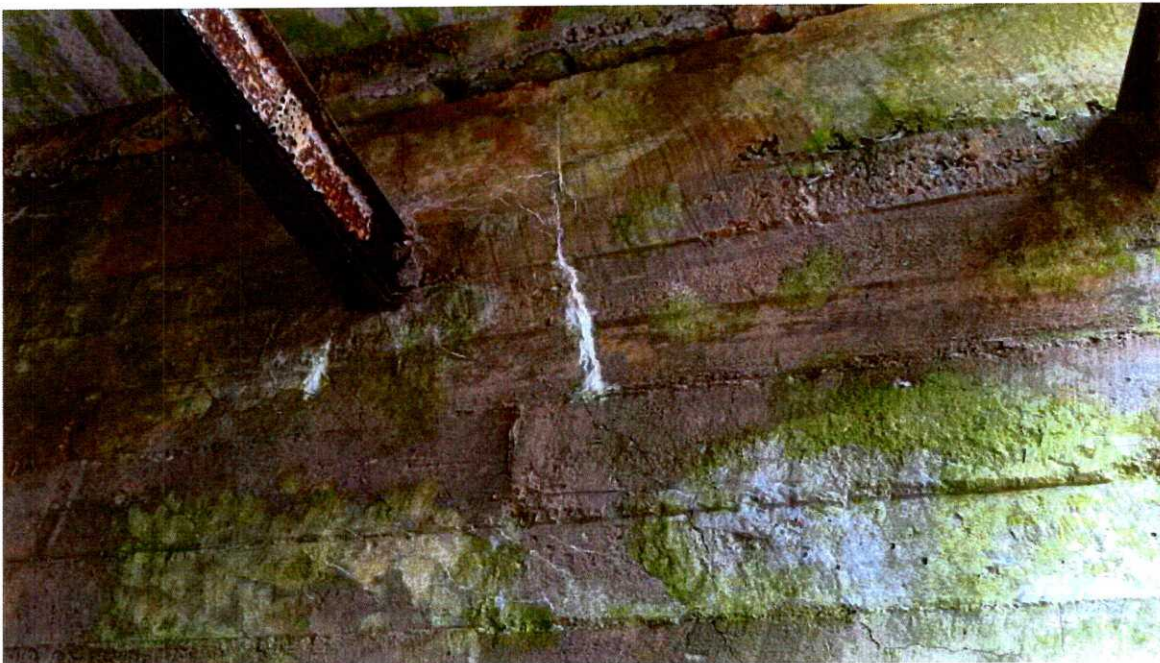
Photo 24. West Abutment, Middle Brace Corrosion with Section Loss and Adjacent Cracking with Efflorescence in Concrete.

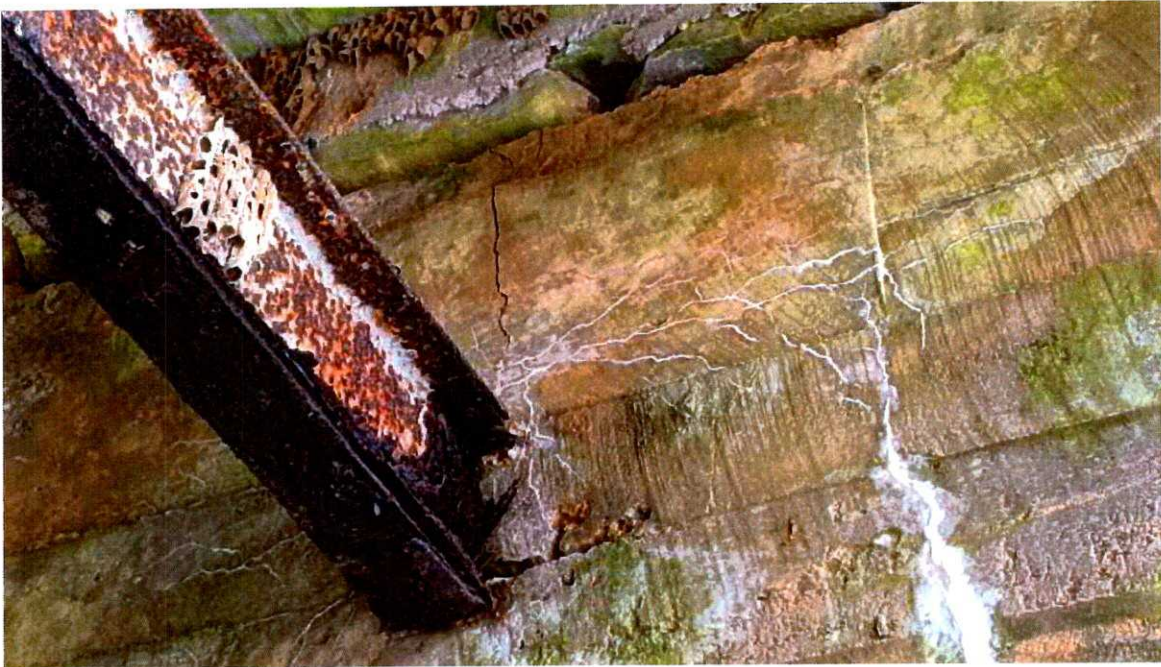
Photo 25. Vertical Crack at Top of West Abutment Leading to Middle Brace

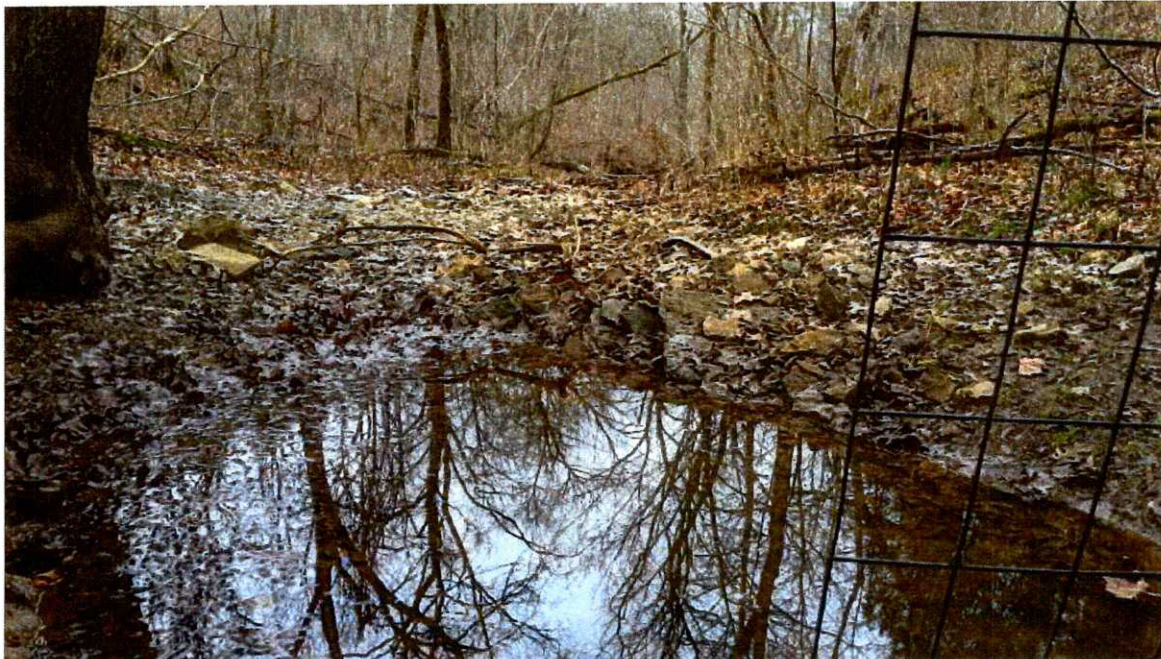
There is a scour hole at the downstream end of the bridge and undermining of the abutments. Some undermining of the tree at the northwest quadrant. The upstream channel has layered rock with vertical slopes along the bank.

Photo 26. Downstream, Looking North and Scour Hole

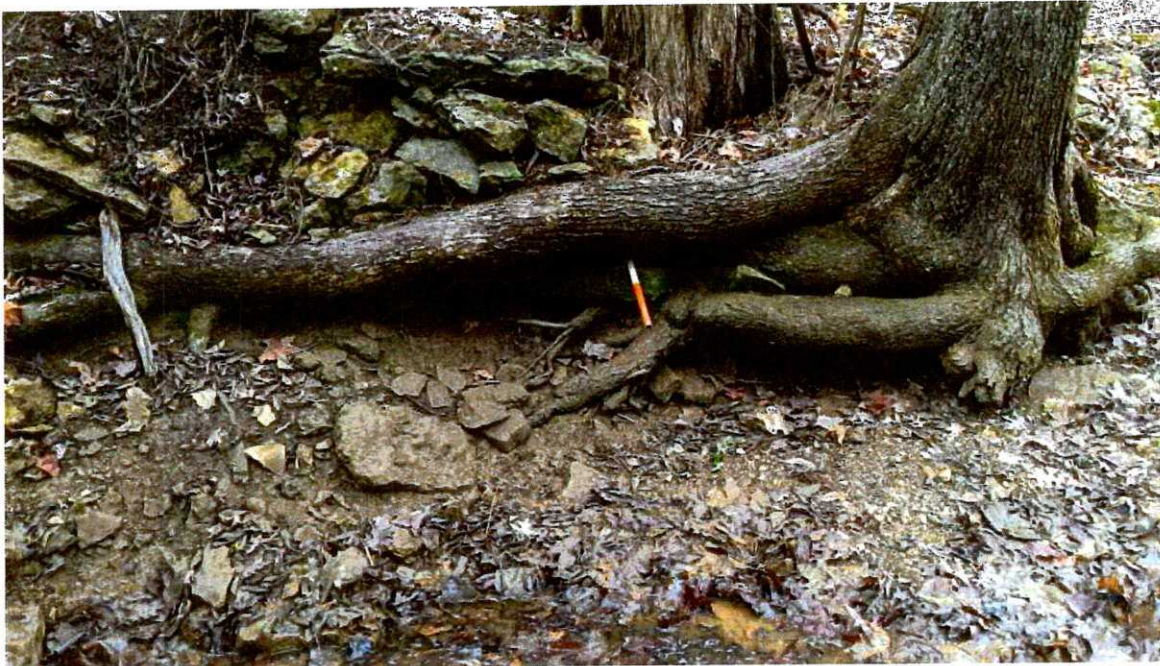
Photo 27. Scour with Undermining of Trees at Northwest Quadrant

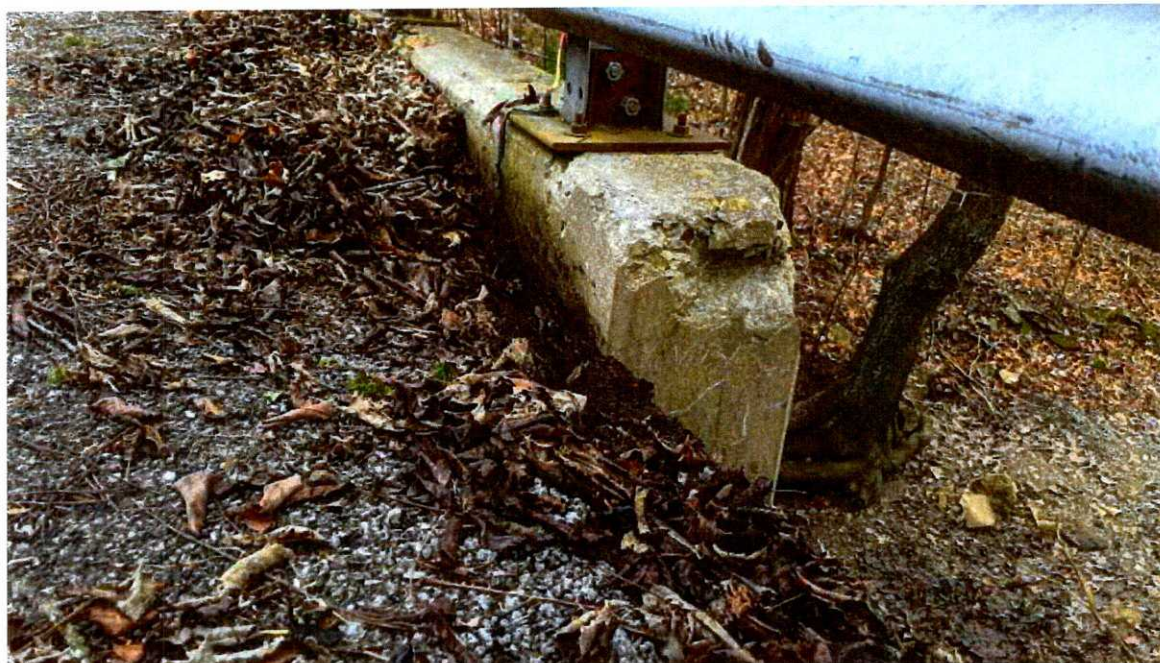
There is debris along the curb lines, more significantly along the north curb line. Depth of asphalt overlay unable to be measured with presence of roadway base also being under asphalt overlay.

Photo 28. Spall at End of Curb at Northeast Corner and Debris Along North Gutterline

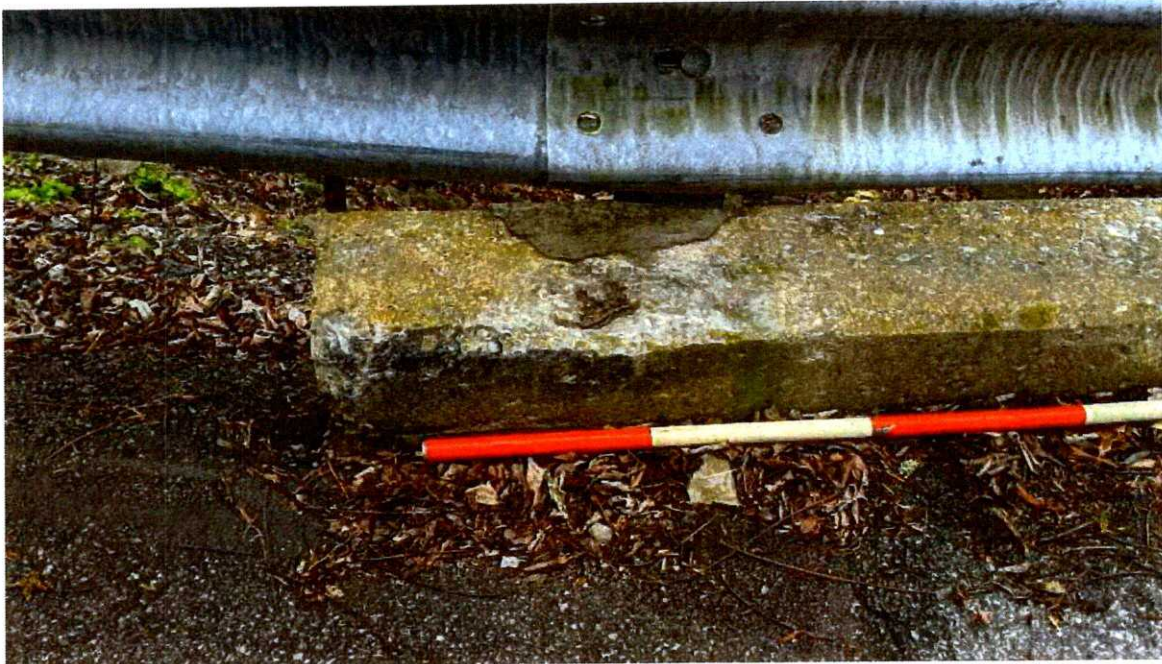
Bridge Railing: Standard ☐ Substandard ☒ N/A ☐ Notes: There are spalls on concrete curb  
Rail Transition: Standard ☐ Substandard ☒ N/A ☐ ends. Damaged post/curb from impact at  
Approach Rail: Standard ☐ Substandard ☒ N/A ☐ SE corner has been repaired, but the concrete  
End Treatments: Standard ☐ Substandard ☒ N/A ☐ patch has spalled (See Photo 29).

Photo 29. Spall and Patch at Southeast End of Curb
