Asbestos & Lead Based Paint Assessment

City of Spartanburg
107 Amelia Street
Spartanburg, South Carolina 29303

Project Number: 0123-01

February 9, 2023

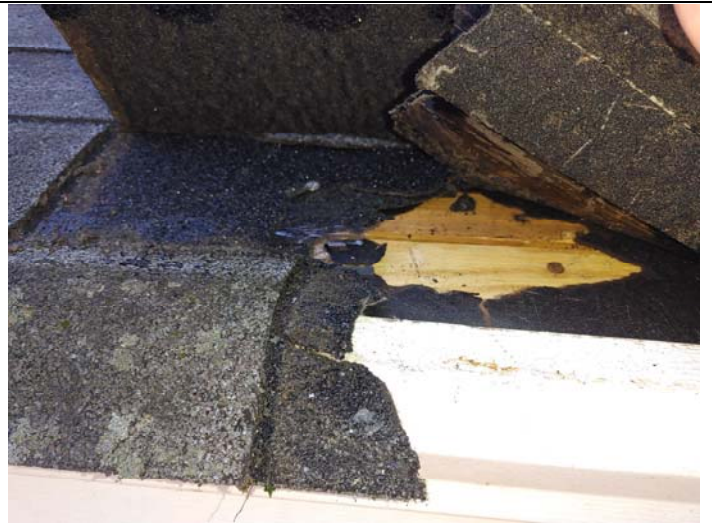
Photo 2 – Roof shingles (1 layer) & felt paper (1 layer)

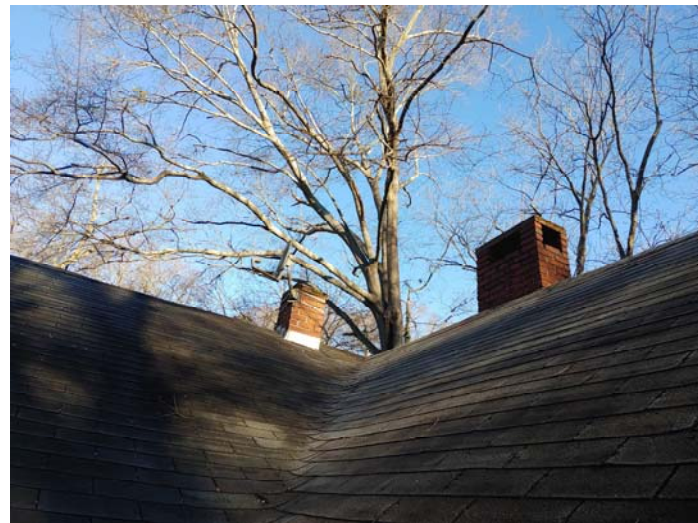
Photo 3 – View of 2 chimney's with tar – assumed positive

1. Abate the asbestos containing materials from the residence prior to renovation or demolition.
2. No suspect ACM was identified at the exterior wooden barn during the assessment. Therefore, no recommendations are warranted at this time.

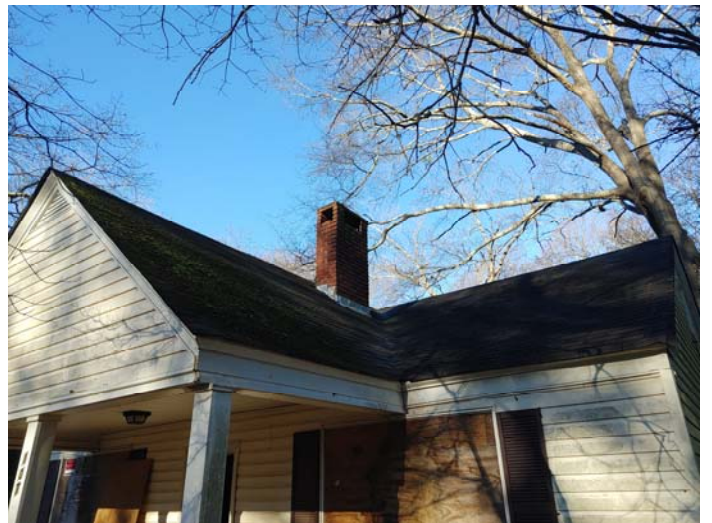
Photo 4 – View of 1 of 2 chimney's with tar – assumed positive

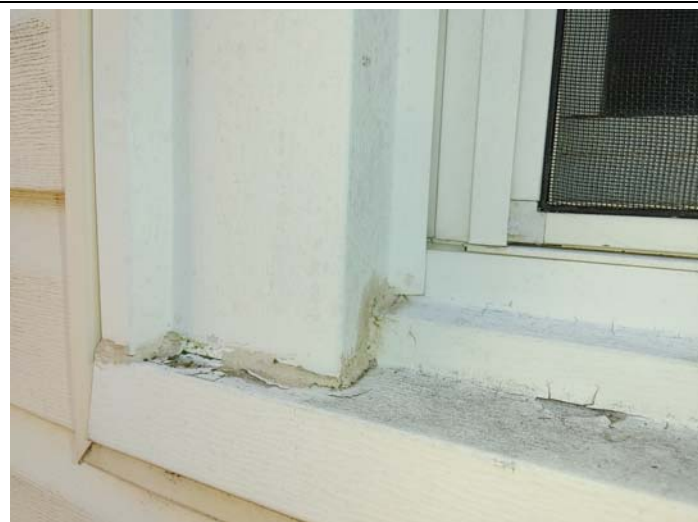
Photo 5 – Caulk on metal wrapping over window casings/frames

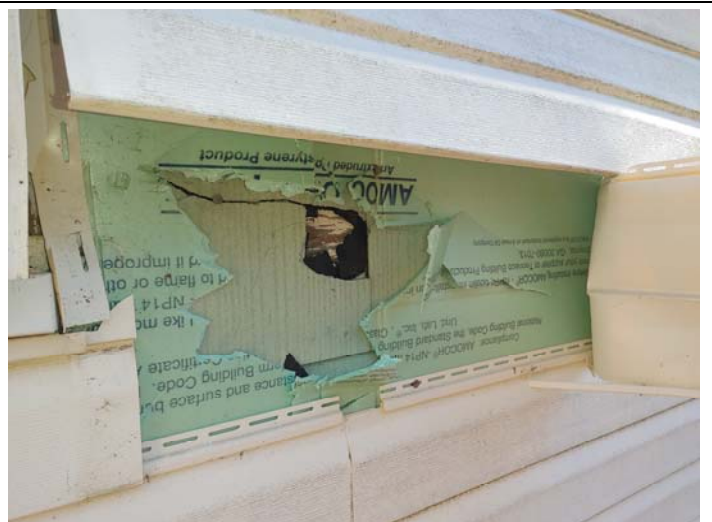
- Approximately 1,750 SF of transite siding beneath the vinyl siding & under the back door.
- Approximately 50 LF of cloth HVAC A-Tape on the crawlspace.
- Approximately 12 LF of tar on 2 chimney's – assumed positive.

Photo 6 – Transite with felt below the vinyl siding

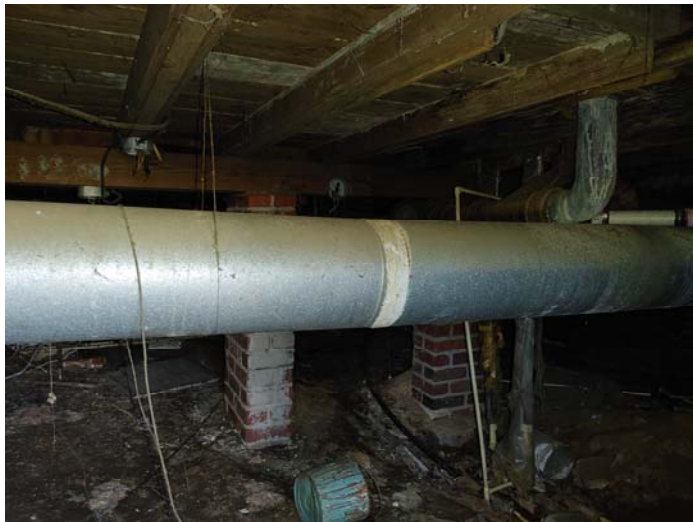
Photo 7 – HVAC A-Tape in the crawlspace

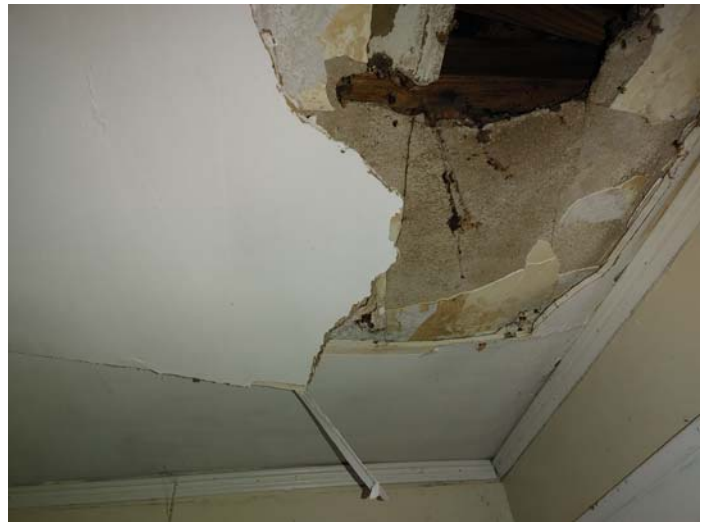
Photo 8 – Drywall with joint compound ceilings with plaster & finish located above

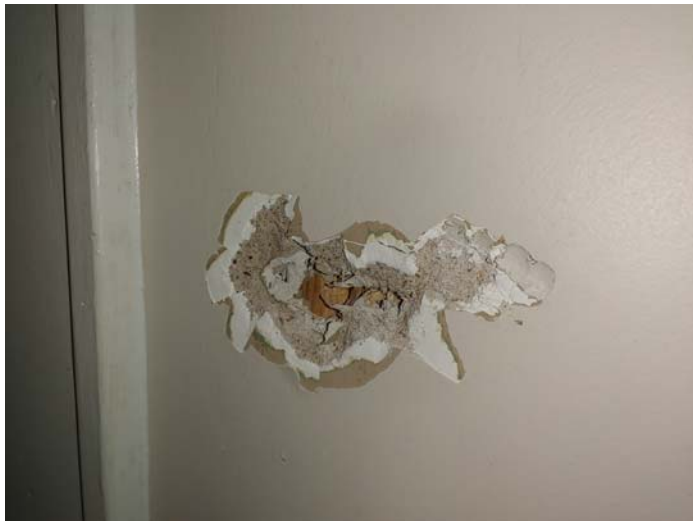
Photo 9 – Plaster with finish walls throughout

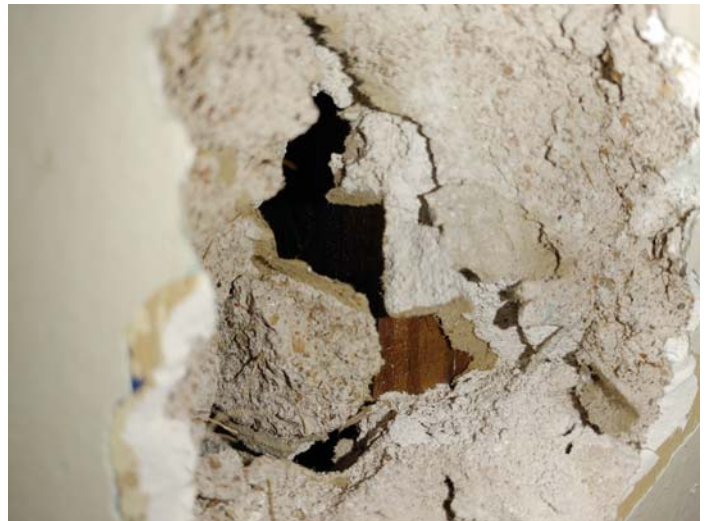
Photo 10 – Unfinished drywall scattered throughout beneath the plaster walls

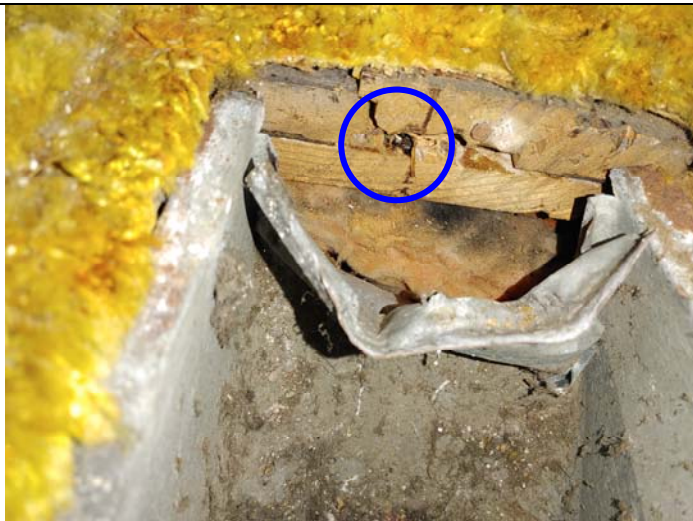
Photo 11 – Felt paper under wooden floor throughout

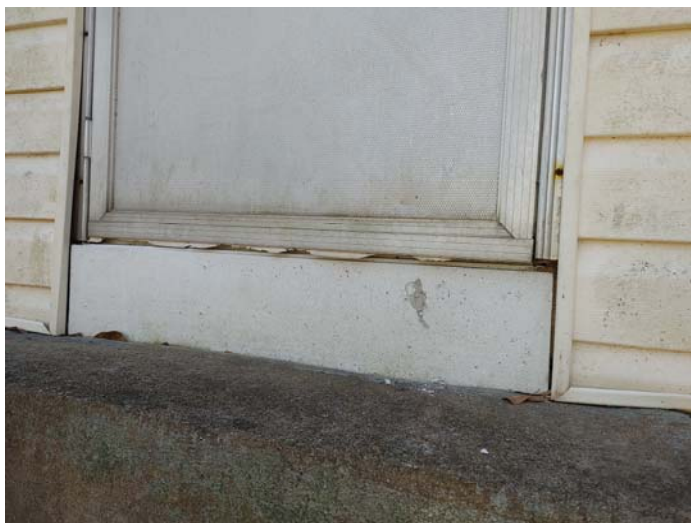
Photo 17 – Transite under back door

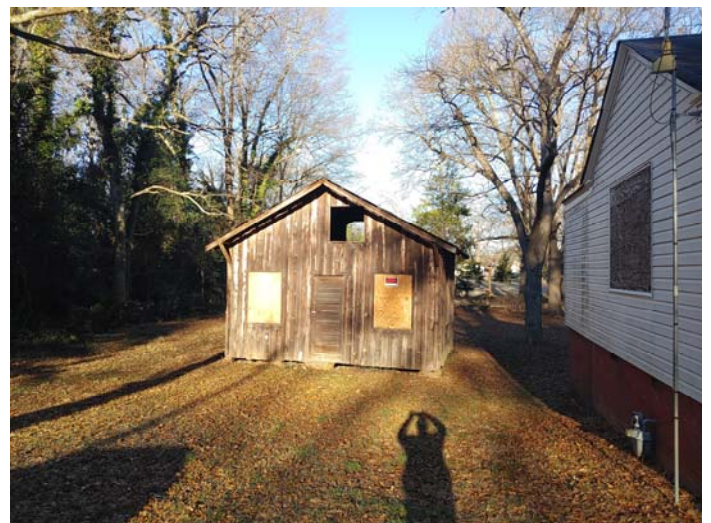
Photo 18 – View of the exterior barn with no suspect ACM identified

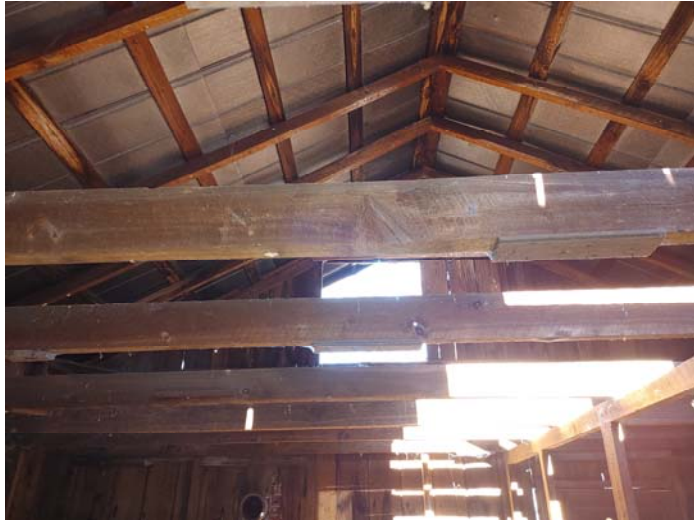
Photo 19 – View of the interior of the barn with no suspect ACM identified

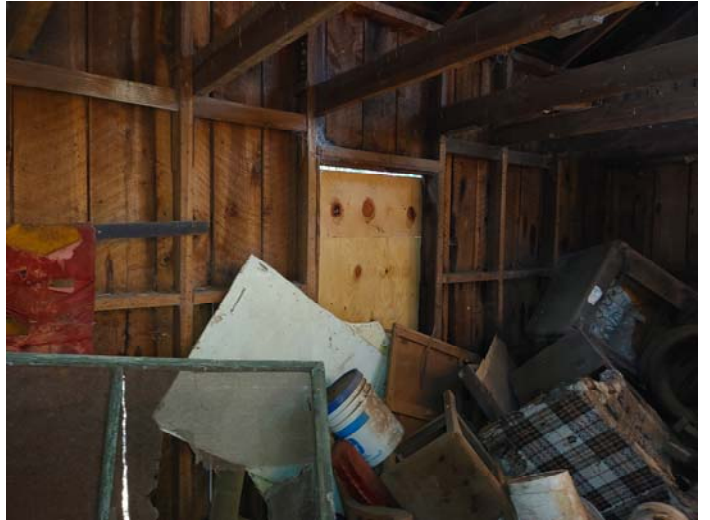
Photo 20 – View of the interior of the barn with no suspect ACM identified
