# Yates Hall Steam Tunnel

## Pittsburg State University

# Structural Assessment Report

**Date:**  
October 20, 2022

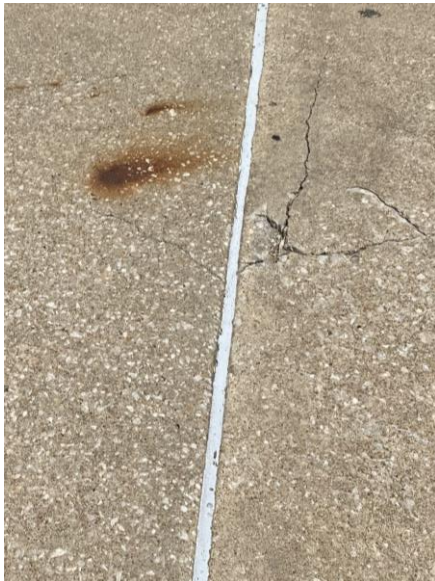
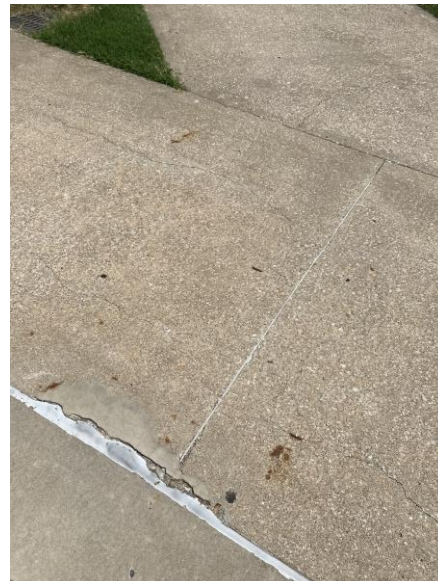
### EXTERIOR RUST SPOTS

Rust spots were visible throughout the length of the tunnel on the top side of the slab.

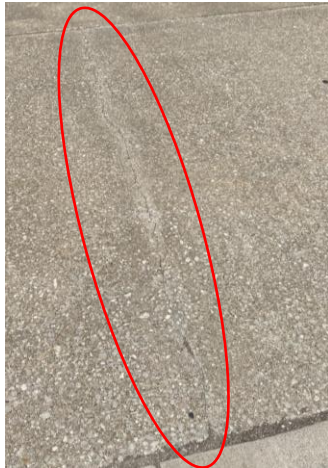
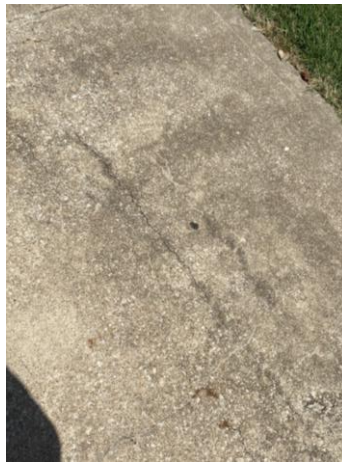
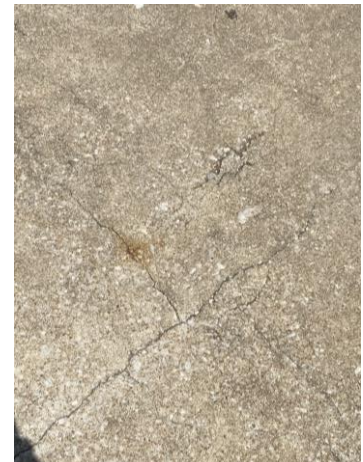
## EXTERIOR CRACKING

Cracks were observed when viewing the top of the steam tunnel lid from outside Yates Hall. One crack in the concrete propagated the full width of the steam tunnel.

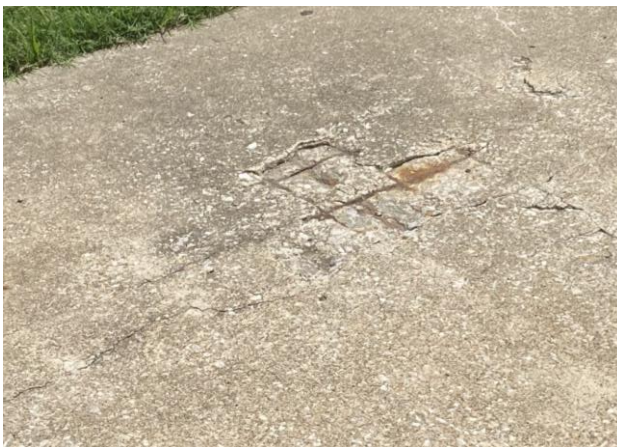
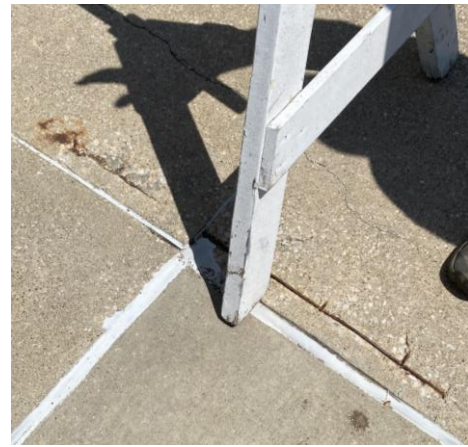
## EXTERIOR SPALLING

In multiple locations on the top side of the slab, the concrete spalled and the welded wire fabric reinforcing was exposed to the elements.

The spalled concrete on top of the slab reveals that the welded wire fabric reinforcing does not have the concrete cover of 1½" to the surface of the slab as indicated in the detail. To protect the reinforcing from water infiltration and subsequent damage, the reinforcing should have been placed to maintain the indicated clear distance between it and the top of the slab. The American Concrete Institute (ACI) requires a cover of 1" minimum between top of concrete and reinforcing for exposed slabs. From the images provided in the exterior spalling section, it is shown that the depth between the top of concrete and the welded wire reinforcing is less than required.

Based on the observations, PEC recommends repairing the impacted areas as indicated in the construction documents prepared by PEC dated October 20, 2022. The exposed rebar will need to be cleaned of all rust and the concrete replaced to avoid continued degradation.

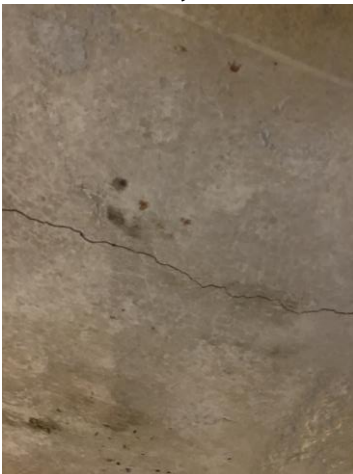
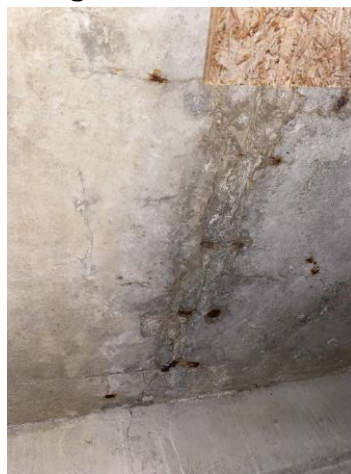
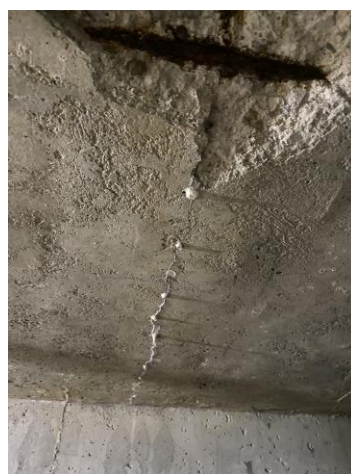
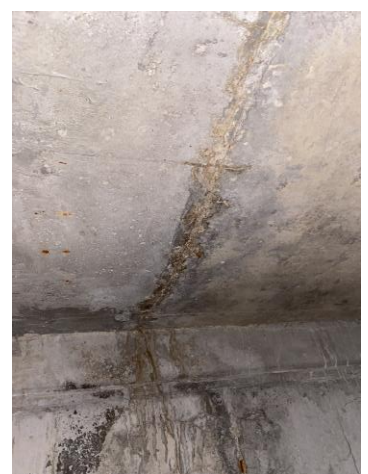
## INTERIOR CRACKING - LID

Observed interior cracking propagated along the width of the tunnel. Some full width cracks may have been control joints from the original construction of the tunnel.

It was difficult to align the observed damage within the tunnel to the tunnel lid as observed from above in the exterior photos. It is possible some of the interior cracks observed that were straight across the width of the tunnel were due to control joint locations on the surface of the tunnel lid. The control joints provide a location for the concrete to crack in a controlled manner. These cracks are caused by concrete movement due to temperature changes and shrinkage while drying. They are expected as the concrete ages and are not cause for concern. It is recommended to seal these cracks against water infiltration.

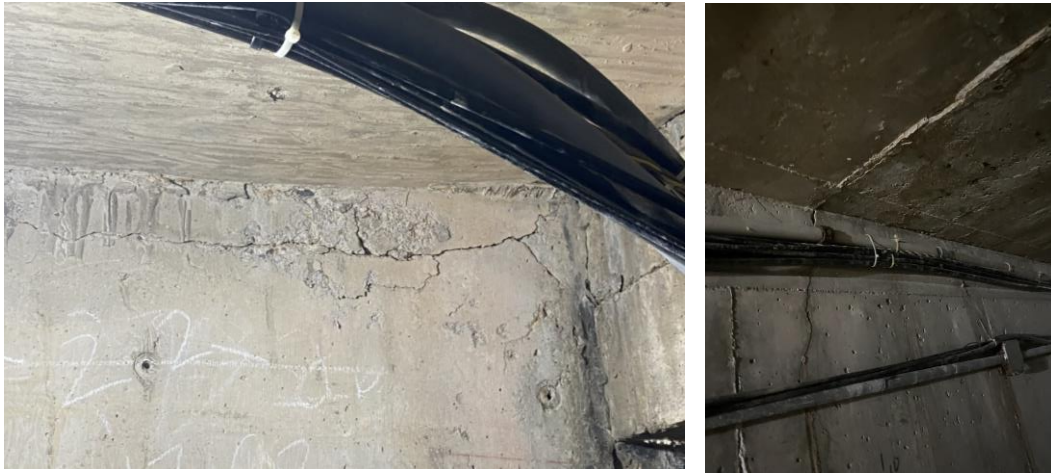
## INTERIOR CRACKING - WALLS

At multiple locations throughout the length of the tunnel, cracking in the walls was observed. The cracks were located near the top of the wall adjacent to the connection to the tunnel lid.

It was also noted in the report that there were cracks visible in the wall of the tunnel past the hatch, where the tunnel lid drops in elevation. The cracks in the walls are not cause for structural concerns at this time.

While repairing the notable areas of concern, it is also recommended to patch minor cracks or spalling in the tunnel lid and walls with the repair grout.

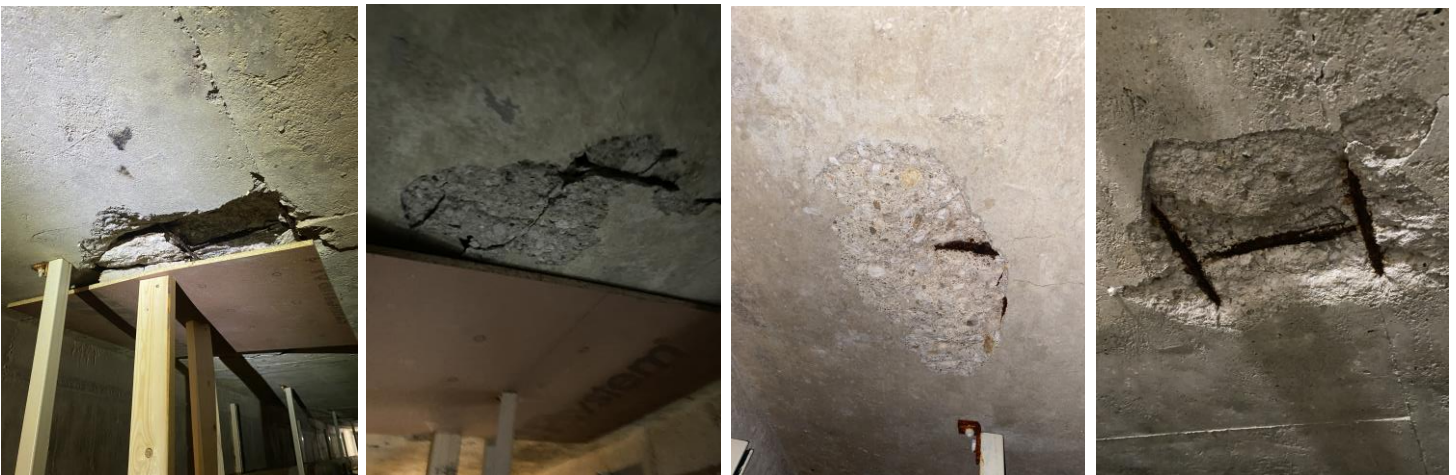
## INTERIOR SPALLING

Large pieces of spalled concrete were observed within the tunnel in various locations. The impacted areas had been shored to try to mitigate further movement of the concrete so not all damage was able to be observed.
