Pre-Demolition Limited Regulated Hazardous Materials Survey Report

**Warehouse Building, Arlington County
2700 Nelson Street
Arlington, VA 22206**

November 11, 2021

JSK Project Number JSK-2021-56

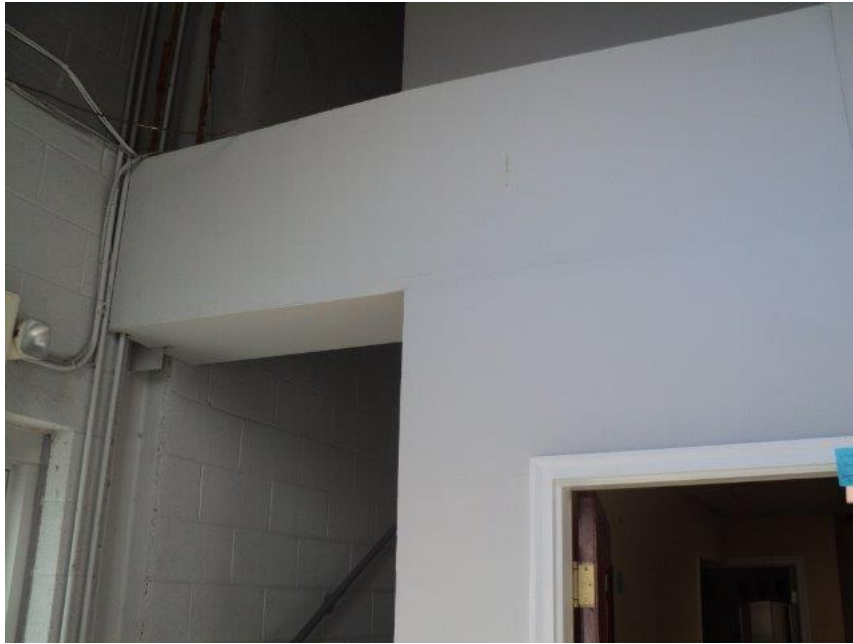
Homogeneous Material No. 1 – Non-ACM White Drywall with White Joint Compound located throughout the Subject Property

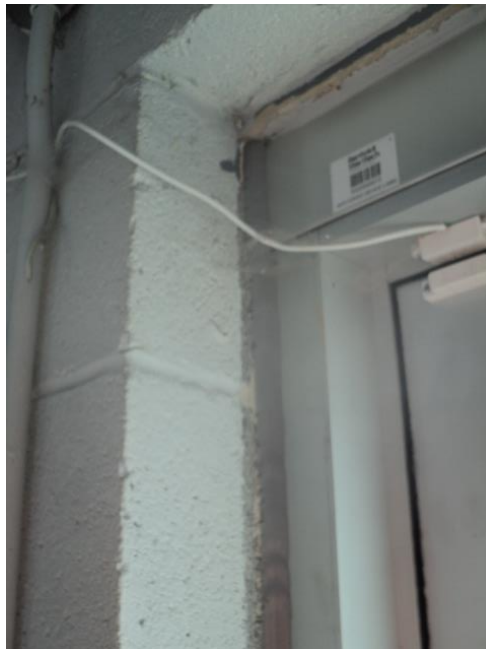
Homogeneous Material No. 2 – Non-ACM Grey Caulk located at the Interior Door in the 2nd Floor Front Mezzanine Area

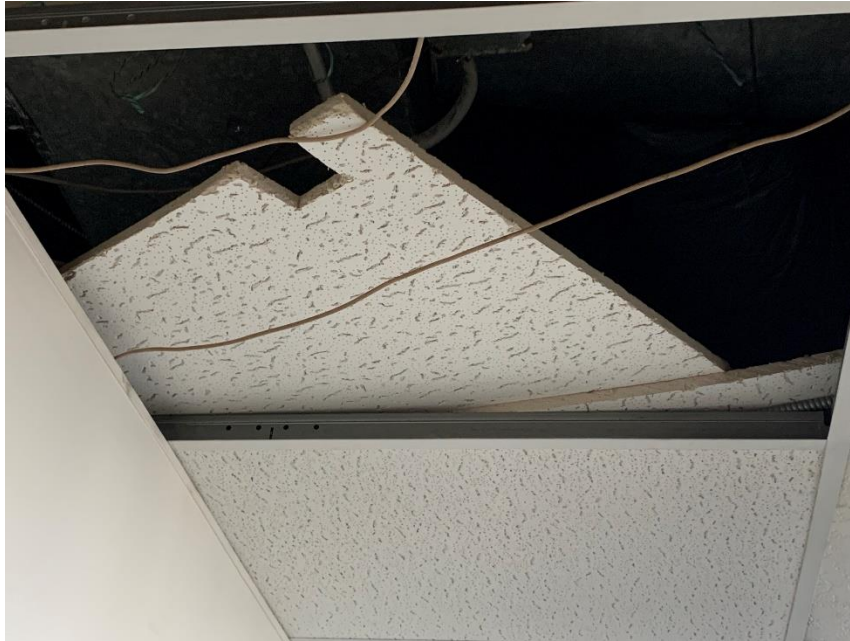
Homogeneous Material No. 3 – Non-ACM 2’X4’ White Textured Lay-in Ceiling Tile (dots with dashes design), located in all of 1st floor and 2nd floor front Mezzanine Plus part of back Mezzanine Area

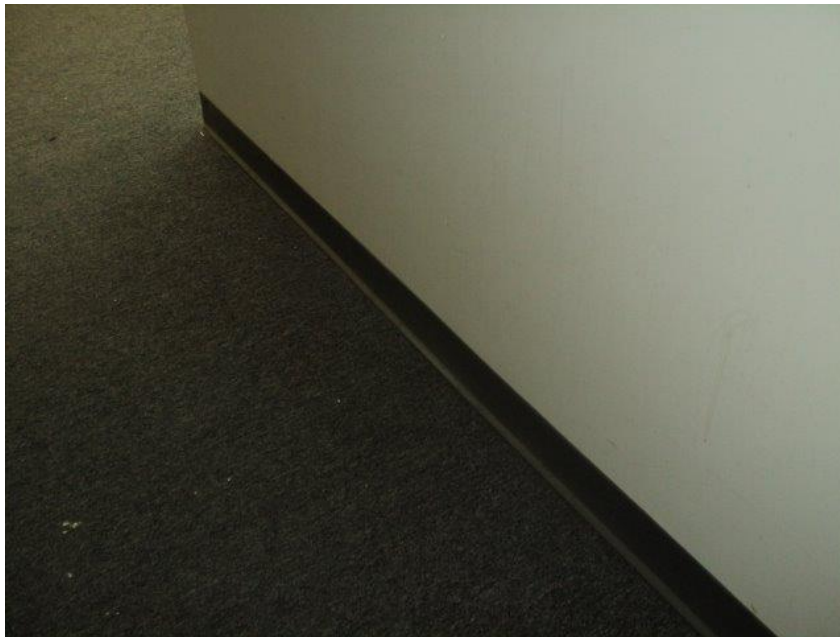
Homogeneous Material No. 4 – Non-ACM Grey 4” Vinyl Cove Base with Cream and Yellow Mastic located throughout 1st Floor and 2nd floor front Mezzanine Area

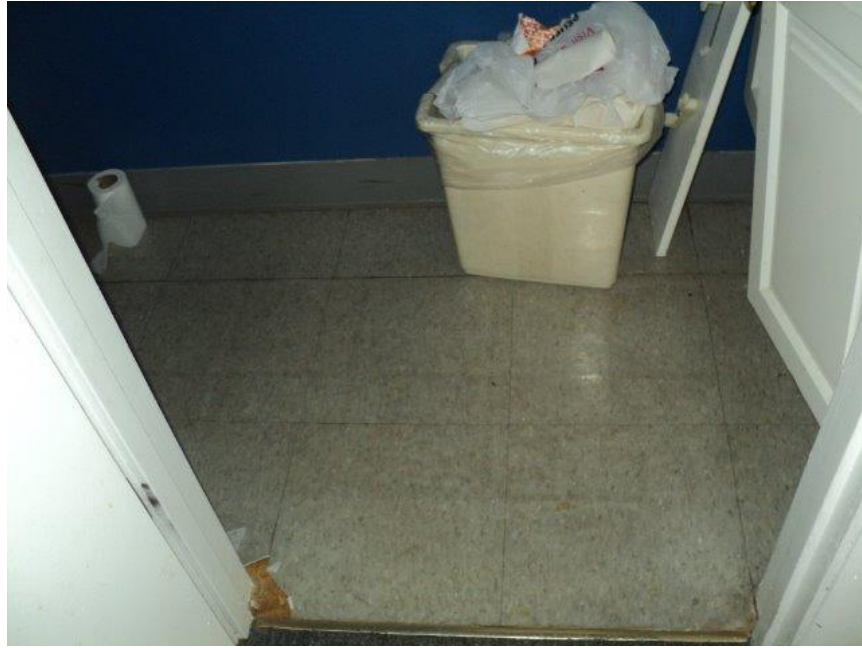
Homogeneous Material No. 5 – Non-ACM Grey 12" X 12" Vinyl Floor Tile with Light Yellow Mastic located throughout 1st Floor and Restrooms in 2nd floor front Mezzanine Area

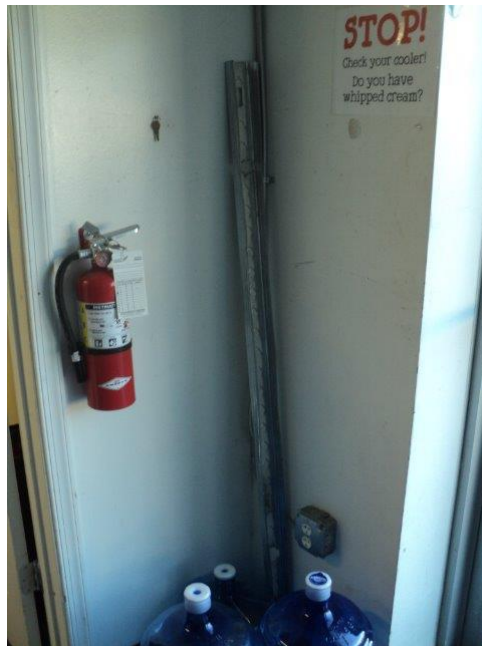
Homogeneous Material No. 6 – Non-ACM White Dry Wall with White Joint Compound located throughout Ben and Jerry Area

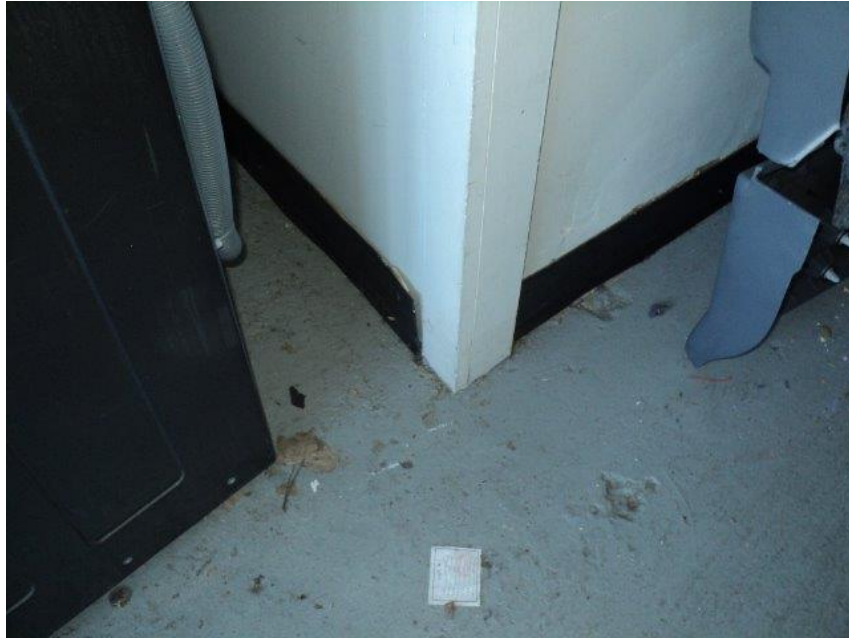
Homogeneous Material No. 7 – Non-ACM Black 4" Vinyl Cove Base with Light Yellow Mastic located throughout Ben and Jerry Area

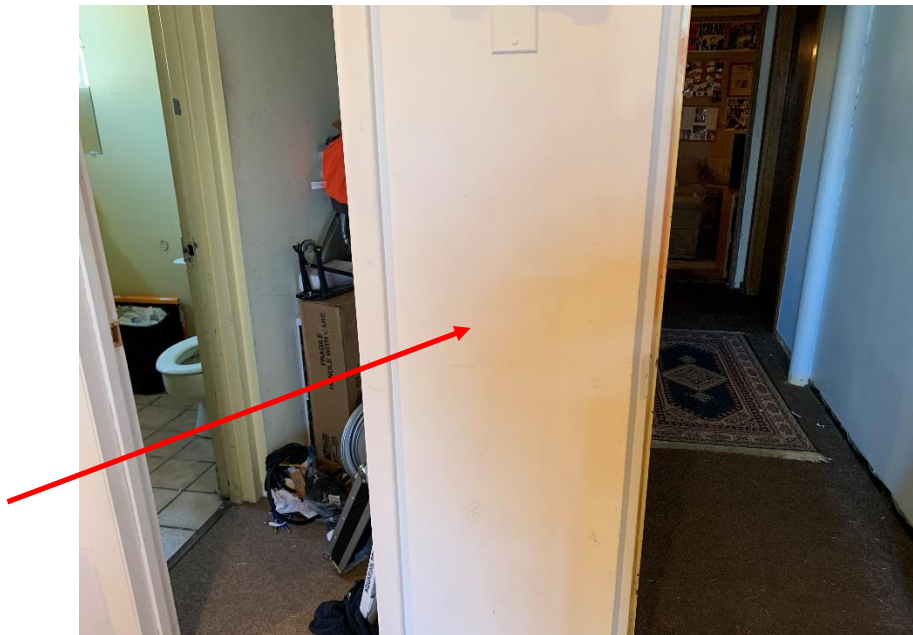
Homogeneous Material No. 8 – Non-ACM White Dry Wall with White Joint Compound located throughout Inner Studio Area

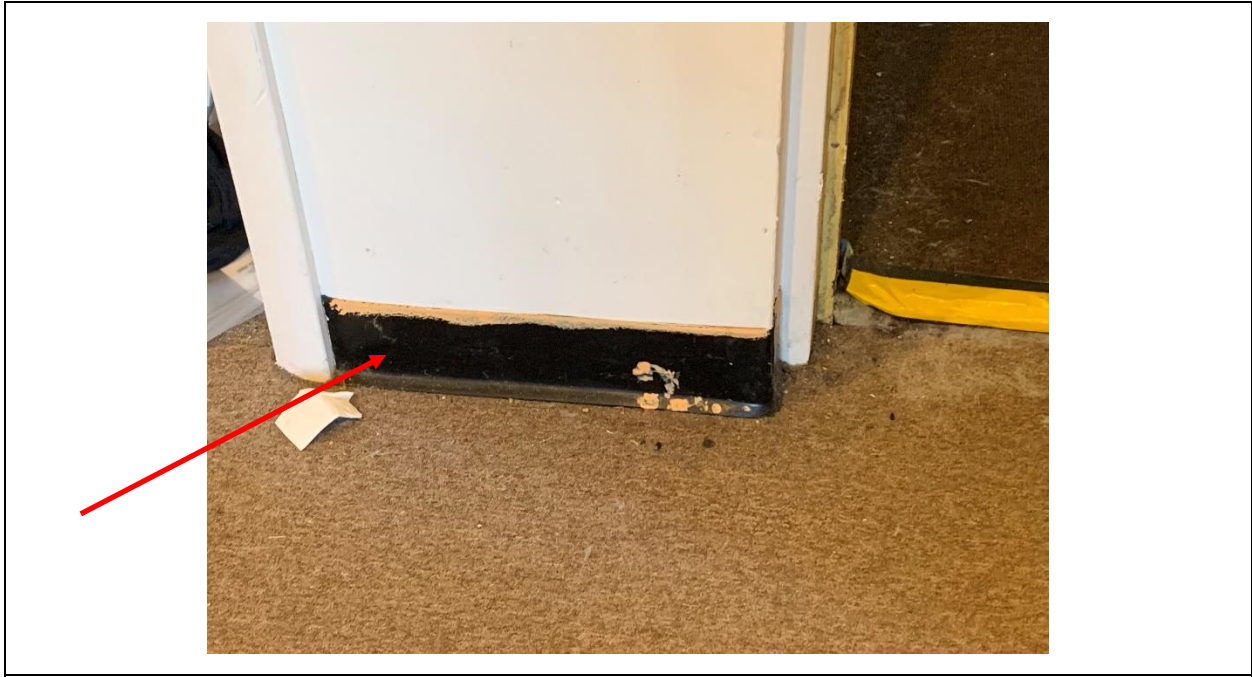
Homogeneous Material No. 9 – Non-ACM Black 4” Vinyl Cove Base with Tan Mastic located throughout Inner Studio Area

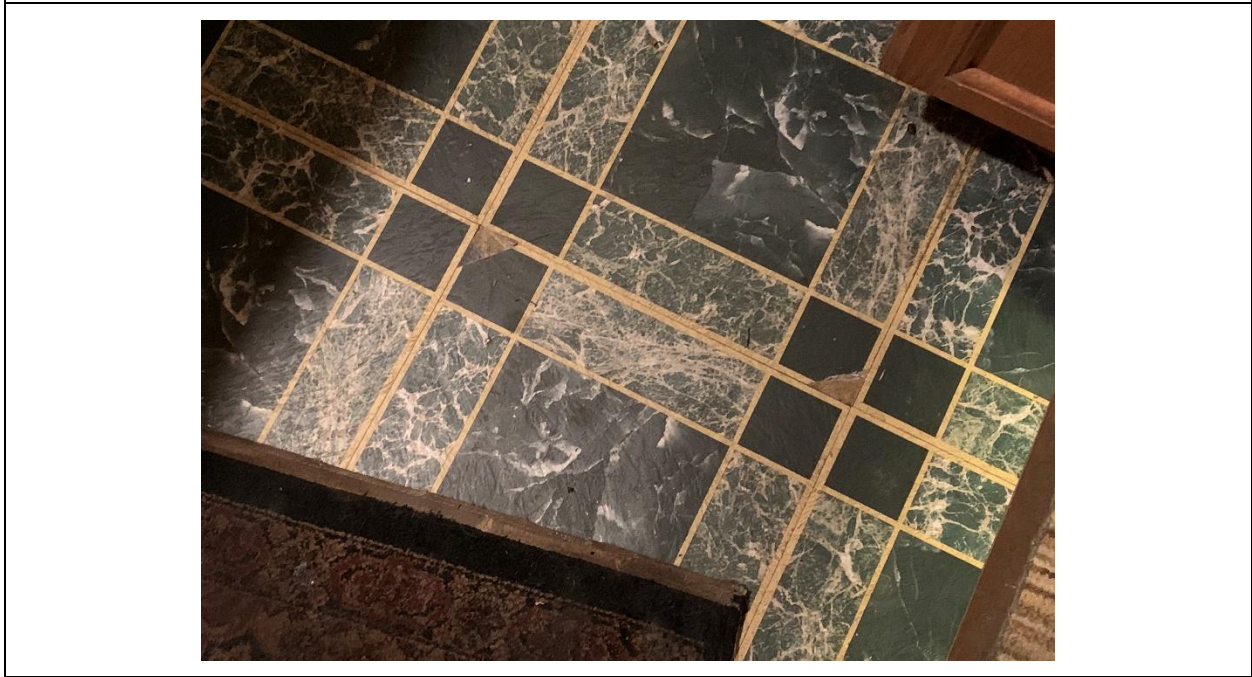
Homogeneous Material No. 10 – Non-ACM Green Geometric Pattern Peel & Stick 12” X 12” Vinyl Floor Tile with Yellow Mastic located in Kitchen area of Inner Ear Studio

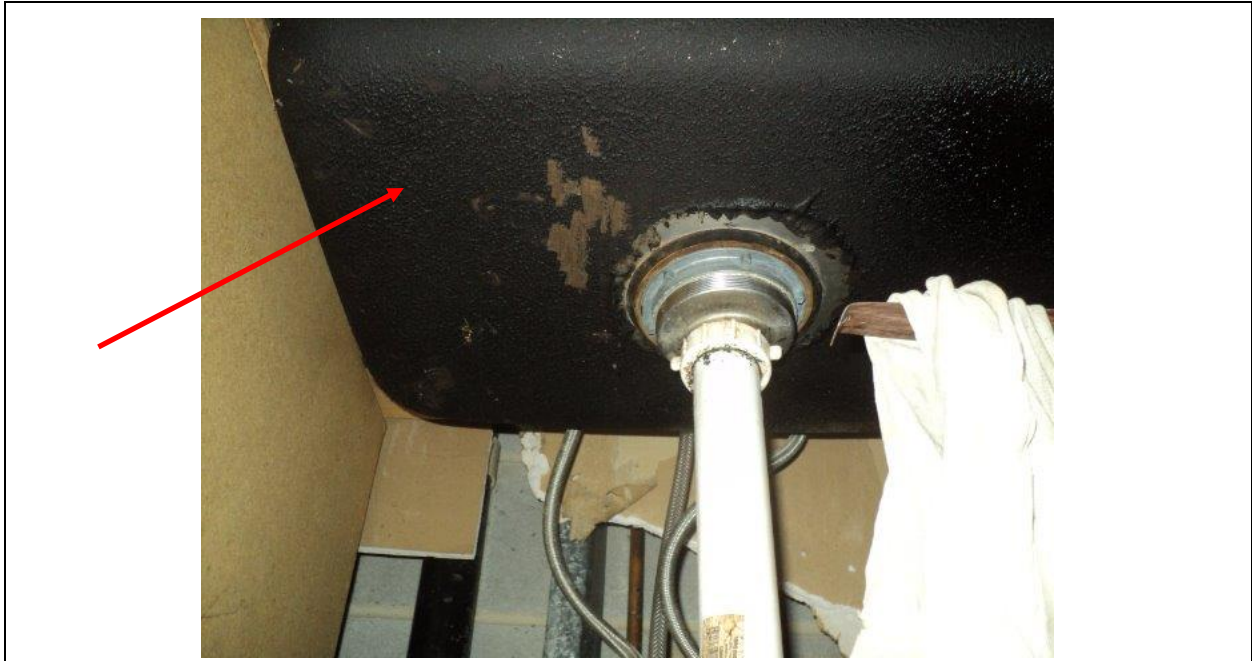
Homogeneous Material No. 11 – ACM Black Sink Bowl Mastic Coating located in Kitchen of the Inner Ear Studio

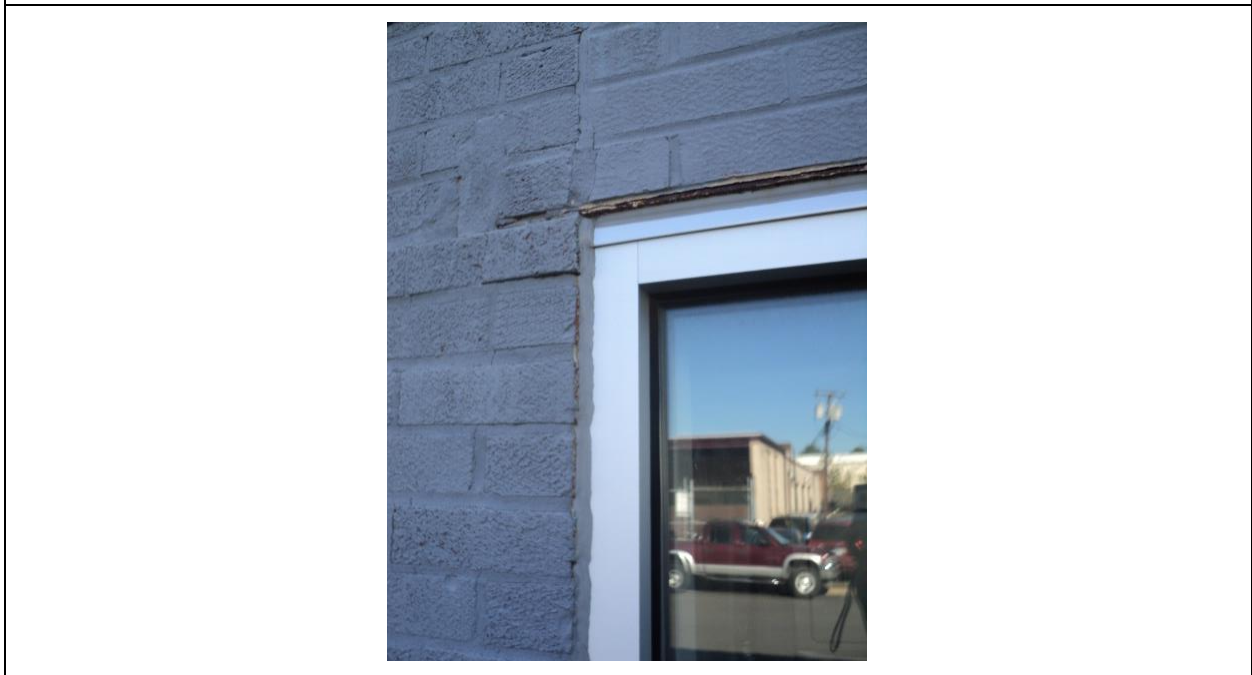
Homogeneous Material No. 12 – Non-ACM Grey Exterior Door Caulk located in Ben & Jerry area

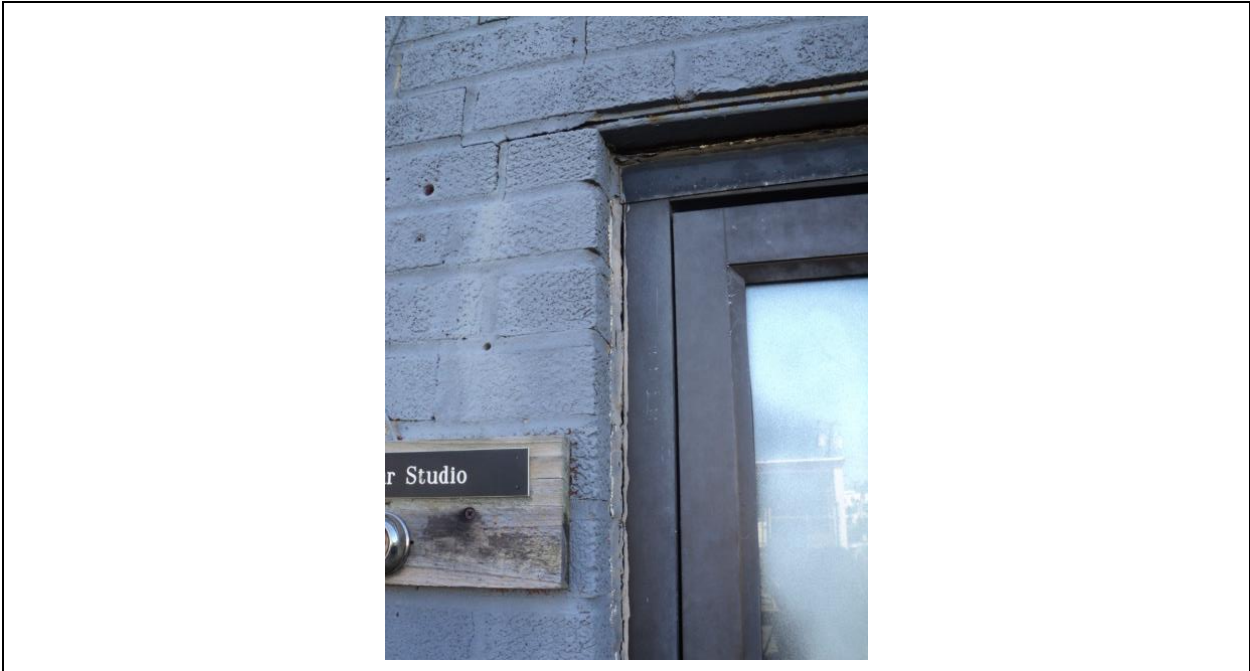
Homogeneous Material No. 13 – Non-ACM Grey Exterior Door caulk located outside the Inner Ear Studio

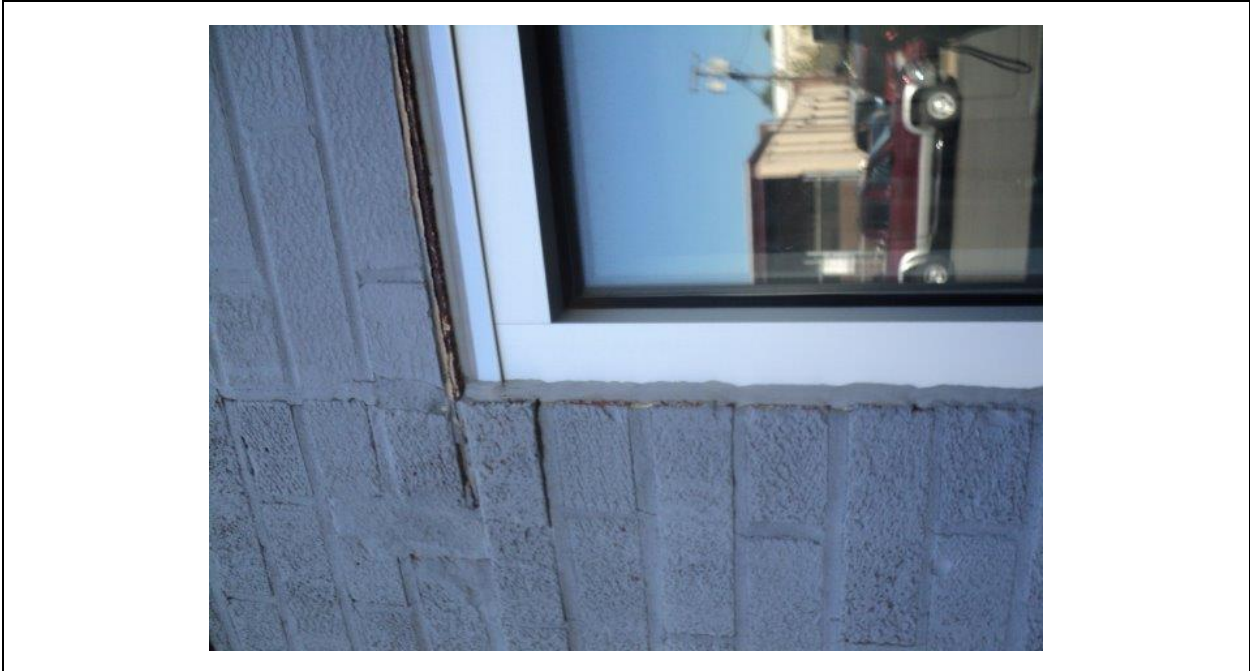
Homogeneous Material No. 14 – Non-ACM White Exterior Window Caulk located outside the Inner Ear Studio

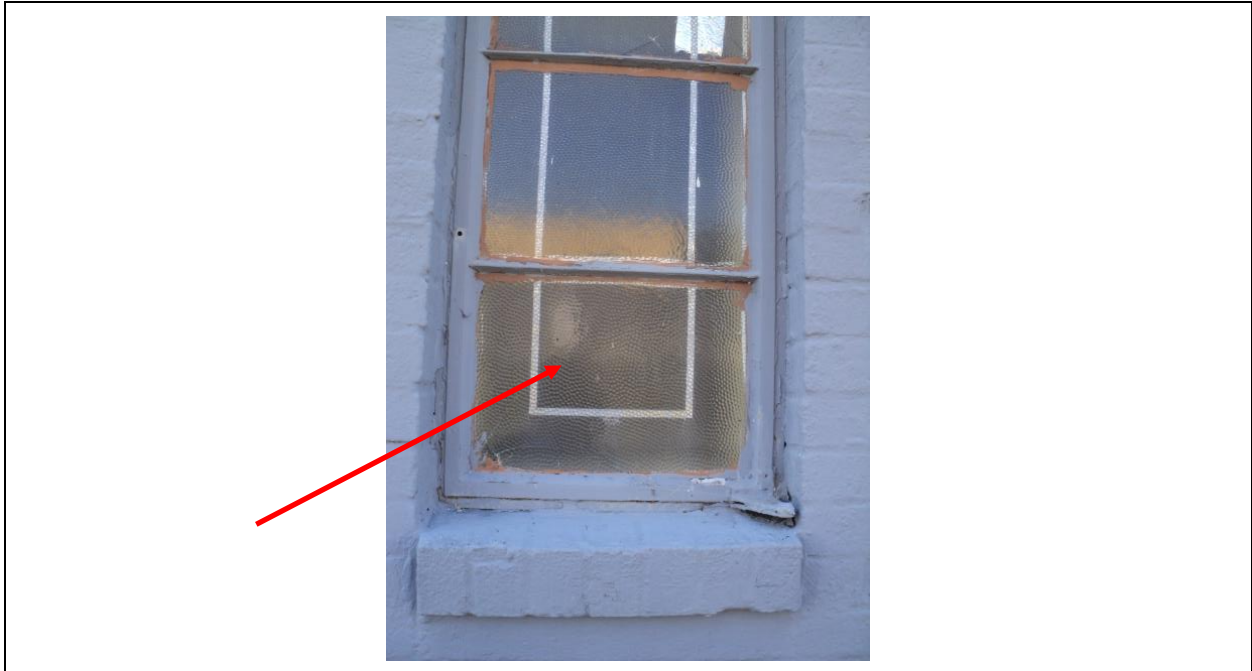
Homogeneous Material No. 15 – ACM White/Off-White exterior Window glazing compound located in the Exterior Metal Window of Inner Ear Studio

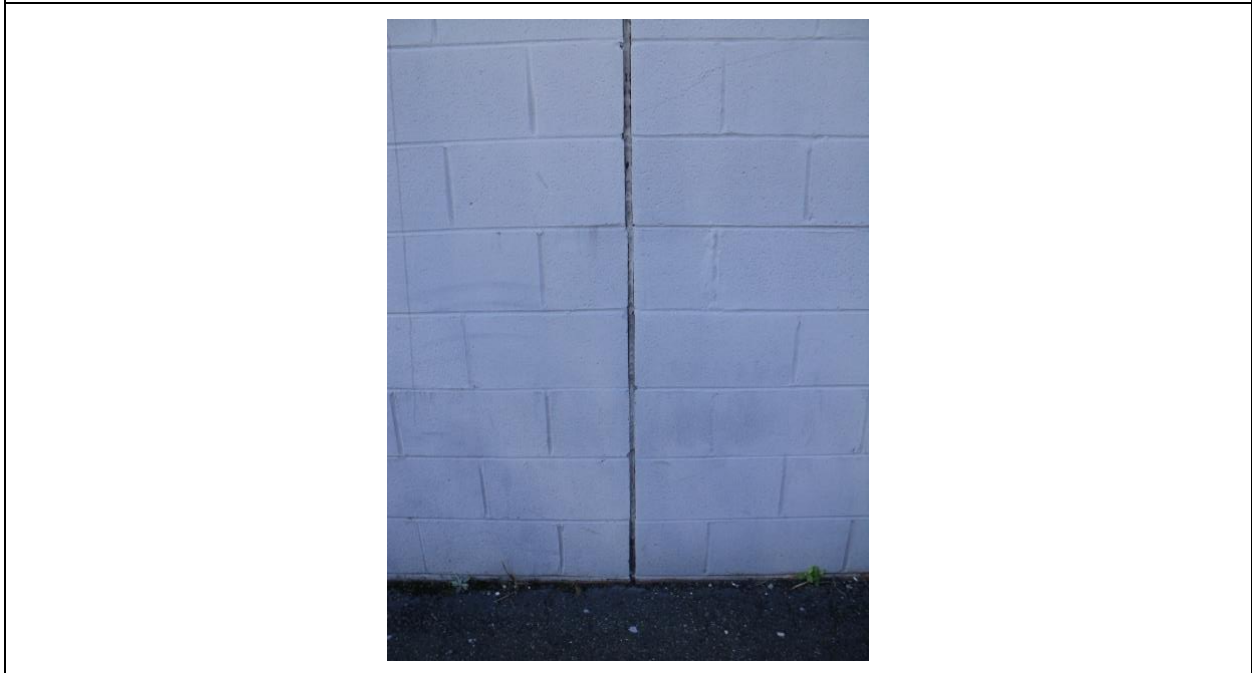
Homogeneous Material No. 16 – Non-ACM Grey Wall Expansion Joint Caulk located in the Exterior Wall of Building

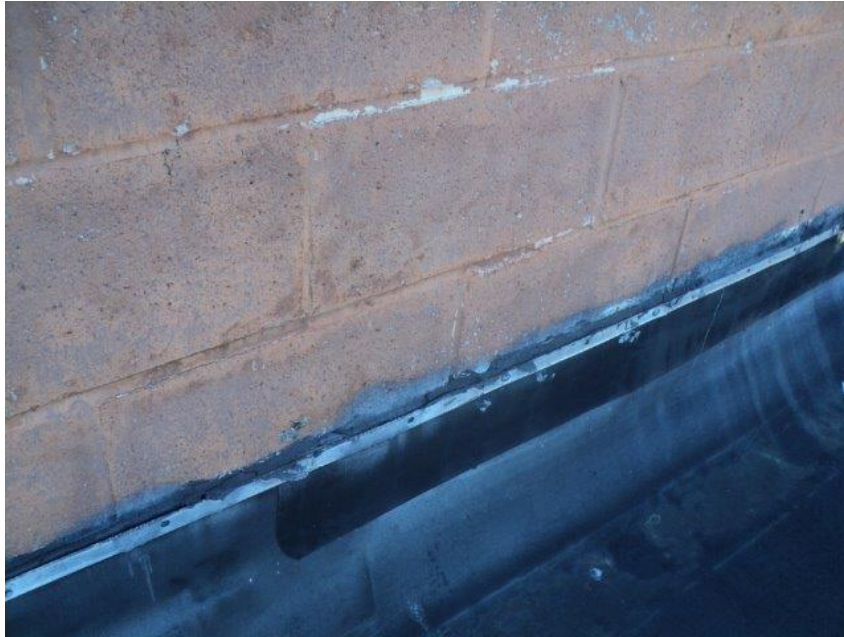
Homogeneous Material No. 17 – Non-ACM Black flashing caulk located on the Lower Roof of the Building

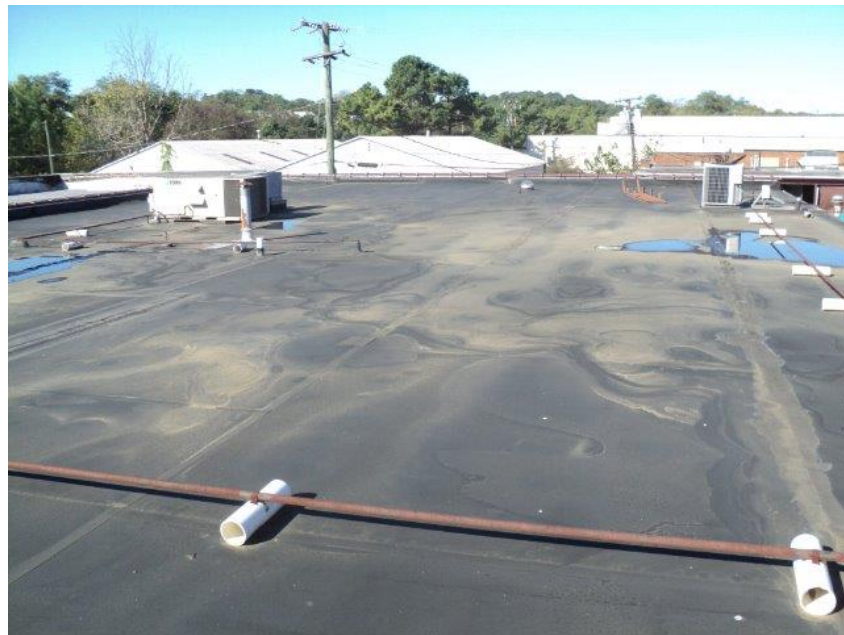
Homogeneous Material No. 18 – Non-ACM Black asphalt Sheet Roofing located on the upper Roof of the Building

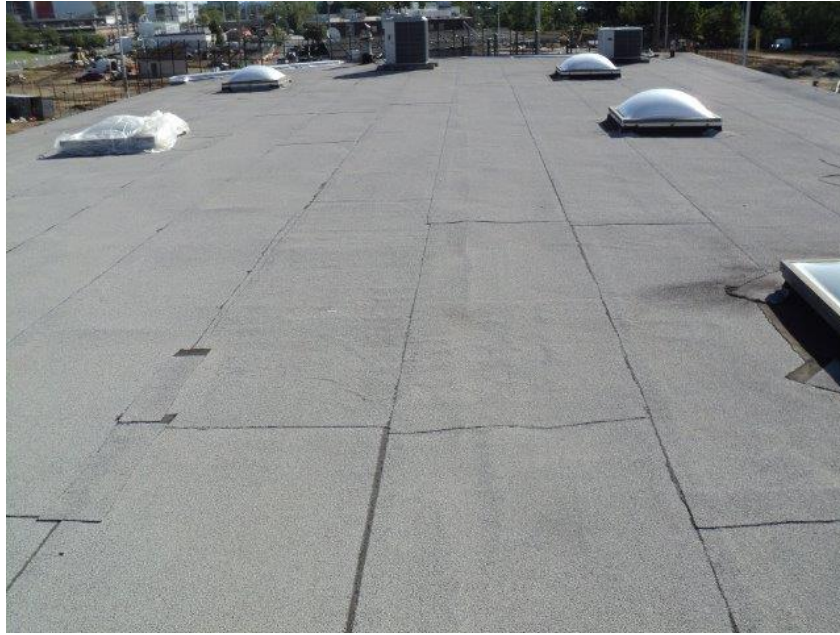
Homogeneous Material No. 19 – Non-ACM Grey Caulk – White/Grey Parapet wall Cap Caulk located on the Upper Roof of the Building

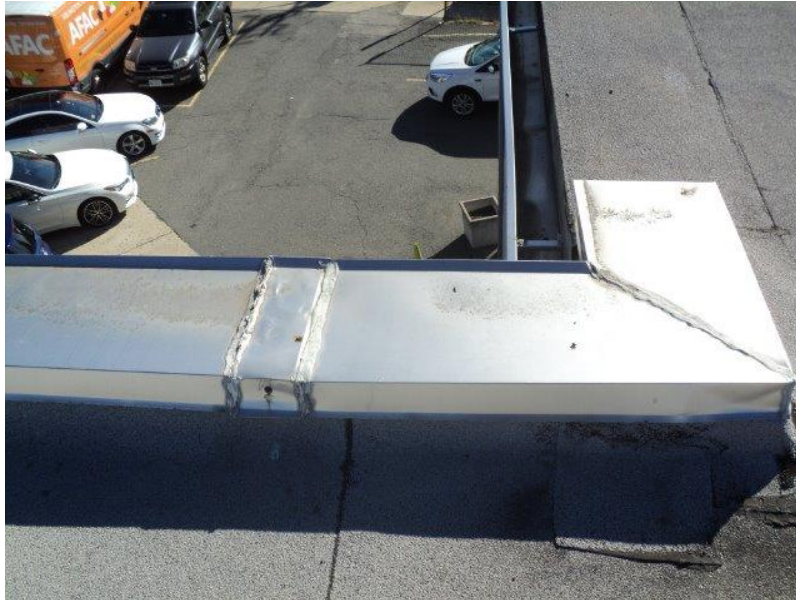
Homogeneous Material No. 20 – Non-ACM Grey Mastic – Grey HVAC Duct Mastic located on the Lower Roof of the Building

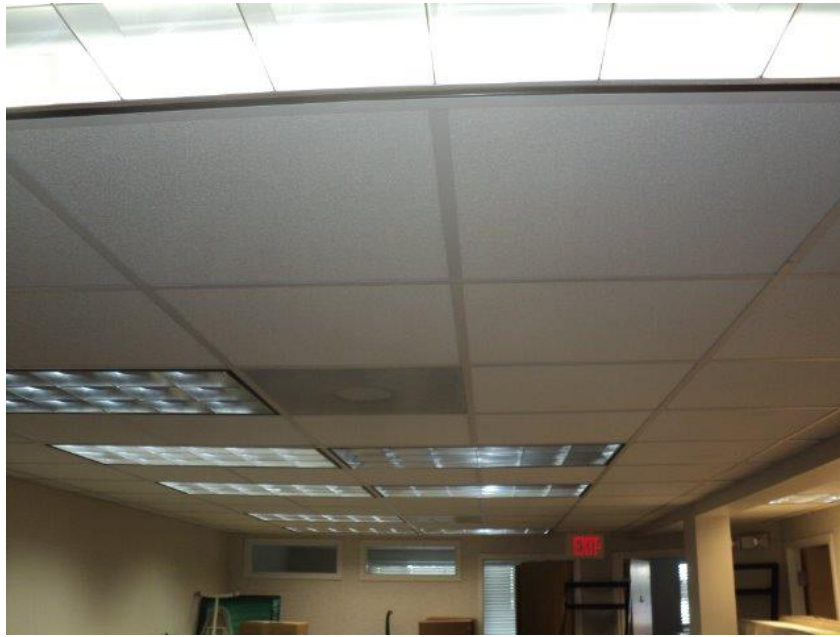
Homogeneous Material No. 21 – Non-ACM 2' X 2' White textured pinhole Lay-in Ceiling Tile located in Portion of the 2nd Floor Mezzanine Area in the Back

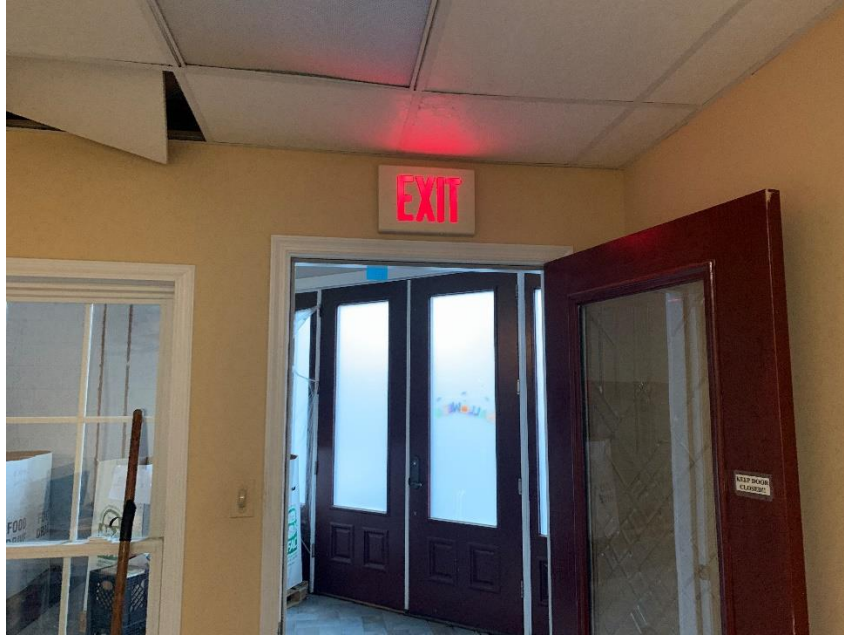
Lighted Exit Sign near the Front Entrance of the Arlington Count Food Assistance Center

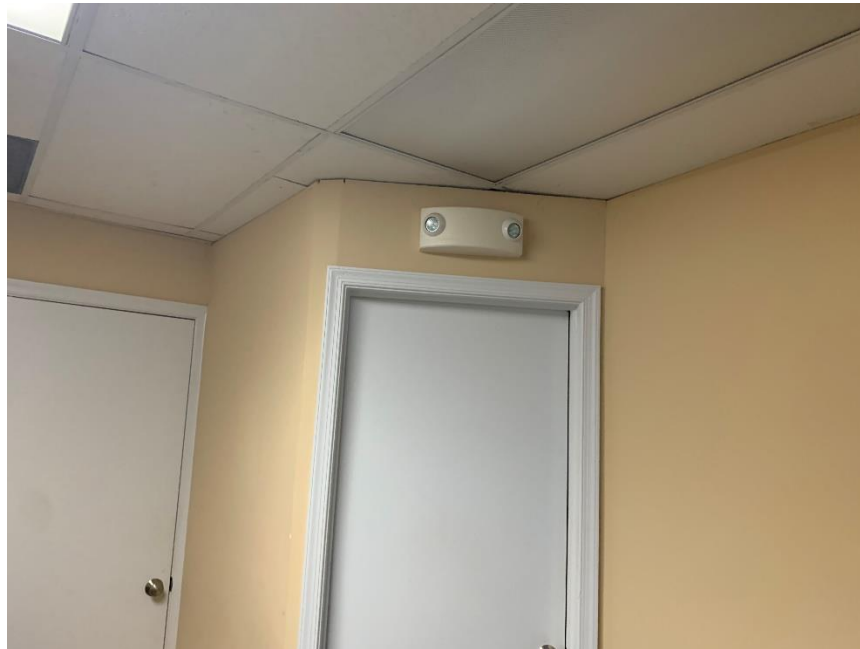
Typical Emergency Lighting at the Arlington Count Food Assistance Center

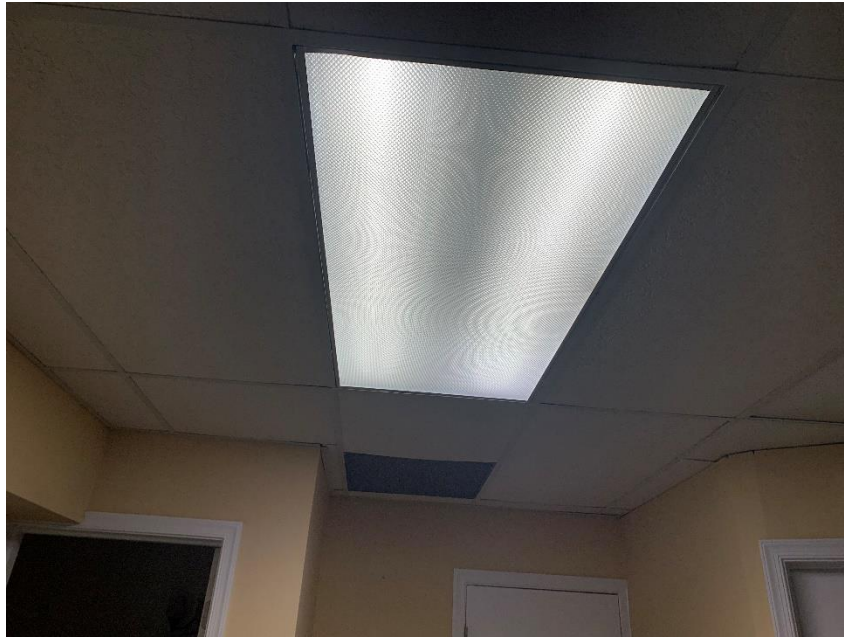
Typical fluorescent Lighting at the Subject Property

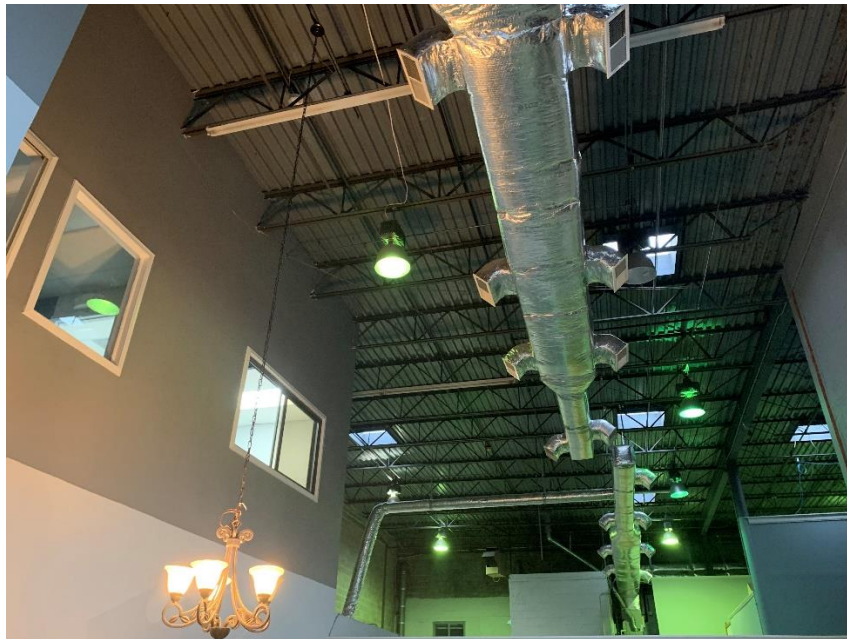
Typical Ceiling-Mounted Lighting Fixtures at the Subject Property

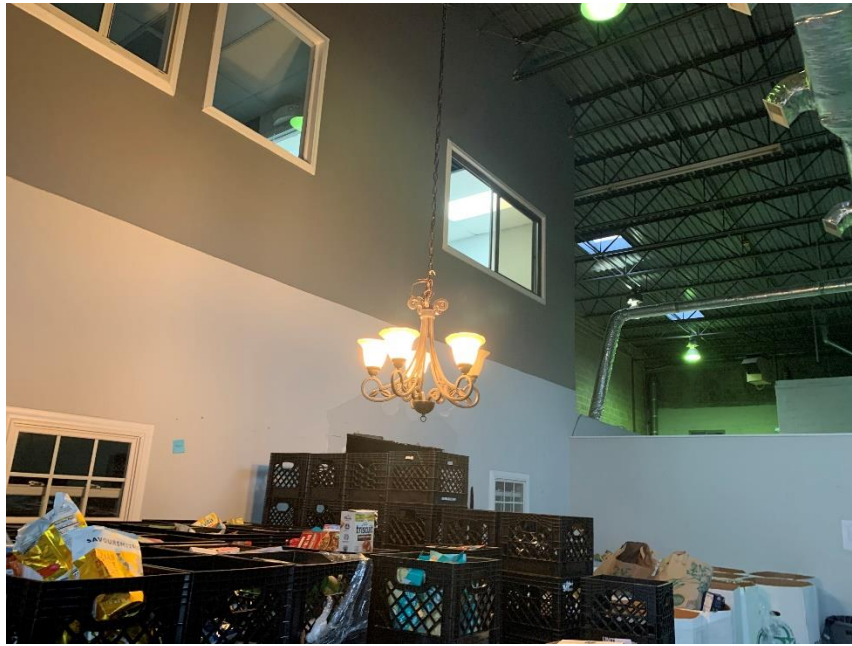
Typical fluorescent Bulb Lighting at the Subject Property

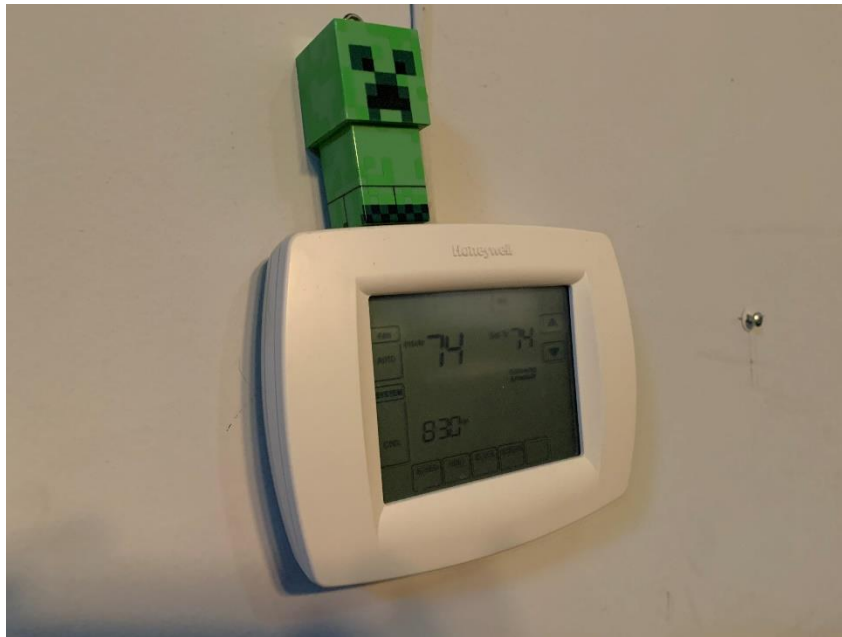
Digital Thermostat for interior climate control at the Subject Property

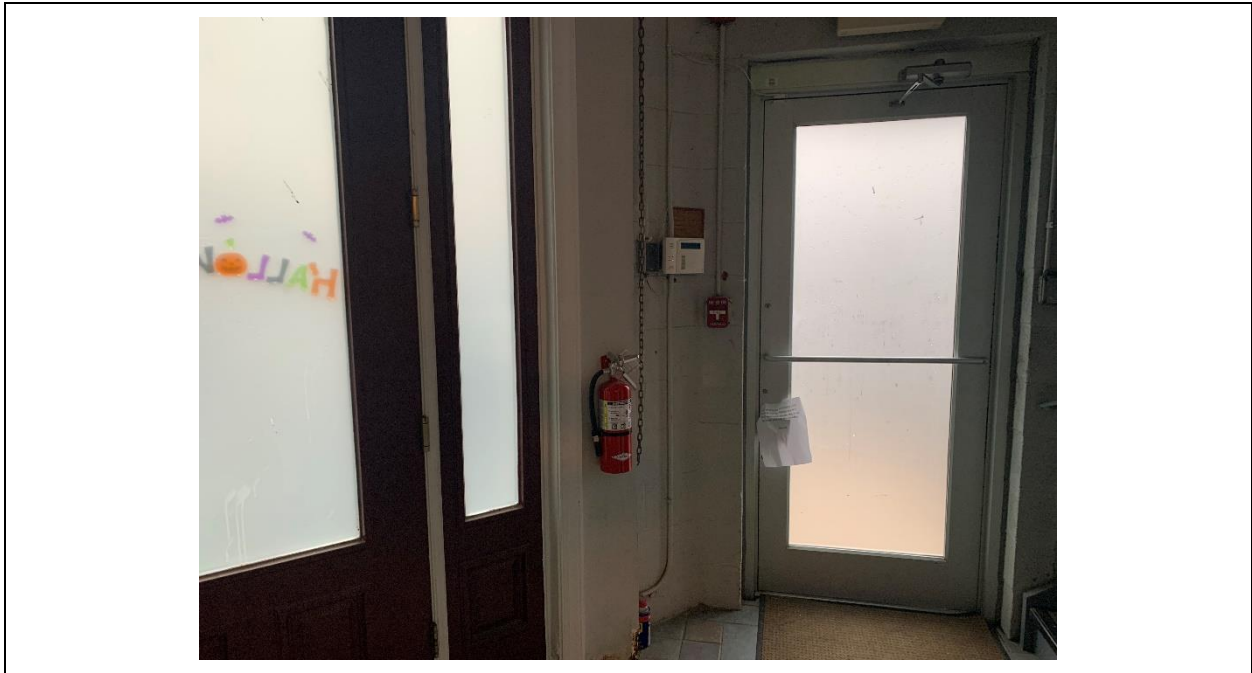
Typical Fire Extinguisher and Fire Alarm Pull-Down Station at the Subject Property

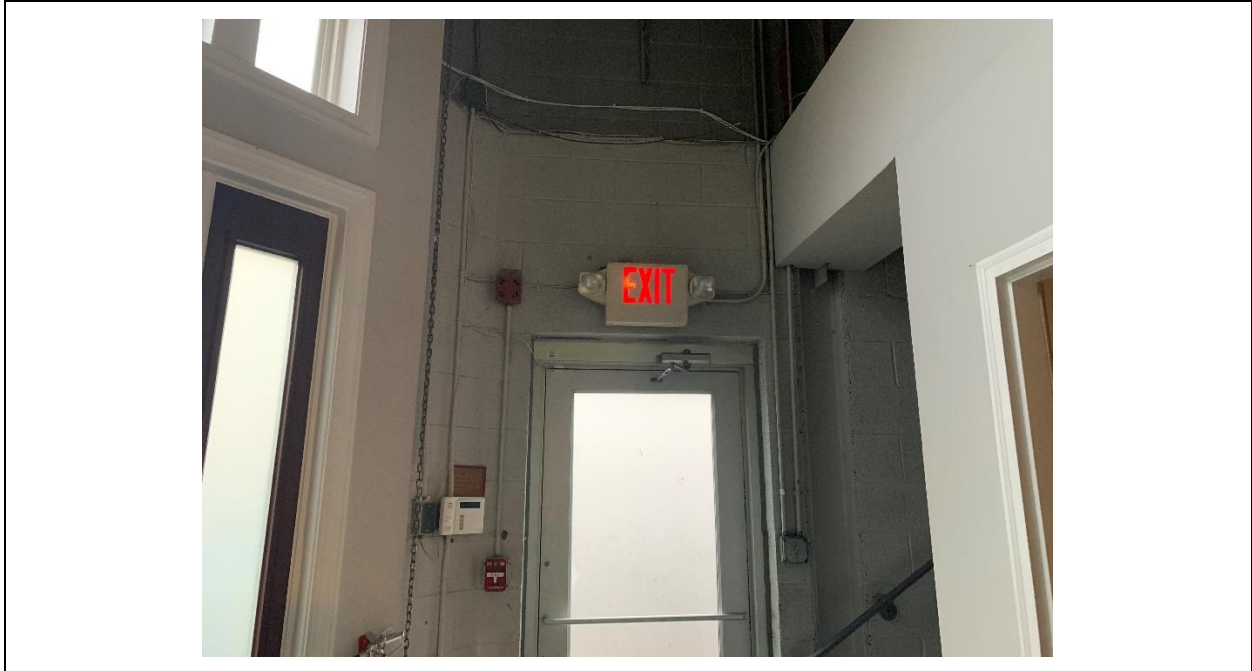
Typical Lighted Sign and Emergency Lighting Combination at the Subject Property

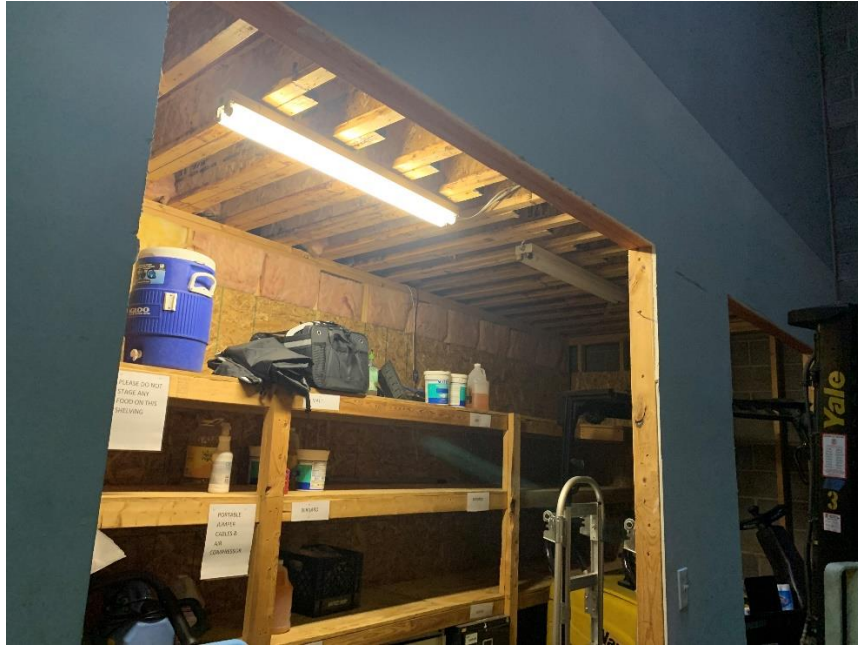
Typical Fluorescent Lighting in the Storage Area of the Arlington Food Assistance Center at the Subject Property

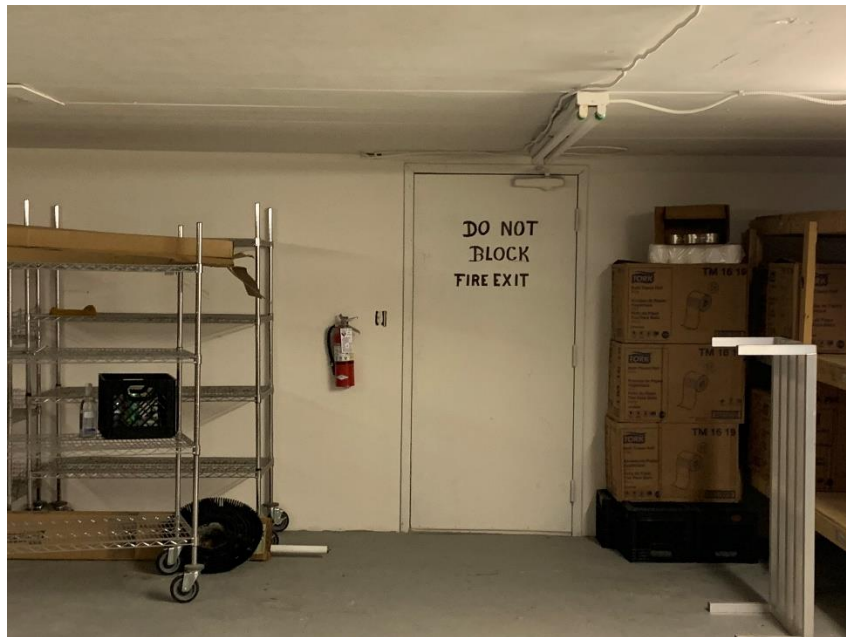
Fire Extinguisher in the Storage Areas of the Subject Property

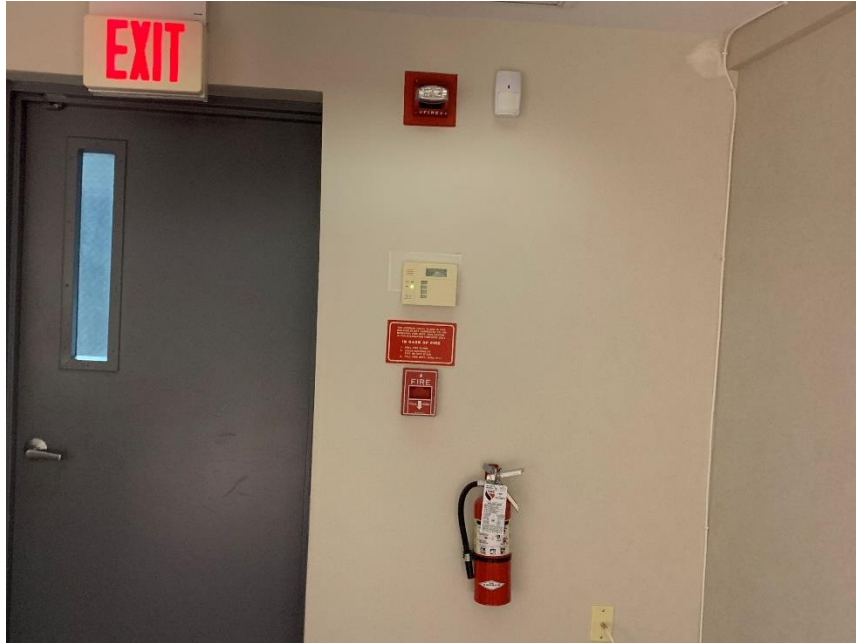
Fire Extinguisher, Pull-Down Station, Fire Strobe, Alarm System Control Panel and Motion Detector at the Subject Property

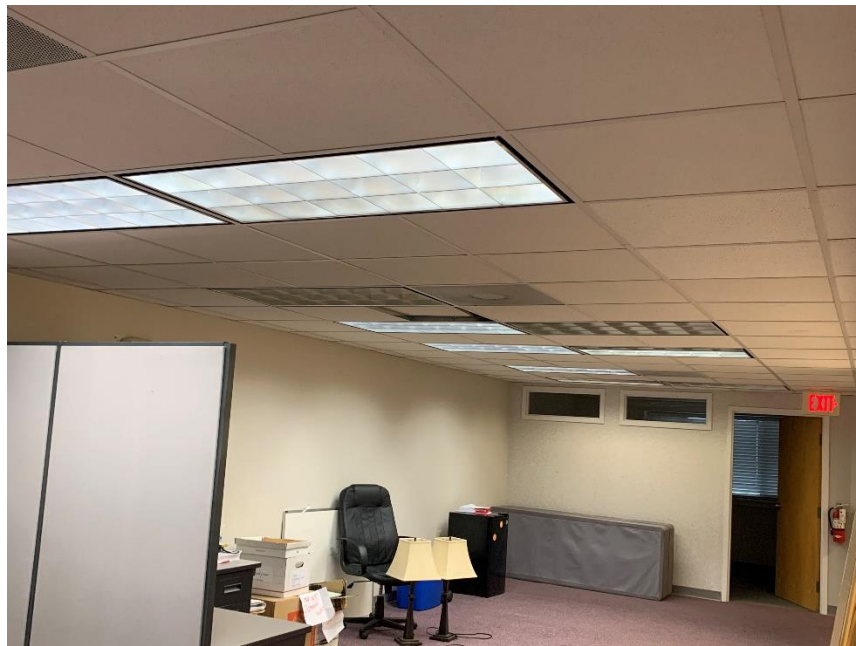
Recessed Fluorescent Lighting in the office Space of the 2nd Floor Front Mezzanine Area of the Subject Property

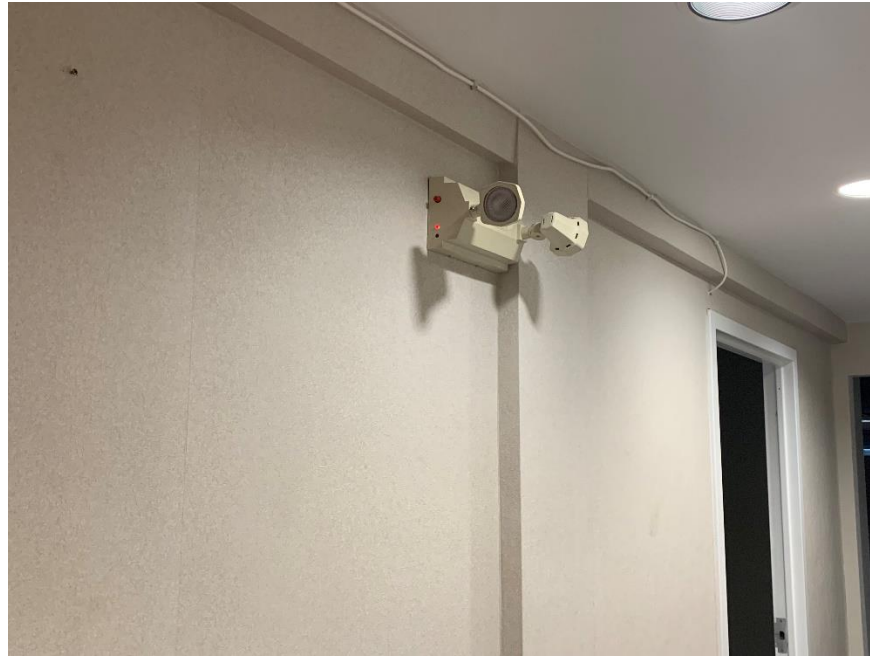
Different Type of Emergency Lighting at the Subject Property
