LIMITED LEAD-BASED PAINT INSPECTION REPORT

GROVECENTER ELEMENTARY SCHOOL
HVAC REPLACEMENT PROJECT
775 NORTH LARK ELLEN AVENUE
WEST COVINA, CALIFORNIA 91790

Project Number EE 23-Z0172-0076
June 9, 2023 (Amended July 11, 2023)

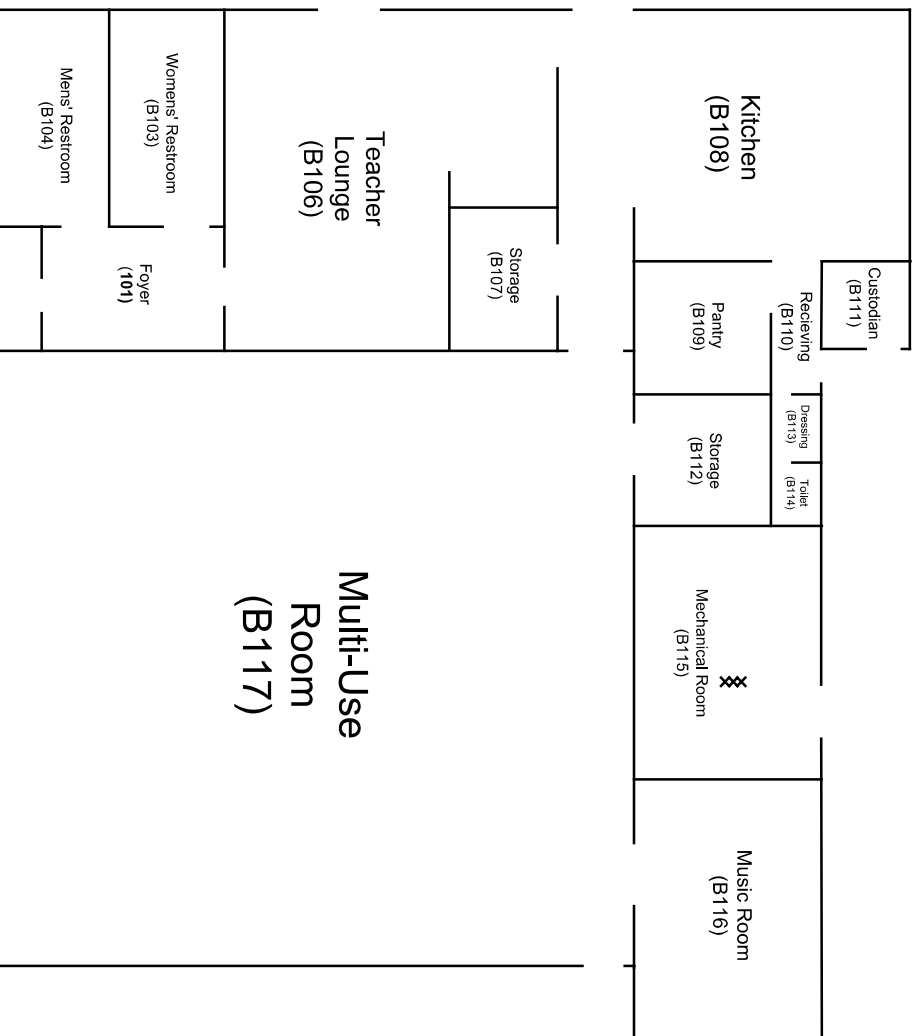
Building B Interior

Info: Lead-Based Paint Identified

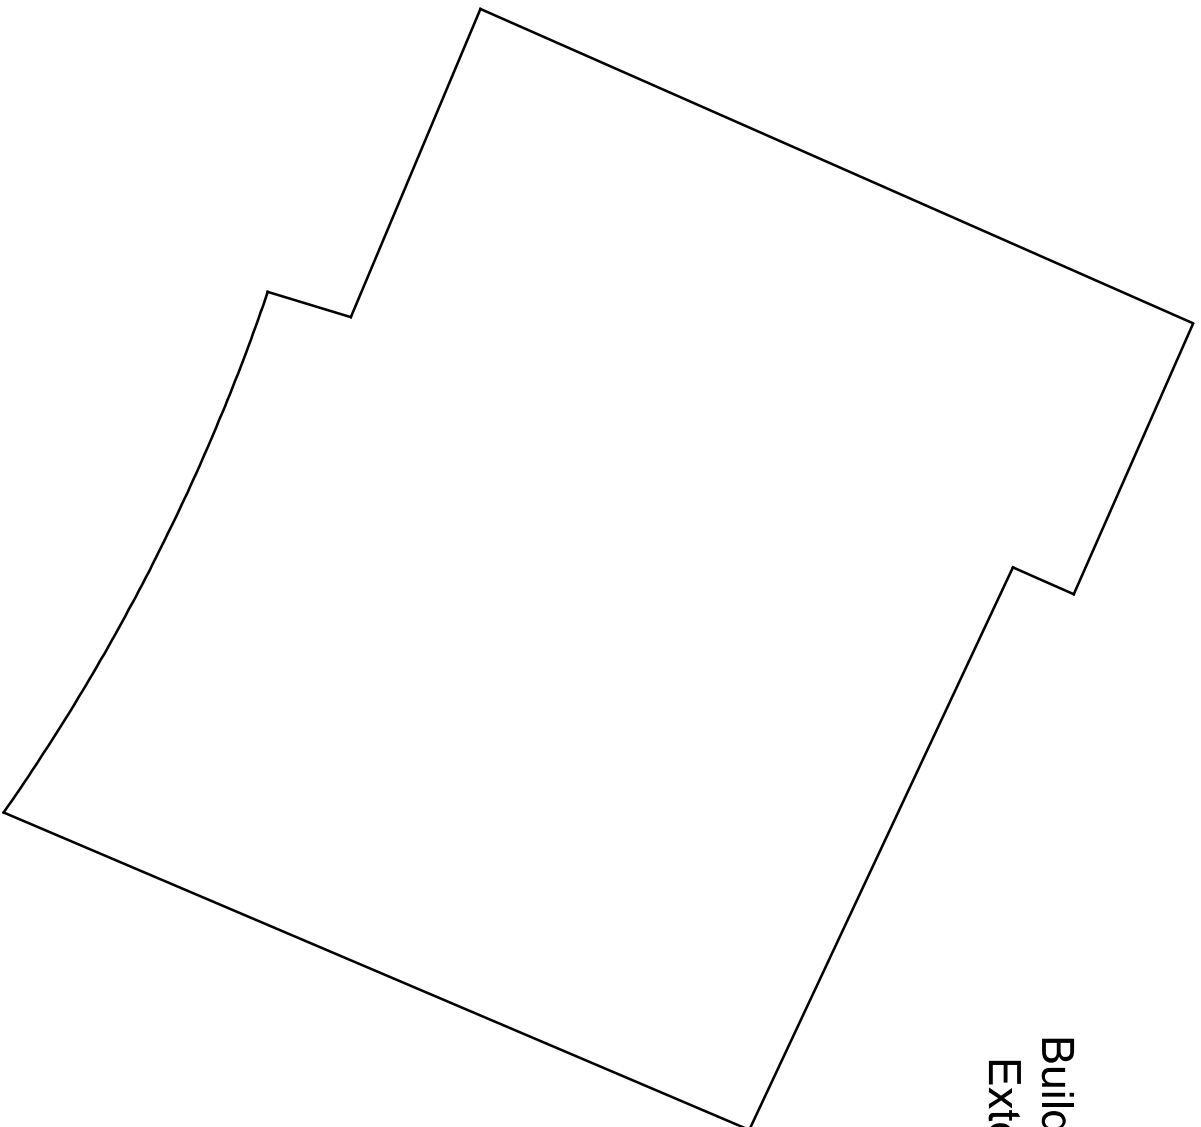
Building B
Exterior

Info: No Lead-Based Paint Identified

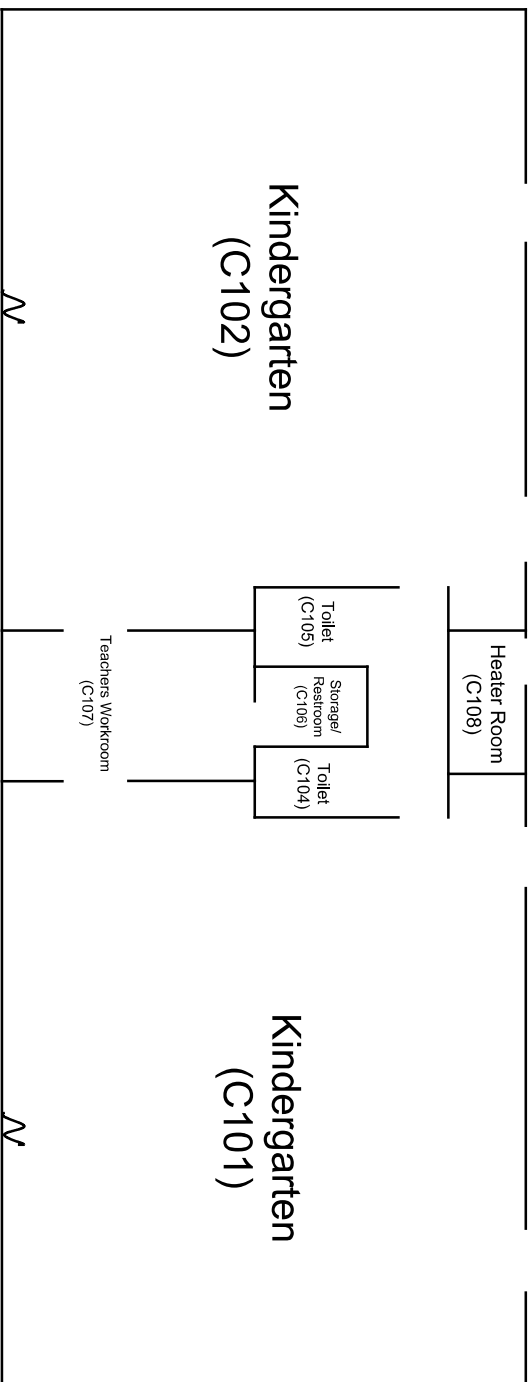
Building C Interior

Info: Lead-Based Paint/ Lead-Containing Materials Identified
