LIMITED LEAD-BASED PAINT INSPECTION REPORT

WORKMAN ELEMENTARY SCHOOL
HVAC REPLACEMENT PROJECT
1941 EAST WORKMAN AVENUE
WEST COVINA, CALIFORNIA 91791

Project Number EE 23-Z0172-0078
June 26, 2023

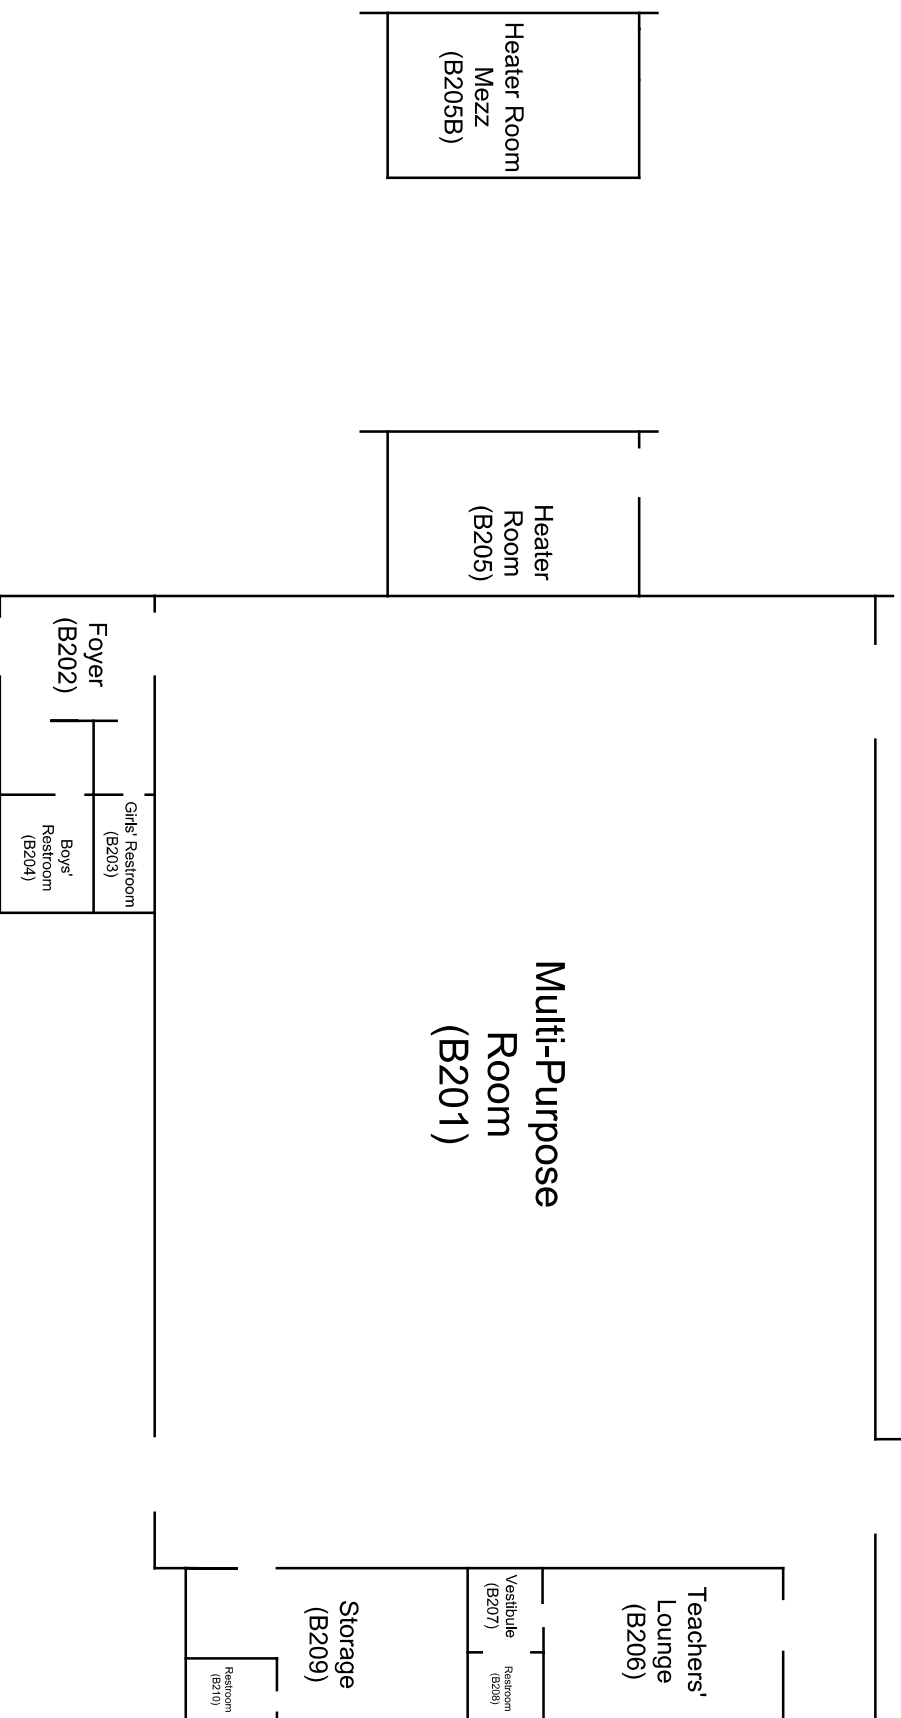
Building B Interior

^B NOTE: 1) Window frame near AC unit at side C to be impacted.

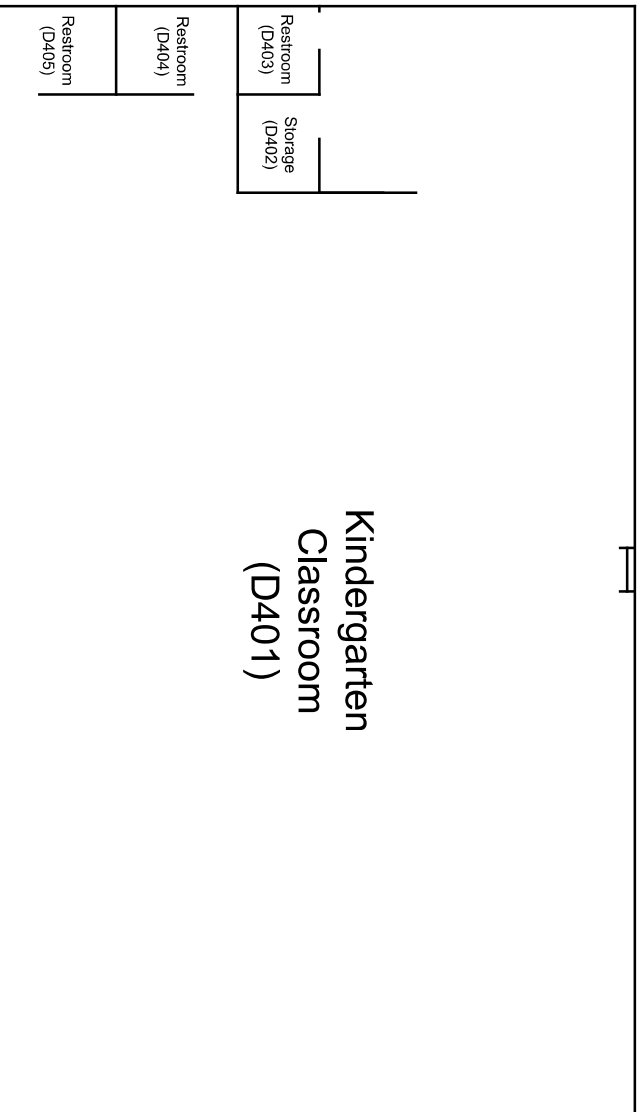
Building D
Interior

—|— Metal Window Frame(to be impacted)

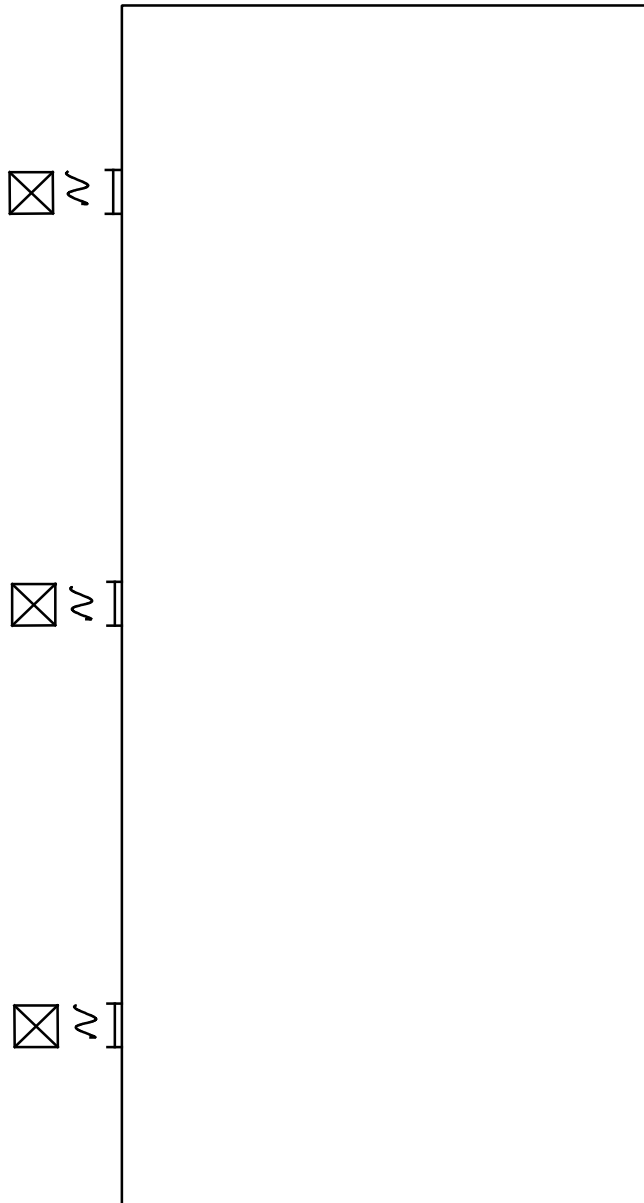
Building H
Exterior

- ☒ - AC Condensers
- ┆┆ - Metal Window Frame (to be impacted)
- ∞ - 1" Flexible Conduit

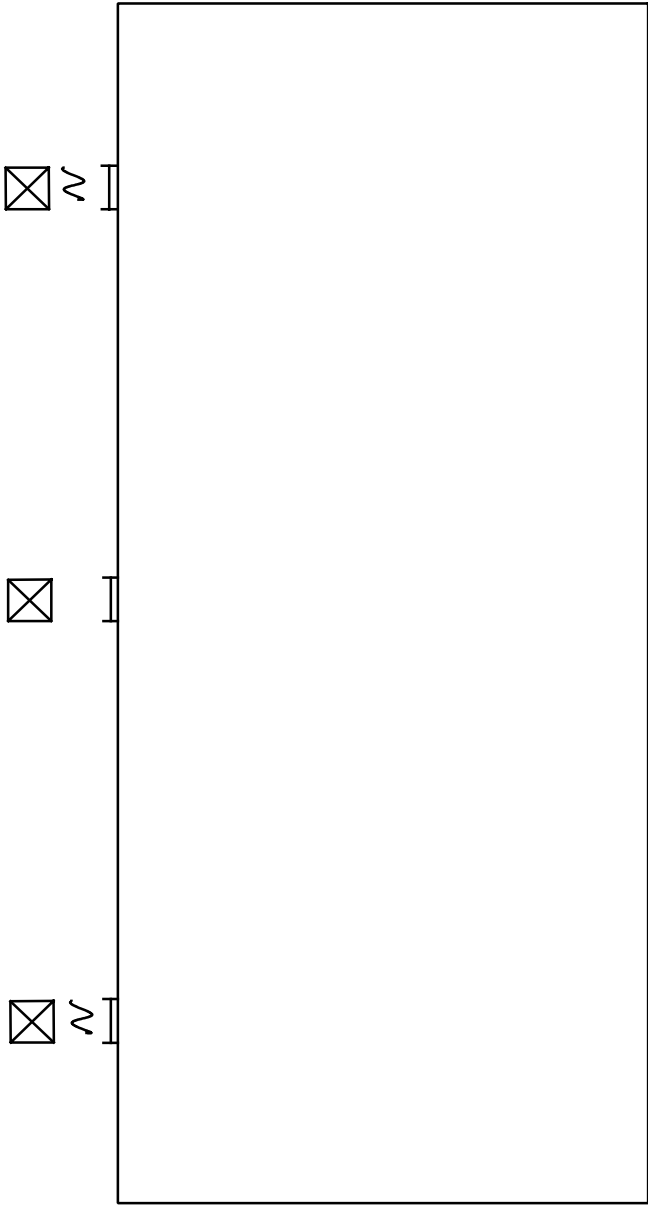
Building I
Exterior

- ☒ - AC Condensers
- ┌─┐ - Metal Window Frame (to be impacted)
- ∞ - 1" Flexible Conduit

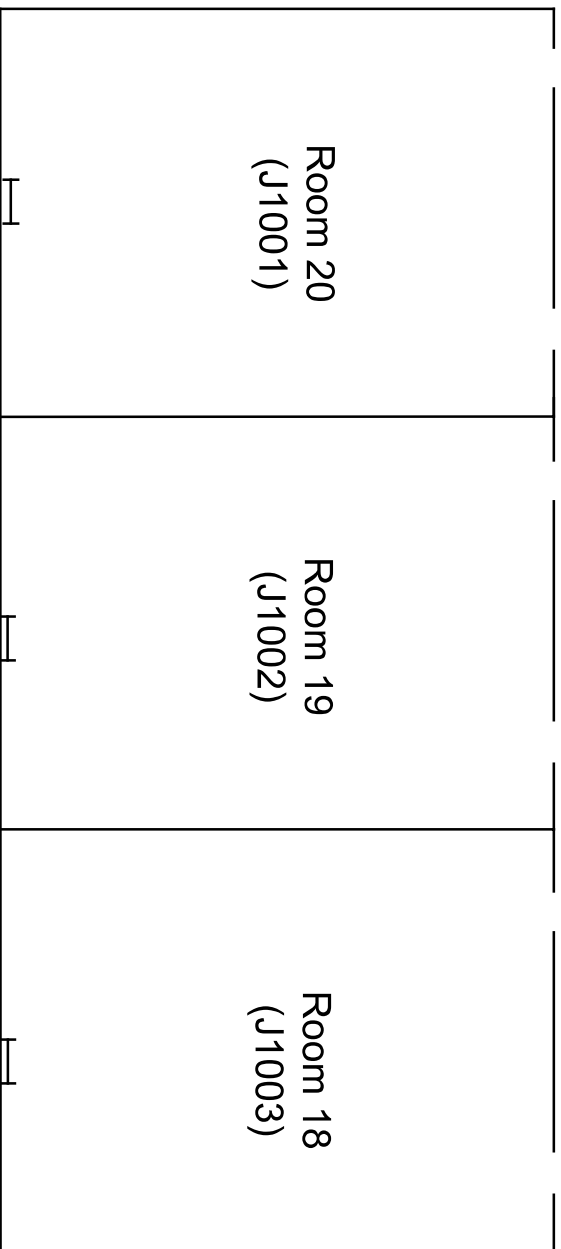
Building J
Interior

^E NOTE: 1) Window frame near AC units at side A to be impacted.

—|— Metal Window Frame (to be impacted)

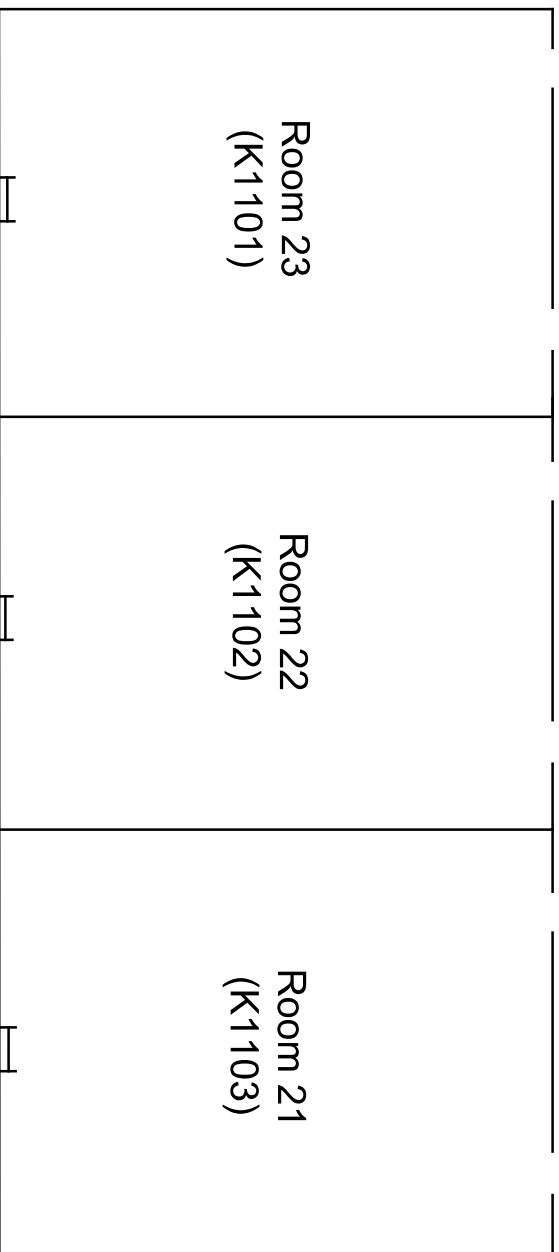
Building K
Interior

Legend
—|— - Metal Window Frame (to be impacted)
