Asbestos & Lead Based Paint Assessment

City of Spartanburg
773 Saxon Avenue
Spartanburg, South Carolina

Project Number: 0118-14

March 12, 2017

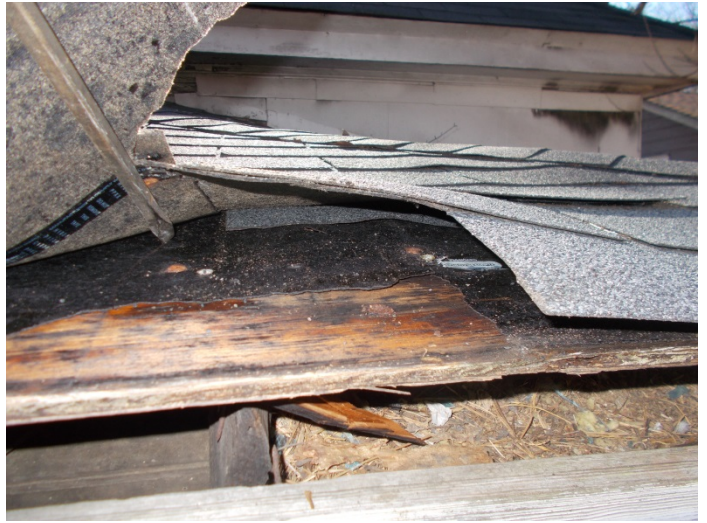
Photo 2 – Roof shingles and felt.

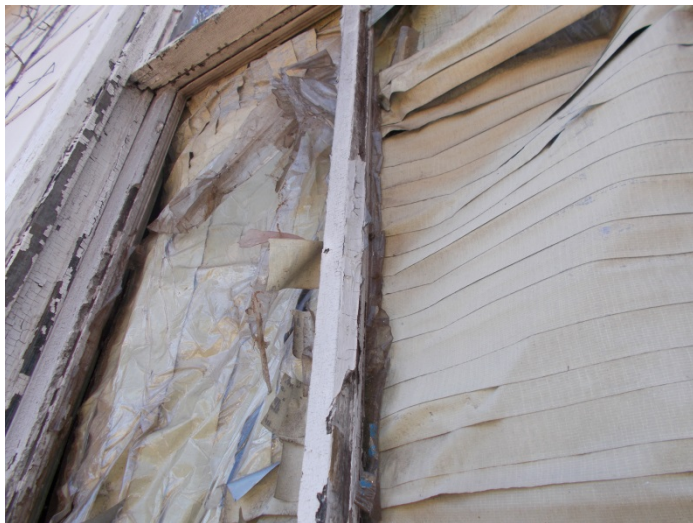
Photo 3 – Wooden windows with glazing.

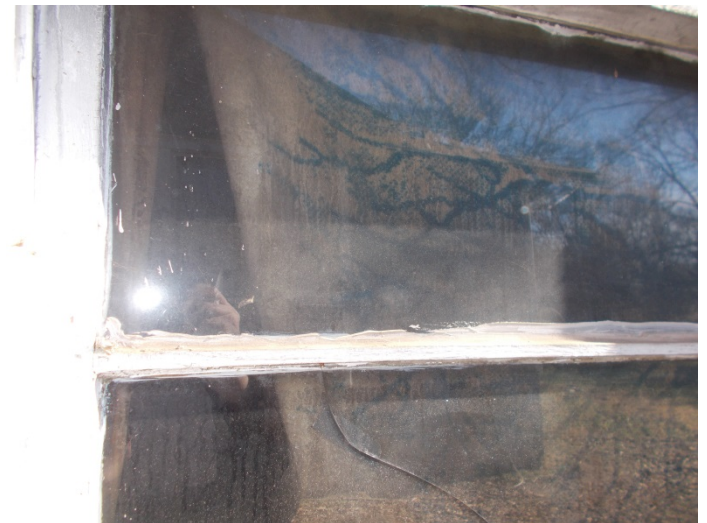
Photo 4 – Wooden windows with caulk.

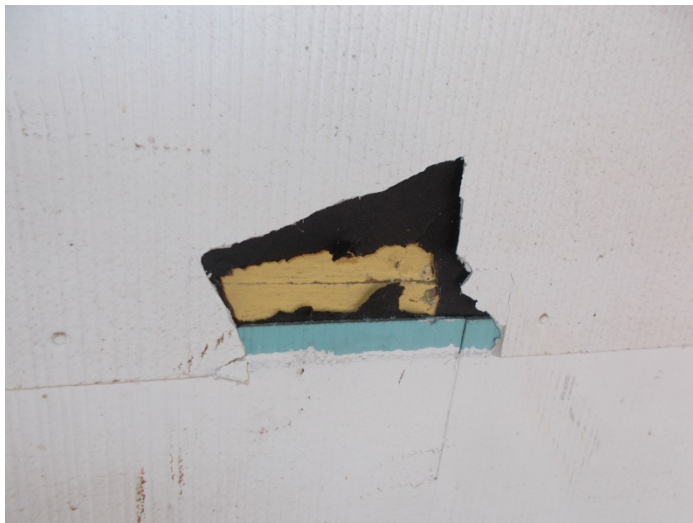
Photo 5 – Cement board siding with felt beneath.

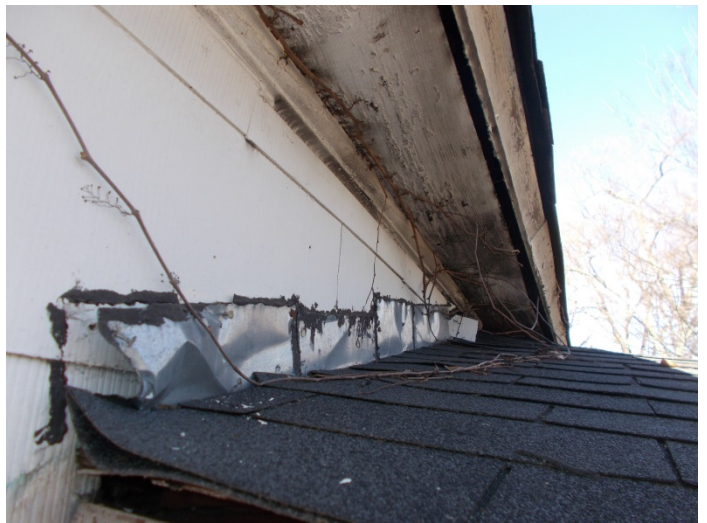
Photo 6 – Black mastic on roof flashing.

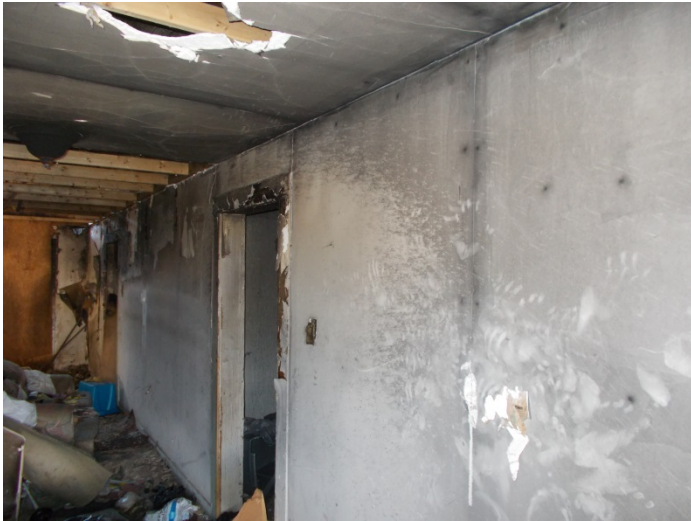
Photo 7 – Drywall with joint compound & tape.

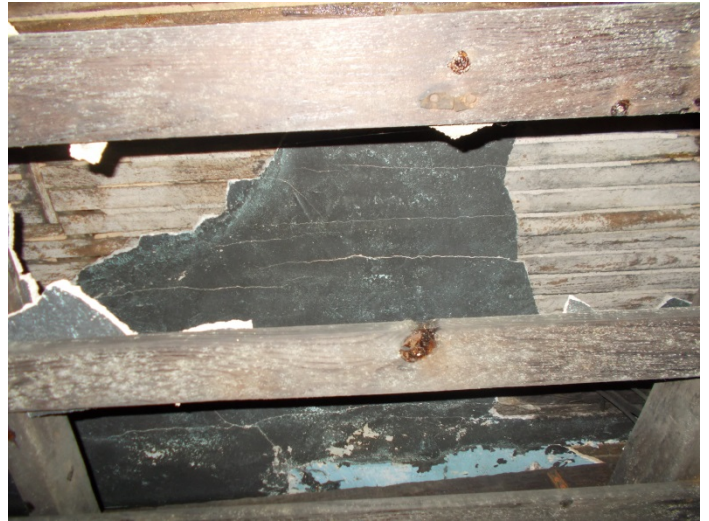
Photo 8 – Plaster with finish.

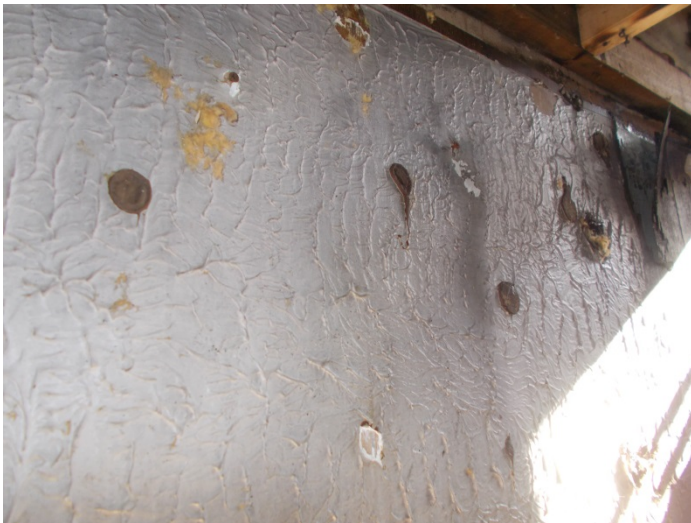
Photo 9 – Black mastic dots behind drywall walls.

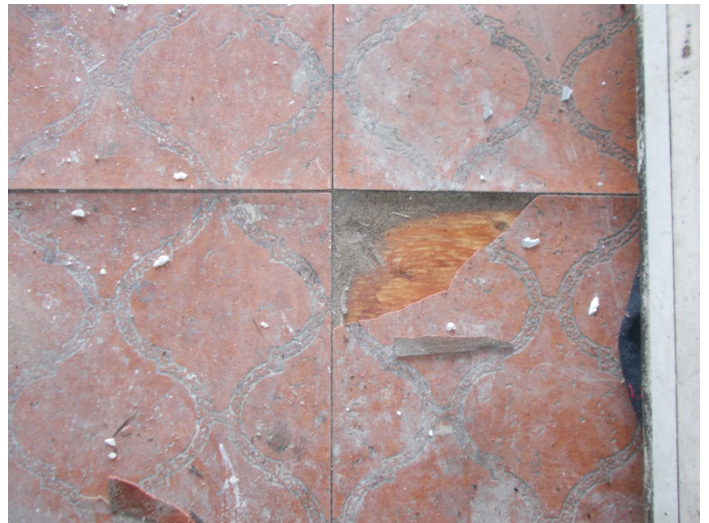
Photo 10 – 12" x 12" brown thin pattern floor tile & adhesive in the main hallway.

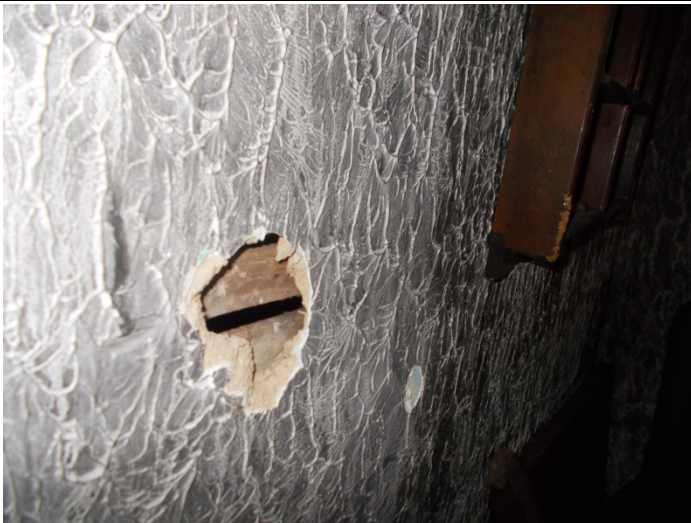
Photo 11 – Wall texture in the main hallway, front left & right bedrooms & kitchen.

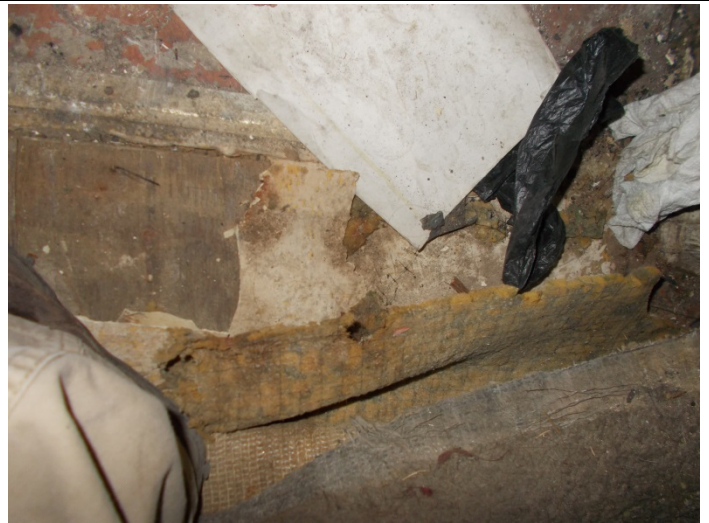
Photo 12 – Yellow pattern vinyl floor with no mastic in the front right bedroom under carpet.

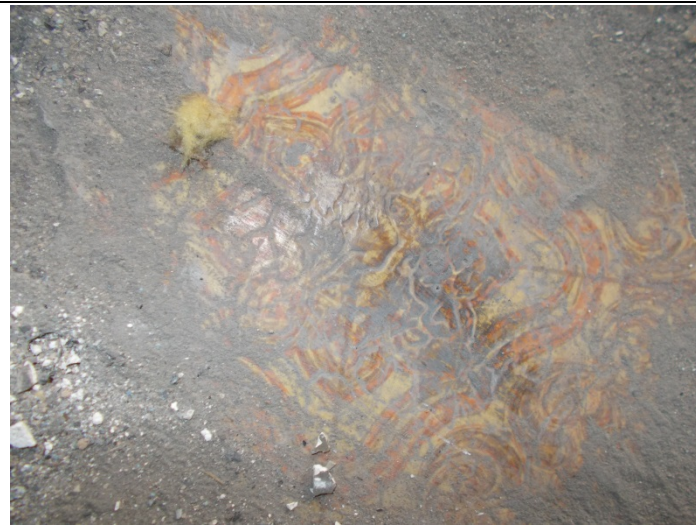
Photo 13 – Beige paisley pattern vinyl floor with no mastic in the dining room in front of the kitchen.

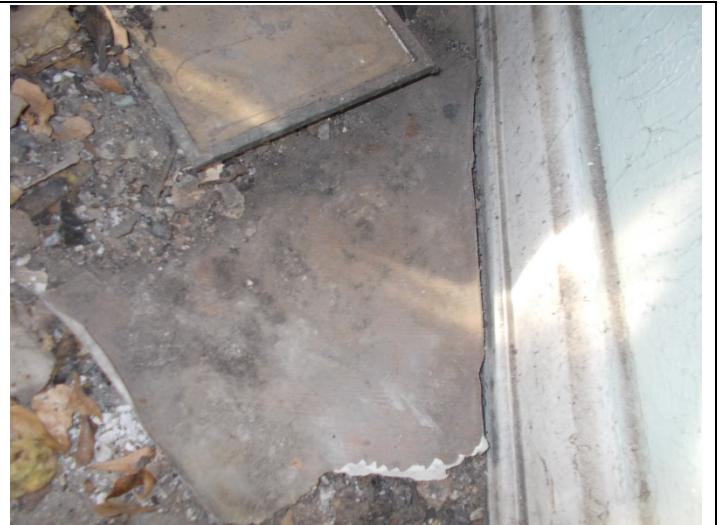
Photo 14 – Brown pattern vinyl floor with no mastic in the kitchen (top layer).

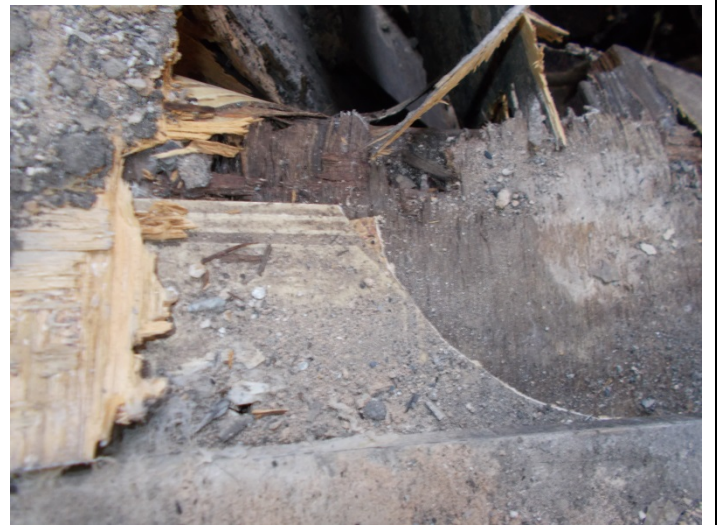
Photo 16 – 3 layers of vinyl flooring with & without mastics in the back damaged area.

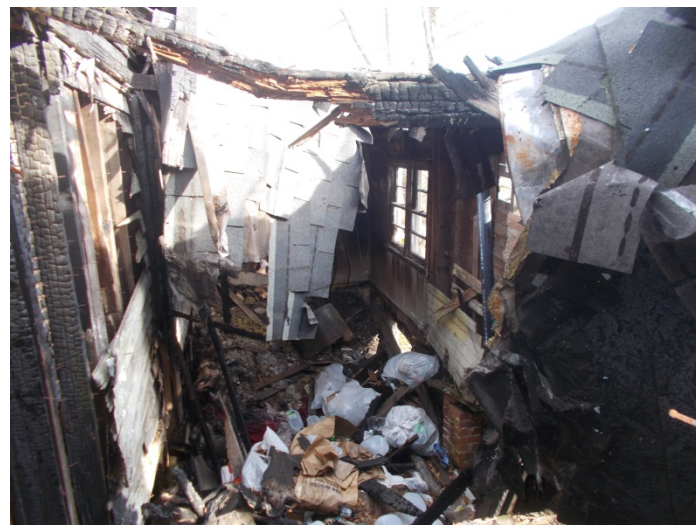
The residence has fire and structural damage in the back portion and throughout the residence. ACM was identified to exist in the back portion of the residence where the floors, ceilings and walls are collapsed. Apex recommends that the building be demolished in place and materials

Photo 17 – Back damaged area.

1. Demolish the residence with ACM in place and dispose of the waste stream as friable Regulated Asbestos Containing Materials (RACM) and delivered to an asbestos approved hazardous waste landfill for disposal.
