**EXHIBIT "A"**  
**SCOPE OF WORK**

REMOVAL OF ASBESTOS  
MATERIALS (ACBM)

# **COMPREHENSIVE ASBESTOS SURVEY**

**COMMERCIAL BUILDING  
1240 YEAMANS HALL ROAD  
HANAHAN, SC 29410**

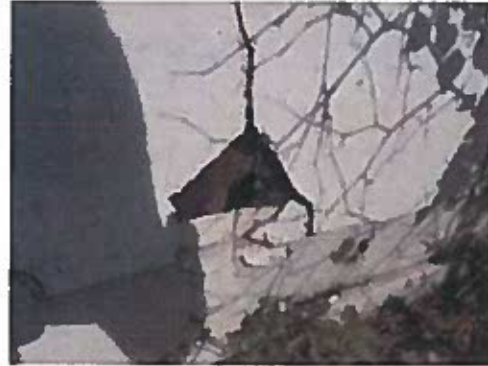
Asbestos fibers were identified in the Transite Siding. Approximately 1,440 square feet is present and in good condition. This material is considered Category II – Non Friable Asbestos and is located on the exterior walls.

**HOMOGENEOUS AREA 01  
TRANSITE PANEL**

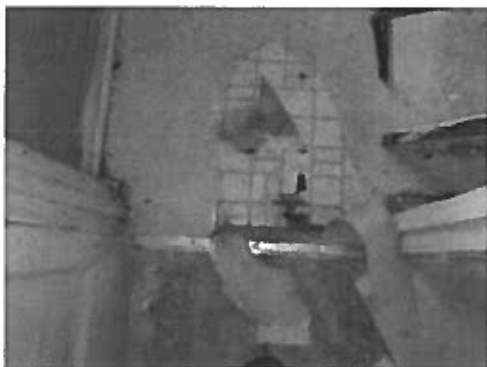
Asbestos fibers were identified in the 9” Floor Tile (beige) and the associated Floor Tile Mastic (black). Approximately 236 square feet of each is present and is significantly damaged condition. These materials are considered RACM – Friable Asbestos and are located in Bedroom B (layer 2) and Bedroom A (layer 1). **Note: Floor Tiles may be located under cabinets, appliance and non-load bearing walls.**

**HOMOGENEOUS AREAS 13, 14  
9" FLOOR TILE (BEIGE)  
MASTIC (BLACK)**

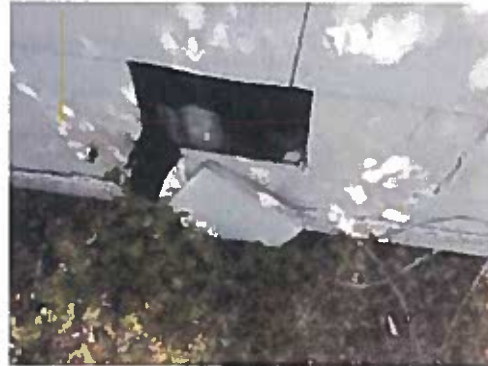
Asbestos fibers were identified in the Transite Siding. Approximately 1,788 square feet is present and in good condition. This material is considered Category II – Non Friable Asbestos and is located on the exterior.

**HOMOGENEOUS AREA 01  
TRANSITE SIDING**

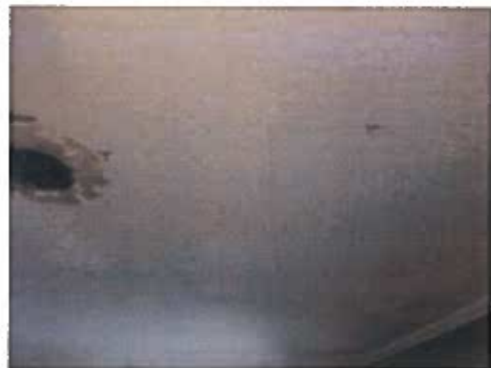
Asbestos fibers were identified in the Ceiling Texture (texture). Approximately 170 square feet is present and is good condition. This material is considered RACM – Friable Asbestos and is located in the Unit B Living Room.

**HOMOGENEOUS AREA 11  
CEILING TEXTURE (TEXTURE)**
