## **Asbestos & Lead Based Paint Assessment**

City of Spartanburg  
418 Carpenter Street  
Spartanburg, South Carolina 29301

Project Number: 0521-99

August 4, 2021

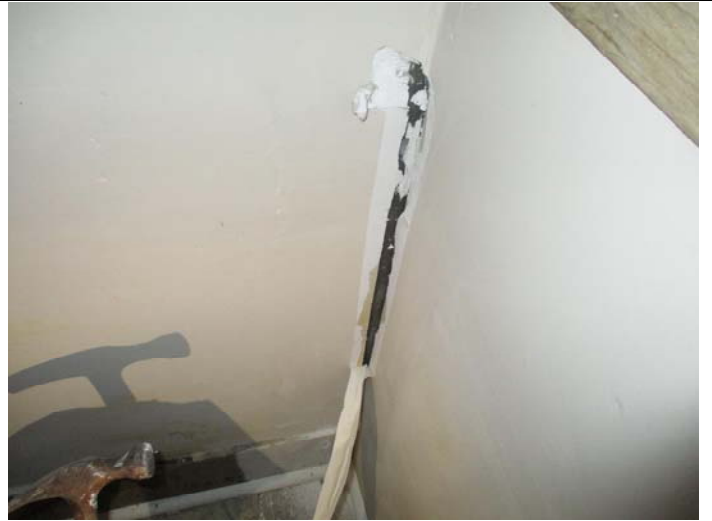
Photo 2 – Drywall with joint compound & tape walls & ceilings throughout

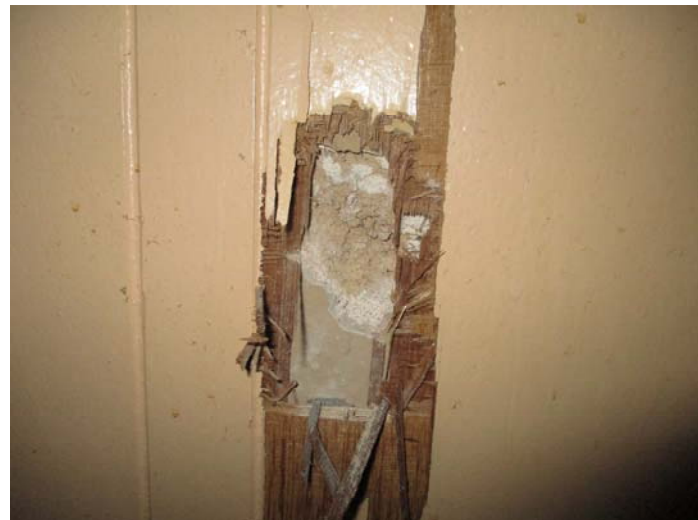
Photo 3 – Plaster & finish walls & ceilings throughout

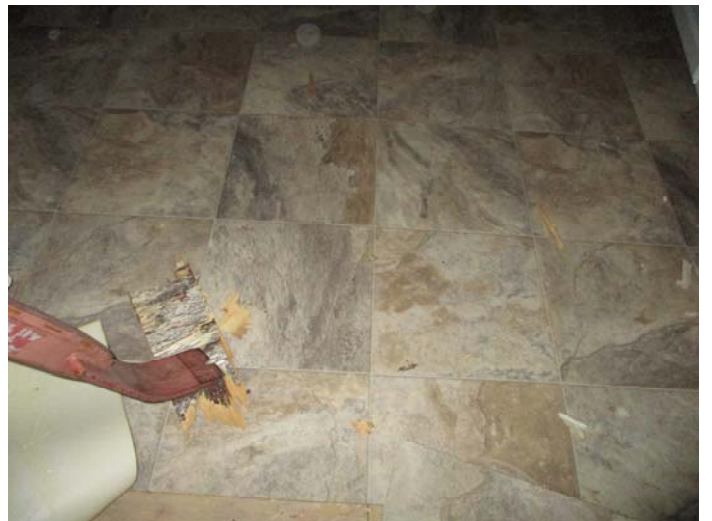
Photo 4 – 12" x 12" stone square pattern roll vinyl floor with no adhesive in the kitchen & back entry (top layer)

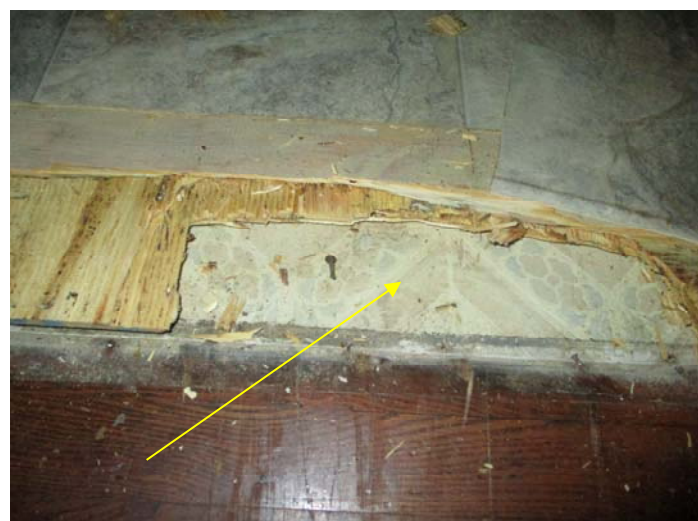
Photo 5 – Tan & gray flower pattern vinyl floor & adhesive in the kitchen (2<sup>nd</sup> layer under wood)

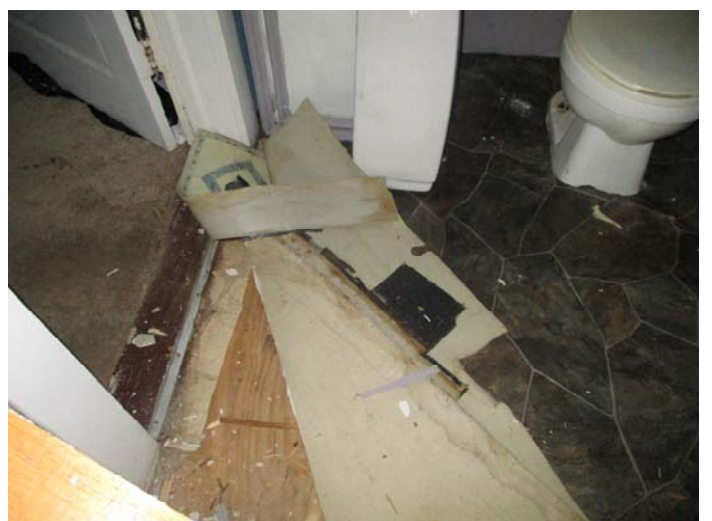
17- Flooring 4 <small>412105883-0015C</small>	4 Layers of Vinyl Flooring w/ & w/out Adhesives	Gray/White Non-Fibrous Homogeneous		85% Non-fibrous (Other)	15% Chrysotile

Photo 6 – 4 layers of vinyl flooring with no adhesives in the back bathroom

1. Abate the asbestos containing materials in the structure prior to renovation or demolition.
2. Follow applicable asbestos regulations during renovation or demolition of the structure. You should be aware that stringent requirements are imposed upon anyone renovating or demolishing a structure in which ACM will be disturbed. This work must be performed in accordance with OSHA asbestos regulations, 29 CFR 1910 & 1926, and NESHAP asbestos regulations 40 CFR 61, subpart M. South Carolina regulations require the accreditation of personnel who work in the asbestos field and notification and permitting fees for asbestos removal projects. There is a 10 working day notification period required prior to abatement of asbestos in a facility. Failure to take proper precautions and actions to protect human health and the environment can result in penalties, danger to personnel, and construction delays.

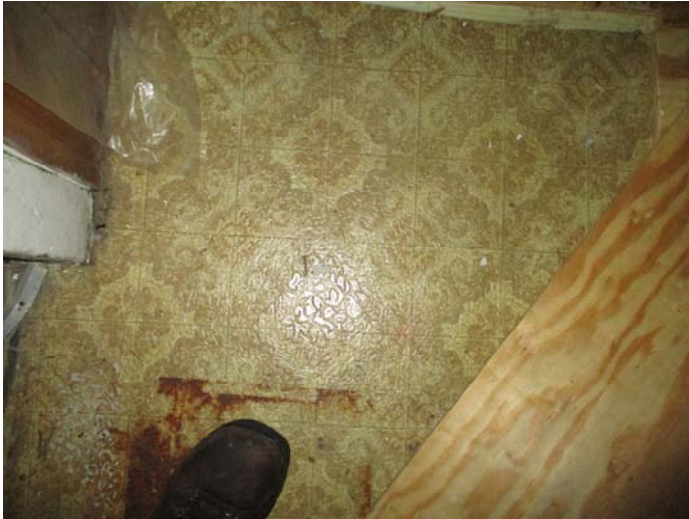
Photo 7 – Brown small square pattern roll vinyl floor & mastic in the back entry (2nd layer under wood)

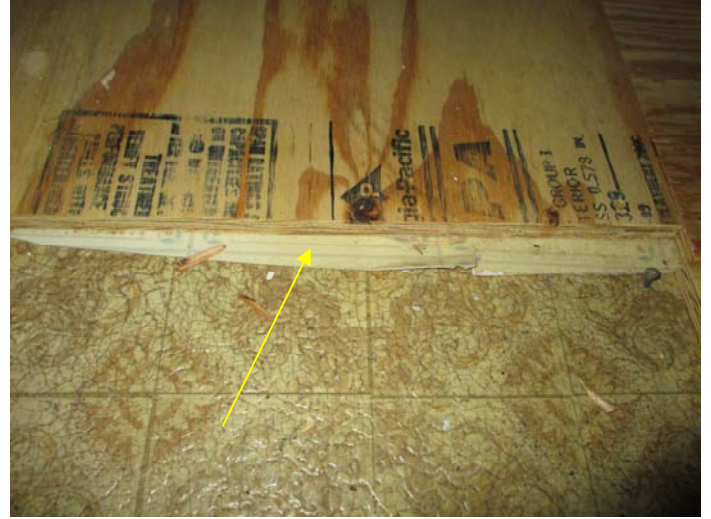
Photo 8 – Tan & gray flower pattern vinyl floor & adhesive patch in the back entry (under wood)

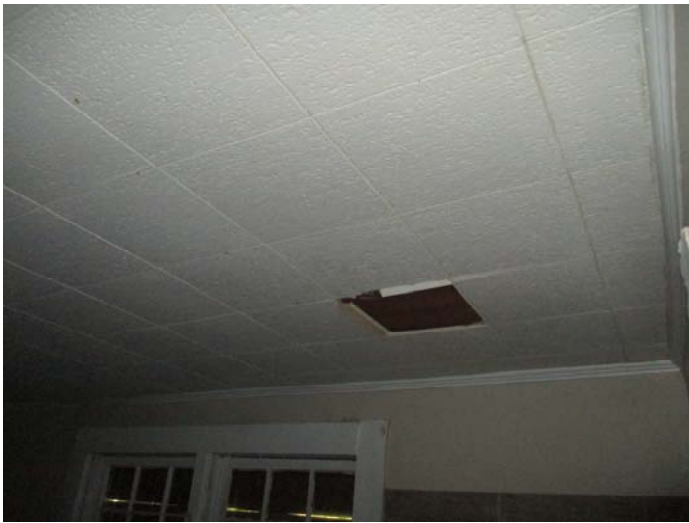
Photo 9 – 12" x 12" ceiling tiles with no mastic in the kitchen

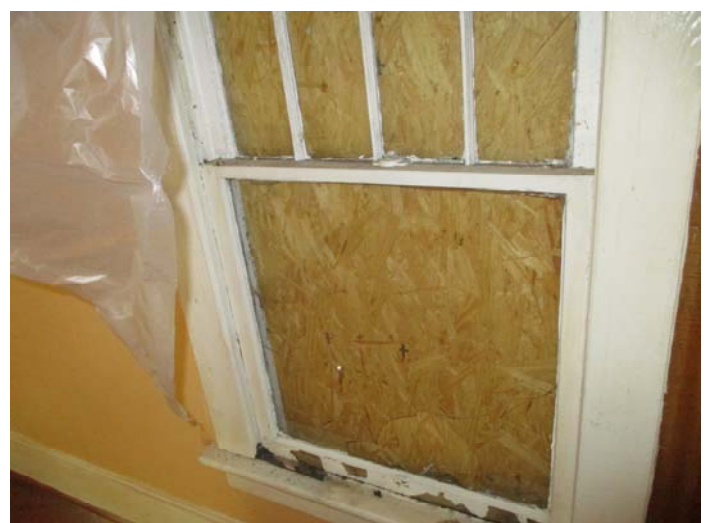
Photo 10 – Wooden windows with glazing

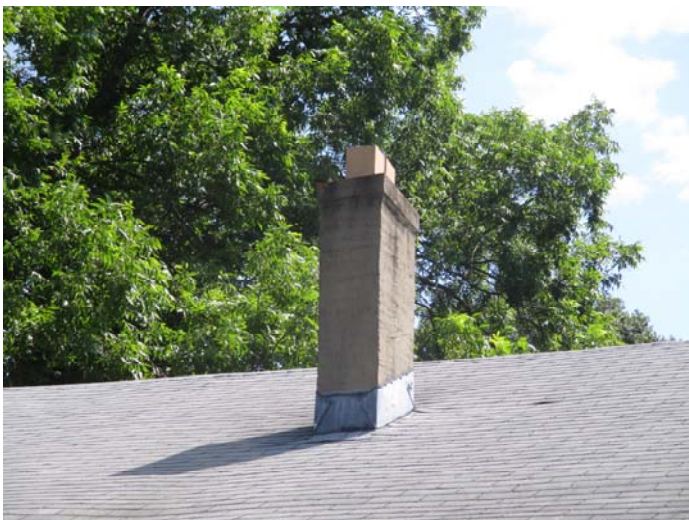
45						
46						
<b>Assumed</b>	<b>Chimney's (2 chimneys)</b>	<b>Tar on 2 chimney's</b>	<b>Assumed</b>	<b>Non-Friable</b>	<b>Good</b>	<b>12 LF</b>

Photo 11 – 1 of 2 chimneys with tar – assumed positive

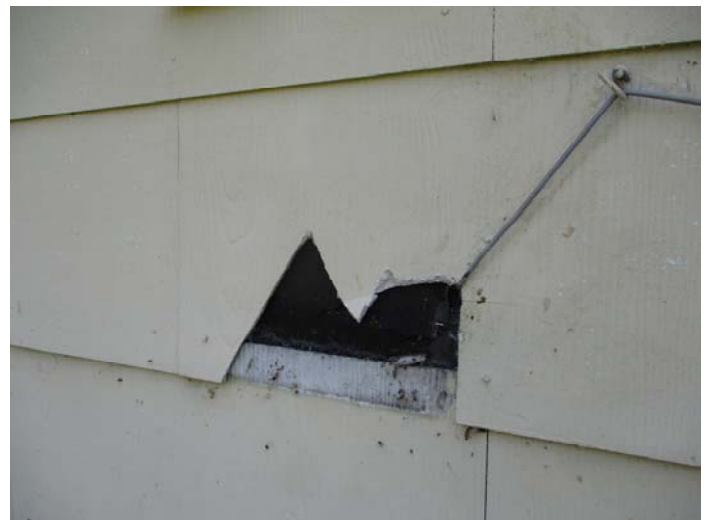
- Approximately 1,400 SF of transite siding beneath the exterior vinyl siding and in the interior back entry room beneath the wooden wall panels.
- Approximately 40 SF of brown small square pattern roll vinyl flooring in the back entry room (2<sup>nd</sup> layer under wood).
- Approximately 10 SF of tan and brown square pattern roll vinyl flooring in the back left bedroom closet.
- Approximately 12 LF of tar on two chimneys – assumed positive.

32 412105883-0024 Sample Bag labeled 35	Transite Siding	Gray Non-Fibrous Homogeneous		80% Non-fibrous (Other)	20% Chrysotile
33 412105883-0025 Sample labeled 36	Transite Siding				Positive Stop (Not Analyzed)
34 412105883-0026	Transite Siding				Positive Stop (Not Analyzed)
35 412105883-0027 Sample labeled 32	Felt Paper Under Transite Siding	Black Non-Fibrous Homogeneous	70% Cellulose	30% Non-fibrous (Other)	None Detected
36 412105883-0028 Sample bag labeled 33.	Felt Paper Under Transite Siding	Black Fibrous Homogeneous	80% Cellulose	20% Non-fibrous (Other)	None Detected

Photo 12 – Transite siding with felt paper beneath

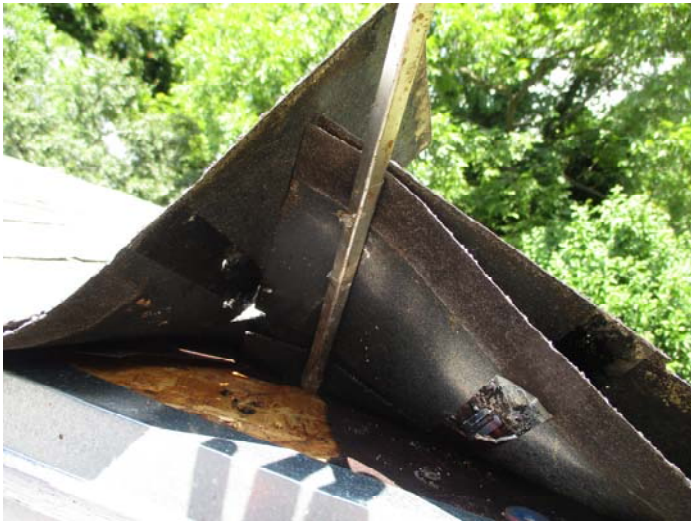
Photo 13 – Roof shingles & felt

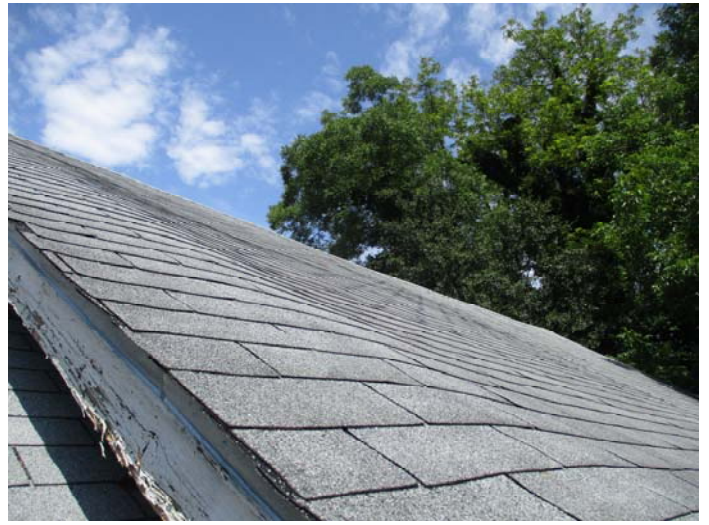
Photo 14 – Roof shingles & felt

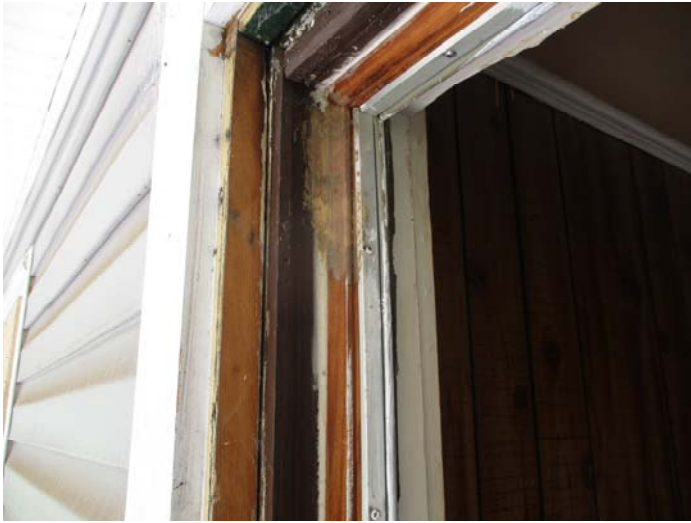
Photo 15 – Wooden door caulk

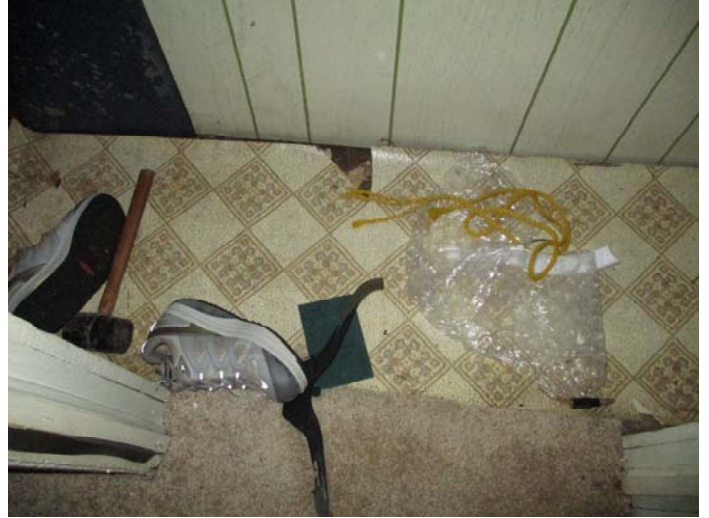
44 <i>412105883-0033</i> <i>No mastic present</i>	Tan & Brown Square Pattern Roll VF w/ Adhesive	Gray Non-Fibrous Homogeneous		85% Non-fibrous (Other)	15% Chrysotile
45 <i>412105883-0034</i> <i>No mastic present</i>	Tan & Brown Square Pattern Roll VF w/ Adhesive				Positive Stop (Not Analyzed)

Photo 16 – Tan & brown square pattern roll vinyl floor with no adhesive in the back left bedroom closet
