## **Asbestos & Lead Based Paint Assessment**

City of Spartanburg  
669 Clinchfield Street  
Spartanburg, South Carolina 29303

Project Number: 0521-99

August 4, 2021

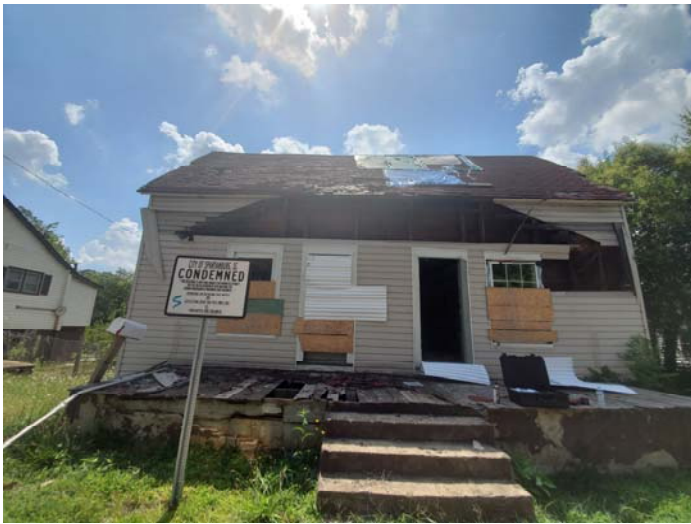
Photo 1 – 669 Clinchfield Street in Spartanburg, South Carolina 29303

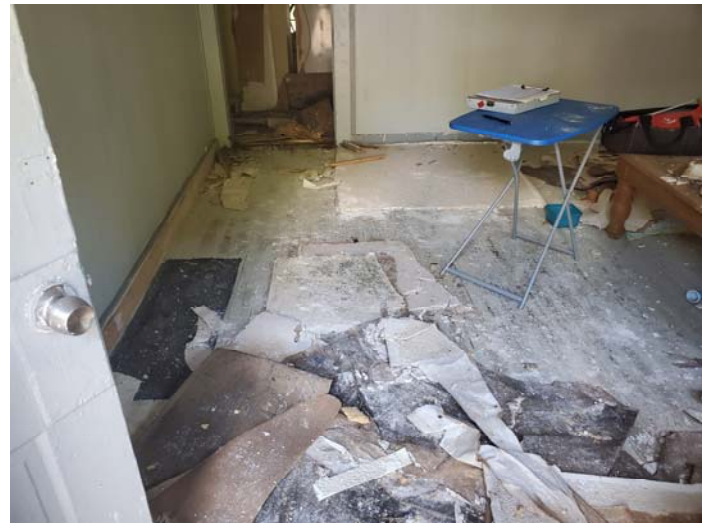
Photo 2 – Living room with household debris.

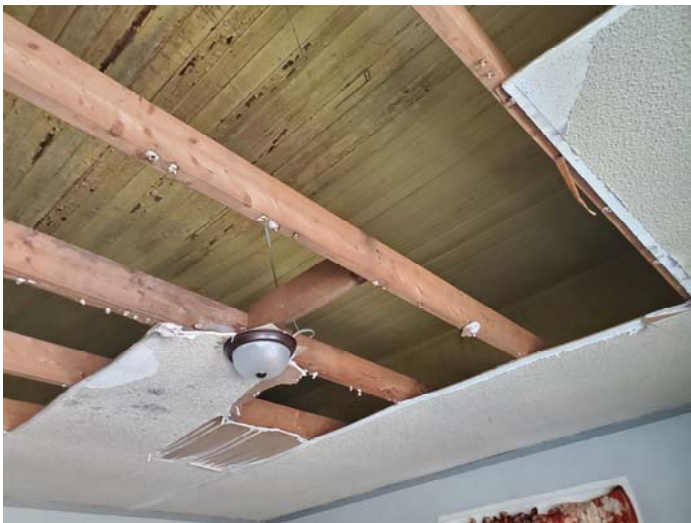
Photo 3 – Textured ceiling over drywall throughout.

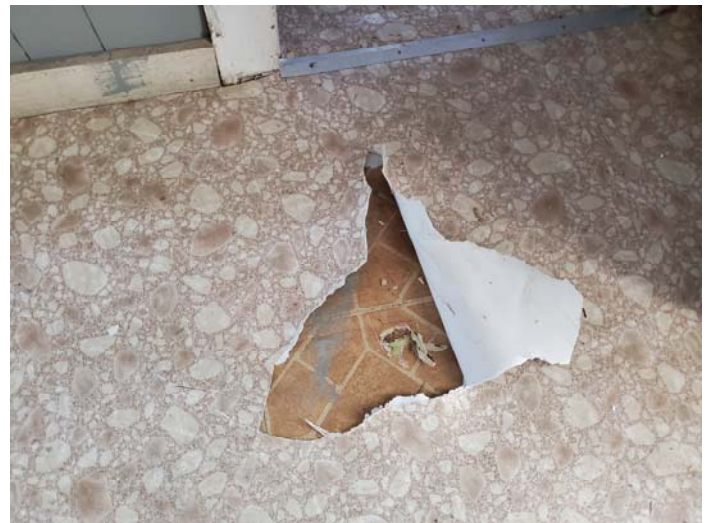
Photo 4 – Two layers of roll vinyl located over wood floors in kitchen, bathroom, bedroom and hallway.

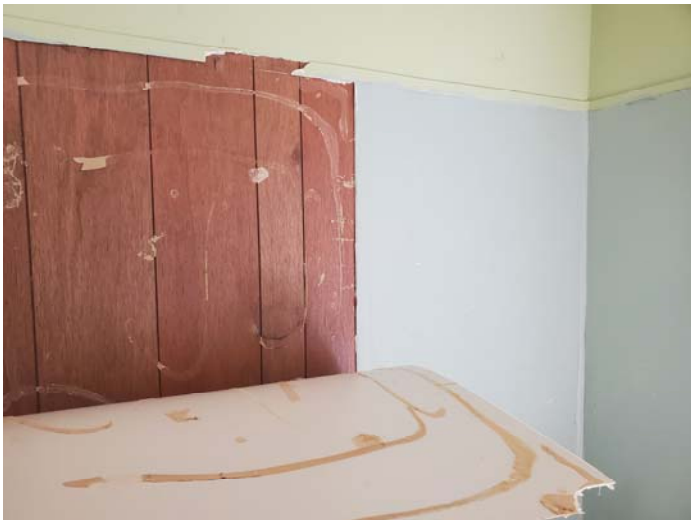
Photo 5 – Bathroom surround mastic.

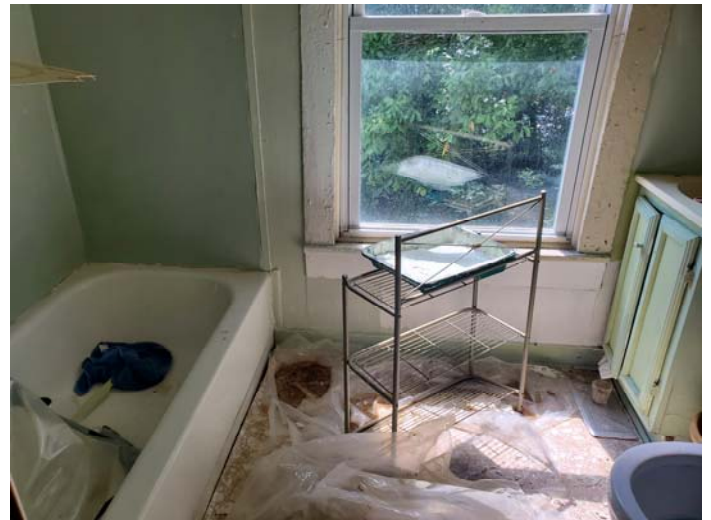
Photo 6 – Household debris located in bathroom.

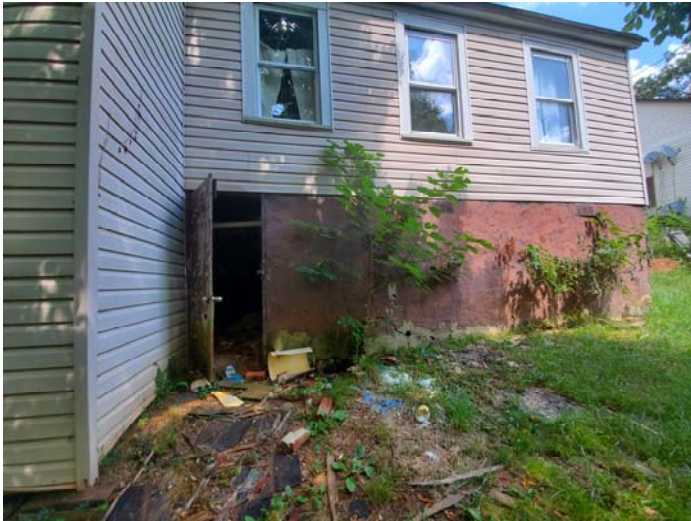
Photo 7 – Rear entrance into basement.

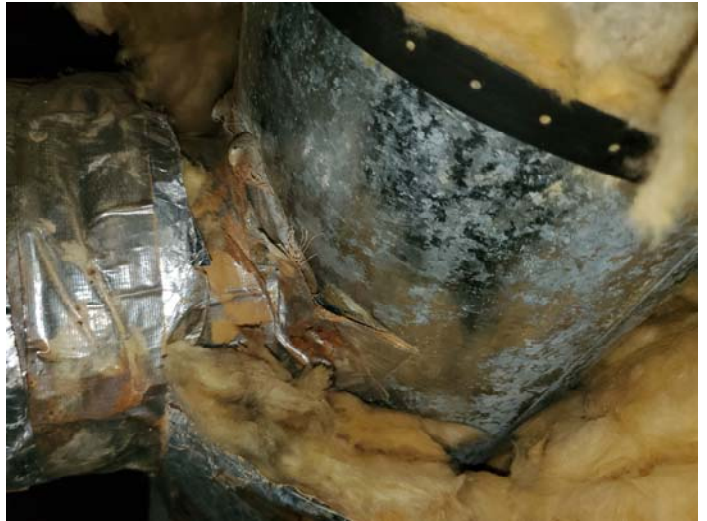
Photo 8 – HVAC insulation and tape.

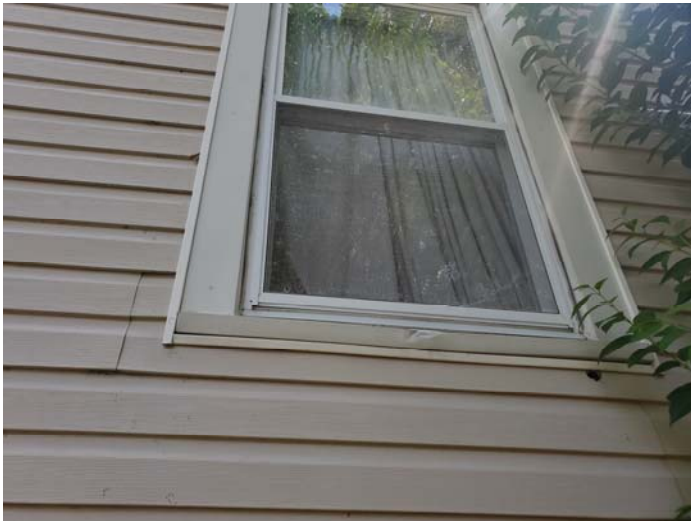
Photo 9 – Vinyl windows with window caulk.

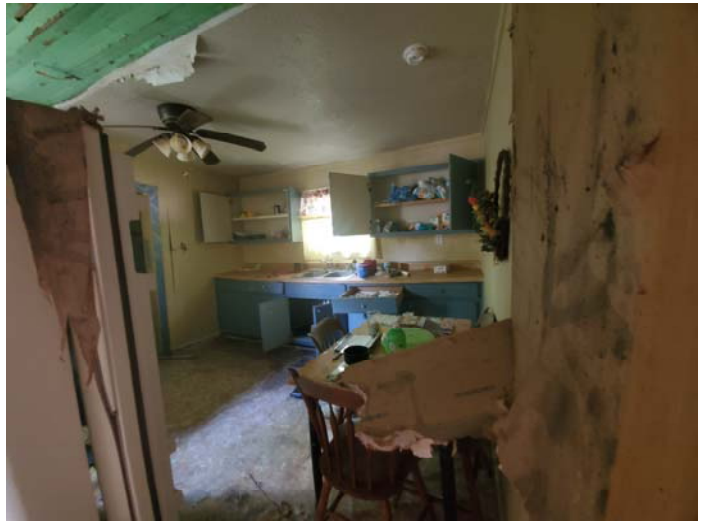
Photo 10 – Kitchen with household debris.

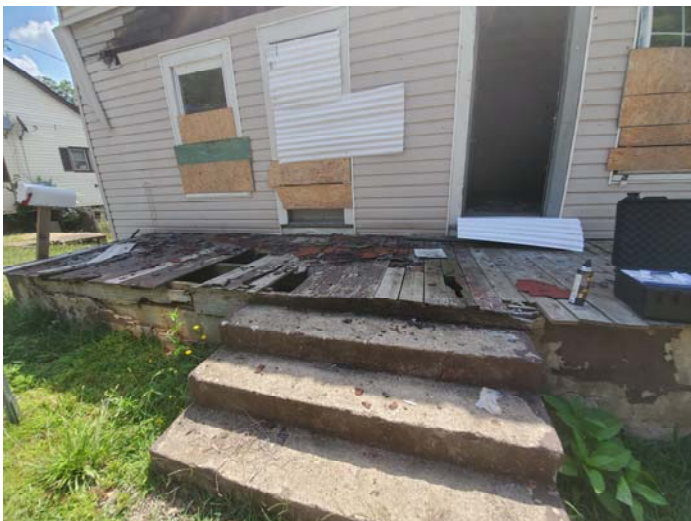
Photo 11 – Rotten wood on front porch is unstable.
