South side –
Front of
Schoolhouse –
Facing Hwy 98

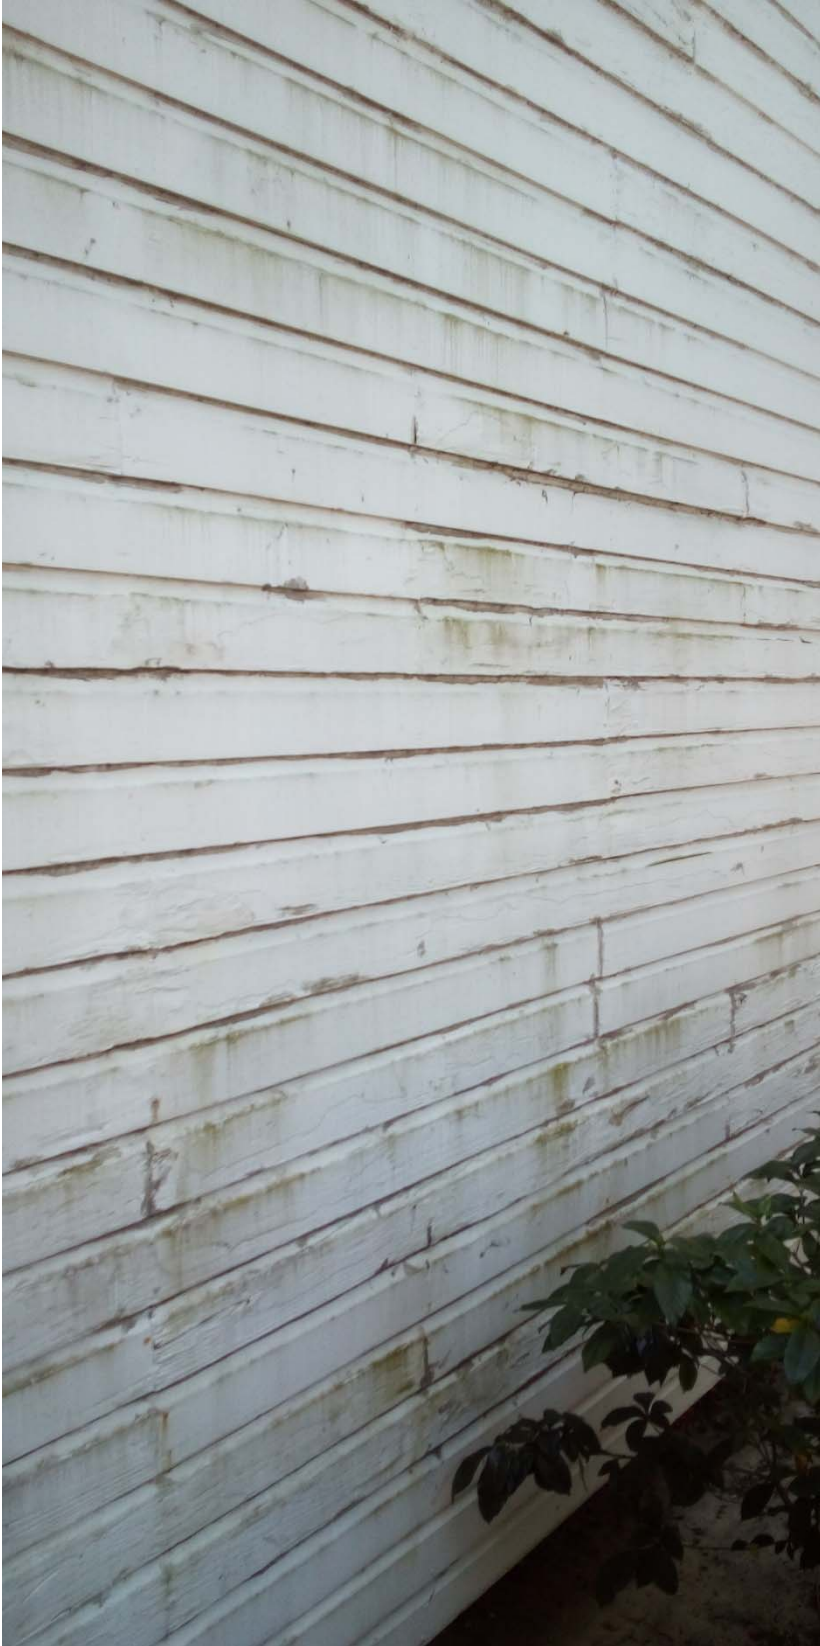
North Wall detail – showing example of wood that needs replacing.

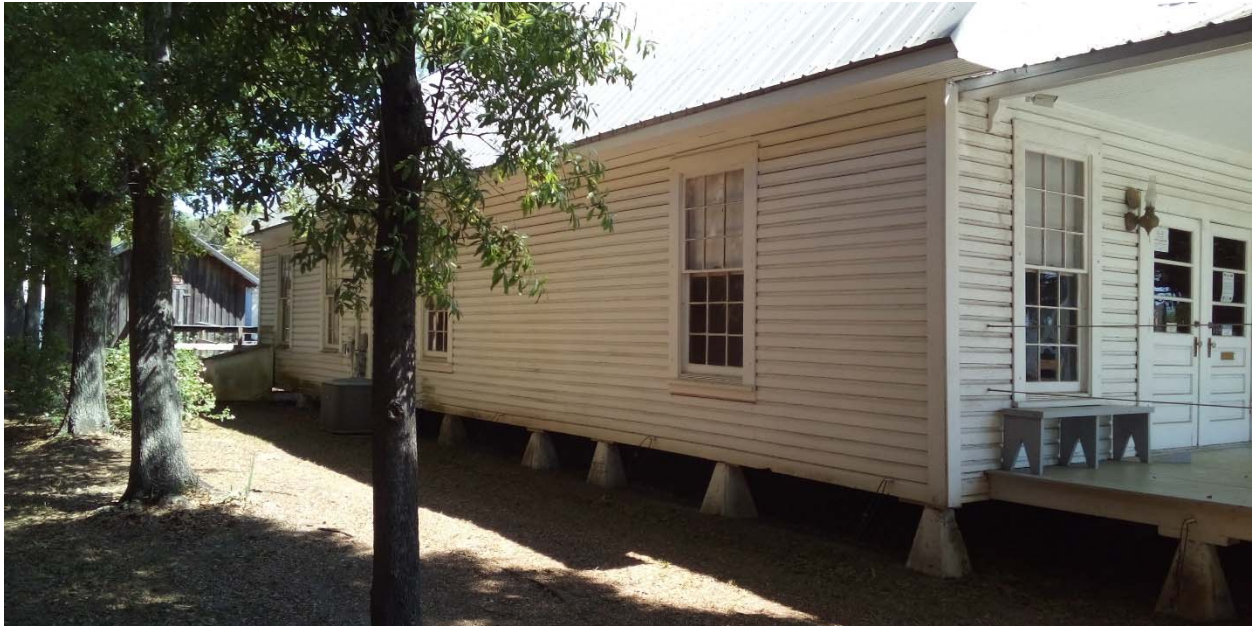
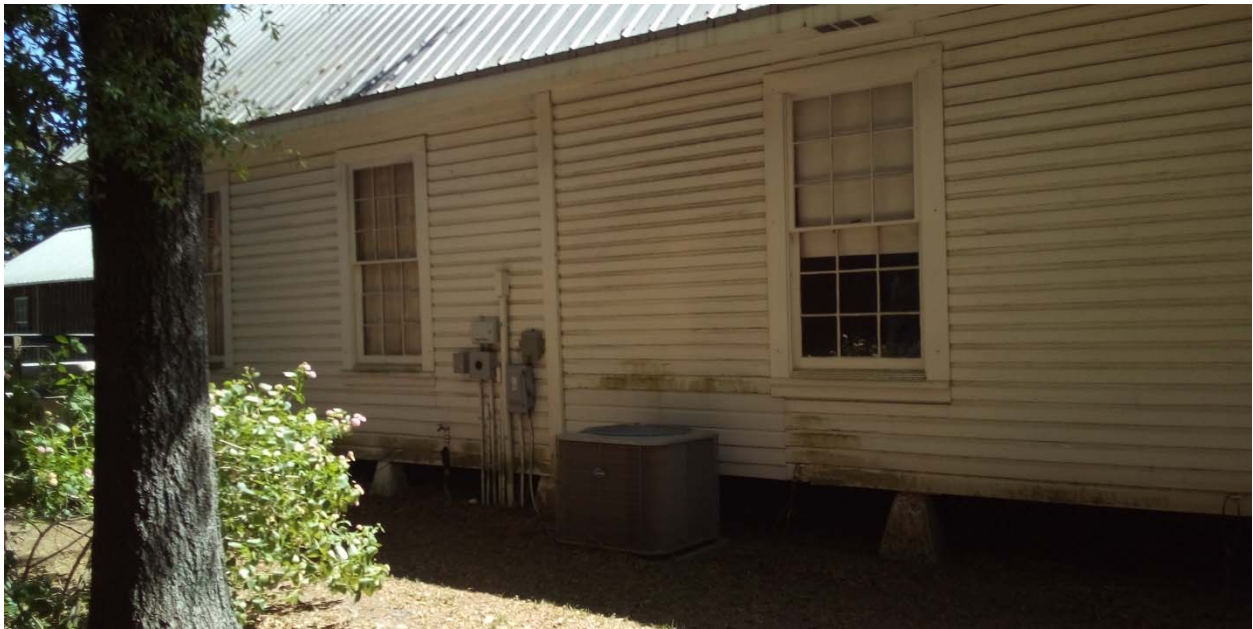
WEST Wall – details (example of repairs required)
