REPORT DATE: June 7, 2023
MAA PROJECT #: R3950.00

NESHAP ASBESTOS SURVEY REPORT

WILSON MALL

1635 and 1673 Parkwood Boulevard West, Wilson, Wilson County, North Carolina

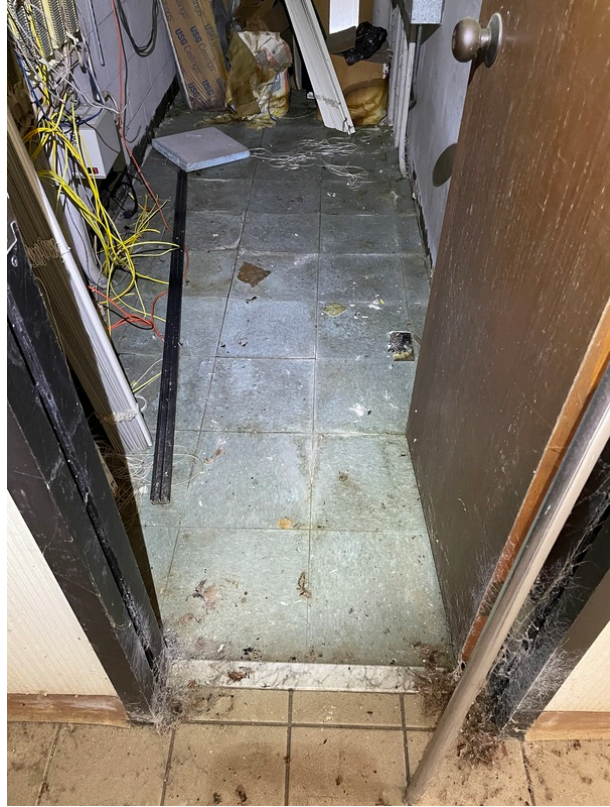
- Brown Felt Paper associated with Black Tar over Brown Felt Paper over Black Tar (Metal Canopy Roof); and
- Tan/Black Mastic associated with 12" x 12" Green Floor Tile over Tan/Black Mastic (Electrical Room).

Layer 2	B2311159.26B	Brown	Mastic	None Detected
14-1		B2311159.27A	Green	Floor Tile	None Detected
		B2311159.27B	Tan,Black	Mastic	Chrysotile 2%
14-2		B2311159.28A	Green	Floor Tile	None Detected
		B2311159.28B	Tan,Black	Mastic	Chrysotile 2%
15-1		B2311159.29A	Brown	Covebase	None Detected
		B2311159.29B	Brown	Mastic	None Detected
15-2		B2311159.30A	Brown	Covebase	None Detected
		B2311159.30B	Brown	Mastic	None Detected
16-1		B2311159.31	Off-white	Hvac Duct Tape	None Detected
16-2		B2311159.32	Off-white	Hvac Duct Tape	None Detected

General view of asbestos-containing Tan/Black Mastic beneath 12" x 12" Green Floor Tile (HA 14)

At the time of this survey, non-friable ACM were observed in good condition. Non-friable resilient flooring materials do not pose a threat to occupants of the building in their current state; however, non-friable materials can be made friable if handled incorrectly and should be removed by professionals qualified in asbestos abatement. The Asbestos-Containing Sample Location Map is provided as [Drawing 2](#).
