Asbestos & Lead Based Paint Assessment

City of Spartanburg
654 West Main Street; Building 1
Spartanburg, South Carolina 29301

Project Number: 0521-99

May 20, 2021

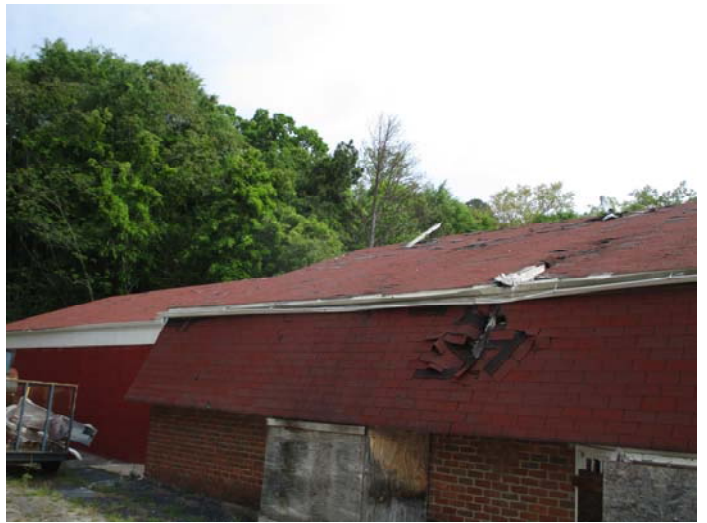
Photo 2 – Roof shingles & felt

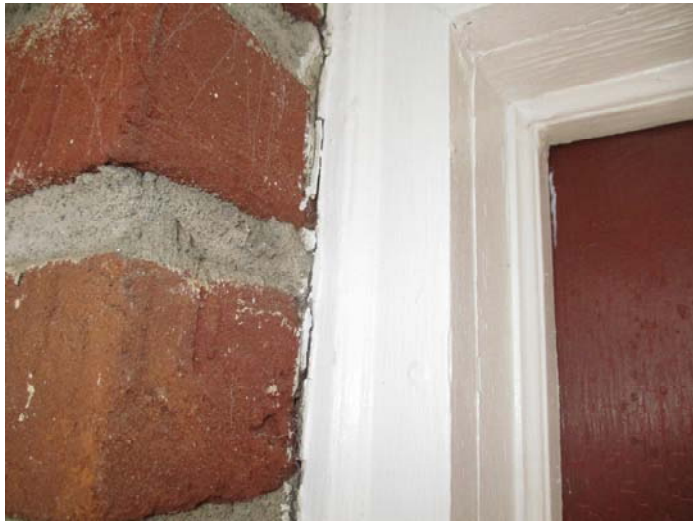
Photo 3 – White wooden door caulk

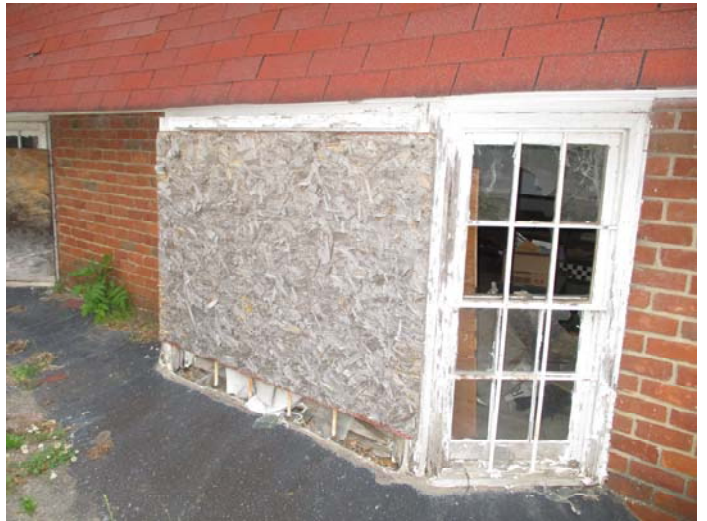
Photo 4 – Wooden window with glazing

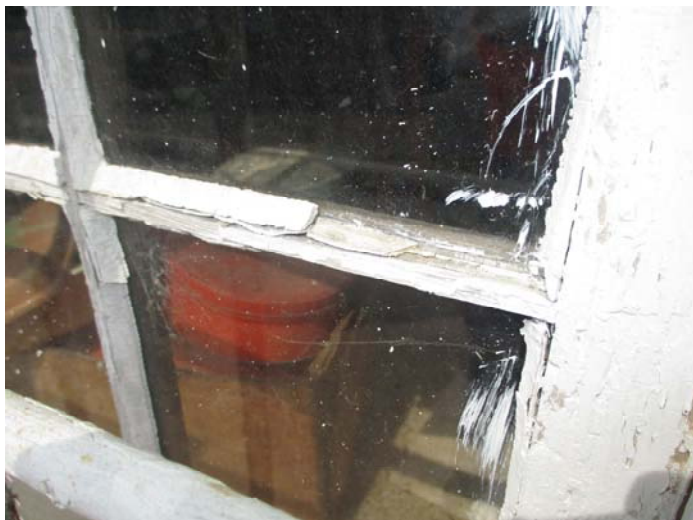
Photo 5 – Wooden window with base, inner & outer layers

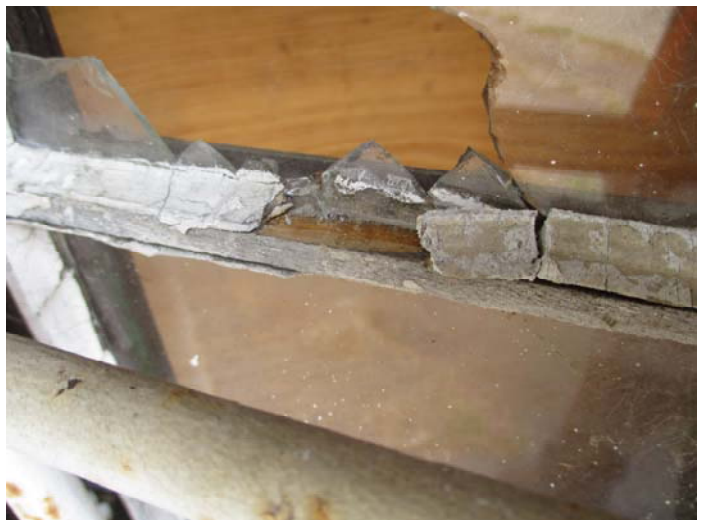
Photo 6 – Wooden window with base, inner & outer layers

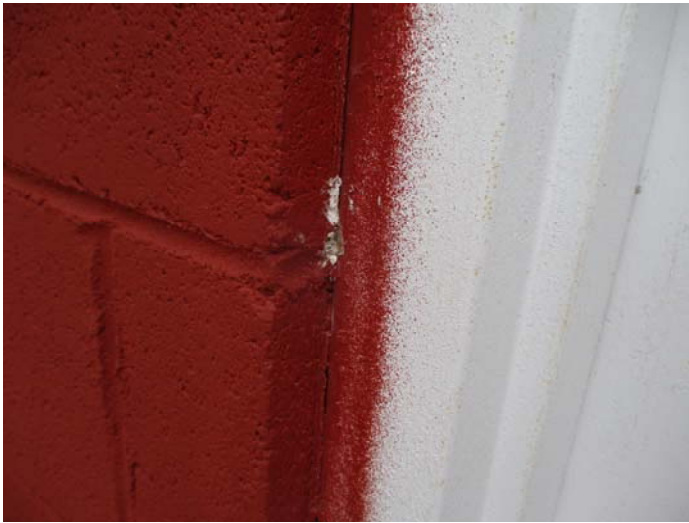
Photo 7 – Red metal door caulk

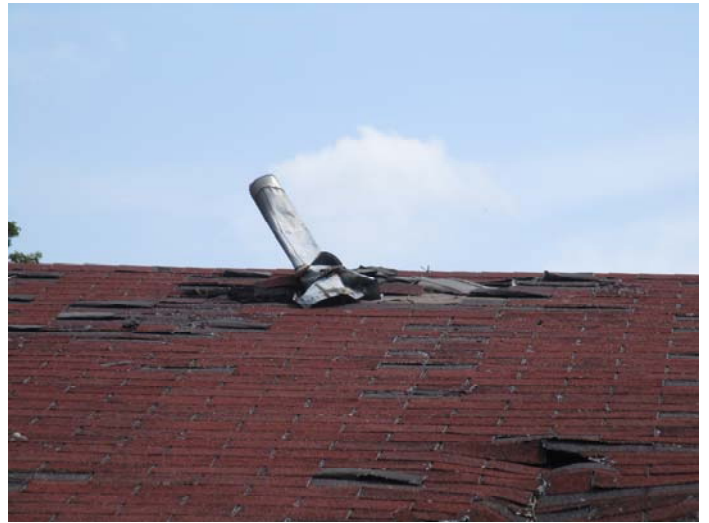
- Approximately 2 SF of tar on one roof vent – assumed positive.

Photo 8 – Tar on 1 roof vent – assumed positive

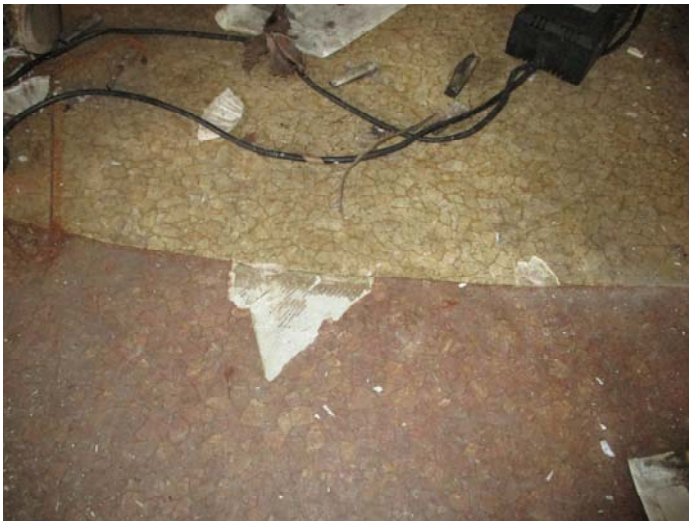
Photo 9 – Typical view of the tan & brown vinyl floor & adhesive. Exists as single layers & 2nd layers

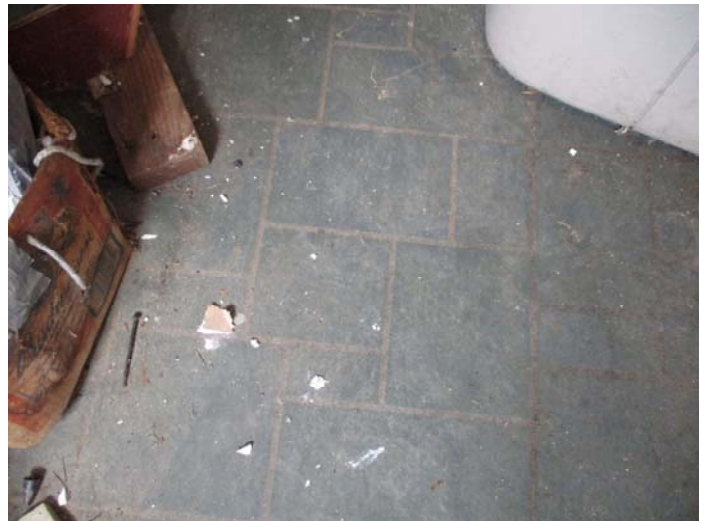
- Right side front room and hallway (2nd layer).
- Approximately 170 SF green square and rectangle pattern vinyl floor in the front side of the left area.

Photo 10 – Green square & rectangle pattern vinyl floor & adhesive in the left side front area

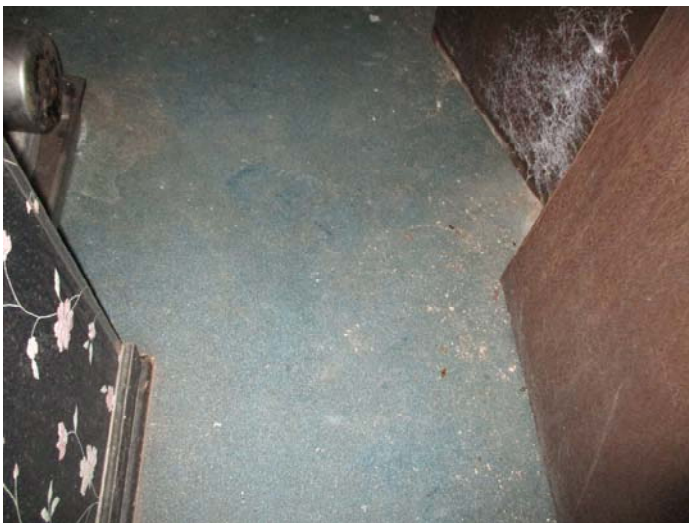
Photo 11 – Blue pattern vinyl floor with no adhesive in the left side 1st bathroom on the right

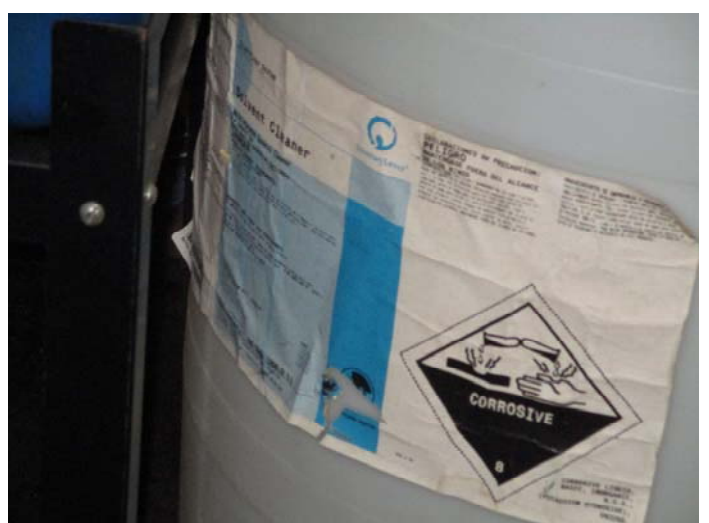
Photo 12 – 55 gallon container of “corrosive” material

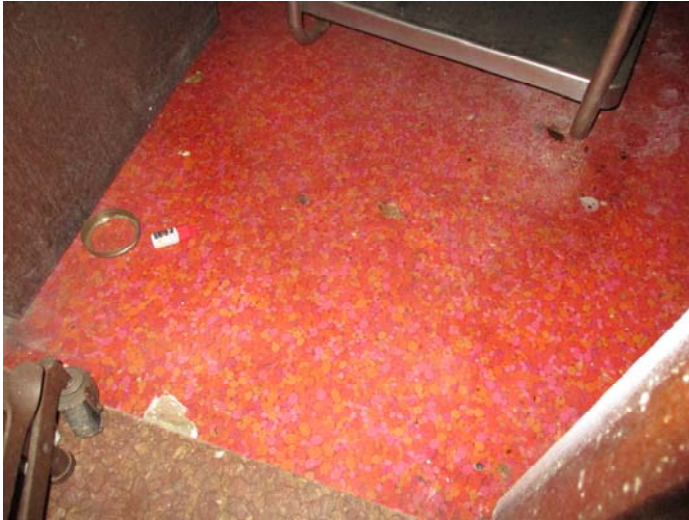
Photo 13 – Red pattern vinyl floor & adhesive in the left side 2nd bathroom on the right & right side 2nd room

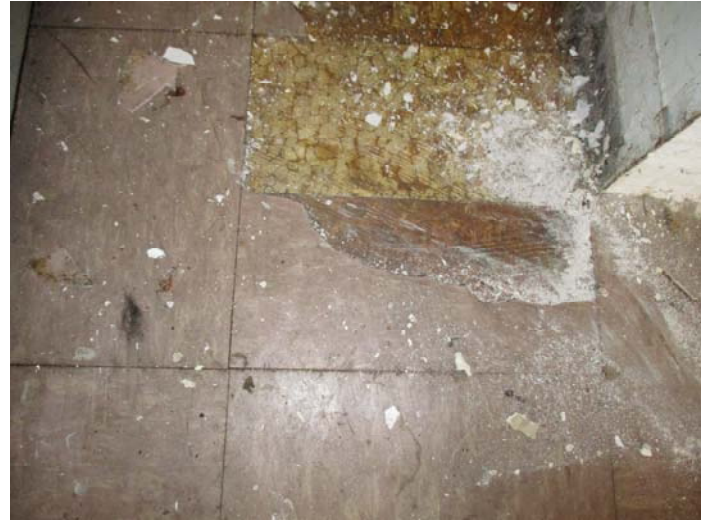
Photo 14 – Top layer of 12" x 12" tan/gray peacock floor tile & brown adhesive in the right side front room, hallway & right side 1st room

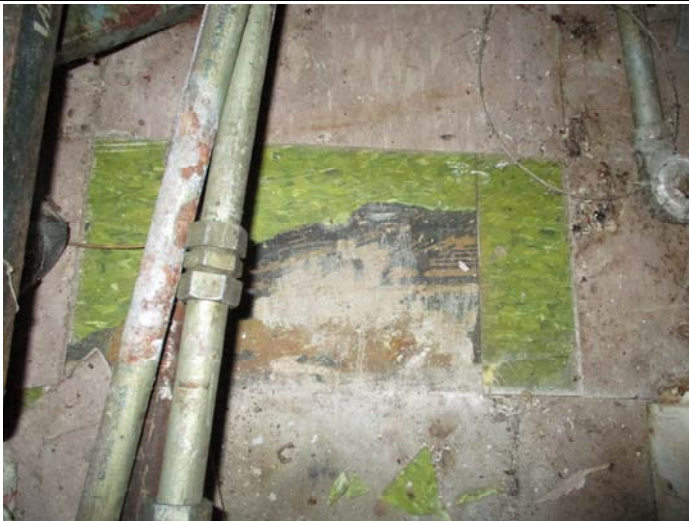
Photo 15 – 2nd layer 12" x 12" green peacock floor tile & black mastic in the right side 1st room on the right

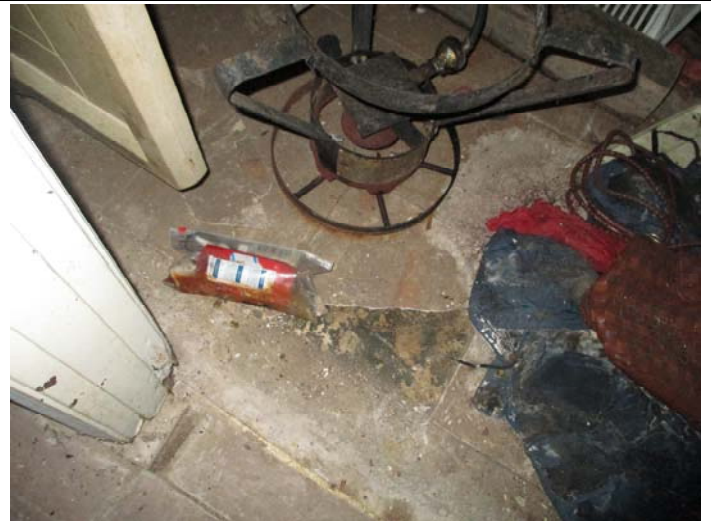
Photo 16 – 12" x 12" floor tile & black mastic in the right side 3rd & 4th rooms on the right

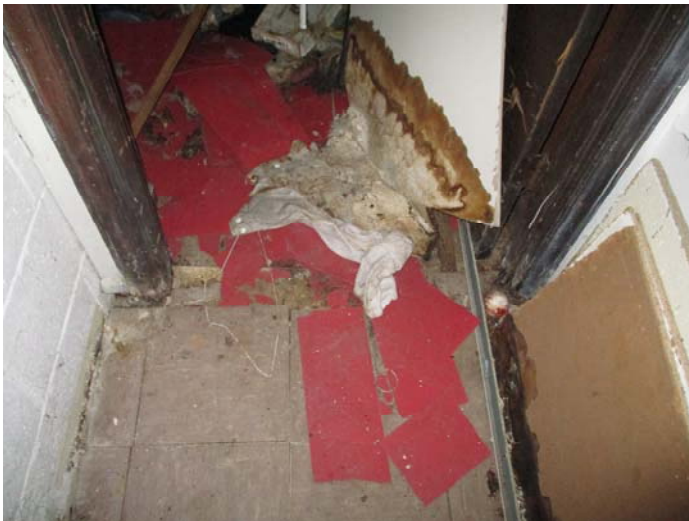
Photo 17 – 12" x 12" red floor tile with no mastic in the right side 4th room on the right

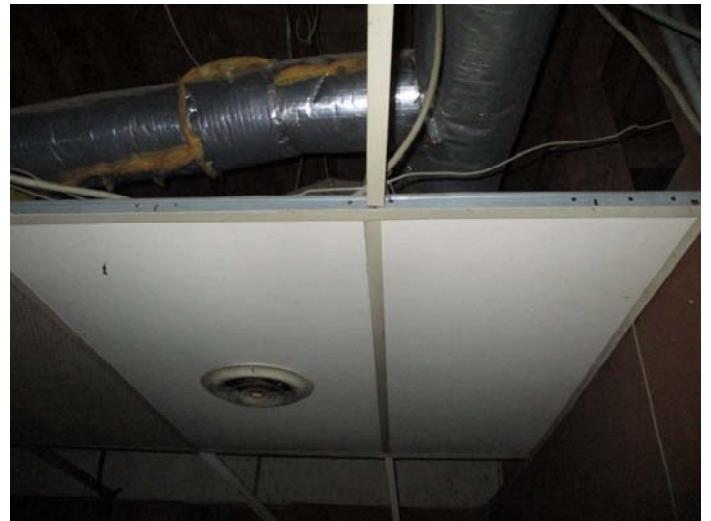
Photo 18 – 2' x 4' smooth ceiling tiles in the right side 4th room on the right & both bathrooms

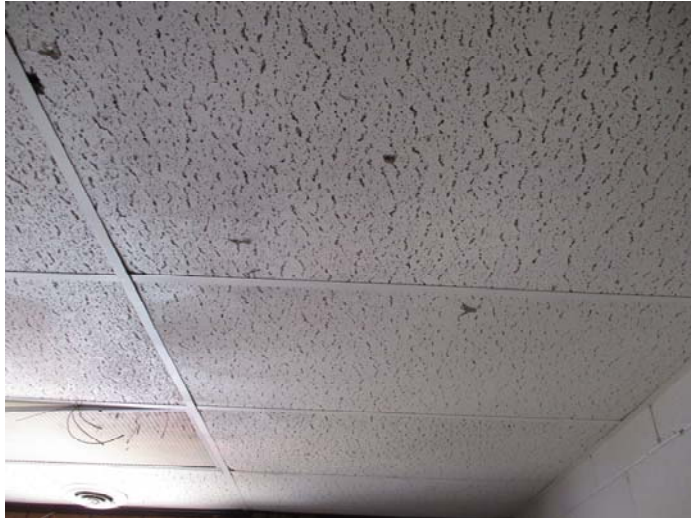
Photo 18 – 2' x 4' fissure ceiling tiles in the right side

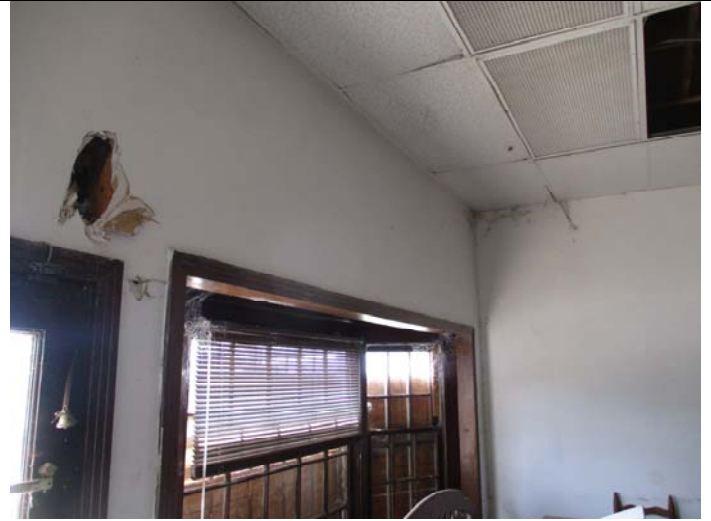
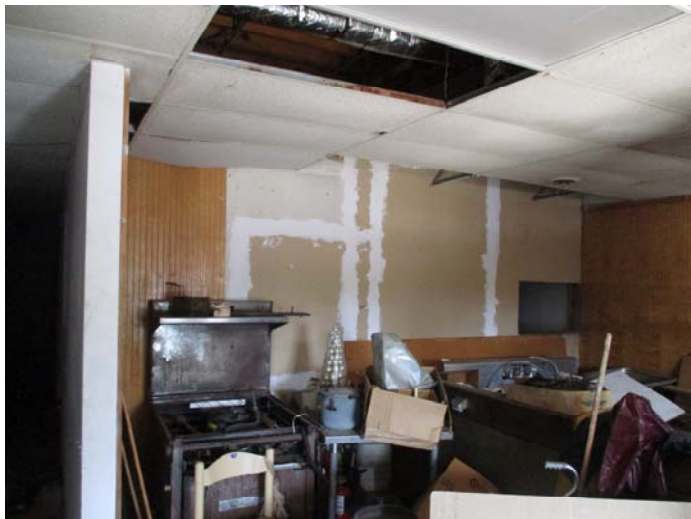
- Approximately 1,500 SF of drywall on the left side walls and bathrooms and throughout the right side except in the back room.
- Approximately 15 LF of A-Tape on the HVAC ducts.

Photo 20 – Drywall with joint compound & tape in the left side walls & bathrooms & throughout the right side except in the back room

Photo 21 – Drywall with joint compound & tape in the left side walls & bathrooms & throughout the right side except in the back room

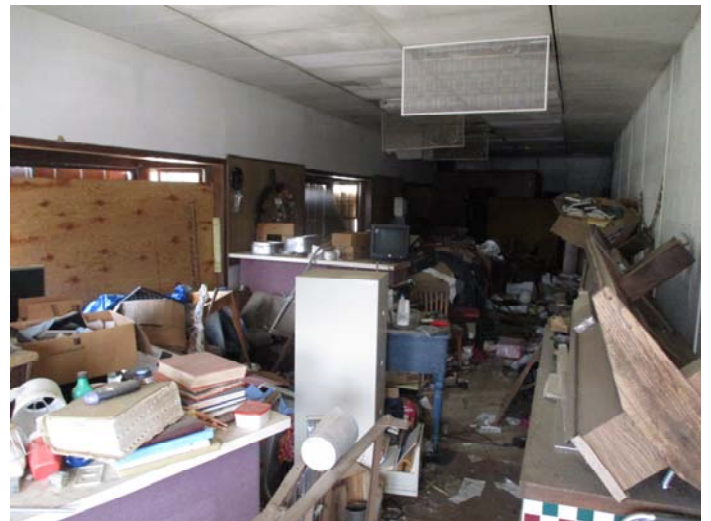
Photo 22 – Typical view of items and debris throughout the building

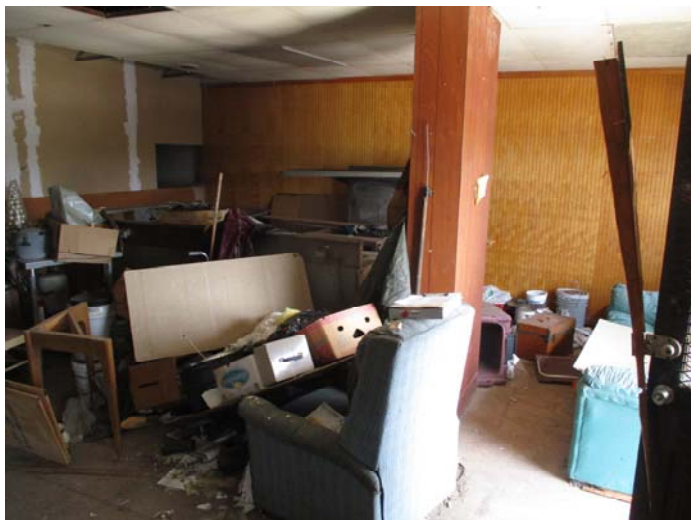
Photo 23 – Typical view of items and debris throughout the building

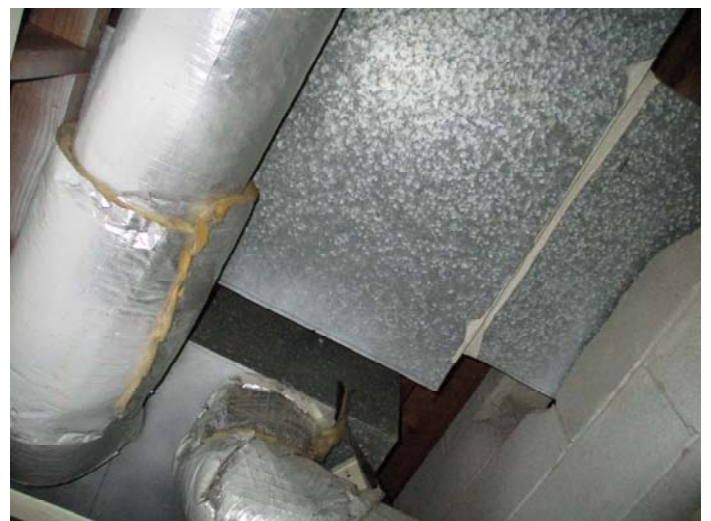
Photo 24 – A-Tape on HVAC
