## **Asbestos & Lead Based Paint Assessment**

City of Spartanburg  
654 West Main Street; Building 2  
Spartanburg, South Carolina 29301

Project Number: 0521-99

May 25, 2021

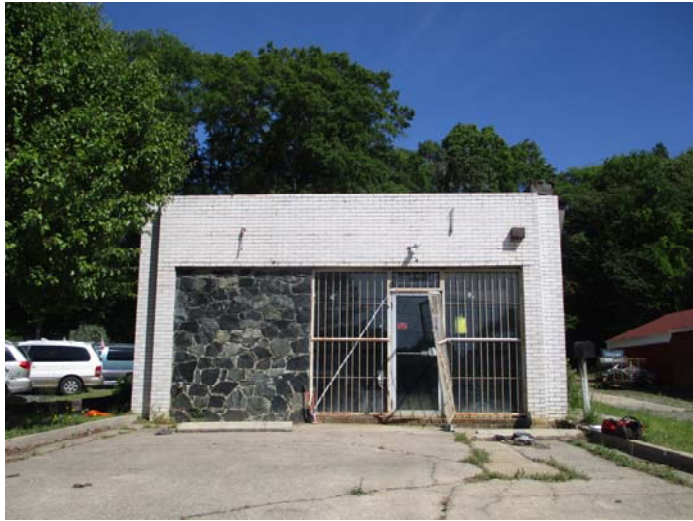
Photo 1 – 654 West Main Street (Building 2) in Spartanburg, South Carolina 29301

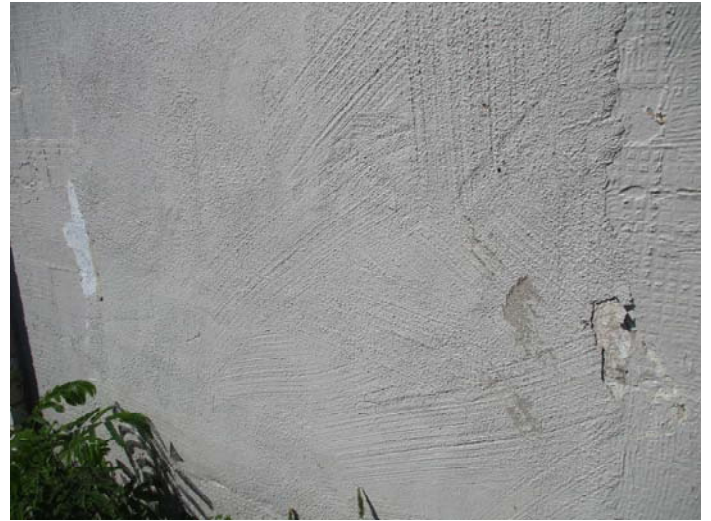
| Sample No. | Location | Sample Description | Analytical Results | Friable/Non Friable | Condition | Quantity |
|---|---|--|---|---|---|---|
| 1 | Exterior siding/walls | Stucco over CMU blocks | PLM - NAD | Friable | Good | 175 SF |

Photo 2 – Stucco over CMU blocks

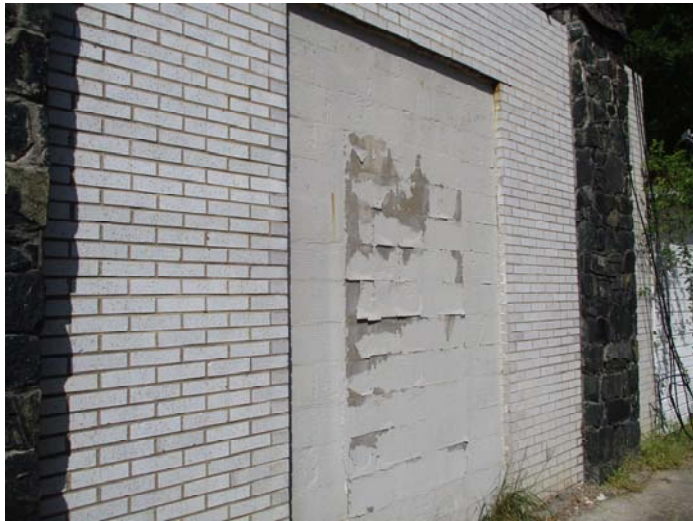
Photo 3 – Stucco over CMU blocks

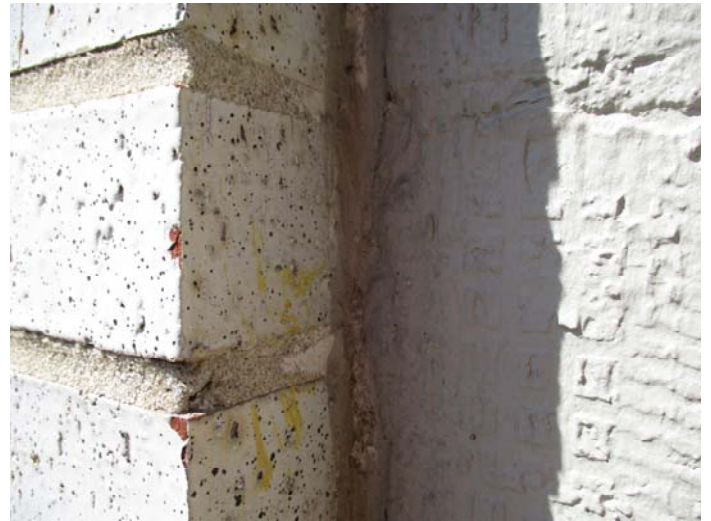
| Sample No. | Location | Sample Description | Analytical Results | Friable/Non Friable | Condition | Quantity |
|---|---|--|---|---|---|---|
| 4 | Exterior siding & stucco | Gray caulk | PLM - 7% chrysotile | Non-Friable | Good | 75 LF |

Photo 4 – Gray caulk on exterior siding & stucco

1. Abate the asbestos containing materials in the structure prior to renovation or demolition.
2. Follow applicable asbestos regulations during renovation or demolition of the structure. You should be aware that stringent requirements are imposed upon anyone renovating or demolishing a structure in which ACM will be disturbed. This work must be performed in accordance with OSHA asbestos regulations, 29 CFR 1910 & 1926, and NESHAP asbestos regulations 40 CFR 61, subpart M. South Carolina regulations require the accreditation of personnel who work in the asbestos field and notification and permitting fees for asbestos removal projects. There is a 10 working day notification period required prior to abatement of asbestos in a facility. Failure to take proper precautions and actions to protect human health

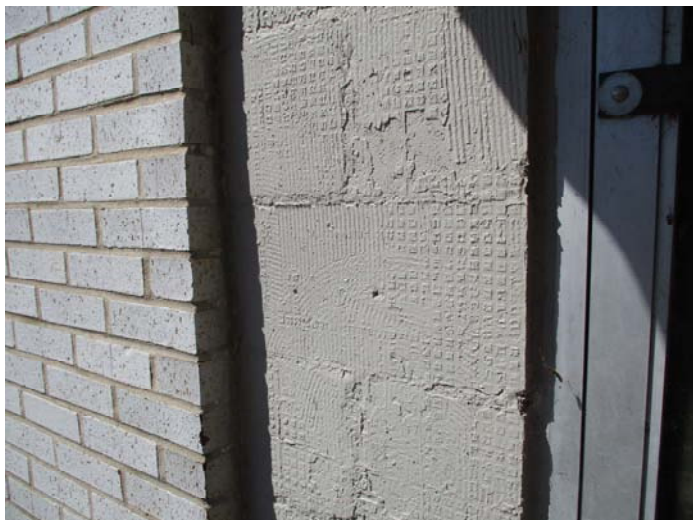
Photo 5 – Gray caulk on exterior siding & stucco

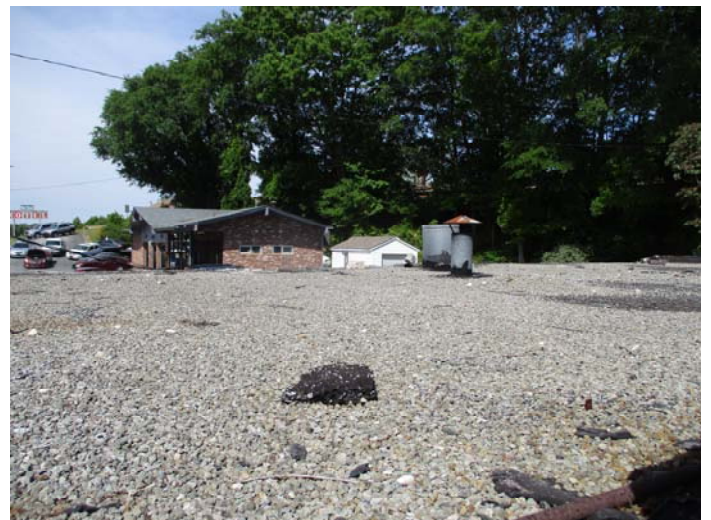
| Sample No. | Location | Sample Description | Analytical Results | Friable/Non Friable | Condition | Quantity |
|---|---|--|---|---|---|---|
| 16 | Flat roof | Built-up tar & gravel roof system | PLM - 6% chrysotile | Non-Friable | Good | 1,225 SF |

Photo 6 – Built up tar and gravel roof system

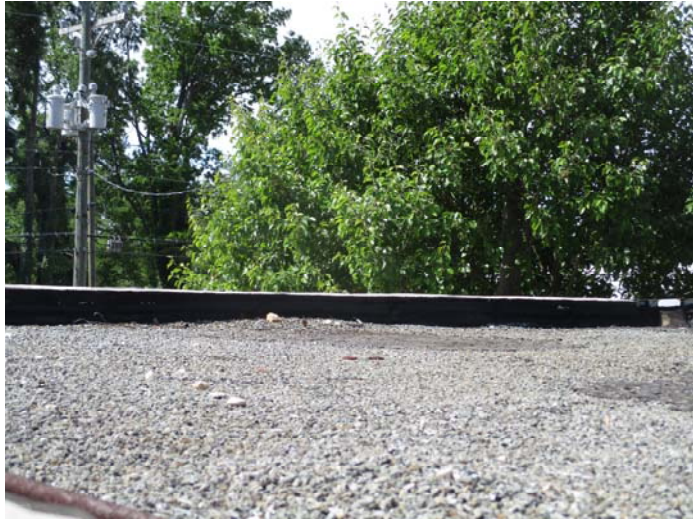
| Sample No. | Location | Sample Description | Analytical Results | Friable/Non Friable | Condition | Quantity |
|---|---|--|---|---|---|---|
| 19 | Flat roof parapet walls & stone | Tar & shingle flashing | PLM - 6% chrysotile (tar) | Non-Friable | Good | 175 SF |

Photo 7 – tar & shingle flashing on the flat roof parapet walls & stone

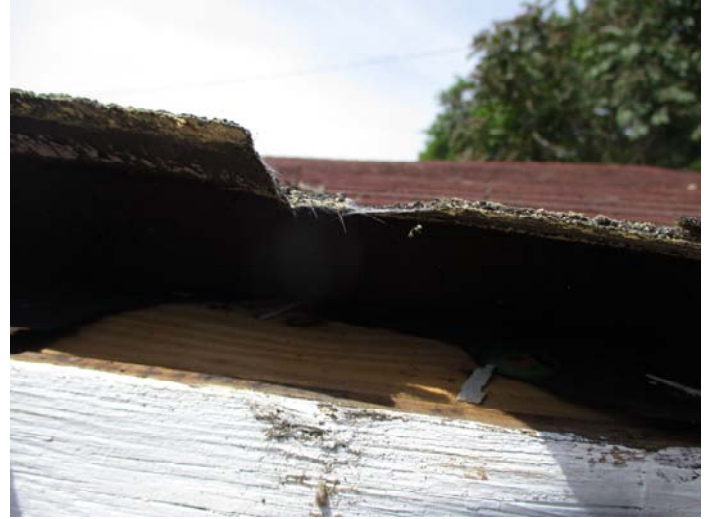
| Sample No. | Location | Sample Description | Analytical Results | Friable/Non Friable | Condition | Quantity |
|---|---|--|---|---|---|---|
| 22 | Back pitched wooden roof | Roof shingles (1 layer) & felt (1 layer) | PLM - NAD | Non-Friable | Good | 600 SF |

Photo 8 – Roof shingles & felt on back pitched wooden roof

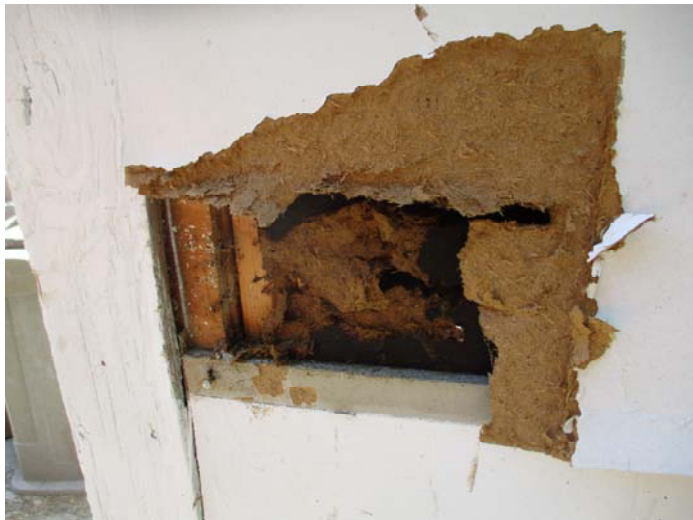
| Sample No. | Location | Sample Description | Analytical Results | Friable/Non Friable | Condition | Quantity |
|---|--|--|---|---|---|---|
| 25 | Beneath wooden & vinyl siding | Felt paper | PLM - NAD | Non-Friable | Good | 600 SF |

Photo 9 – Felt paper beneath wooden & vinyl siding

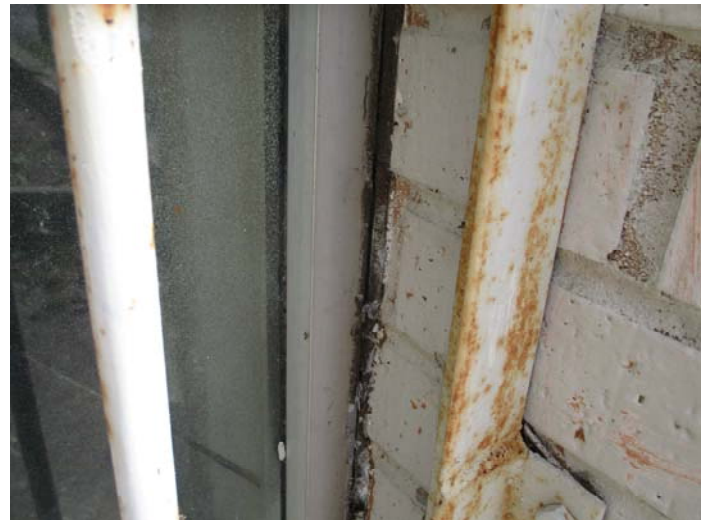
| Sample No. | Location | Sample Description | Analytical Results | Friable/Non Friable | Condition | Quantity |
|---|---|--|---|---|---|---|
| 7 | Metal windows | Black caulk over tan caulk | PLM - NAD | Non-Friable | Good | 2 EA |

Photo 10 – Black caulk over tan caulk on metal windows

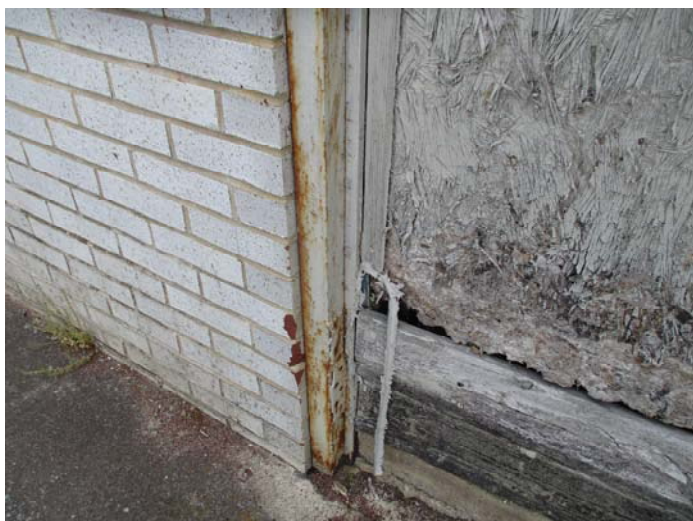
| Sample No. | Location | Sample Description | Analytical Results | Friable/Non Friable | Condition | Quantity |
|---|---|--|---|---|---|---|
| 13 | Wooden plywood siding on left side | White hard caulk | PLM - NAD | Non-Friable | Good | 50 LF |

Photo 11 – White hard caulk on wooden plywood siding on left side

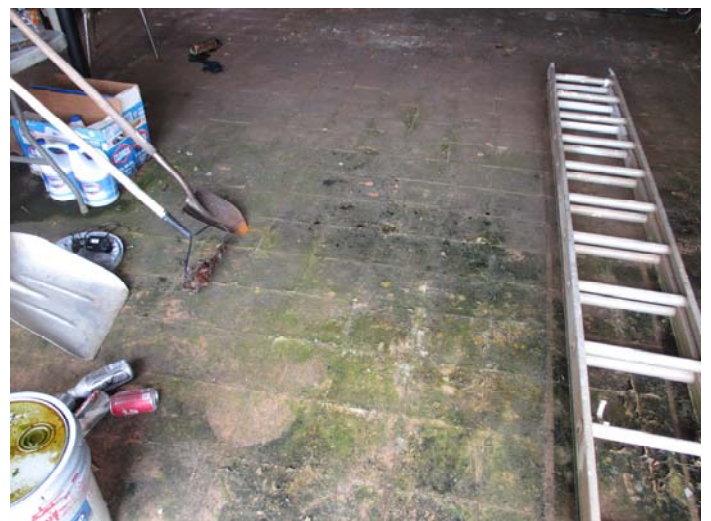
| Sample No. | Location | Sample Description | Analytical Results | Friable/Non Friable | Condition | Quantity |
|---|--|--|---|---|---|---|
| <b>28</b> | Front area | 9" x 9" brown floor tile & brown mastic | <b>PLM - 8% chrysotile (floor tile)</b> | Non-Friable | Good | 550 SF |

Photo 12 – 9" x 9" brown floor tile & brown mastic in the front area

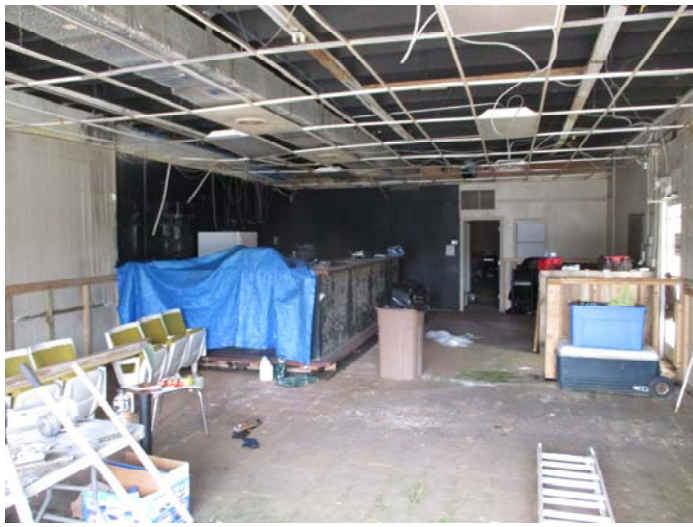
Photo 13 – Typical view of the front area

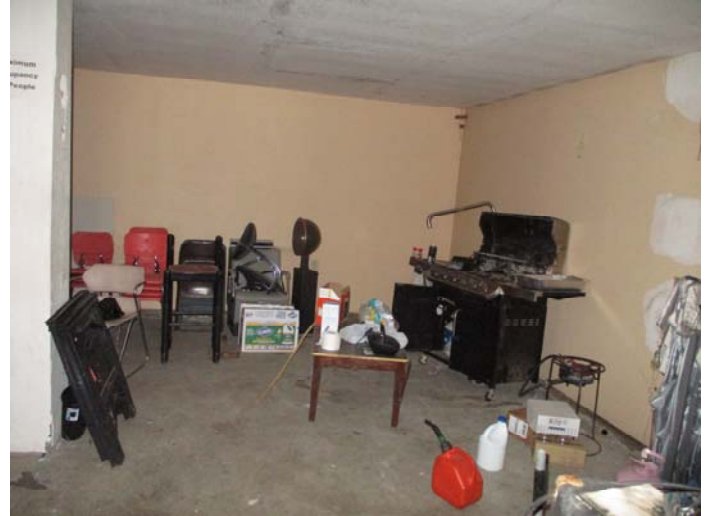
Photo 14 – Typical view of the back area and drywall walls & ceilings

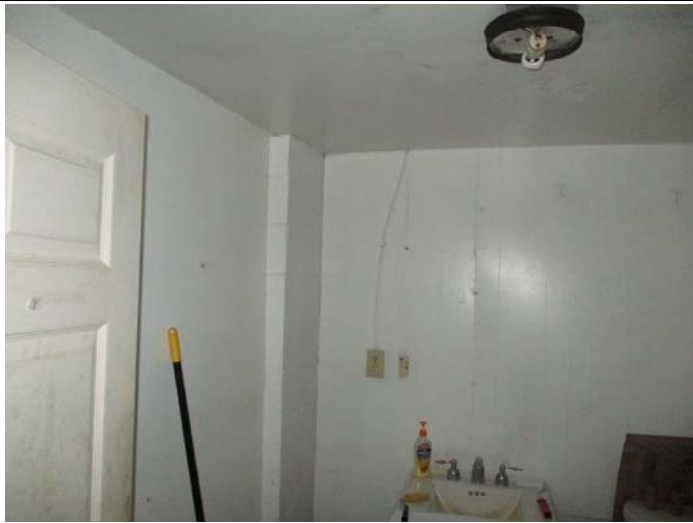
Photo 15 – Typical view of a bathroom and drywall walls & ceilings

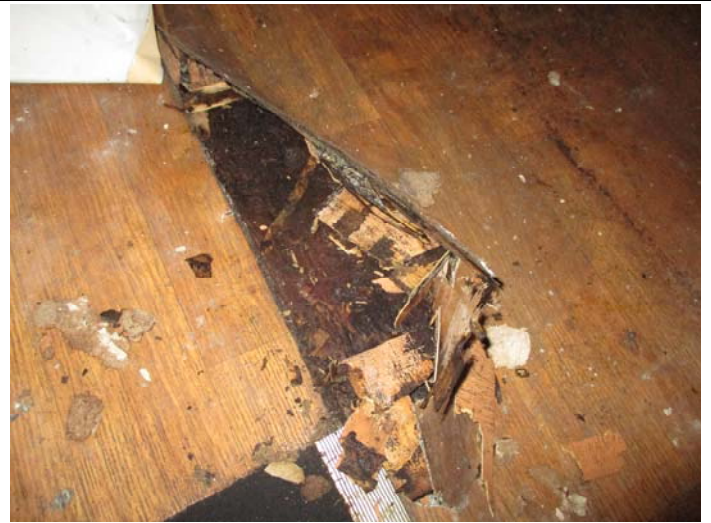
| Sample No. | Location | Sample Description | Analytical Results | Friable/Non Friable | Condition | Quantity |
|---|--|--|---|---|---|---|
| 36 | Behind bar area | Multiple layers of roll vinyl flooring & adhesives | PLM - NAD | Non-Friable | Good | 125 SF |

Photo 16 – Multiple layers of roll vinyl flooring & adhesives behind the bar area
