Asbestos & Lead Based Paint Assessment

City of Spartanburg
709 W.O. Ezell Boulevard
Spartanburg, South Carolina 29301

Project Number: 0521-99

May 25, 2021

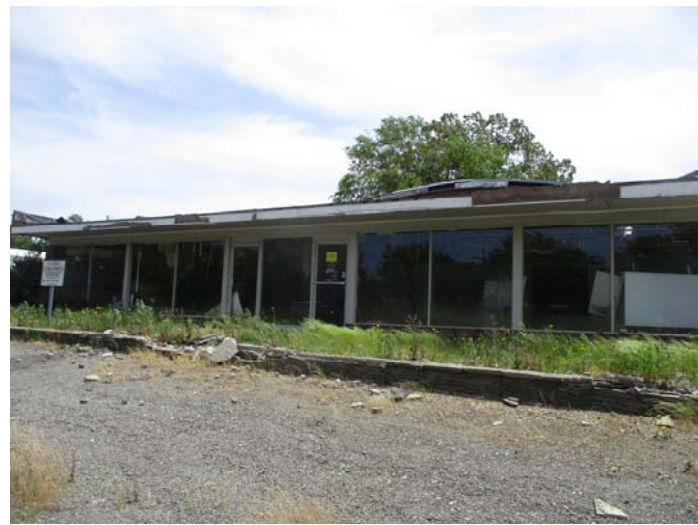
Photo 1 – 709 W.O. Ezell Boulevard in Spartanburg, South Carolina 29301

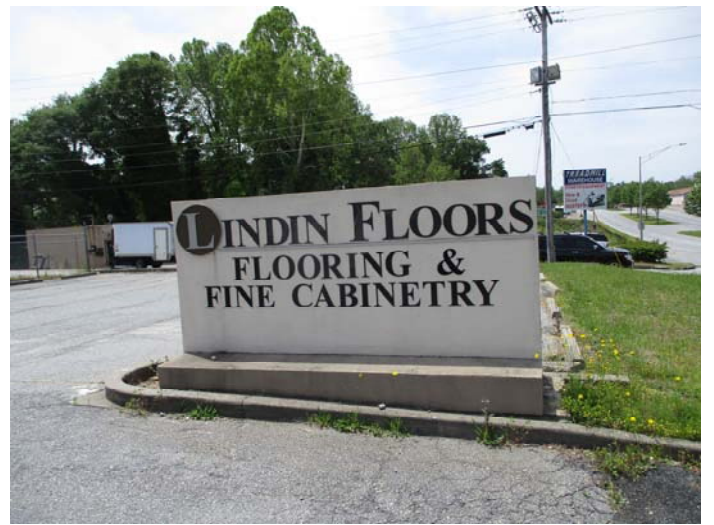
Photo 2 – 709 W.O. Ezell Boulevard in Spartanburg, South Carolina 29301

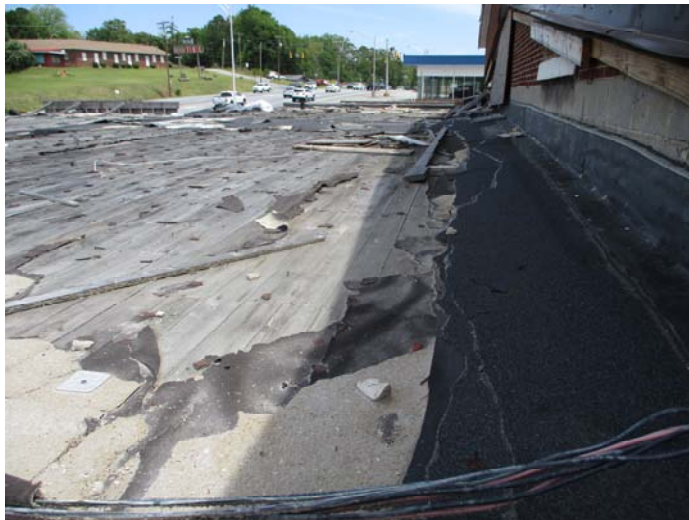
Photo 3 – Roll roofing over brown insulation & felt paper on the front roof

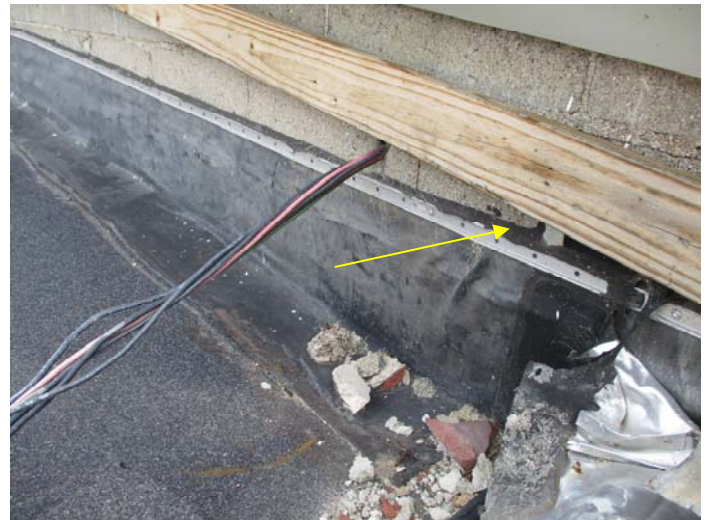
Photo 4 – Flashing caulk on the front roof

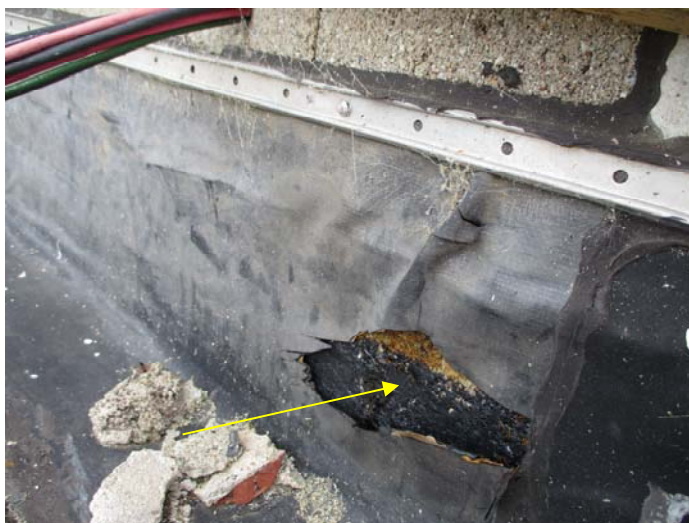
Photo 5 – Flashing tar on the flat roof

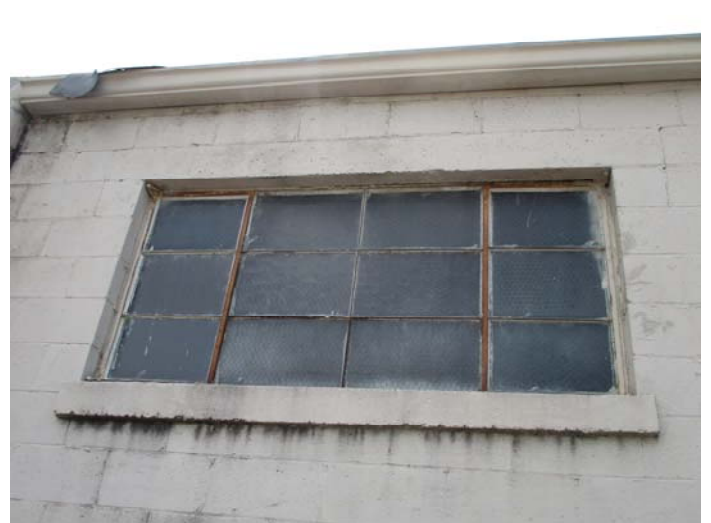
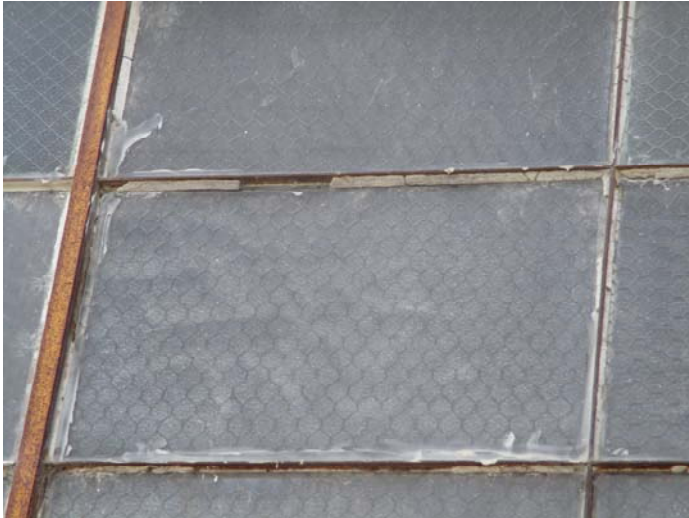
- Approximately 9 metal windows with glazing on the back warehouse portion of the building.
- Approximately 75 SF wall panel adhesive in the front area.

Photo 6 – Back metal window with glazing

Photo 7 – Back metal window with glazing

1. Abate the asbestos containing materials in the structure prior to renovation or demolition.
2. Follow applicable asbestos regulations during renovation or demolition of the structure. You should be aware that stringent requirements are imposed upon anyone renovating or demolishing a structure in which ACM will be disturbed. This work must be performed in accordance with OSHA asbestos regulations, 29 CFR 1910 & 1926, and NESHAP asbestos regulations 40 CFR 61, subpart M. South Carolina regulations require the accreditation of personnel who work in the asbestos field and notification and permitting fees for asbestos removal projects. There is a 10 working day notification period required prior to abatement of

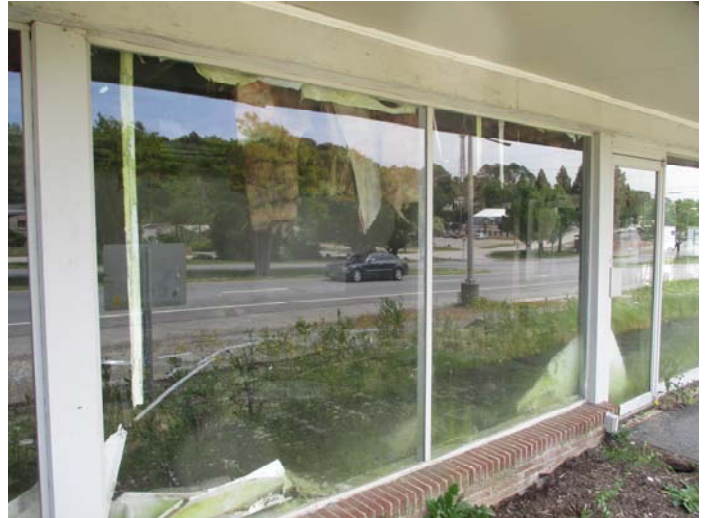
Photo 8 – Front metal windows with caulk over glazing

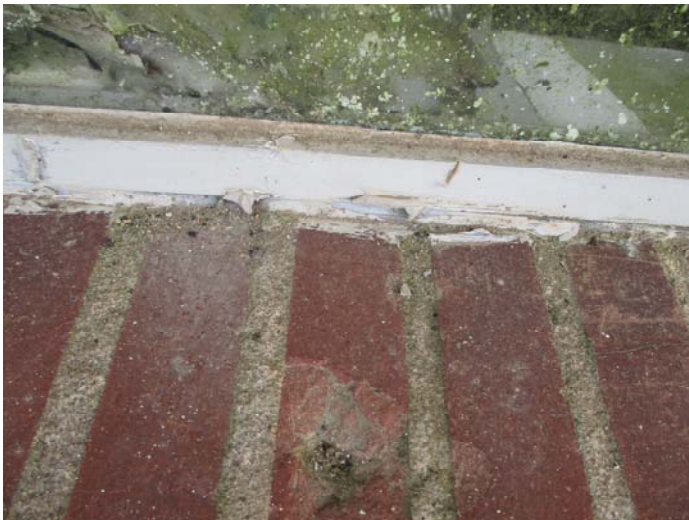
Photo 9 – Front metal windows with caulk over glazing

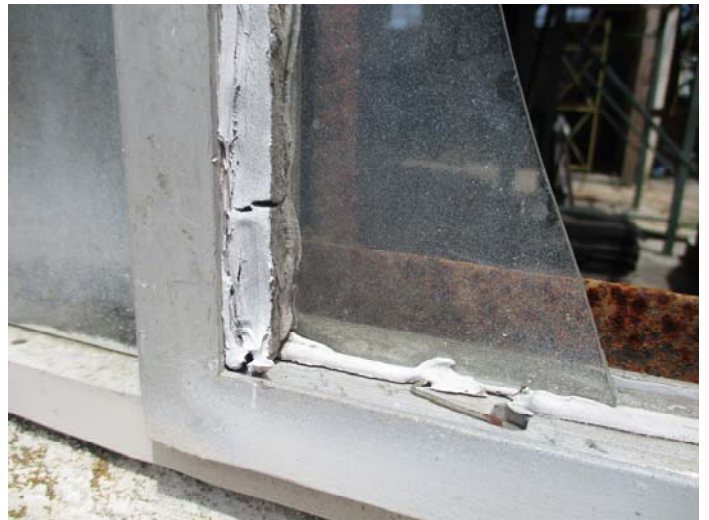
Photo 10 – Caulk patch on back metal windows

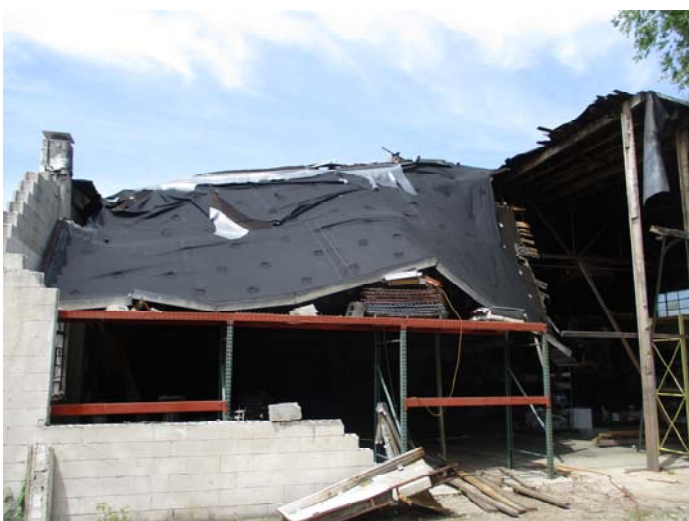
A portion of the roof was observed to have holes and evidence of water damage and vegetation growth was identified inside the building. The building was fully assessed; however, if additional ACM is discovered during demolition activities, Apex recommends that work activities stop until the suspect building materials may be sampled and analyzed.

Photo 11 – Roof felt & rubber membrane on back warehouse roof

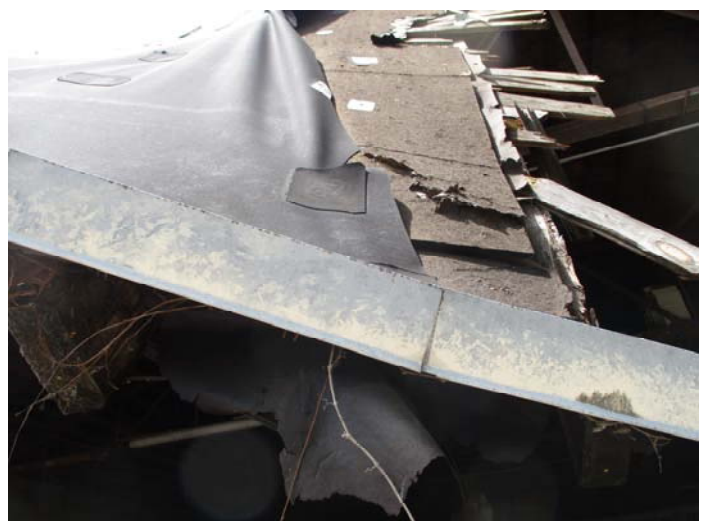
Photo 12 – Roof felt & rubber membrane on back warehouse roof

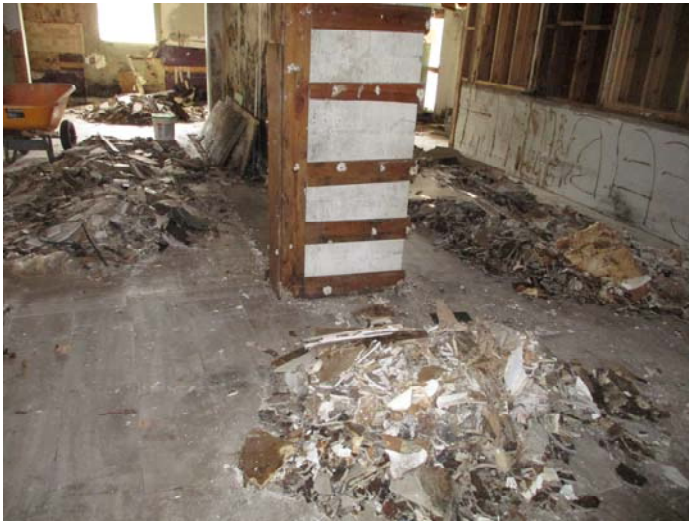
Photo 13 – Drywall with joint compound in debris piles

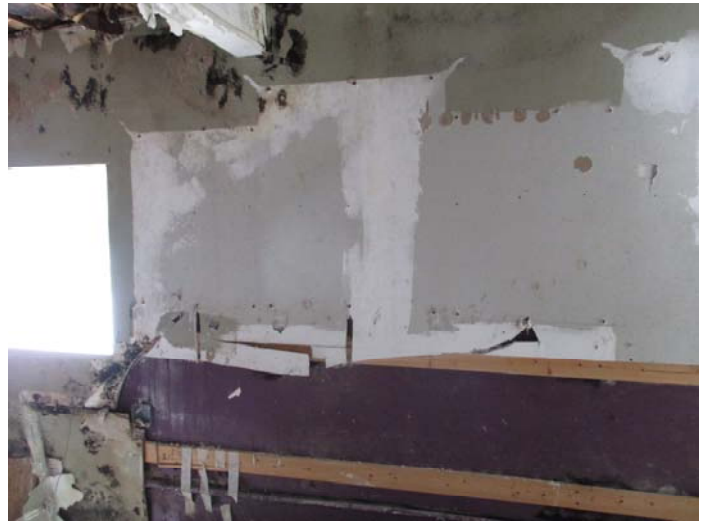
Photo 14 – Drywall with joint compound

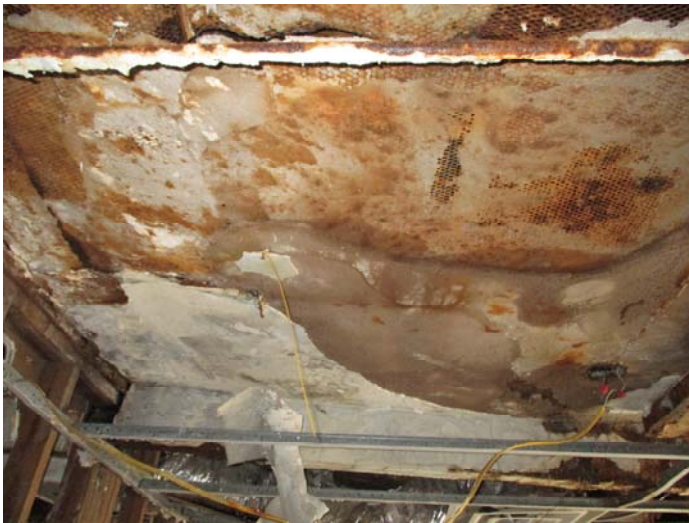
Photo 15 – Plaster with finish ceilings

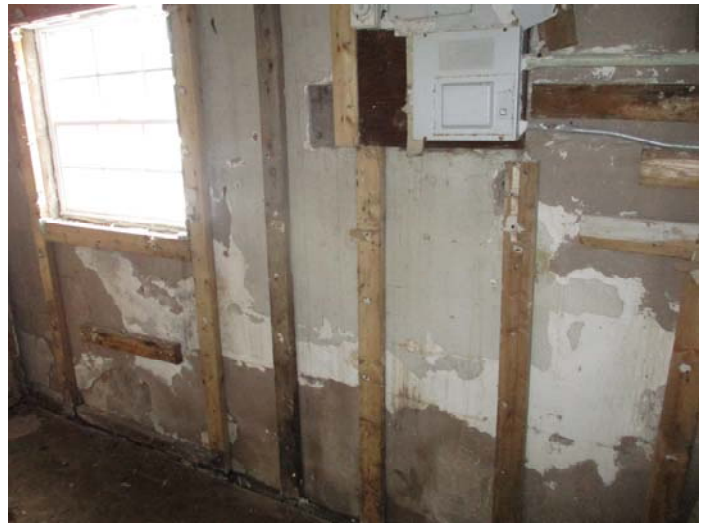
Photo 16 – Plaster with finish walls

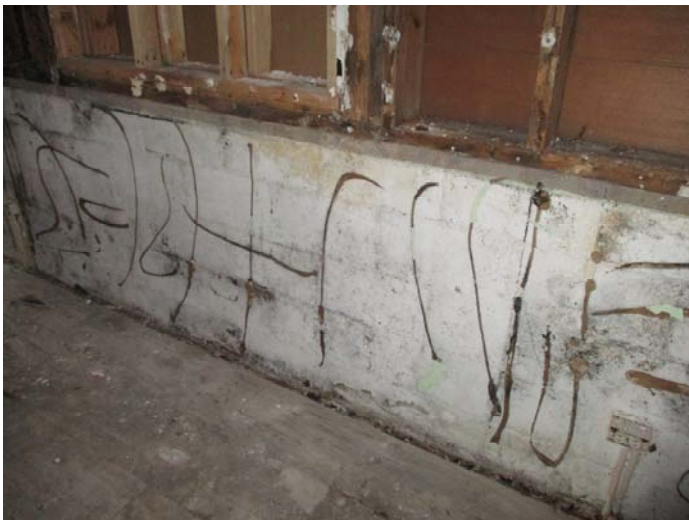
Photo 17 – Wall panel adhesive in the front area

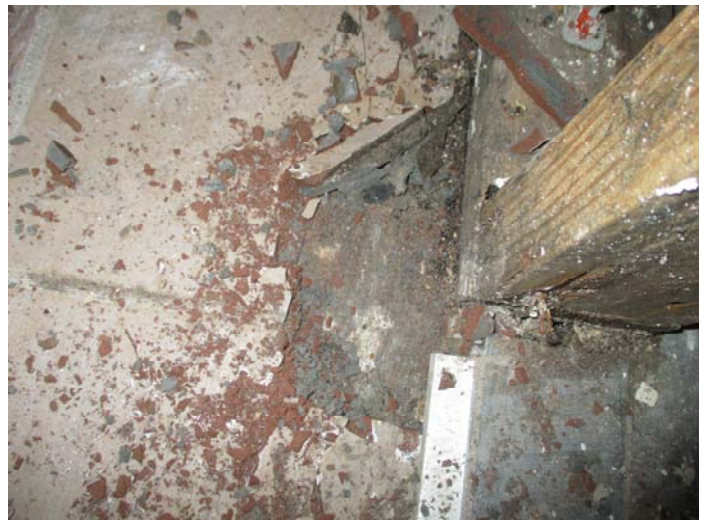
Photo 18 – Gray leveling compound in the front area

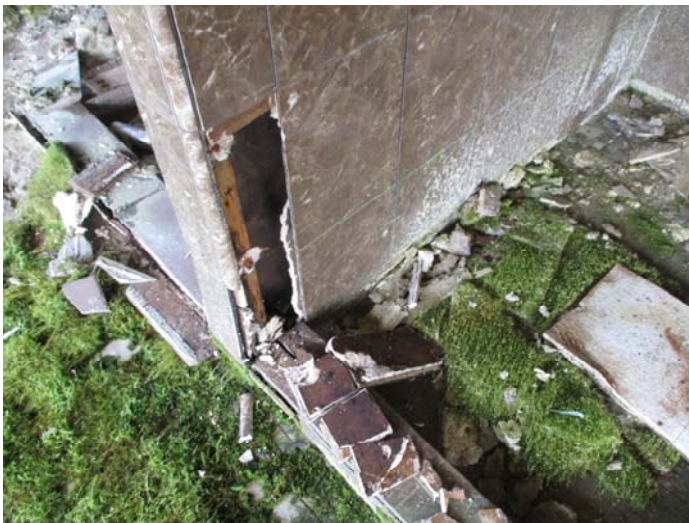
Photo 19 – Display tile adhesive in the front display area

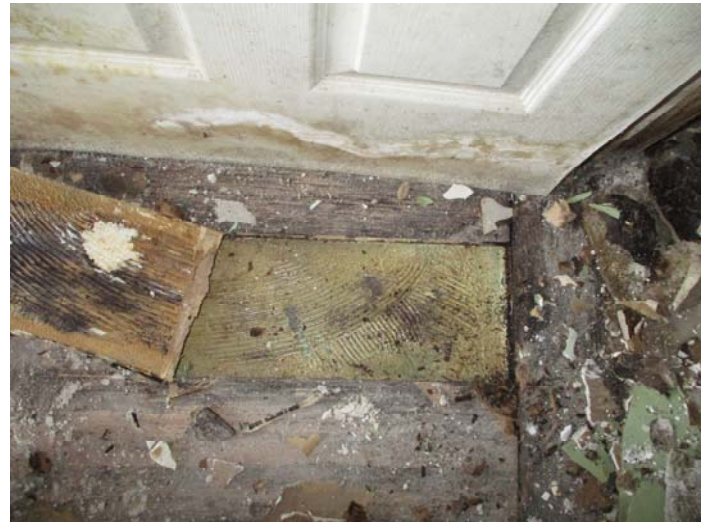
Photo 20 – Adhesive under wooden floors in the front area - left side

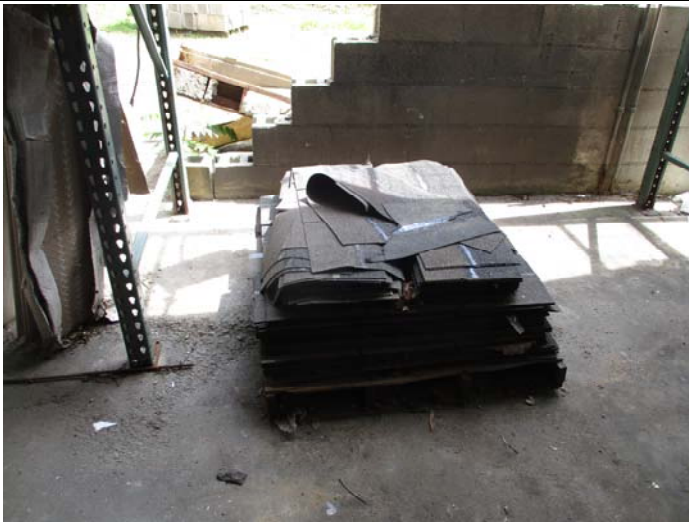
Photo 21 – Roof shingles on a pallet in the back warehouse

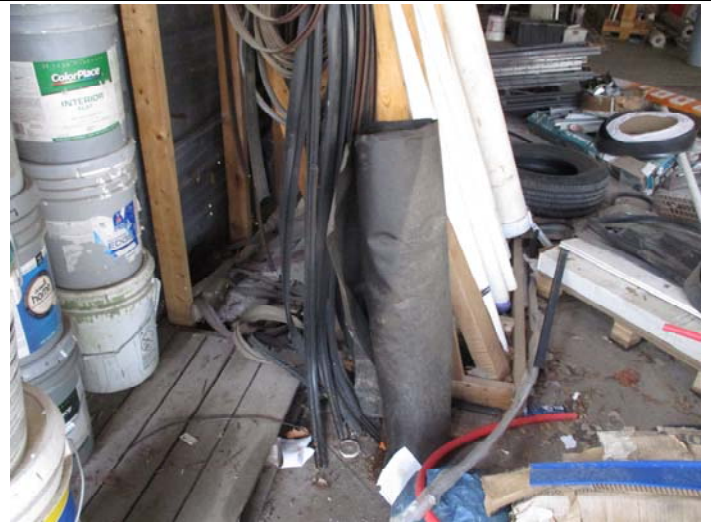
Photo 22 – Roofing felt in a roll in the back warehouse area

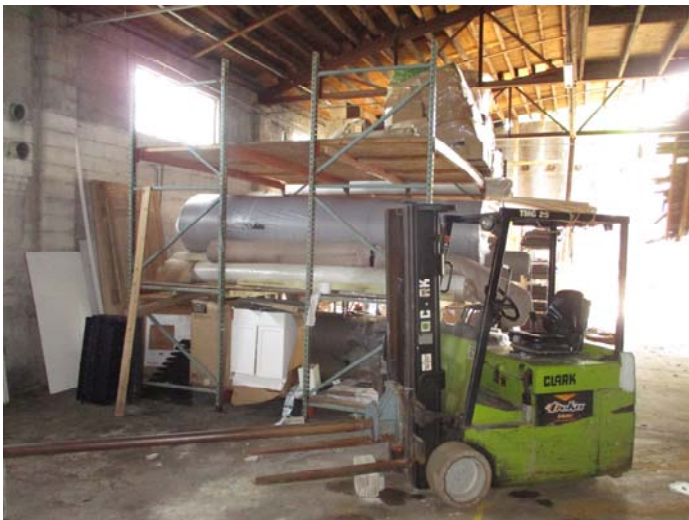
Photo 23 – Typical view of the back warehouse area

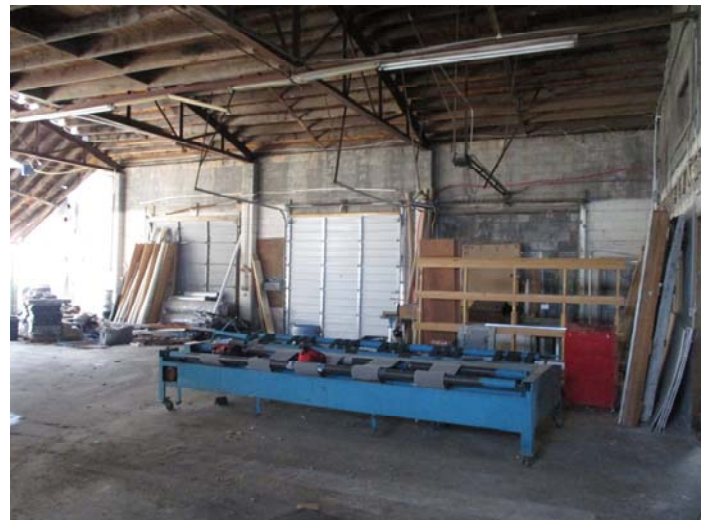
Photo 24 – Typical view of the back warehouse area
