## **Asbestos & Lead Based Paint Assessment**

City of Spartanburg  
706 West Main Street, Building 2  
Spartanburg, South Carolina 29301

Project Number: 0521-99

June 15, 2021

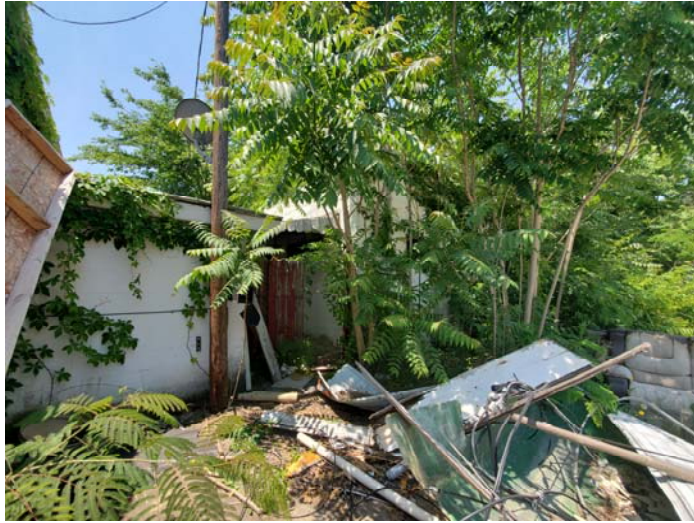
Photo 1 – 706 West Main Street duplex in Spartanburg, South Carolina 29301

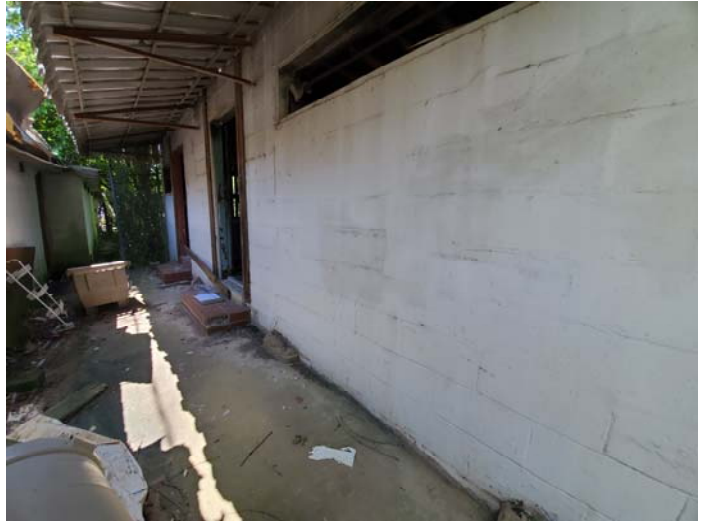
Photo 2 – Alley between commercial building and duplex

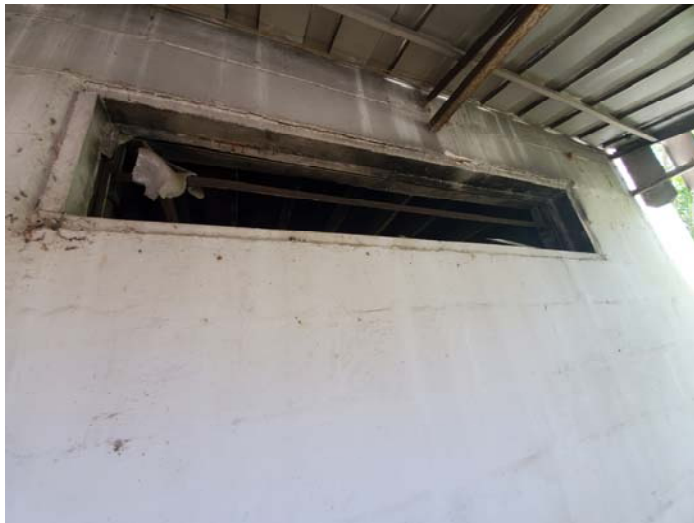
- One exterior metal window with glazing located on the front right side of the second floor.
- Approximately 100 LF of black mastic located on the walls on the first floor.
- Approximately 1,100 SF of roofing material is assumed ACM.
- Approximately 300 SF ceiling texture over drywall, joint compound and tape in back corners of second story is assumed ACM.

Photo 3 – Front metal window with glazing

1. Demolish the residence with ACM in place and dispose of the waste stream as friable Regulated Asbestos Containing Materials (RACM) and delivered to an asbestos approved hazardous waste landfill for disposal.
2. Follow applicable asbestos regulations during renovation or demolition of the structure. You should be aware that stringent requirements are imposed upon anyone renovating or

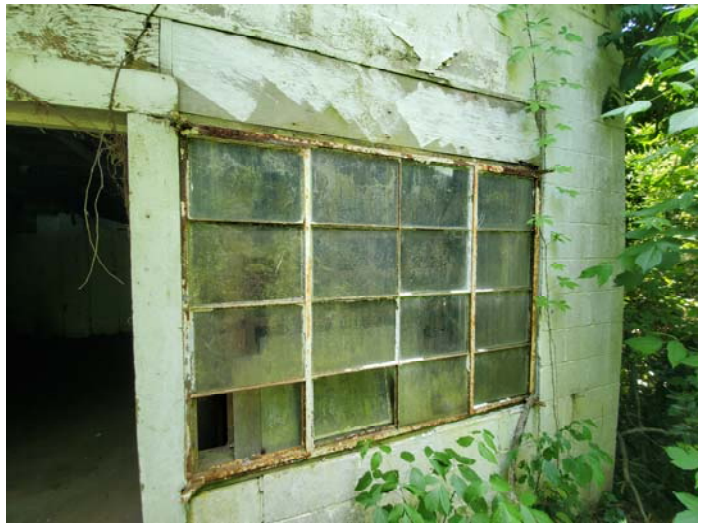
Photo 4 – First floor back metal window with glazing

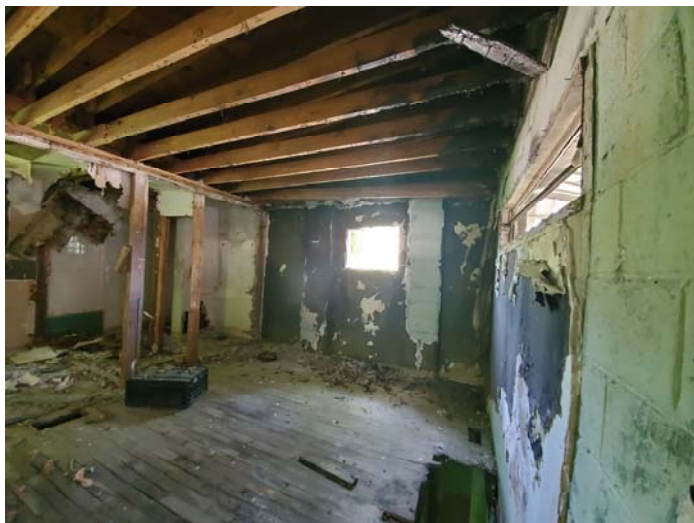
Photo 5 – Plaster with finish over unfinished drywall sporadically located on ceiling and walls

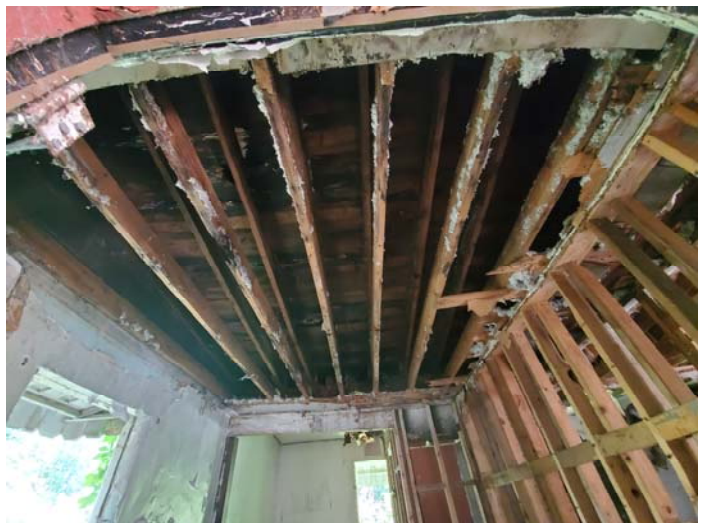
Photo 6 – Unfinished drywall sporadically located on upstairs ceiling and walls

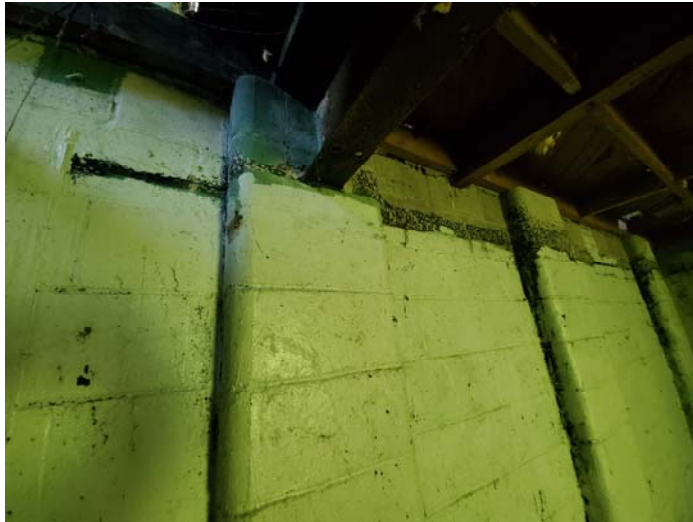
Photo 7 – Black mastic on downstairs walls

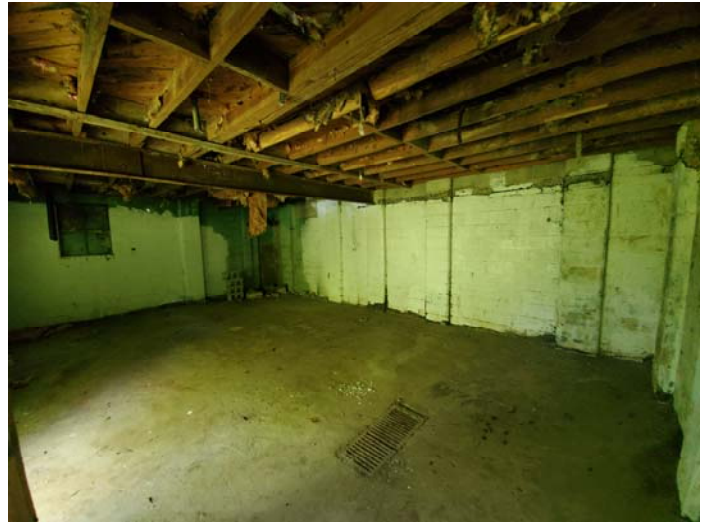
Photo 8 – View of downstairs

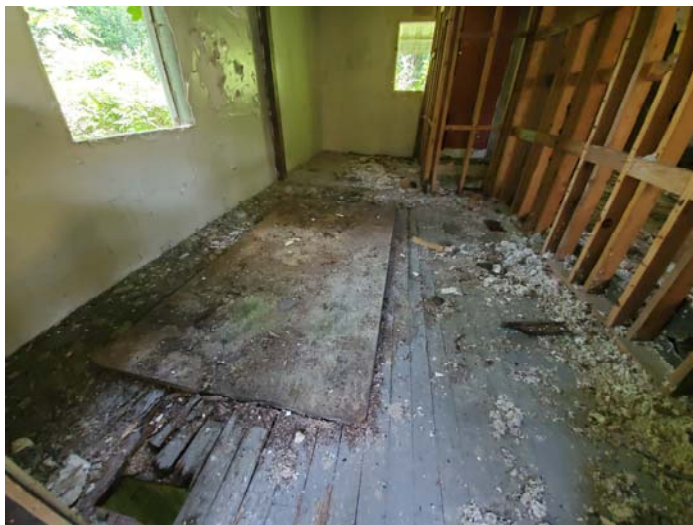
The floor was observed to have holes and evidence of water and fire damage throughout the interior. The exterior walls had vegetation growth and various building debris surrounding the building. A limited assessment was conducted due to safety concerns. Sampling was performed in areas Apex could safely access suspect materials through exterior openings and in debris piles. Apex recommends that the residence be demolished in place and materials be treated and disposed of as friable, regulated ACM.

Photo 9 – Rotten wood on left side of duplex creates unstable floor

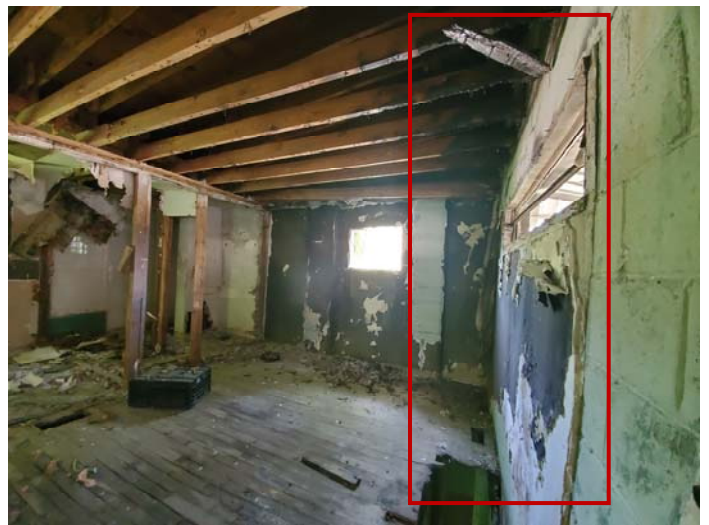
Photo 10 – Evidence of fire inside duplex

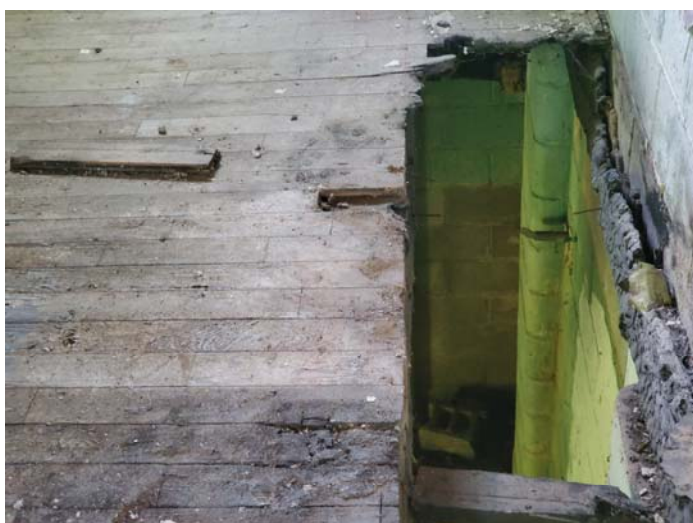
Photo 11 – Unstable floor resulting from previous fire

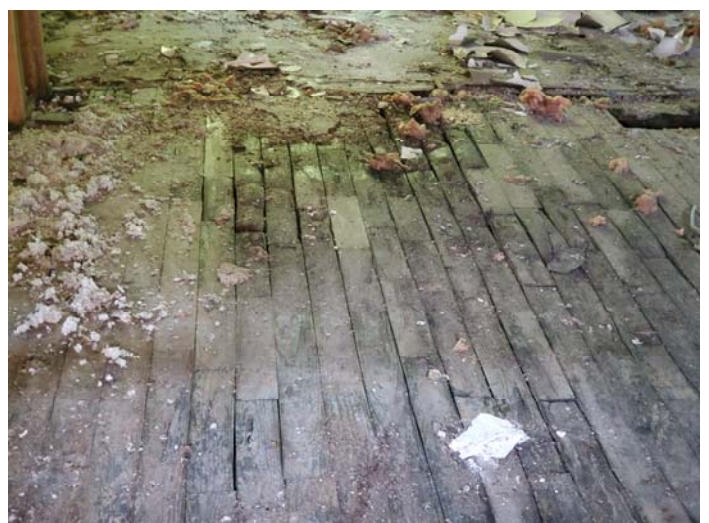
Photo 12 – Rotten wood on right side of duplex creates unstable floor
