Asbestos & Lead Based Paint Assessment

City of Spartanburg
706 West Main Street, Building 1
Spartanburg, South Carolina 29301

Project Number: 0521-99

June 15, 2021

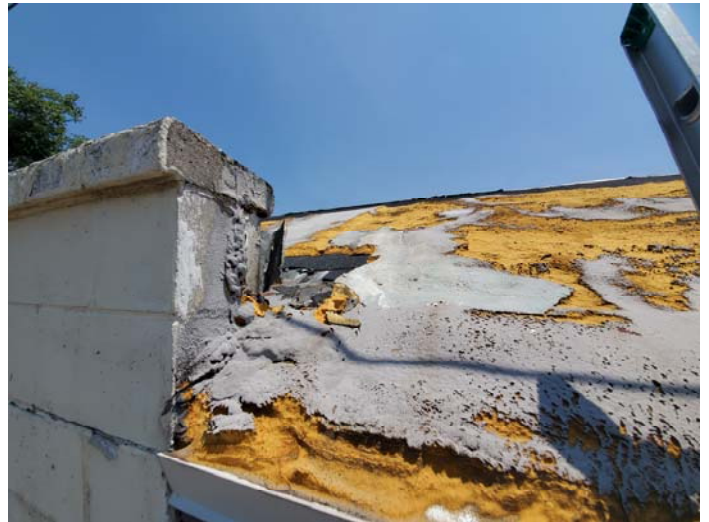
- Approximately 2,400 SF of silver sealant with tar on the metal front roof under two layers of shingles with felt paper.
- Approximately 150 SF of mesh paper with tar located on the parapet wall.

Photo 2 – Foam with grey sealant on top layer and mesh paper with tar on parapet wall.

1. Abate the asbestos containing materials in the structure prior to renovation or demolition.
2. Follow applicable asbestos regulations during renovation or demolition of the structure. You should be aware that stringent requirements are imposed upon anyone renovating or demolishing a structure in which ACM will be disturbed. This work must be performed in accordance with OSHA asbestos regulations, 29 CFR 1910 & 1926, and NESHAP asbestos regulations 40 CFR 61, subpart M. South Carolina regulations require the accreditation of personnel who work in the asbestos field and notification and permitting fees for asbestos removal projects. There is a 10 working day notification period required prior to abatement of asbestos in a facility. Failure to take proper precautions and actions to protect human health and the environment can result in penalties, danger to personnel, and construction delays.

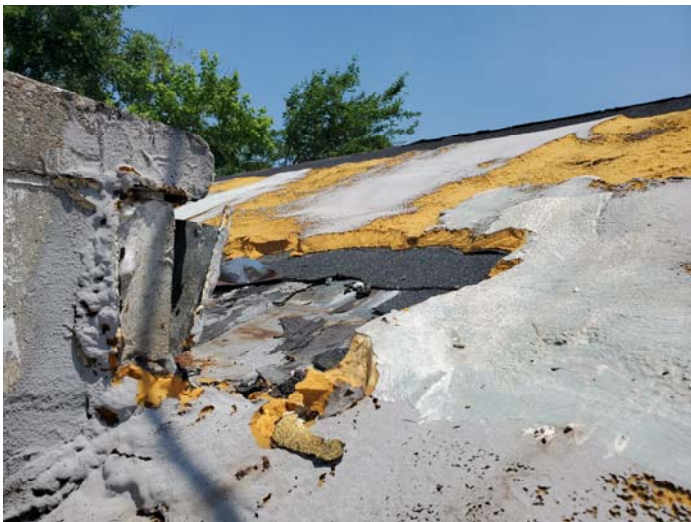
Photo 3 – Front roof has a metal roof with silver sealant and tar under two layers of shingles.

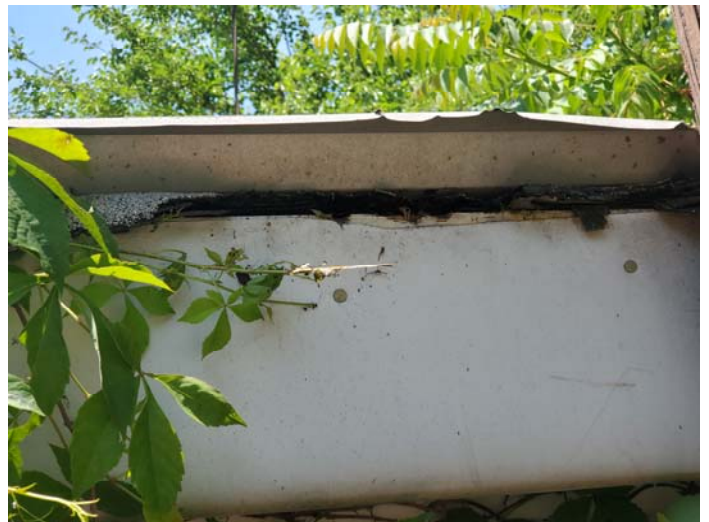
Photo 4 – Flat roof with five layers of shingles and one layer of felt paper located at back of building

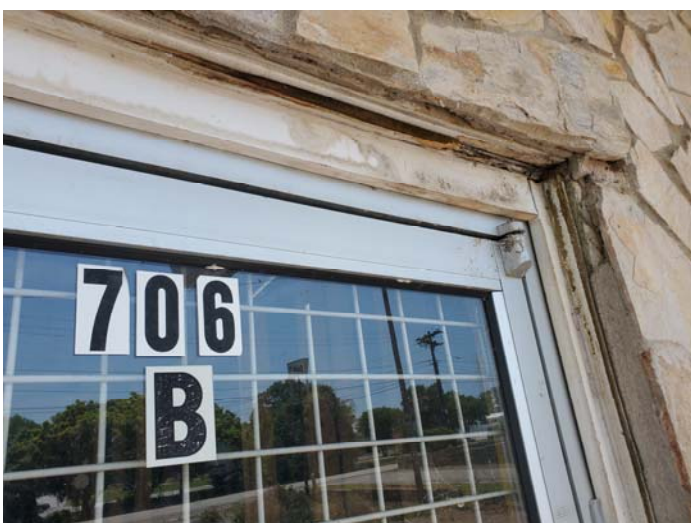
Photo 5 – 706B door frame with white caulk

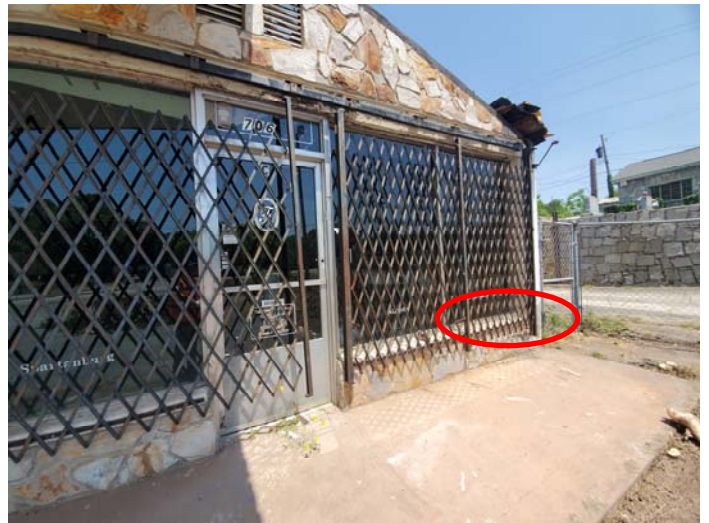
Photo 6 – 706C metal window with white caulk

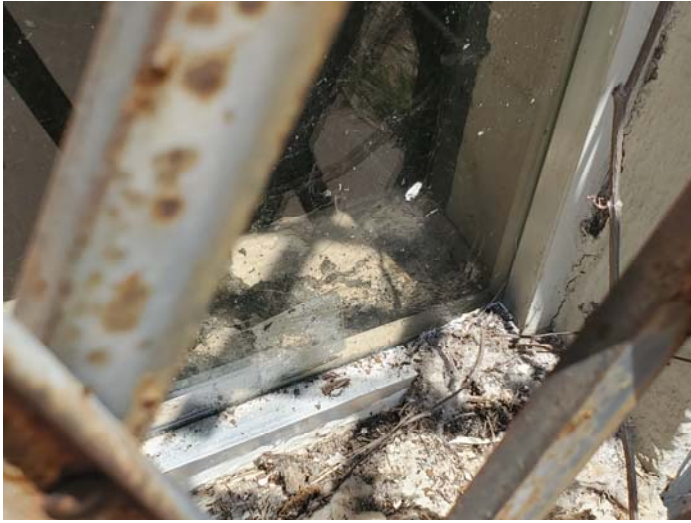
Photo 7 – Close up of 706C metal window with white caulk

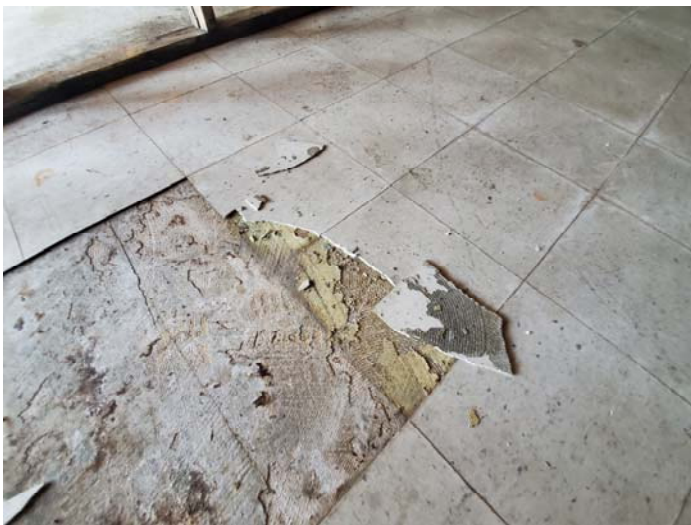
Photo 9 – 12"x12" white with gray/blue specks floor tile with gray and tan mastic located in section A/B

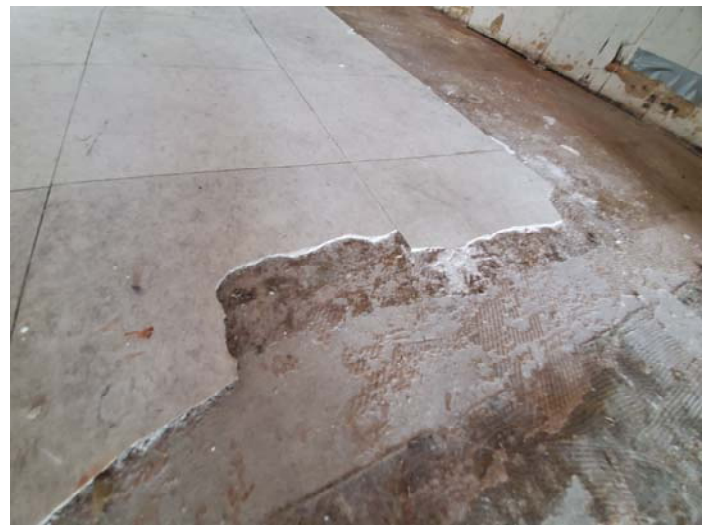
Photo 10 – 12"x12" white with gray/blue specks floor tile with tan adhesive

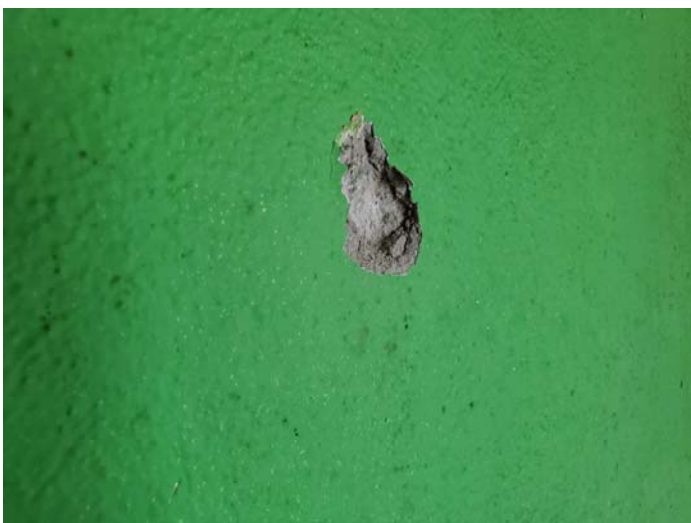
Photo 11 – Skim coat over CMU block wall located in section A/B.

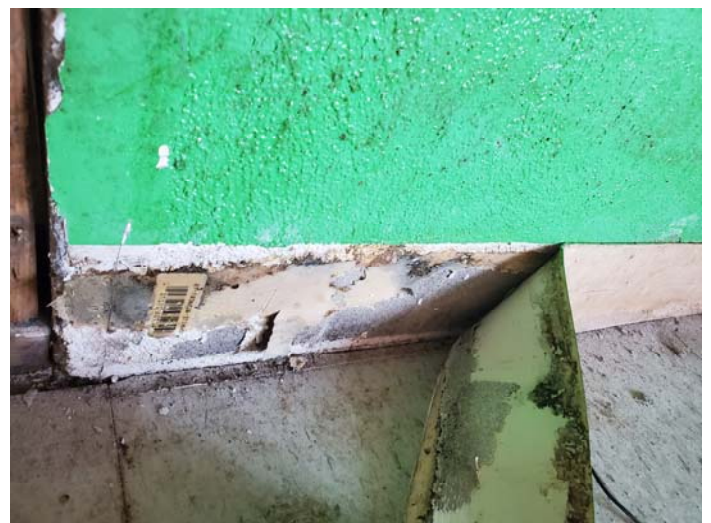
Photo 12 – Tan mastic under cove base located in section A/B

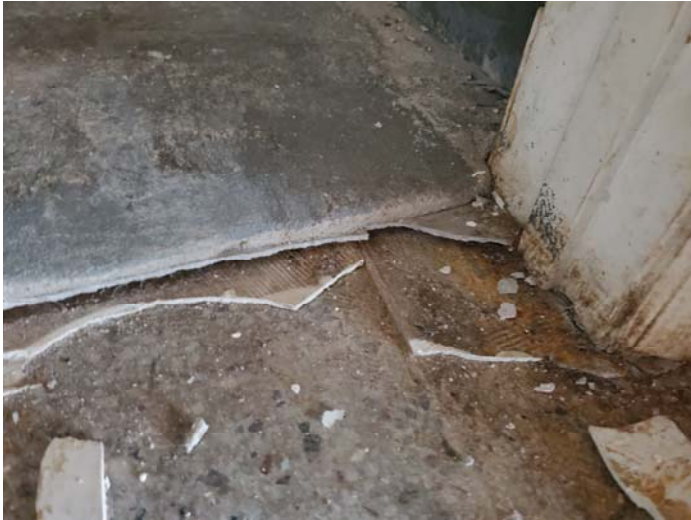
Photo 13 – Grey 12"x12" floor tile over 12"x12" tan floor tile with mastic under concrete in section A/B bathroom

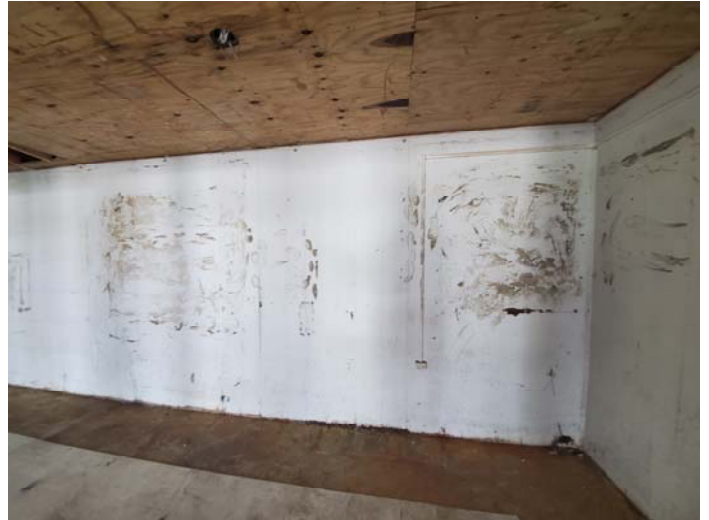
Photo 14 – Tan mastic over paneling on back wall in section A/B

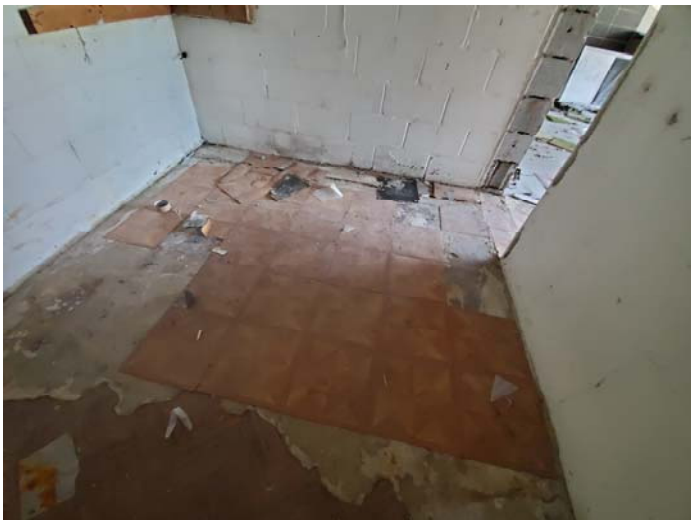
Photo 15 – 12"x12" wood pattern self-stick floor tile with adhesive in section C hallway

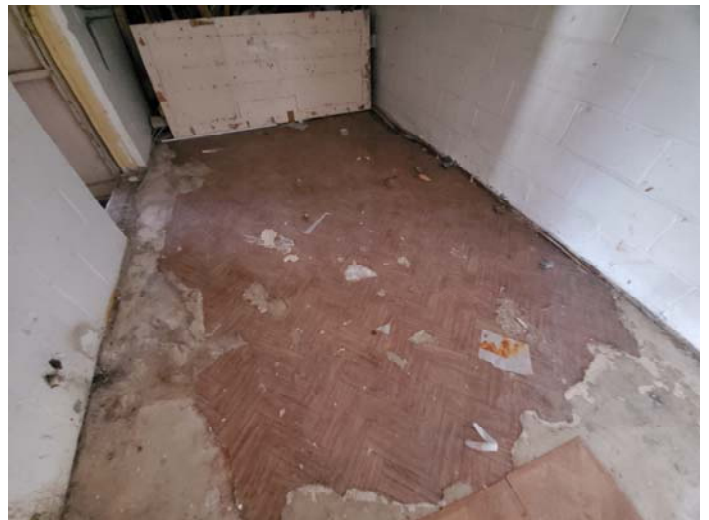
Photo 16 – Wood pattern roll vinyl floor located in section C hallway

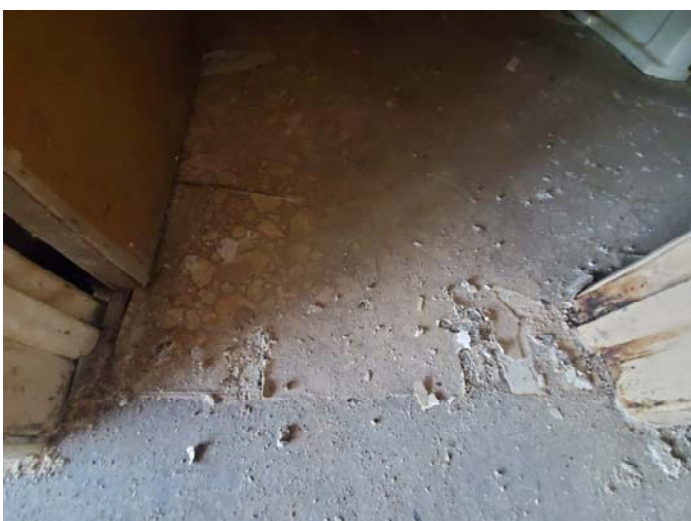
Photo 17 – Tan rock pattern roll vinyl flooring located in section C bathroom

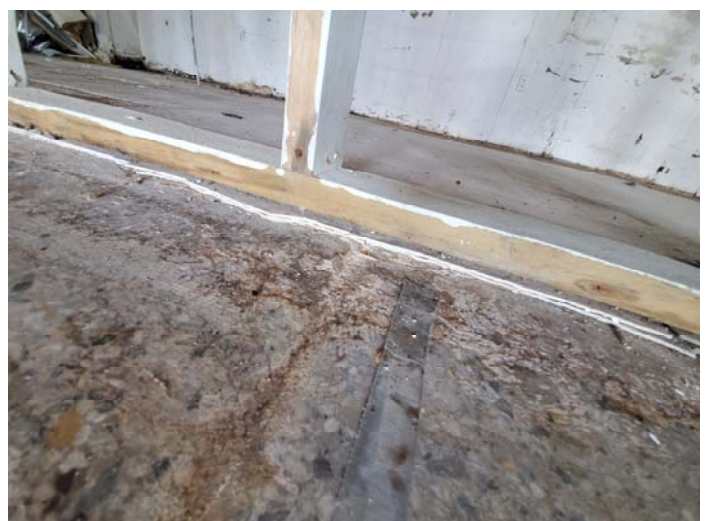
Photo 18 – Second layer of white floor tile under wood framing throughout located in section A/B

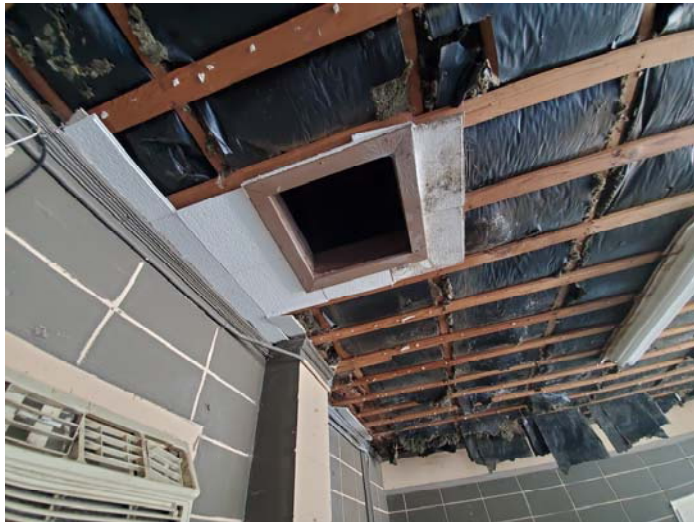
Photo 19 – 12"x12" white ceiling tiles without mastic located in section C

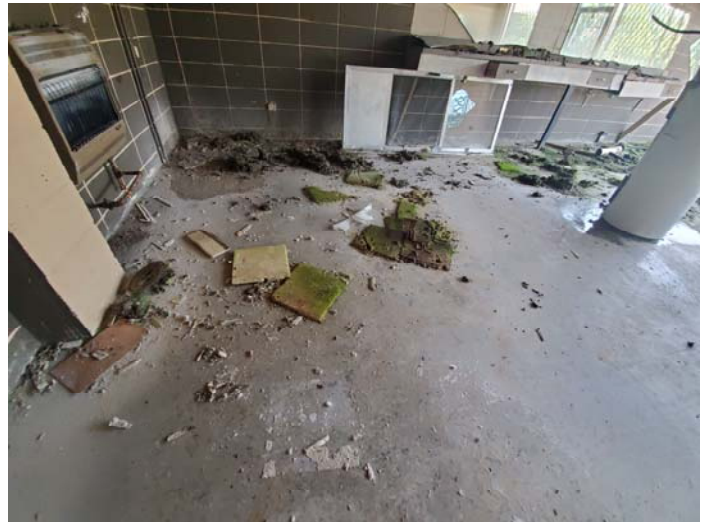
Photo 20 – 12"x12" ceiling tiles located on floor in section C

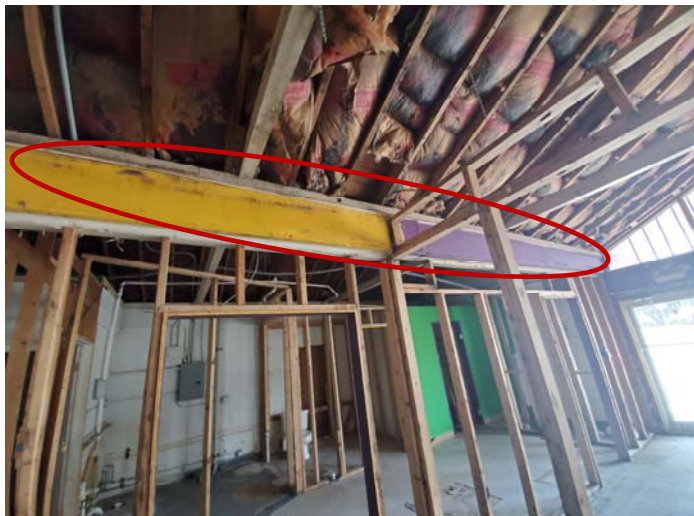
Photo 21 – Joint compound skim coat over ceiling beams located in section A/B

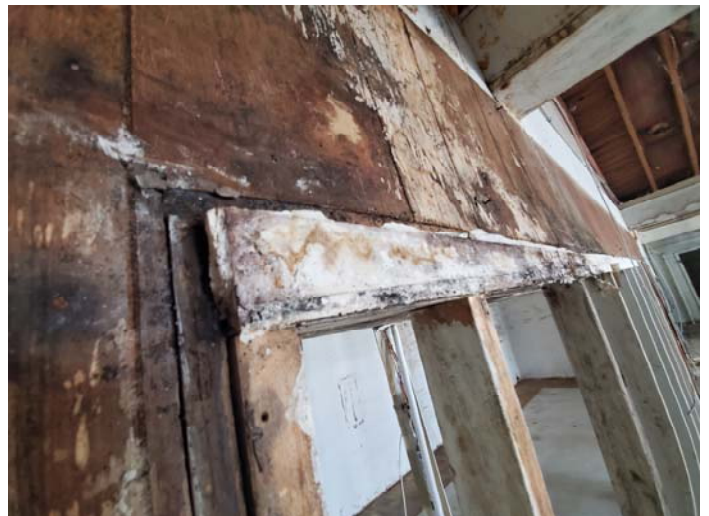
Photo 22 – Drywall, joint compound and tape on walls sporadic in section A/B

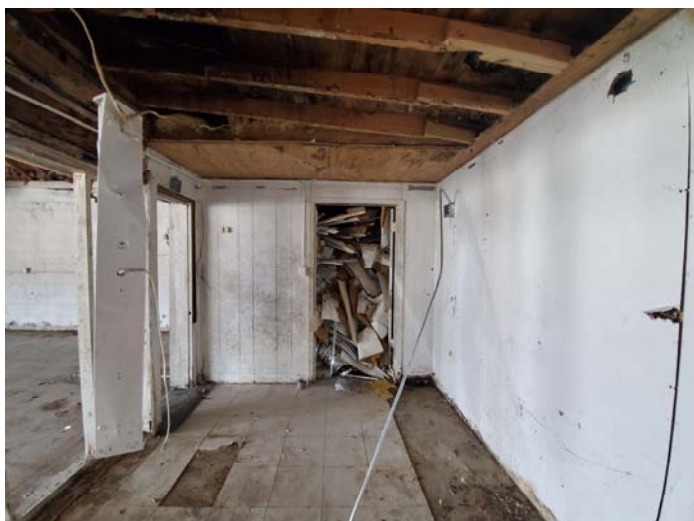
Building debris was observed shoved into a back hallway and closet. The building was fully assessed; however, if additional ACM is discovered during demolition activities, Apex recommends that work activities stop until the suspect building materials may be sampled and analyzed.

Photo 23 – Various types of building debris placed in section A/B closet.

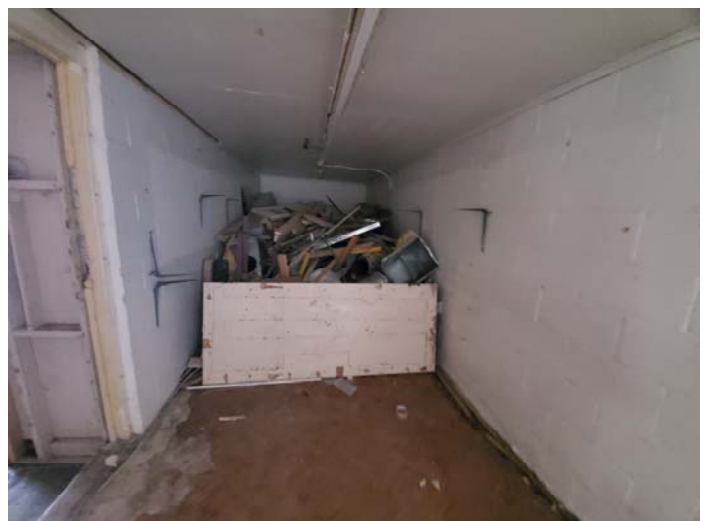
Photo 24 – Various types of building debris stacked in back hallway of section C
