**SB Ed Shouse Road
Over CSX Railway
Loc. 47-5643-0.44L
ID No. 470E99004**

BRIDGE MAINTENANCE RECOMMENDATIONS

BRIDGE INSPECTION REPORT

INSPECTION TEAM'S SUMMARY
BRIDGE NO. 47-5643-00.44L

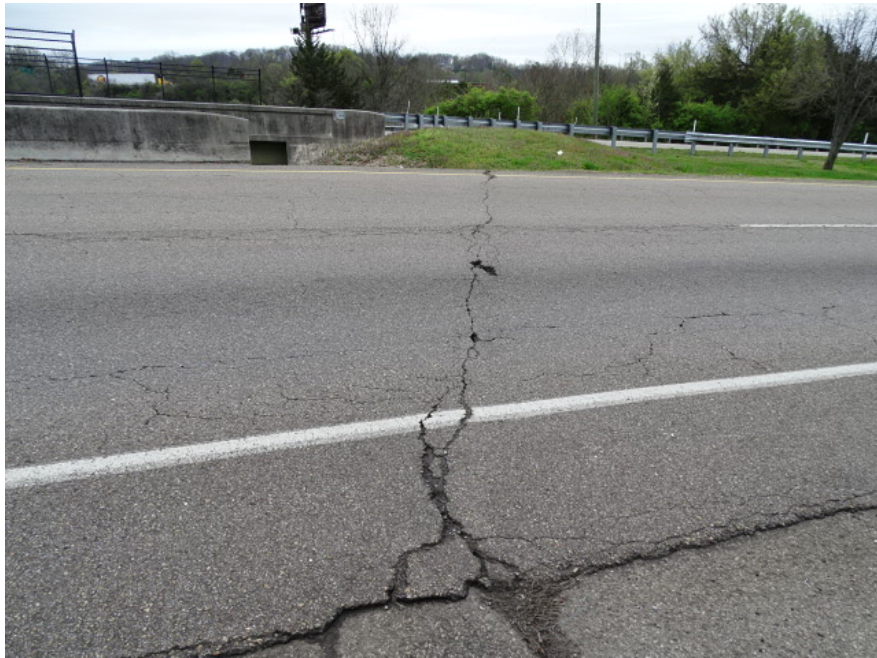
PAVEMENT RAVELING AT APPROACH 1

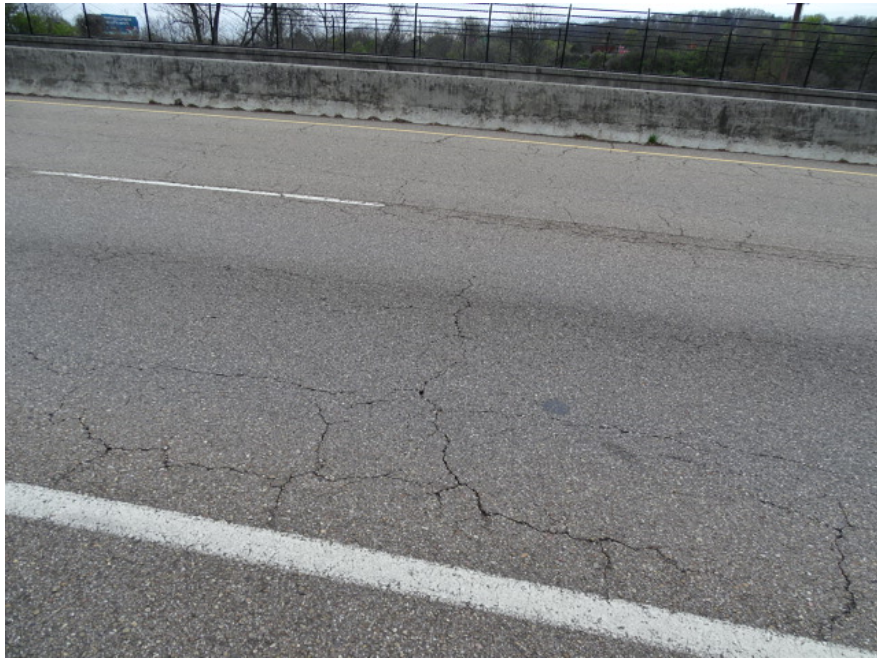
PAVEMENT RAVELING TOP DECK (TYP.)

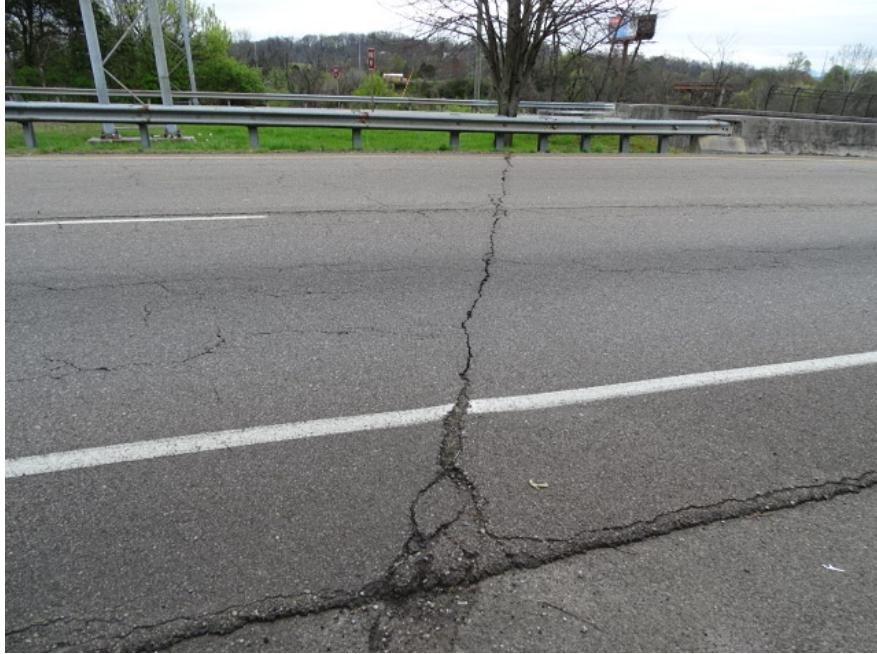
PAVEMENT RAVELING AT APPROACH 2

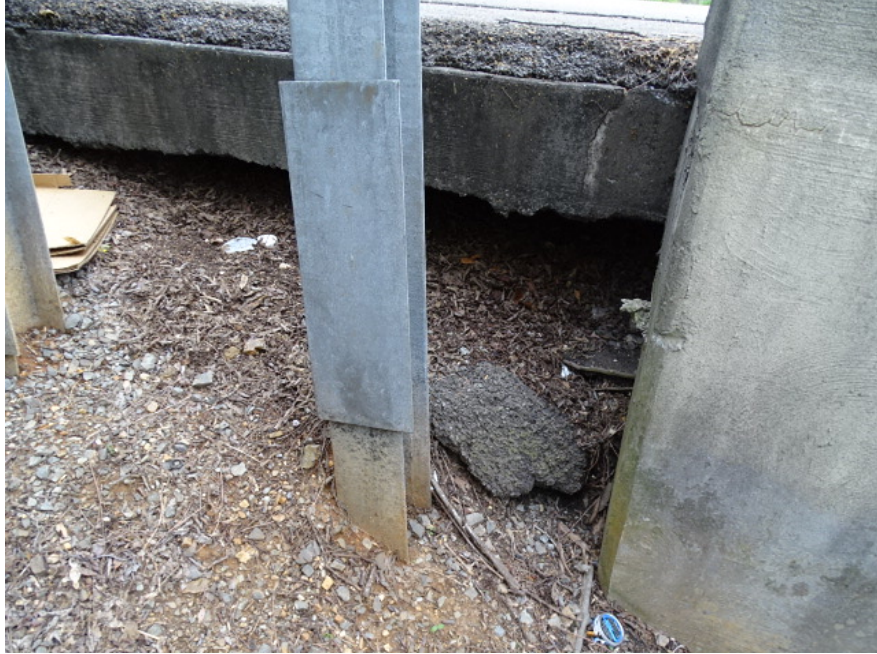
VOID UNDER APPROACH 2

The subject bridge was inspected on the above date and found to be in generally poor condition. Roadway alignment is good. Continuous asphalt overlay across the approaches and the top of the bridge is in good condition. There is a large area of erosion under the approach slab at the No. 2 end. Bridgerails are the only traffic safety feature that meets code. Paddleboard signs are in place.

No.	RECOMMENDATIONS	REPAIR DATE	REPAIRED BY
1.	FILL VOIDS UNDER APPROACH SLAB 2 (LEFT)

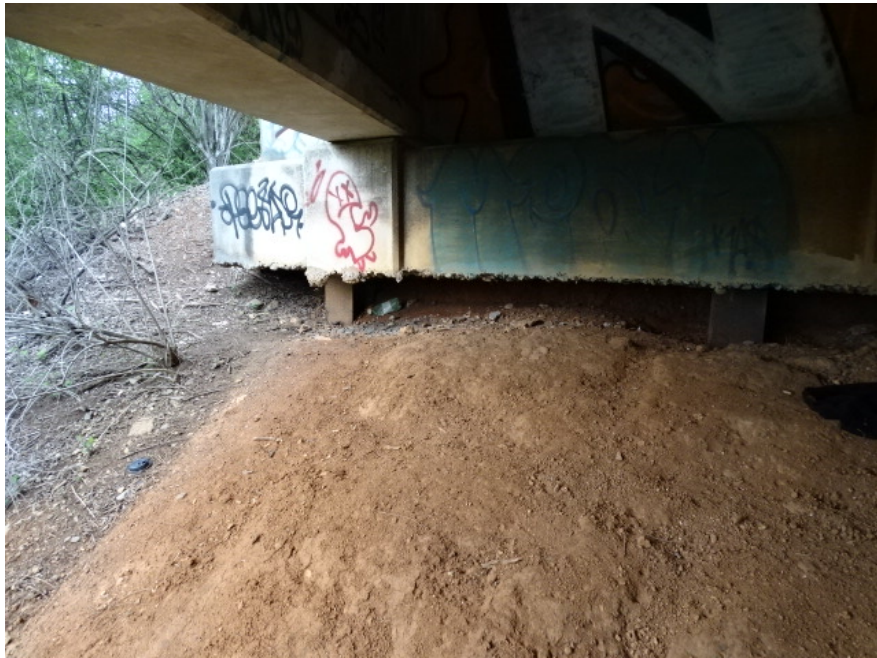
ERROSION WITH EXPOSED PILINGS - ABUTMENT 2

The bottom of the deck, as well as the girders and diaphragms, is in good condition. Abutment caps, backwalls and wings are in good condition. The embankment below both abutments have settled, exposing steel pilings with corrosion and pitting. Bent caps and columns are in good condition.

SUGGESTED ROUTINE MAINTENANCE AND COMMENTS
REPAIR EMBANKMENTS @ BOTH ABUTMENTS
CUT AND REMOVE VEGETATION FROM AROUND & UNDER BRIDGE
END TERMINALS ARE SUBSTANDARD
GUARDRAIL TRANSITIONS ARE SUBSTANDARD
GUARDRAILS ARE SUBSTANDARD

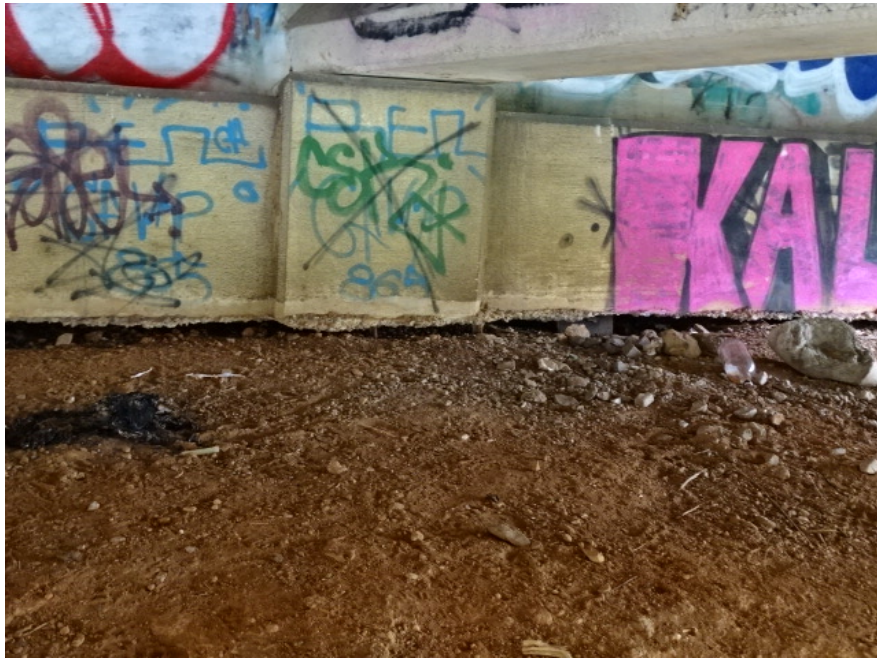
ERROSION WITH EXPOSED PILINGS - ABUTMENT 1

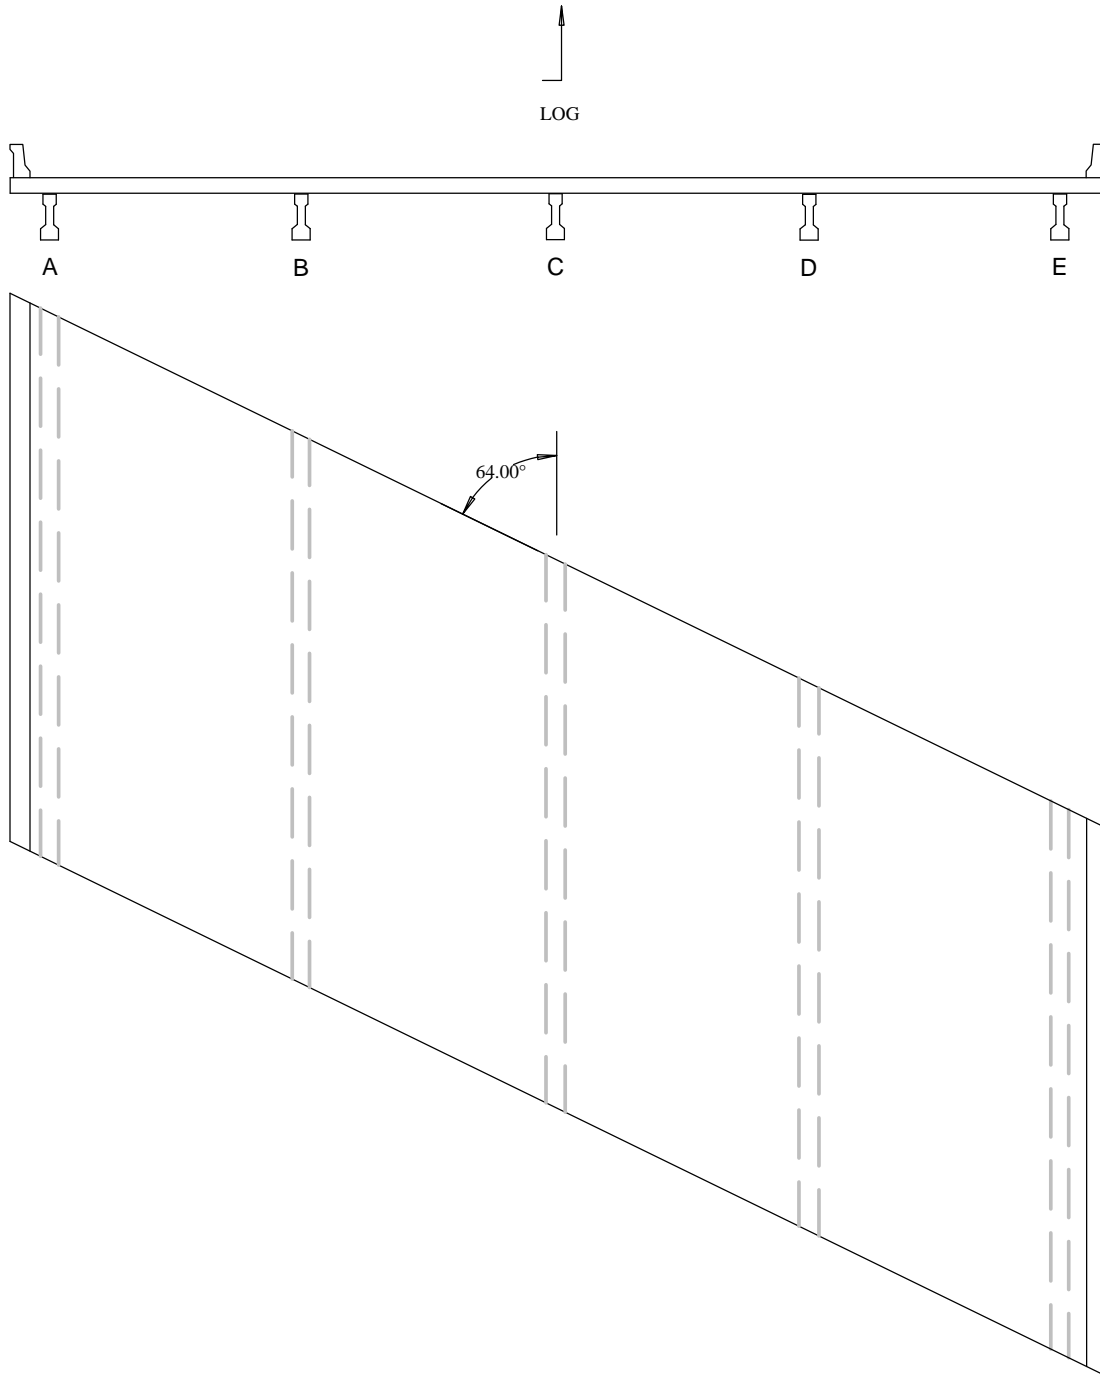
TOP DECK SPAN 1-3

WEARING SURFACE	G	CRACKS IN OVERLAY
		RAVELING AT APPROACH 1
BRIDGE RAIL	G

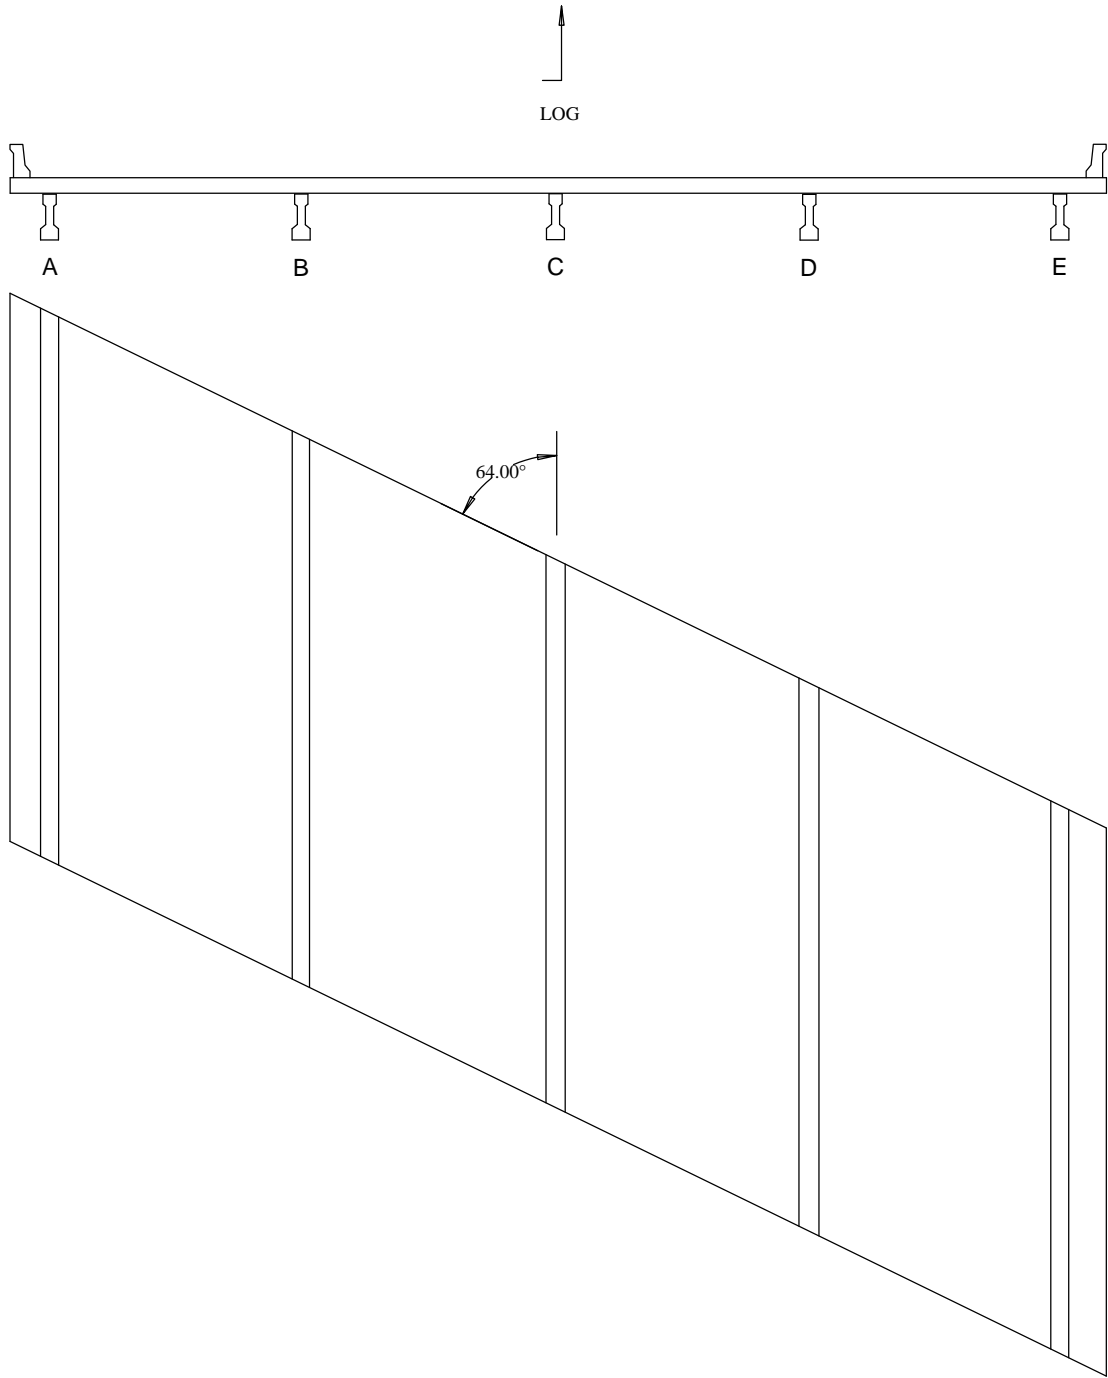
BOTTOM DECK SPAN 1-3

BOTTOM DECK	G	
BEAMS	G	
DIAPHRAGMS	G

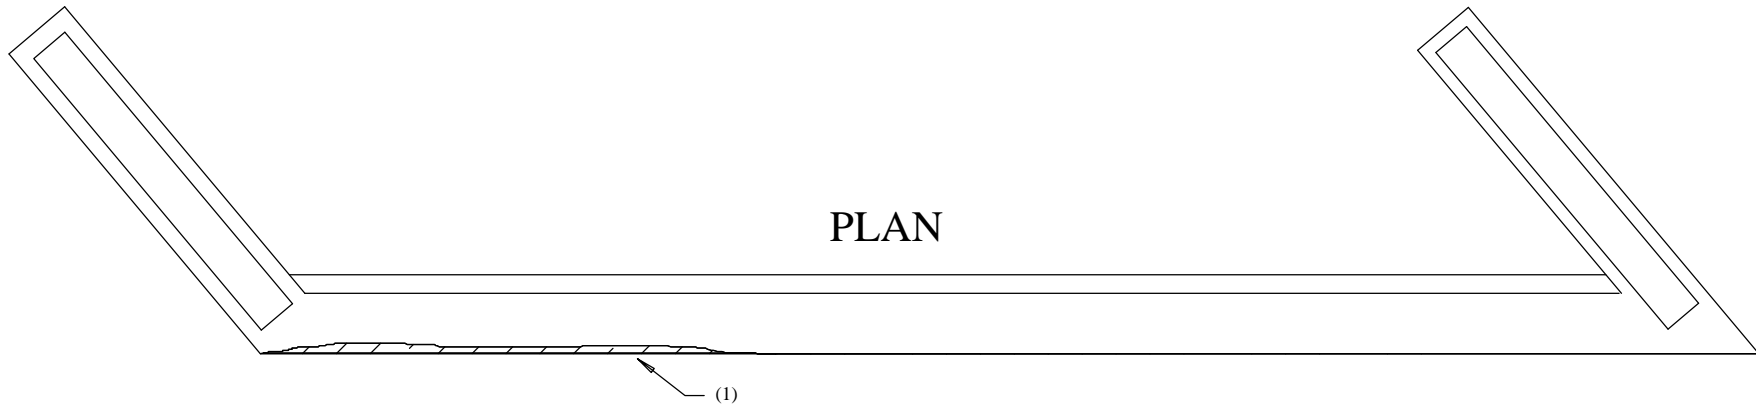
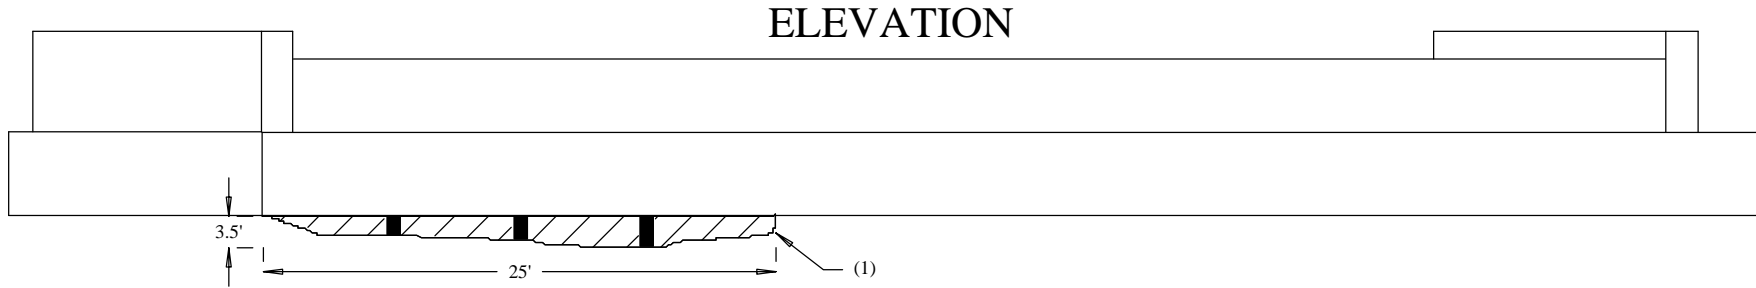
ABUTMENT 1 & 2

CAP	G	
BACKWALL	G	
WINGS	G	
SLOPE/EMBANKMENT	F	(1) SETTLEMENT W/EXPOSED PILINGS ALL ACROSS ABUTMENT 1 & ABUTMENT 2 LI UP TO 6' BACK UNDER

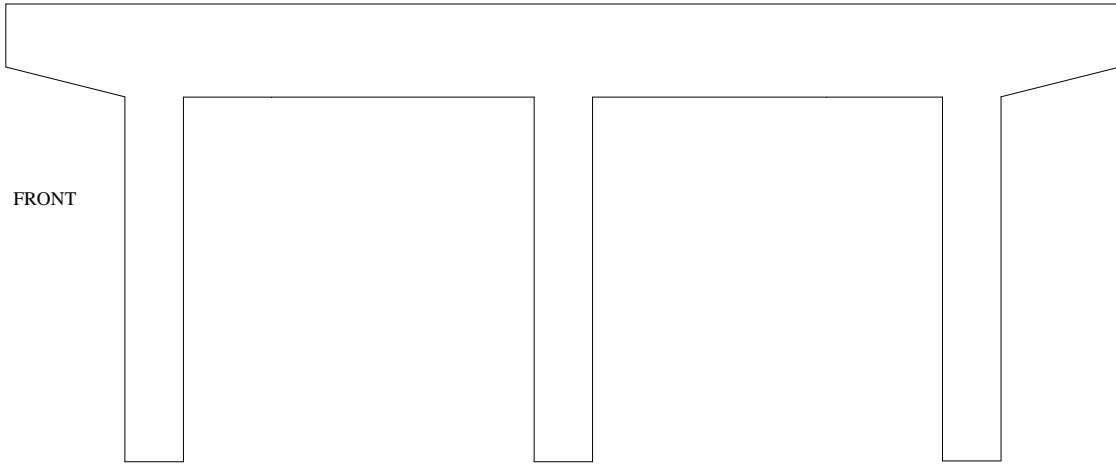
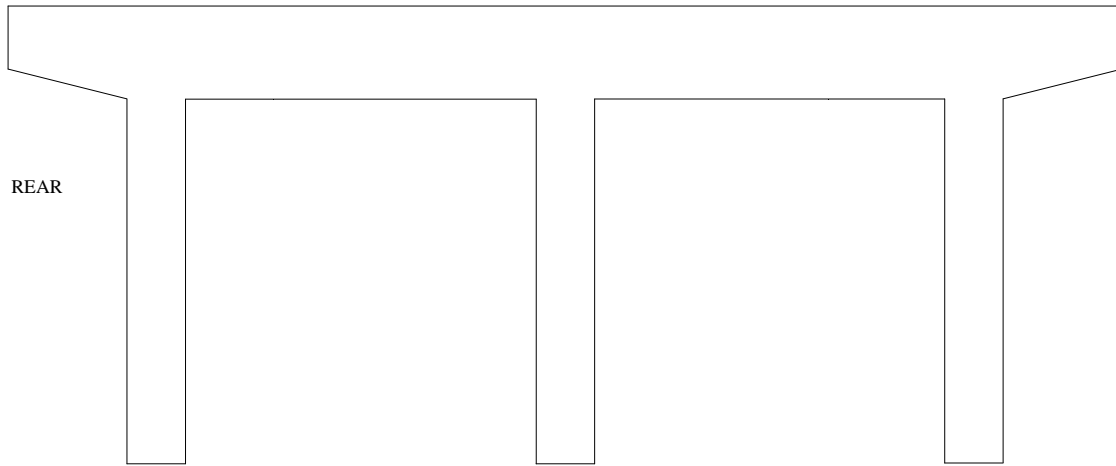
BENT 1&2

CAP	G	
RISERS	G	
COLUMNS	G
