## **Pre-Demolition Limited Regulated Hazardous Materials Survey Report**

**Commercial Office with Attached Bank Branch  
3108 Columbia Pike  
Arlington, VA 22206**

**June 6, 2022**

**JSK Project Number JSK-2022-28**

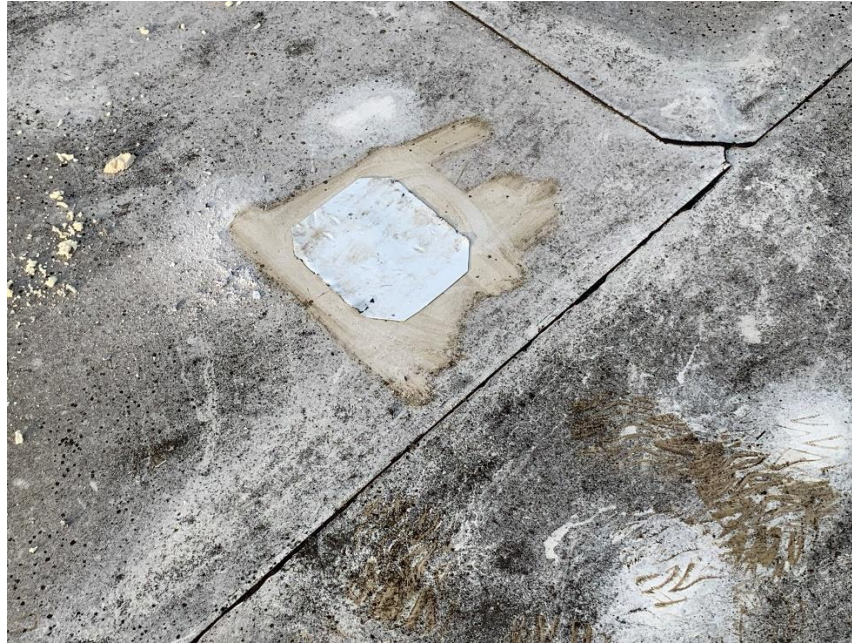
Homogeneous Material No. 1 – Non-ACM Built up Roof Field located on the roof of the Subject Property

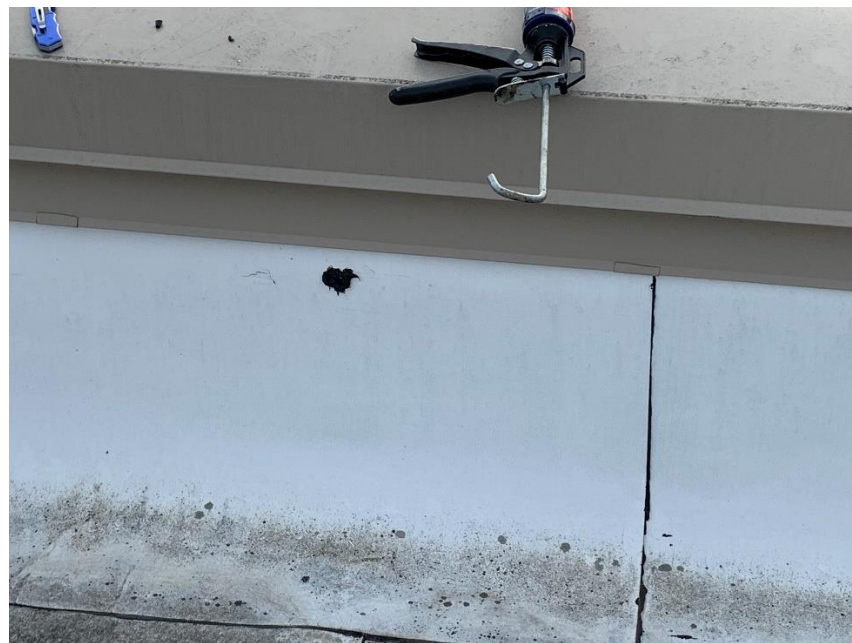
Homogeneous Material No. 2 – Non-ACM White/Black Curbing/Flashing located on the roof of the Subject Property

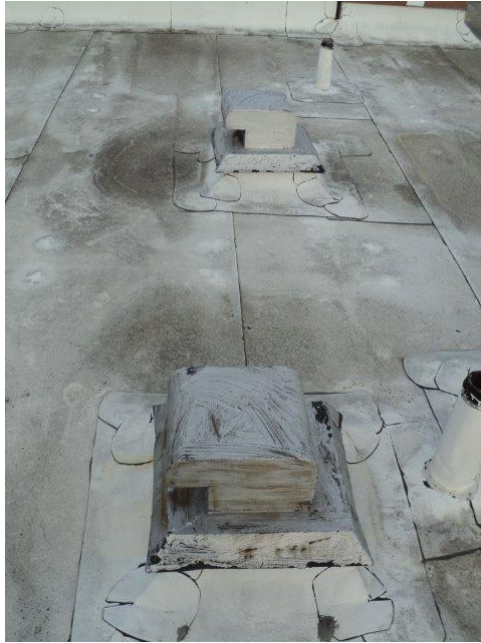
**Homogeneous Material No. 3 – ACM Silver Roof Vent Coating located on the roof of the Subject Property**

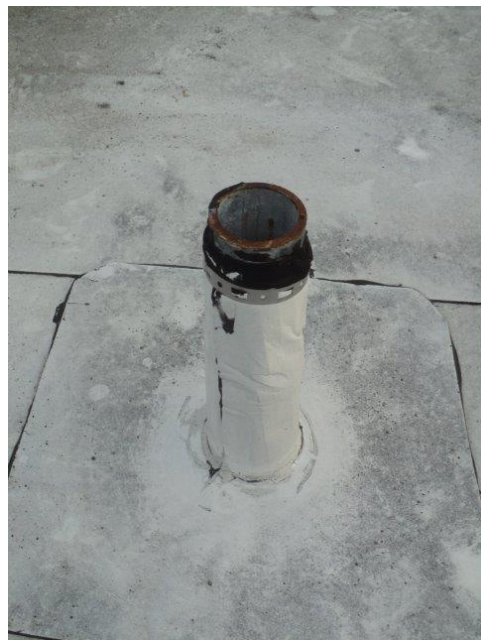
**Homogeneous Material No. 4 – Non-ACM Black Vent Pipe Mastic located in the roof of the Subject Property**

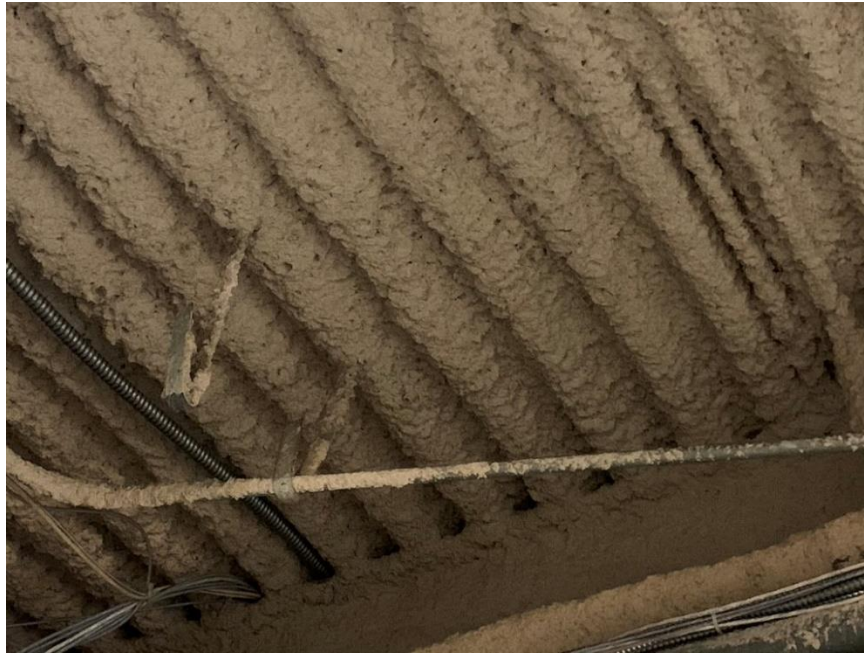
Homogeneous Material No. 5 – Non-ACM Gray Spray-on Fire Proofing located in the Building Basement Corridor, Electrical Room and Boiler Room of the Subject Property

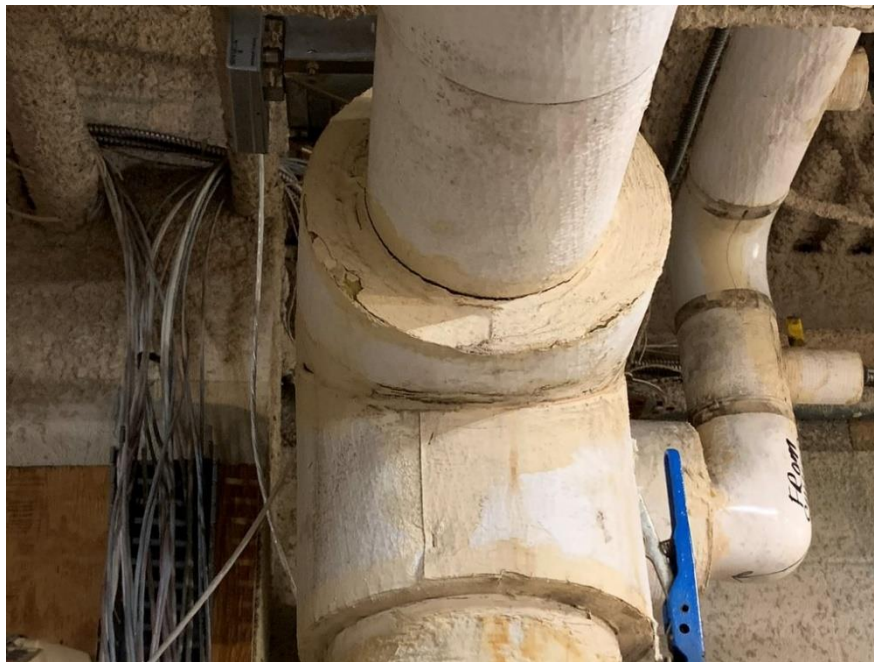
Homogeneous Material No. 6 – Non-ACM Cream Pipe Insulation Mastic located in the Building Basement, Corridor and Boiler Room of the Subject Property

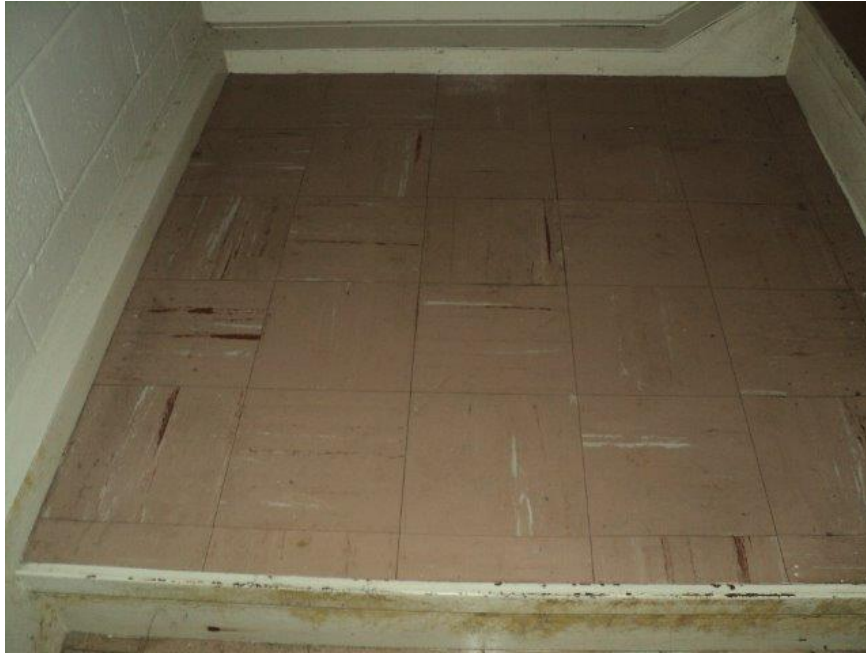
**Homogeneous Material No. 7 –ACM 9” by 9” brown vinyl floor tile with black mastic located in the West Side of the Building Stairwell of the Subject Property**

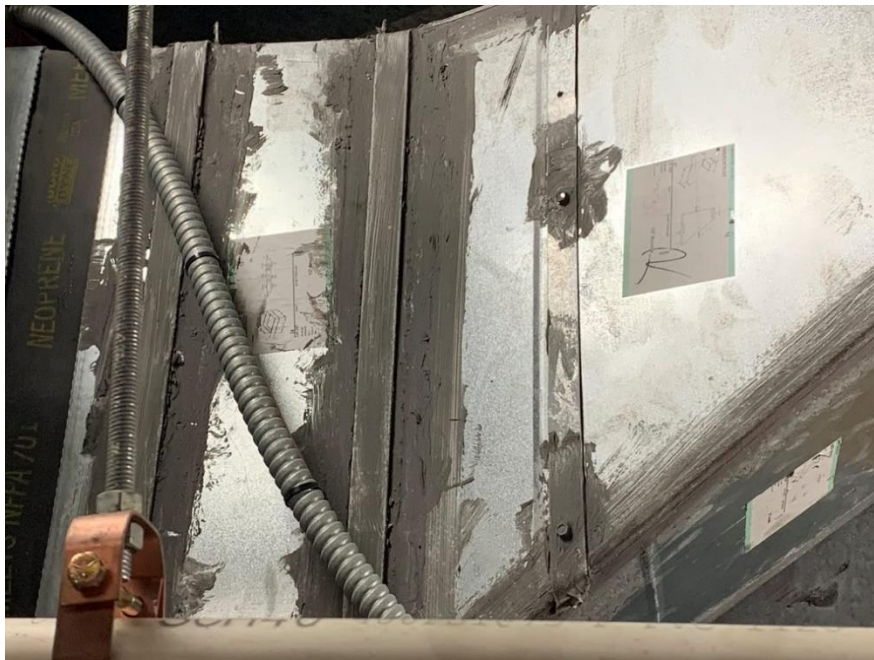
**Homogeneous Material No. 8 – Non-ACM Gray HVAC Duct Seam Mastic located in the Building Basement, HVAC Room Number 1 and 2 of the Subject property**

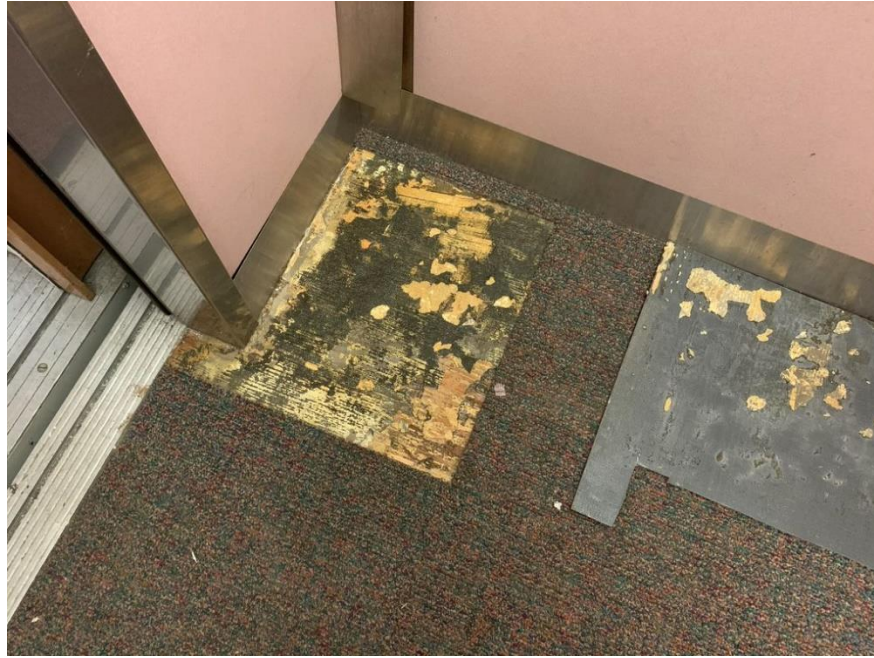
Homogeneous Material No. 9 – Non-ACM Black/Gray/Yellow Mastic located in the Building Elevator of the Subject property

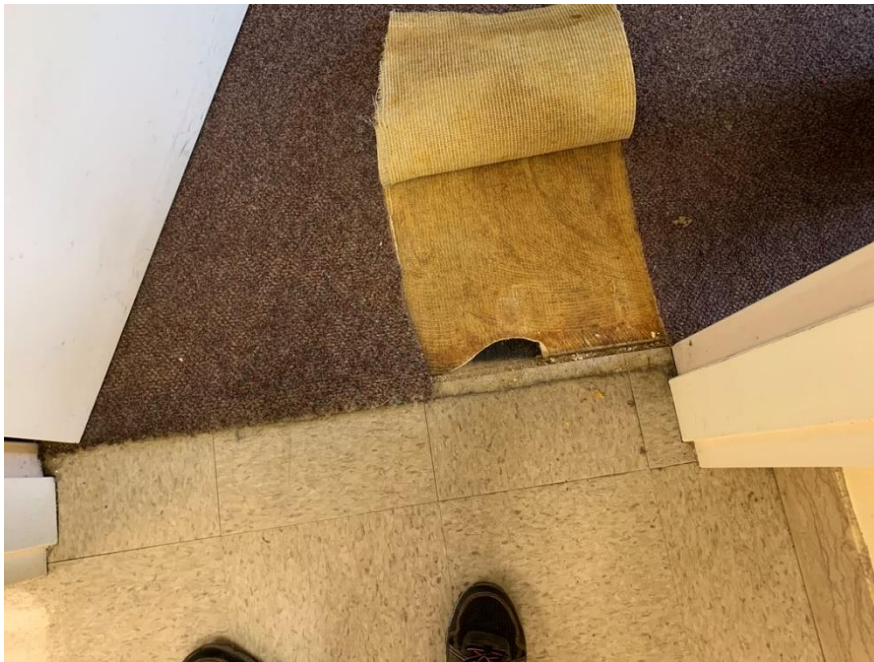
Homogeneous Material No. 10 – ACM Gray Pebble Pattern Resilient Sheet Flooring over Brown Vinyl Floor tiling with black mastic located in Building Main Floor, Corridor near Elevator

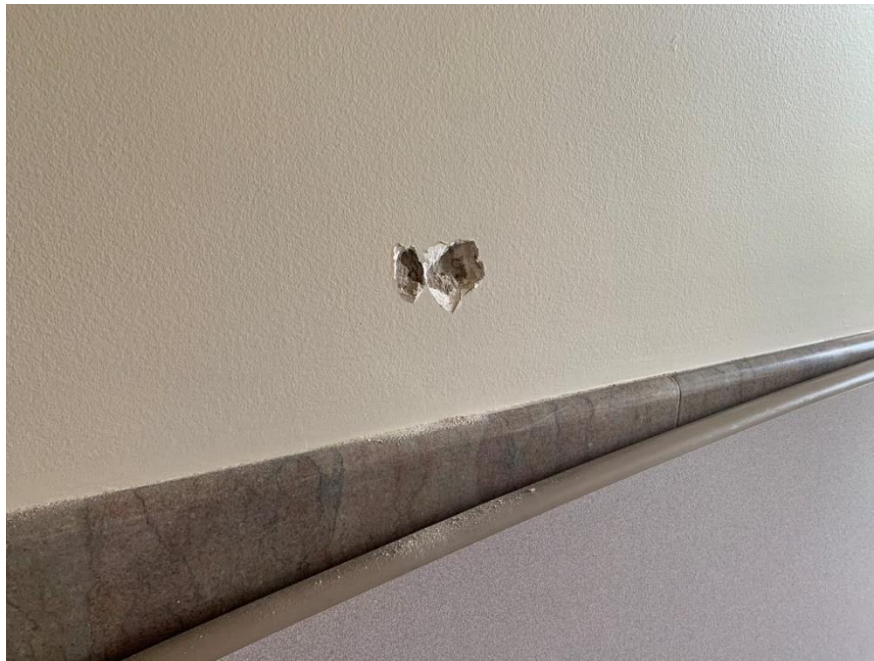
Homogeneous Material No. 11 – Non-ACM Plaster Gray Base White Skim Coat on Wall located in Building Main Floor, Corridor near Elevator of the Subject Property

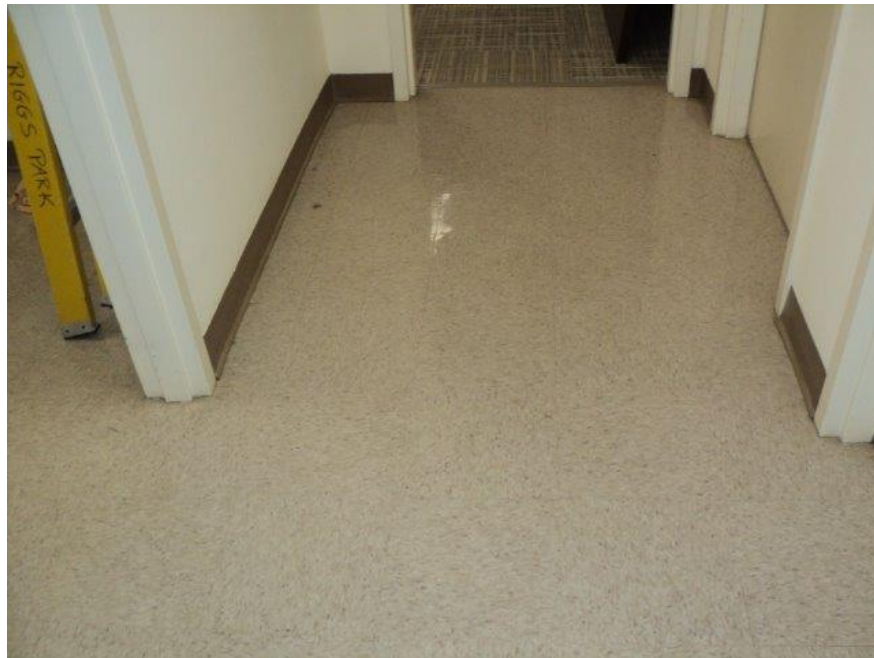
Homogeneous Material No. 12 – Non-ACM 12” by 12” Gray Mottled Vinyl Floor Tile with Tan Mastic located in Building Main Floor, Flooring in Office Area on West Side of Building of the Subject Property

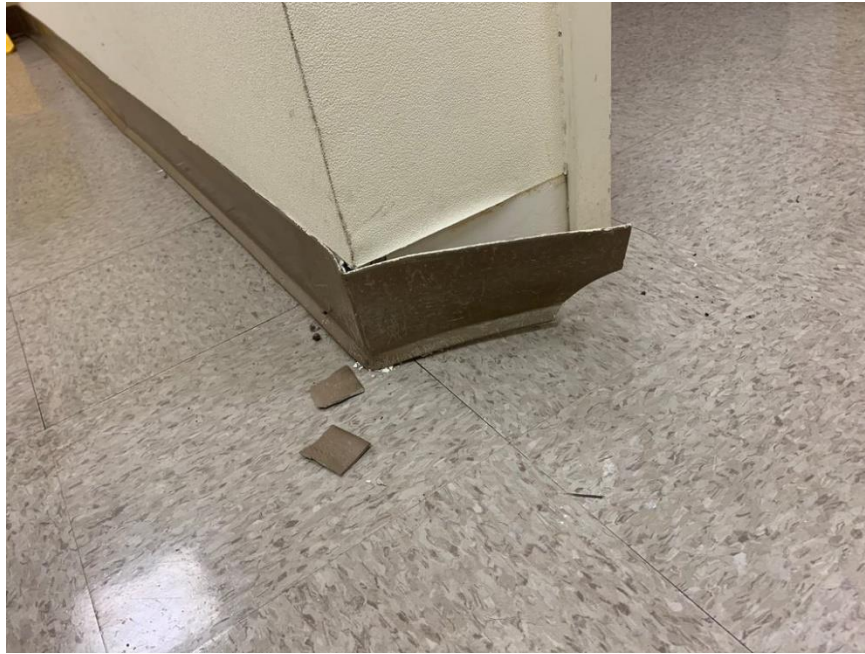
Homogeneous Material No. 13 – Non-ACM 4" Gray Vinyl Cove Base with Gray Mastic Located in the Building Main Floor, Flooring in Office Area on West Side of Building of the Subject Property

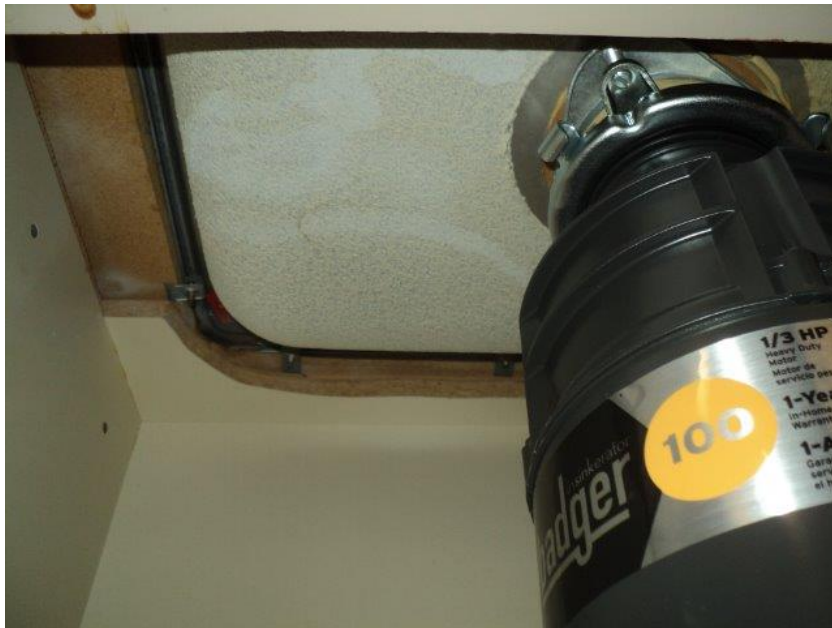
Homogeneous Material No. 14 – Non-ACM Gray Sink Bowl Coating located in the Building Main Floor, Break Room on West Side and on Building 2<sup>nd</sup> floor, Break Room on East Side of the Subject Property

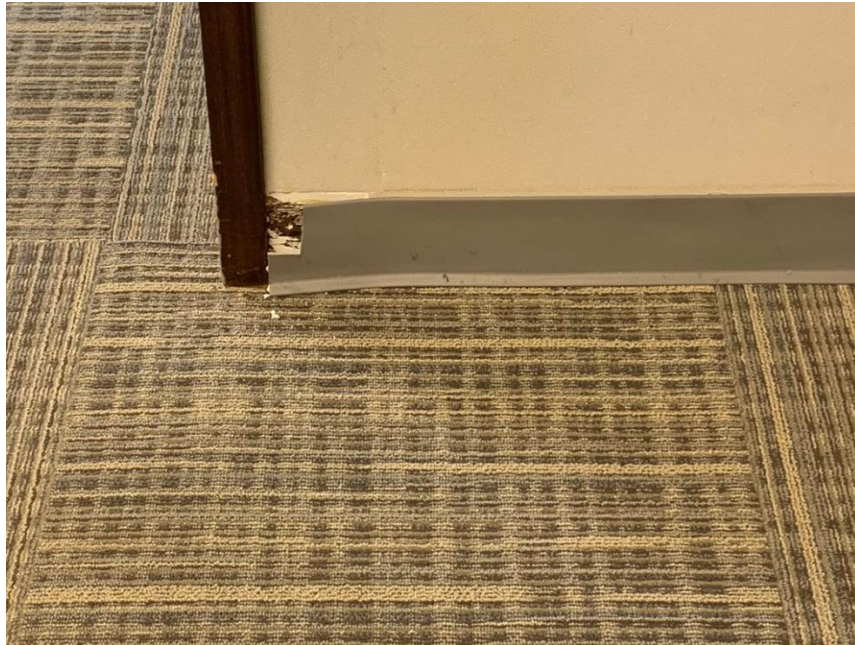
Homogeneous Material No. 15 – Non-ACM 4" Brown Vinyl Cove Base with Brown Mastic Located in the Building Main Floor, Flooring in Some of the Office Area on West Side of Building and Central Customer Area of the Subject Property

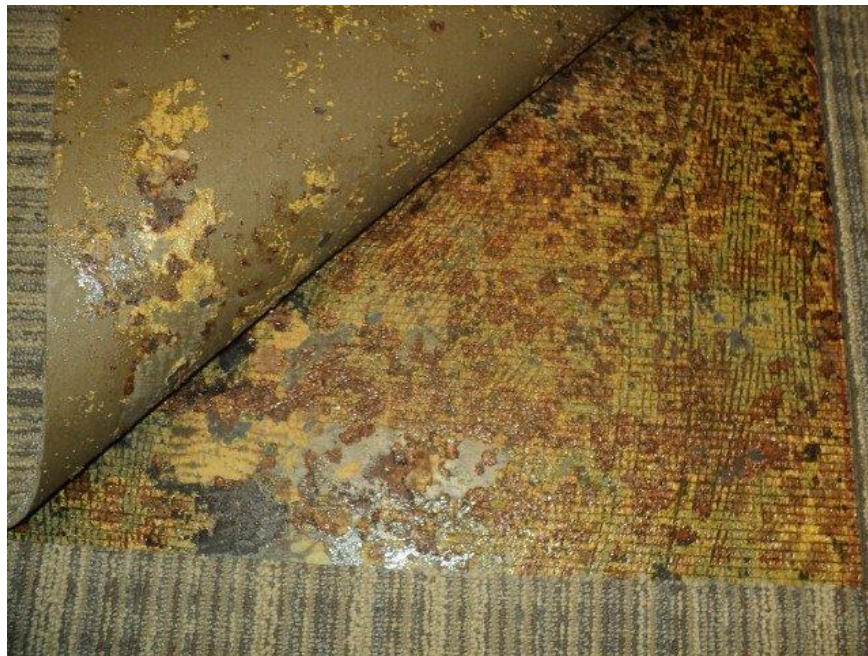
Homogeneous Material No. 16 – Non-ACM Brown/Tan/Black Floor Mastic located in the Building Main Floor, Main Customer Area of the Subject Property

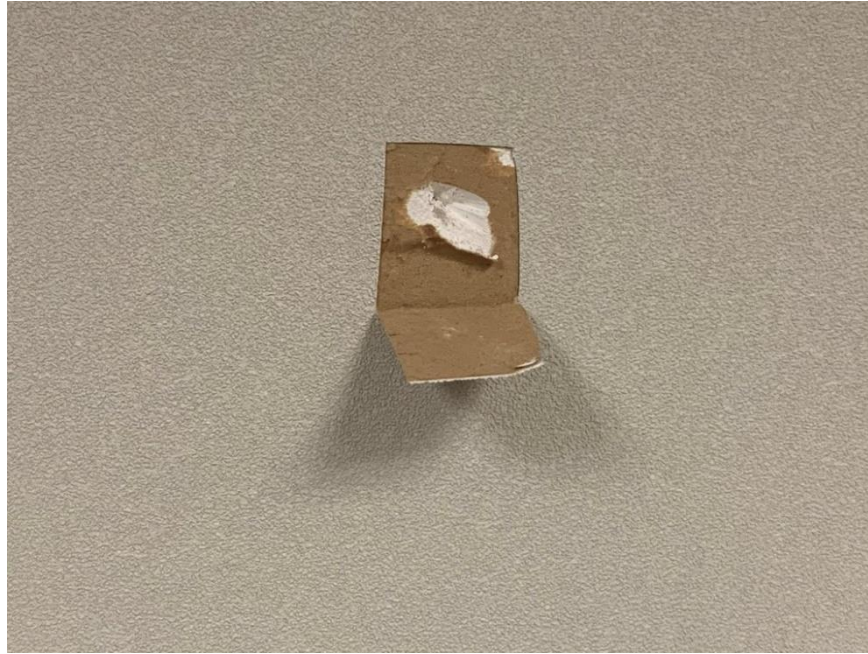
**Homogeneous Material No. 17 – Non-ACM White Drywall with Associated White Joint Compound located in the Building Main Floor, 2<sup>nd</sup> Floor and 3<sup>rd</sup> Floor of the Subject Property**

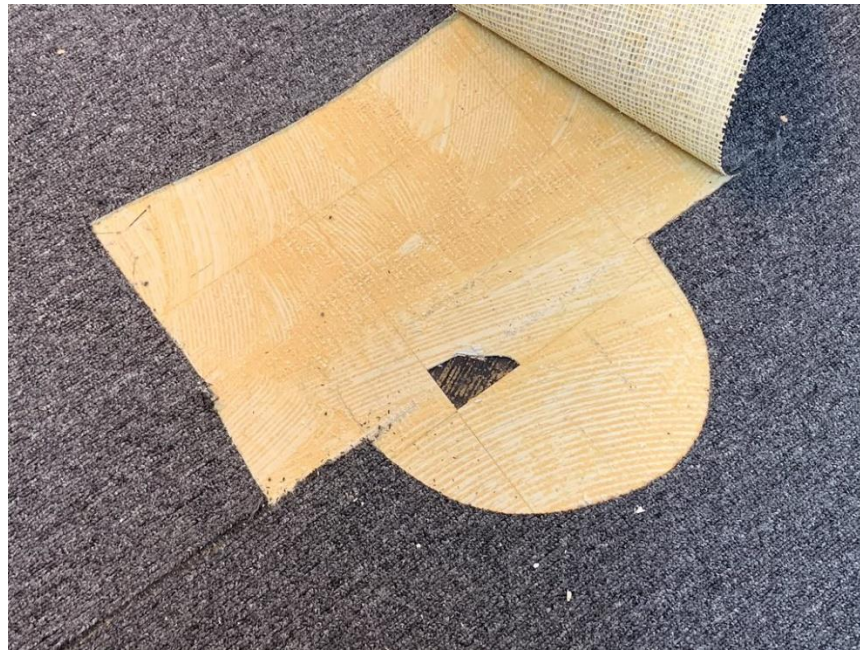
- **9" by 9" White Vinyl Floor Tile with Black Mastic (HM18)** located in the Building Mezzanine Floor, Office Space
- **12" by 12" White Mottled Vinyl Floor Tile with Black Mastic and Gray/White Leveling Compound (HM19) (only the black mastic was found to be asbestos-containing)**, located throughout the building 2<sup>nd</sup> floor.

**Homogeneous Material No. 18 – ACM 9" by 9" White Vinyl Floor Tile with Black Mastic located in the Building Mezzanine Floor, Office Space of the Subject Property**

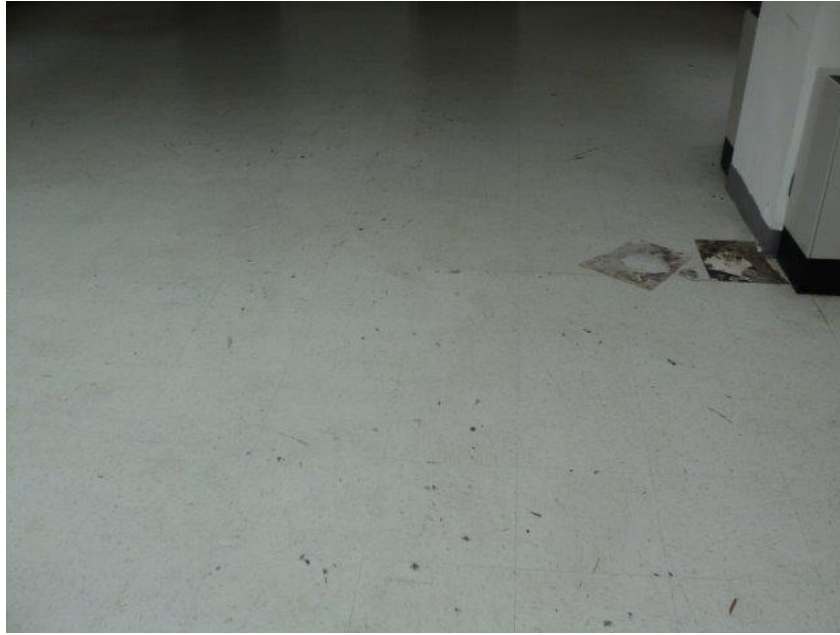
**Homogeneous Material No. 19 – ACM 12” by 12” White Mottled Vinyl Floor Tile with Black Mastic and Gray/White Leveling Compound located throughout the Building 2<sup>nd</sup> Floor Office space of the Subject Property**

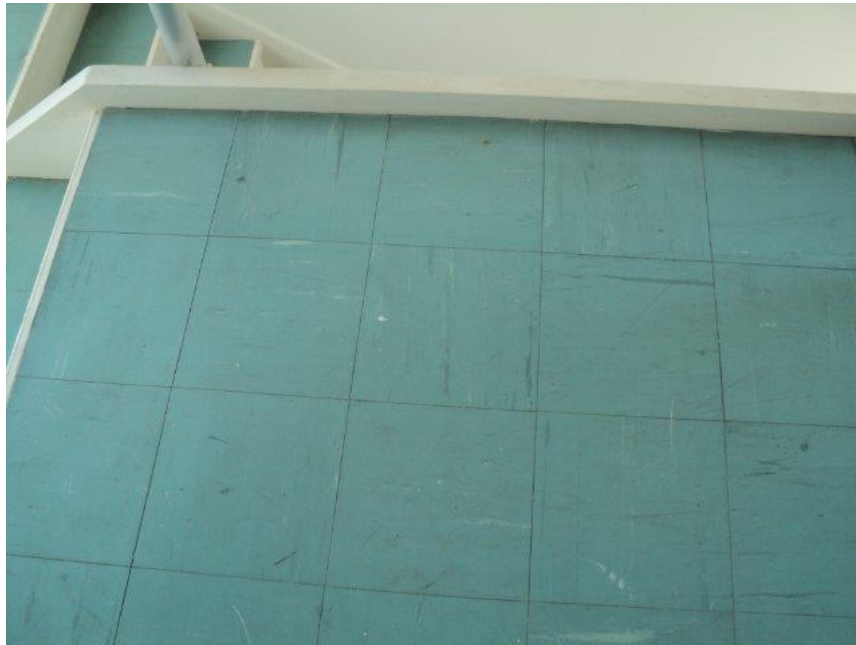
**Homogeneous Material No. 20 – ACM 9” by 9” Green Vinyl Floor Tile with Black Mastic located in the building stairwell on East Side**

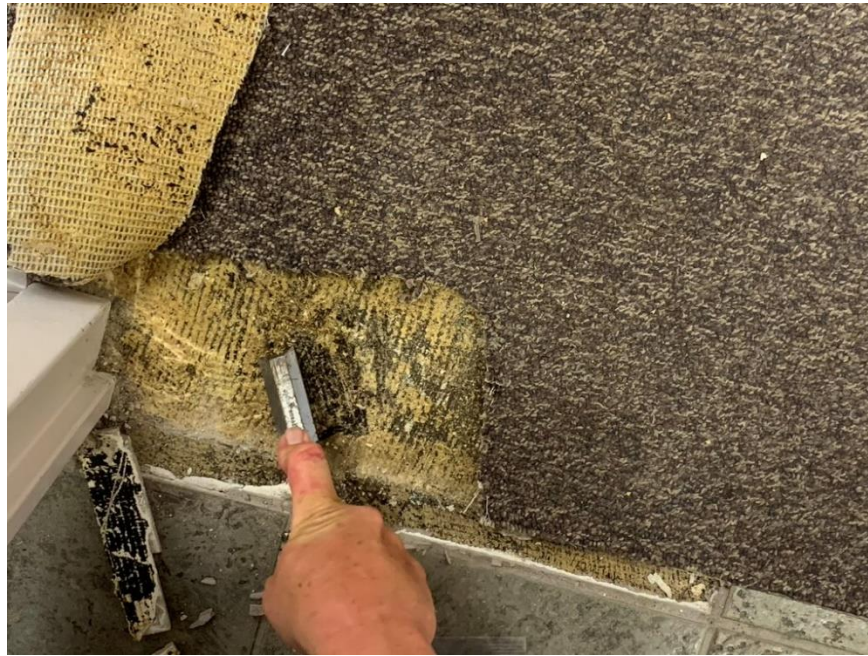
**Homogeneous Material No. 21 – ACM Tan carpet glue with black mastic Located Throughout the offices on the Building 3<sup>rd</sup> floor of the Subject Property**

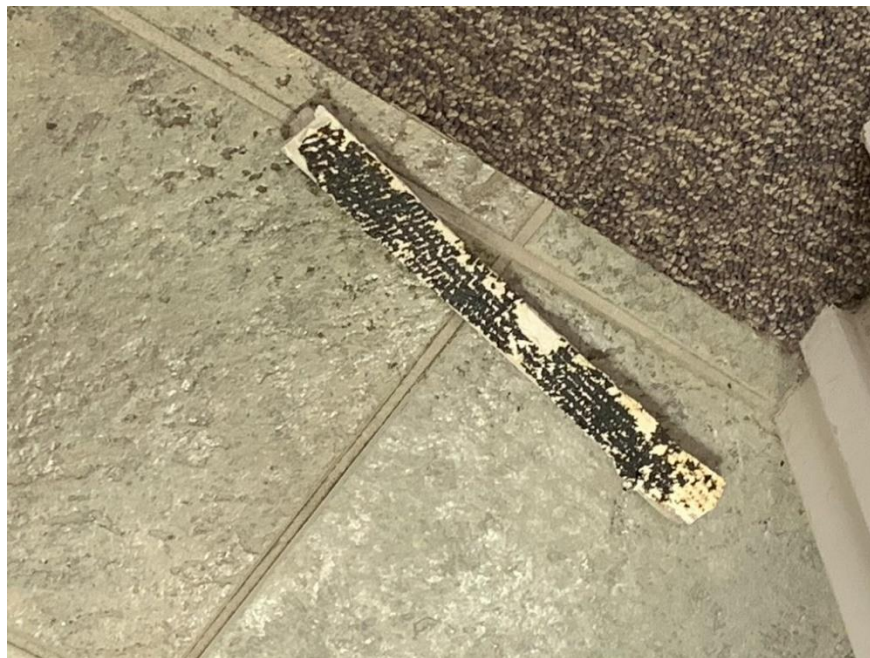
**Homogeneous Material No. 22 – ACM White Setting Bed with Black Mastic located in the Building 3<sup>rd</sup> Floor Break Room on West Side and throughout the 3<sup>rd</sup> floor office areas of the Subject Property**

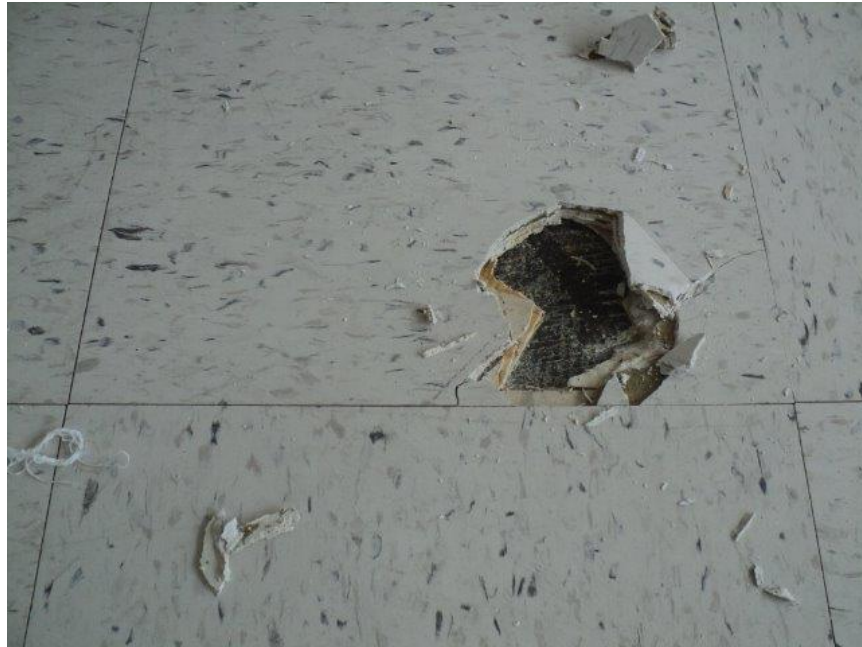
- **12" by 12" Gray/Black Specs Vinyl Floor Tile with Yellow Mastic over Gray Vinyl Floor Tile with Black Mastic over Gray Vinyl Floor Tile with Yellow Mastic over Cream Resilient Floor Sheet with Black Mastic (HM23), (only the black mastic was found to be asbestos-containing)**, located in the Building 3<sup>rd</sup> Floor Office Space on Northwest Corner.

**Homogeneous Material No. 23 – ACM 12” by 12” Gray/Black Specs Vinyl Floor Tile with Yellow Mastic over Gray Vinyl Floor Tile with Black Mastic over Gray Vinyl Floor Tile with Yellow Mastic over Cream Resilient Floor Sheet with Black Mastic located in the Building 3<sup>rd</sup> Floor Office Space on Northwest Corner**

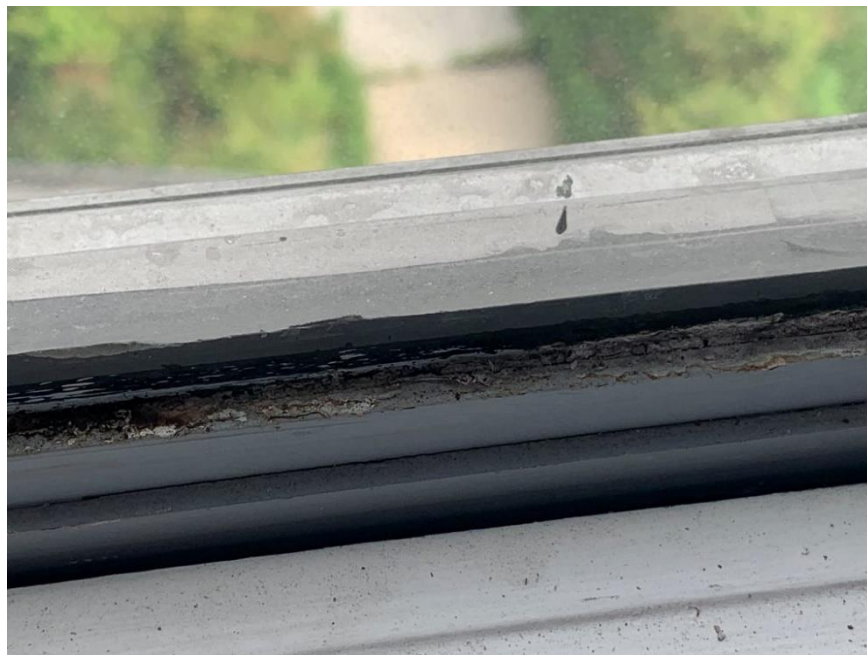
**Homogeneous Material No. 24 – ACM Gray Interior Window Glazing Located in the interior windows on the 3rd floor and throughout the building of the subject property**

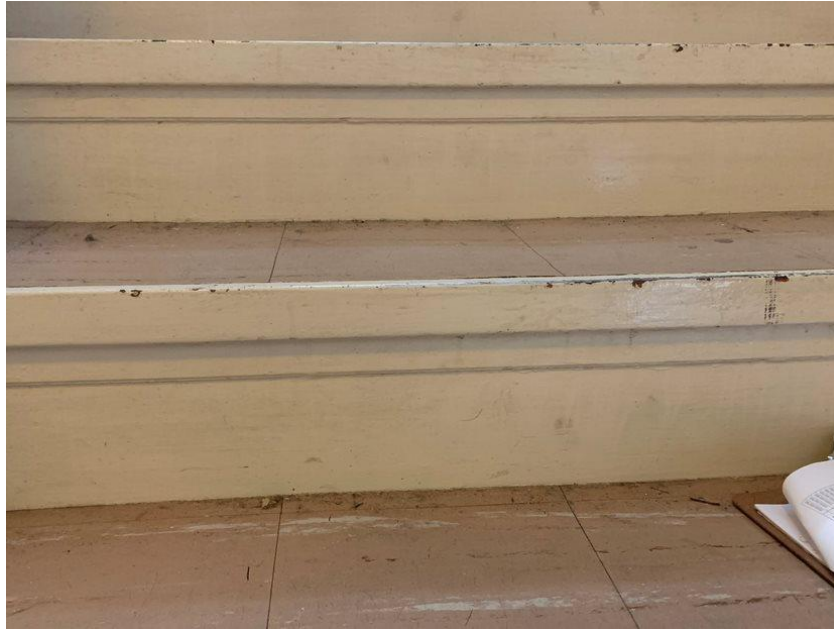
- Cream wooden stair riser in the stairwell on the east side leading from the 1<sup>st</sup> floor to the 2<sup>nd</sup> floor: Reading of 5.8 mg/cm<sup>2</sup>. The paint on this was in a deteriorated condition (10%).
- Cream metal stair riser in the stairwell on the east side leading from the 2<sup>nd</sup> floor to the 3<sup>rd</sup> floor: Reading of 3.4 mg/cm<sup>2</sup>. The paint on this was in an intact condition.

Lead-Containing Paint on the stairwell stair riser on the east side leading from the 1st floor to the 2nd floor.

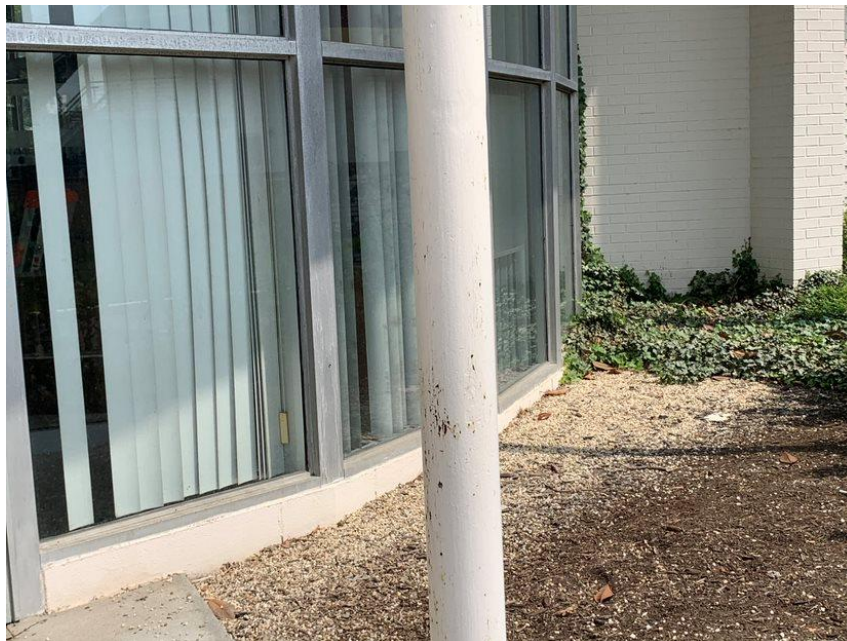
- White metal column at the building rear entrance: Reading of 1.3 mg/cm<sup>2</sup>. The paint on this was in a deteriorated condition (10%).
- Cream metal I-beam at the building rear entrance: Reading of 1.7 mg/cm<sup>2</sup>. The paint on this was in a deteriorated condition (25%).

- White metal column at the building front entrance: Reading of 1.3 mg/cm<sup>2</sup>. The paint on this was in a deteriorated condition (20%).
- Cream metal door casing at the building side entrance (East side): Reading of 1.2 mg/cm<sup>2</sup>. The paint on this was in a deteriorated condition (10%).

Lead-Containing Paint on the White metal column at the building rear and front entrance.

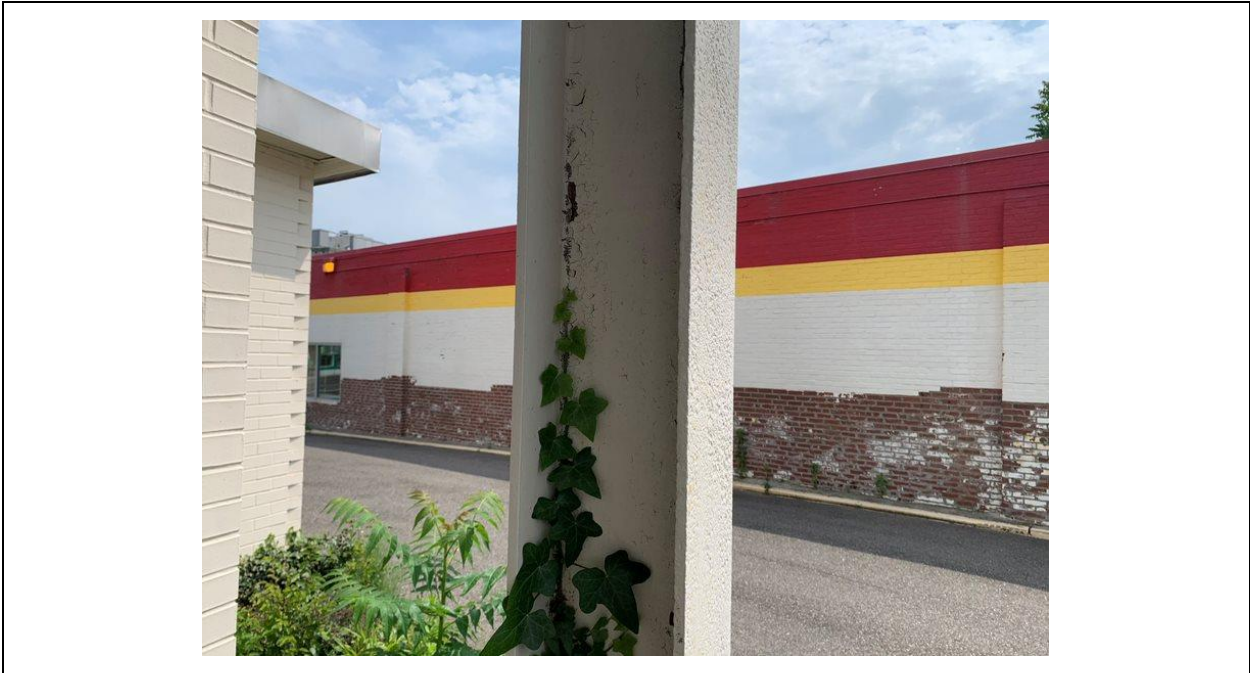
Lead-Containing Paint on the cream metal I-beam at the building rear and front entrance.

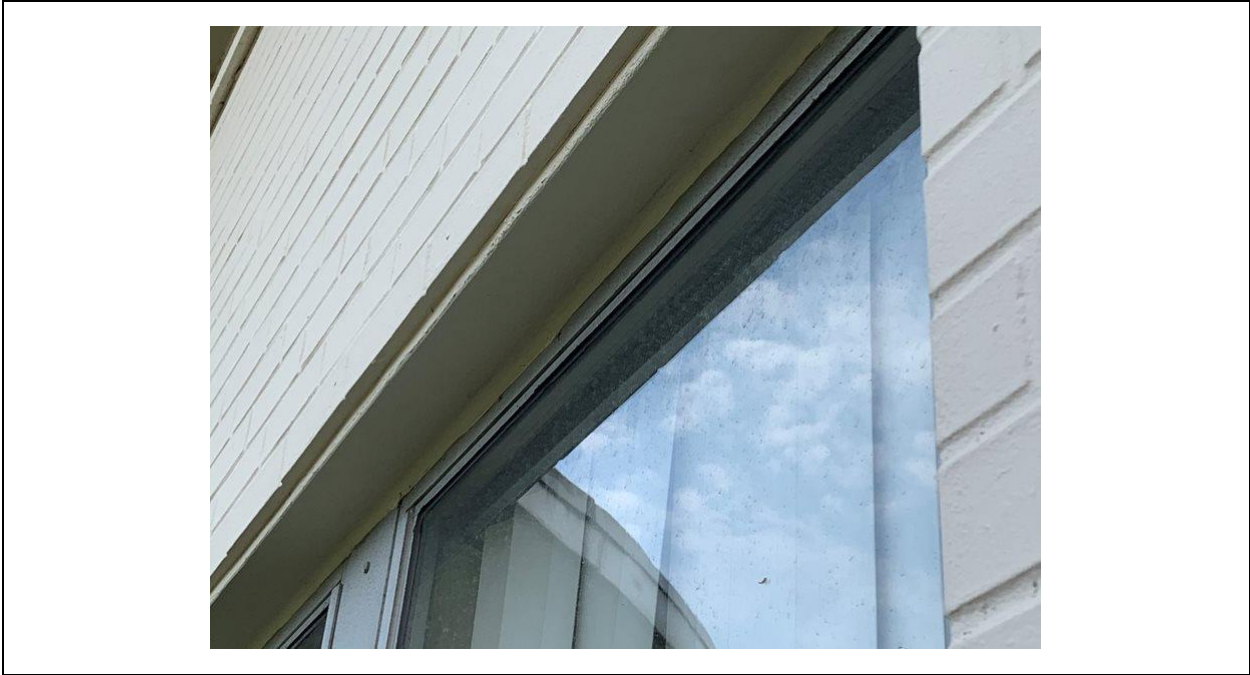
- Cream metal I-beam at the building front entrance: Reading of 1.8 mg/cm<sup>2</sup>. The paint on this was in a deteriorated condition (10%).
- White metal window lintel at the building front entrance: Reading of 2.1 mg/cm<sup>2</sup>. The paint on this was in an intact condition.

Lead-Containing Paint on the white metal window lintel at the building front entrance.

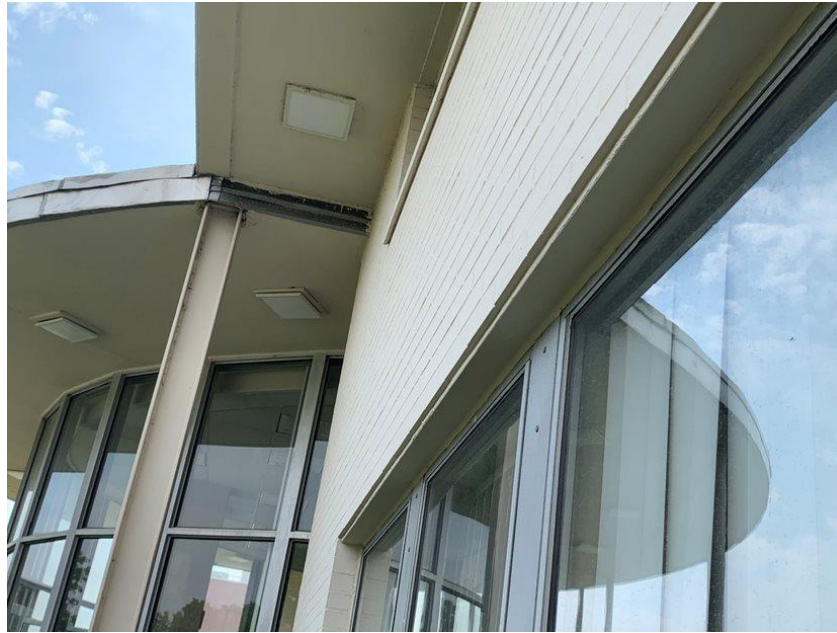
Lead-Containing Paint on the cream metal I-beam at the building front entrance.

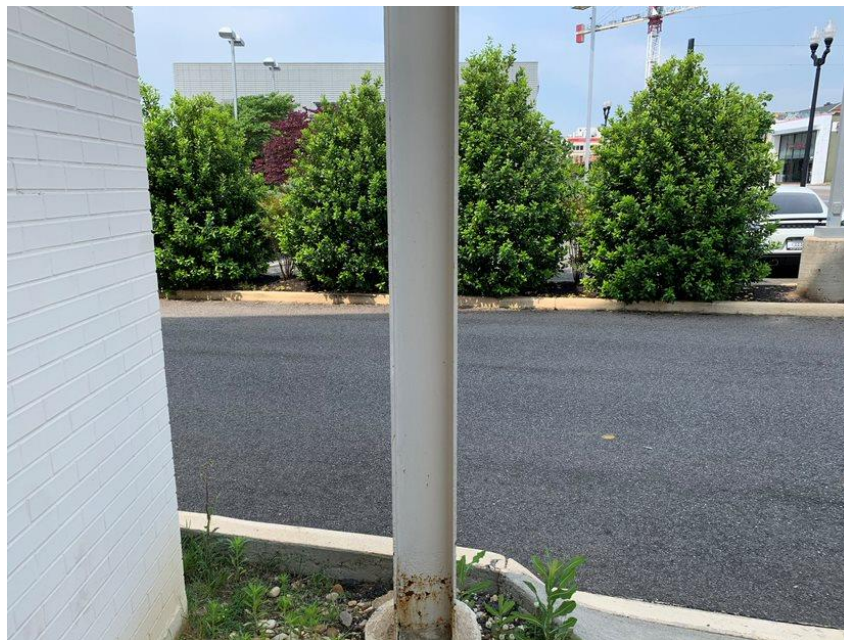
Lead-Containing Paint on the white metal column at the building front entrance.

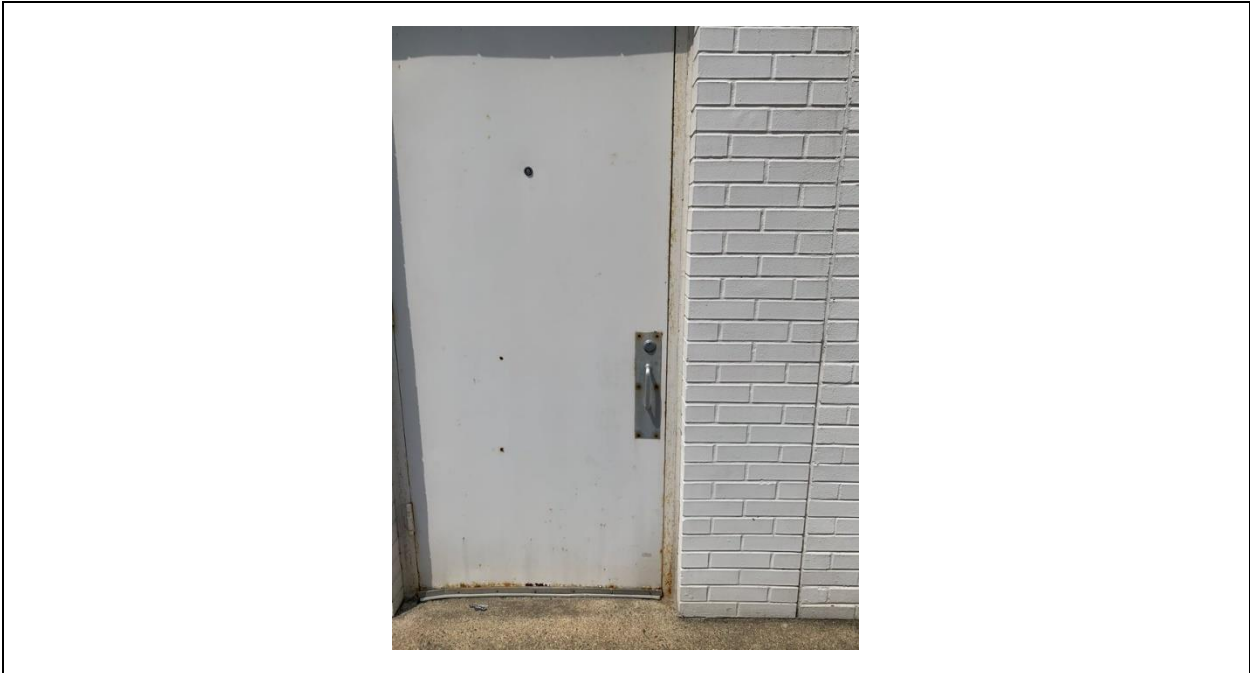
- Cream metal door lintel at the building side entrance (East side): Reading of 1.7 mg/cm<sup>2</sup>. The paint on this was in a deteriorated condition (5%).

Lead-Containing Paint on the cream metal door casing and door lintel at the building side entrance.

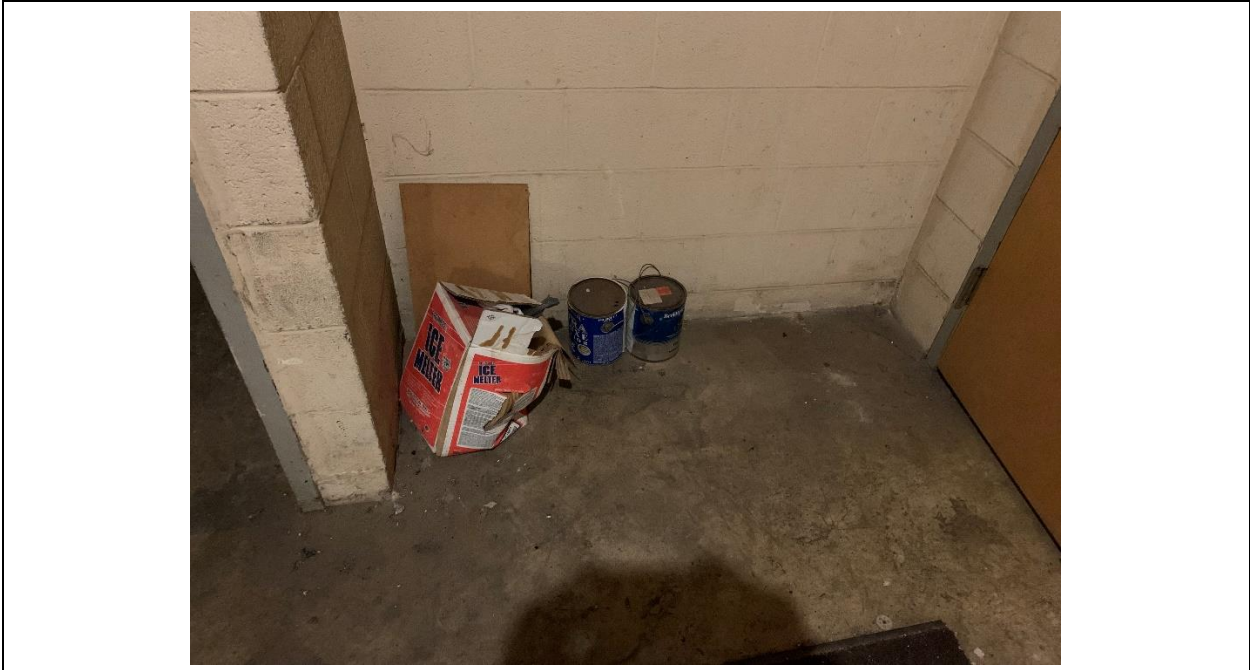
Miscellaneous Paint Cans in the Basement of the subject property building.
