**Engineering Evaluation of Concrete Condition
and Steel Sheet Pile Wing Wall Thickness
St. Johns River Water Control Structure S-96D
Indian River County, Florida**

St. Johns River Water Management District
P.O. Box 1429
Palatka, Florida 32178

Subject: Engineering Evaluation of Concrete Condition and
Steel Sheet Pile Wing Wall Thickness
St. Johns River Water Control Structure S-96D
Indian River County, Florida

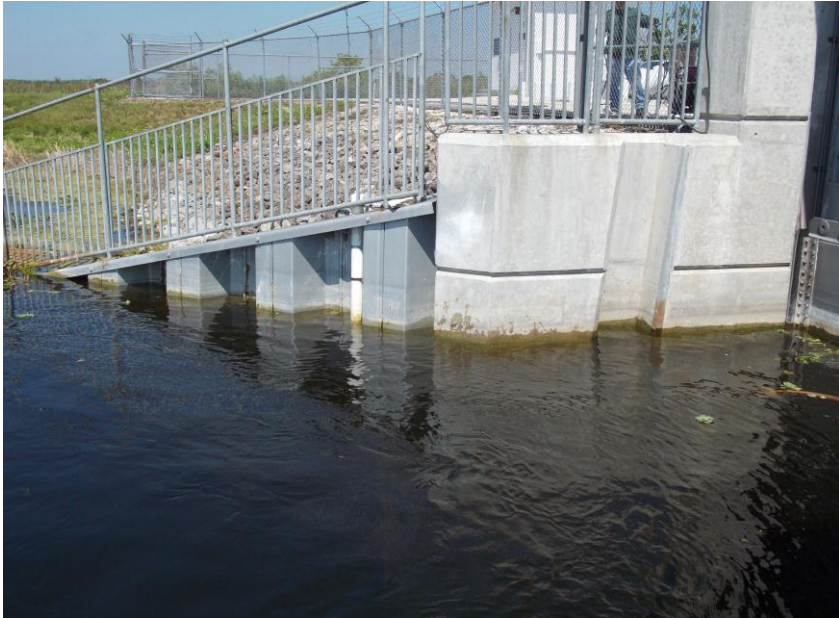
Relative to the steel sheet pile wing walls, the upstream walls appeared to be in “very good” condition. No evidence of corrosion or seepage between the joints was observed. We note that only portions of the first 8 sections of sheet piles were observed. The remaining portions of the steel sheet pile walls were below the water surface and could not be observed relative to their condition.

Upstream - West Wing Wall and Structure Wall.

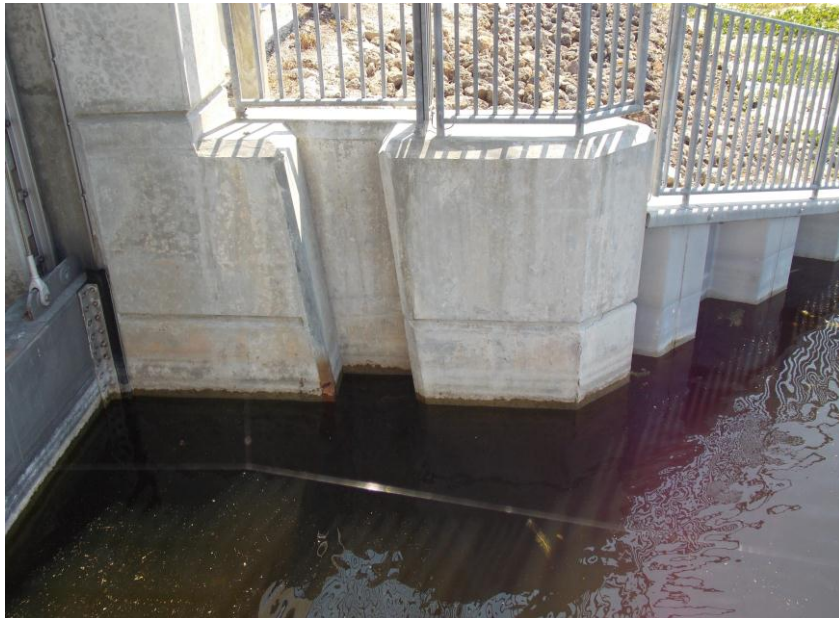
Upstream - East Structure Wall.

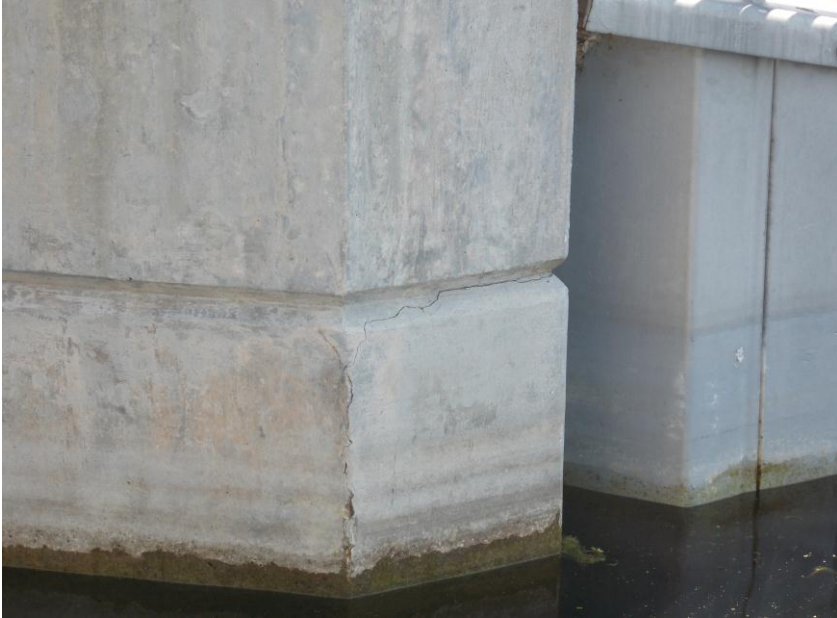
For the upstream side of the structure, our observations indicated that the concrete appeared to be in “very good” condition. Concrete pitting within the water fluctuation zone was observed to be minimal with no significant loss of aggregate. We were unable to observe the concrete structure below a depth of approximately 6 inches due to water clarity. We note that a crack (approximately 1/8 inch in width) was observed at the end of the southeast portion of the concrete structure. We were unable determine if the crack was due to typical concrete shrinkage or related to an impact force. No concrete spalling or rust staining were observed in the vicinity of the crack.

Upstream - East Structure Wall. Note Crack at Construction Joint.

Based on our visual observations and the results of our field exploration and laboratory testing programs, it is our opinion that the structural integrity of the concrete element of the structure is in "very good" condition and is exhibiting normal physical erosion characteristics typical for a hydraulic structure of this age and use. Remediation of the concrete within the water fluctuation zone is not required at this time. The condition of the concrete, considering the years of service, suggests that the concrete should continue to perform for many years before remediation is required. We do however suggest that the crack observed on the southeast end of the structure be repaired to limit potential corrosion and/or spalling. Based on the current condition of the crack, a typical two-part injection epoxy should be sufficient.

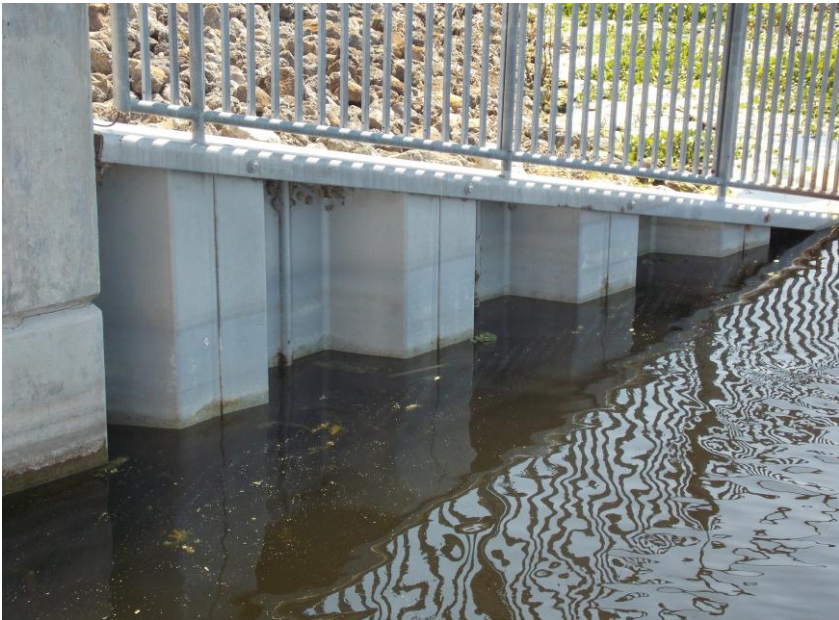
Upstream - East Wing Wall.

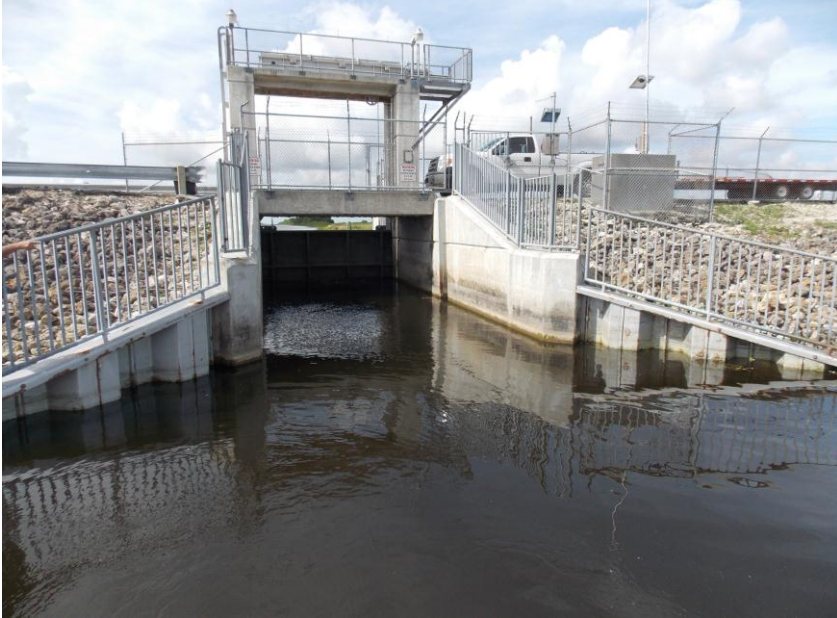
Downstream - Structure Overview and Portion of Wing Wall.

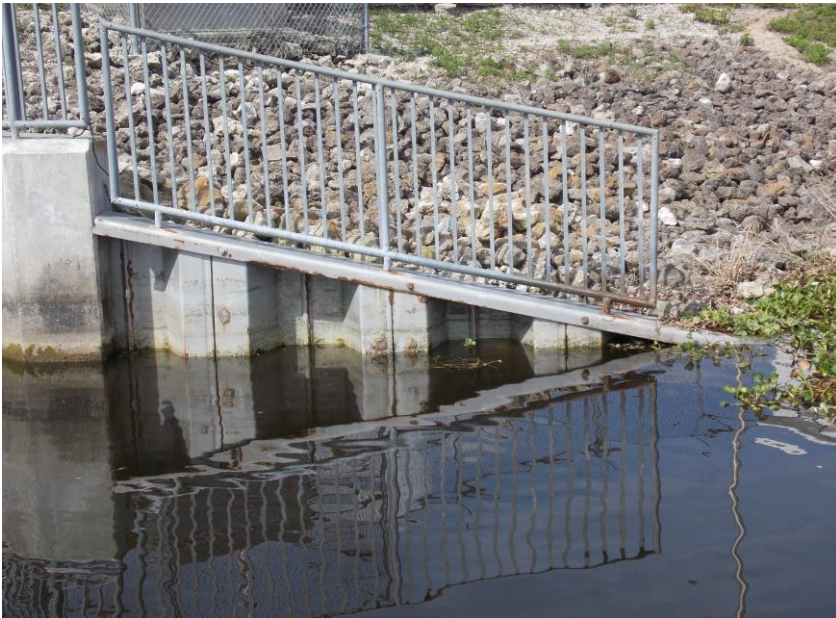
Relative to the steel sheet pile wing walls, the downstream walls appeared to be in “poor” condition. Significant corrosion at the joints, rails and tieback anchors was observed. We note that portions of the first 6 sections of sheet piles were observed. The remaining portions of the steel sheet pile walls were below the water surface and could not be observed relative to their condition.

Downstream - West Wing Wall.

Our observations and testing relative to the steel sheet pile wing walls indicate that the upstream wingwalls are in "very good" condition and that remediation is not needed at this time. However, the downstream wingwalls are in "poor" condition and are exhibiting advanced corrosion. The downstream wingwalls should be remediated as soon as it is feasible. We recommend that the corrosion be removed (i.e. sand blasted/ground, washed, etc.) and then repaired/coated. Depending on the severity of the corrosion that will only be evident after corrosion is removed, joint reinforcement (i.e. welded metal plating) may be required.

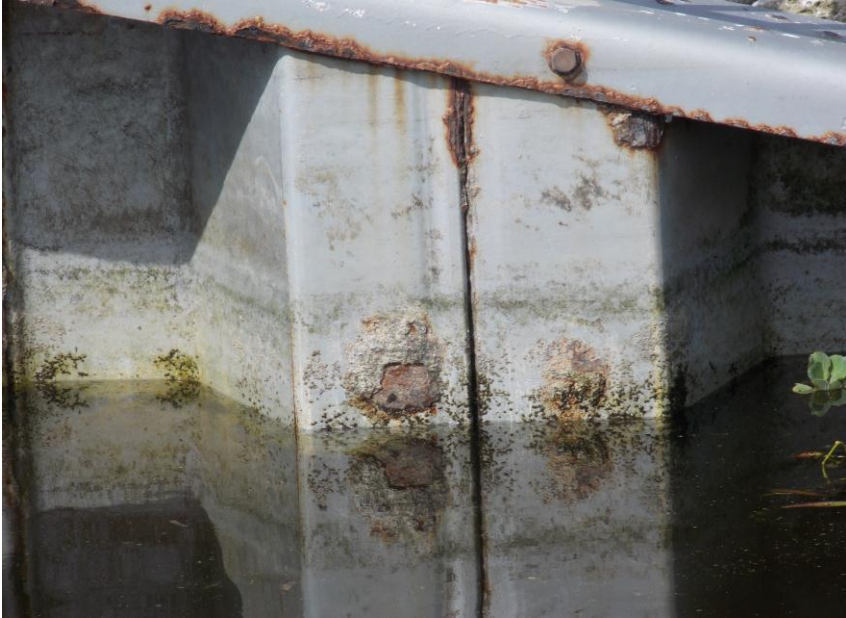
Downstream - West Wing Wall.

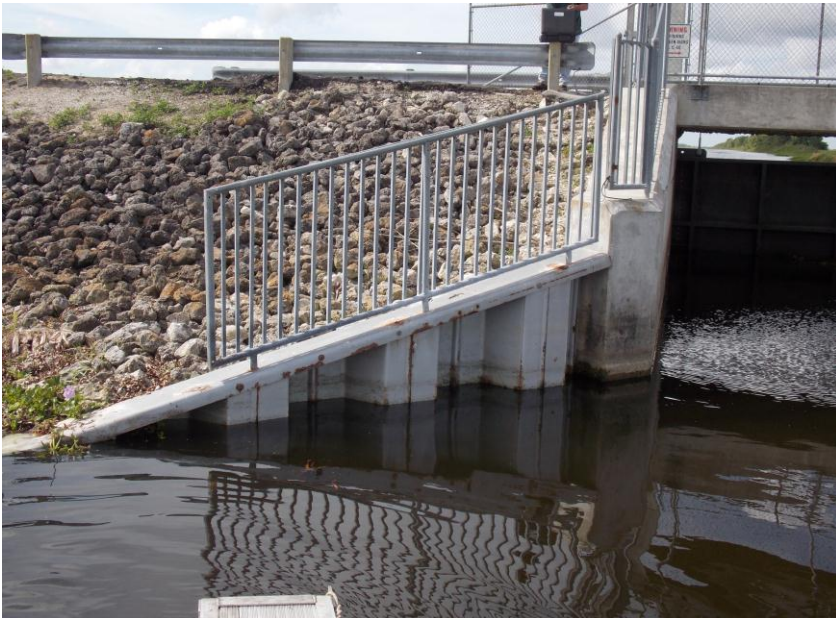
Downstream - East Wing Wall.

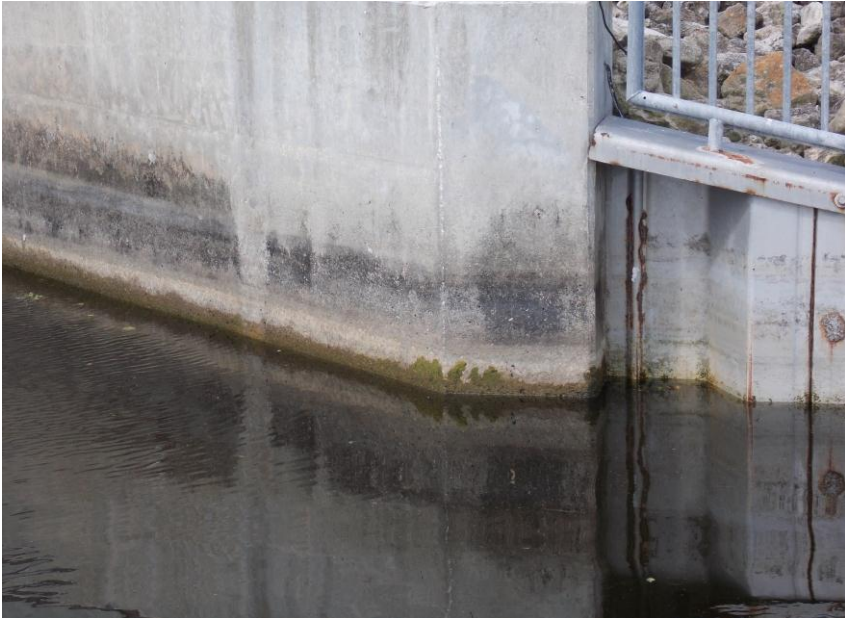
For the downstream side of the structure, our observations indicated that the concrete appeared to be in “very good” condition. Concrete pitting within the water floatation zone and below the water surface was observed to be slightly more advanced than the upstream portion, however the pitting was still considered to be minimal with no significant loss of aggregate. We were unable to observe the concrete structure below a depth of approximately 6 inches due to water clarity. No spalling, significant cracking, rust staining or other indicators of potential structural defects or corrosion were observed.

Downstream - East Structure Wall, North Half.

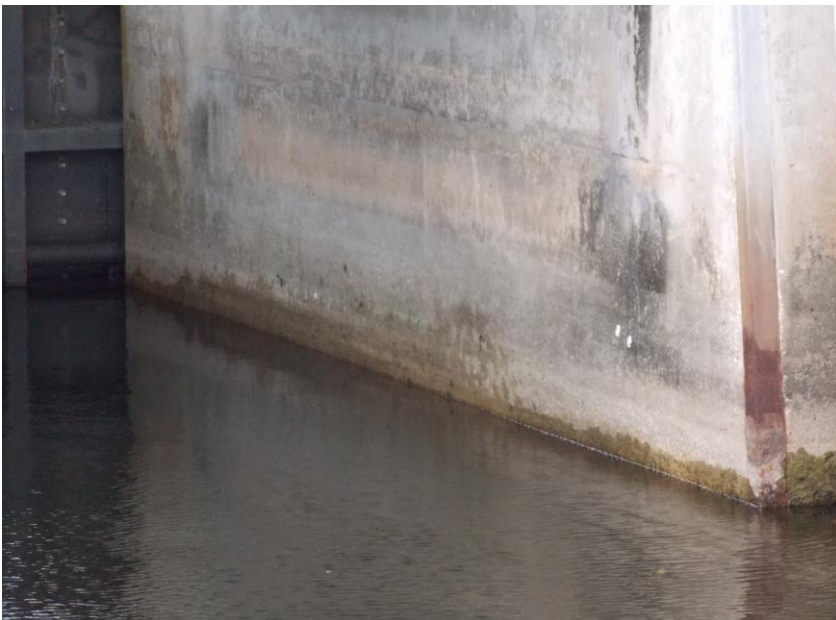
Downstream - East Structure Wall, South Half.

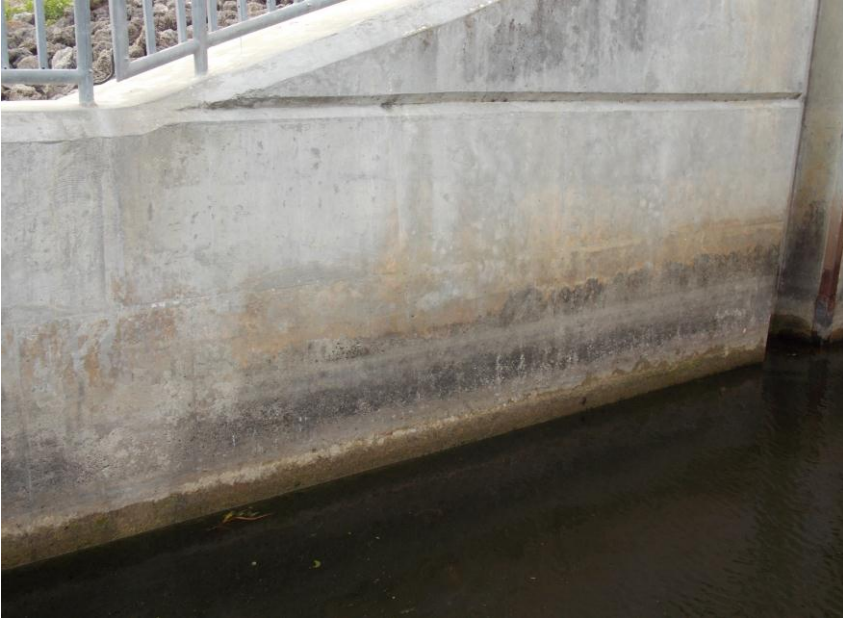
Downstream - East Structure Wall, North Half.

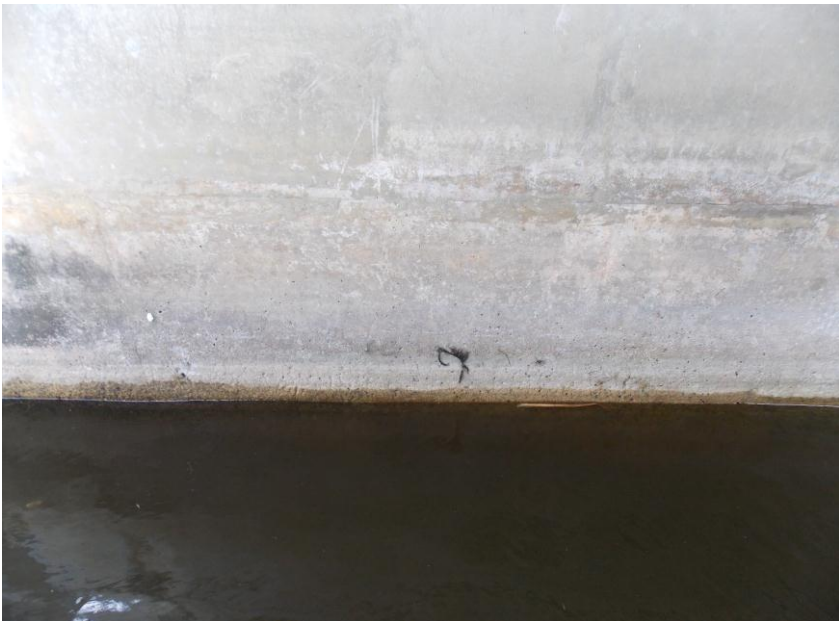
Downstream - East Structure Wall, South Half.

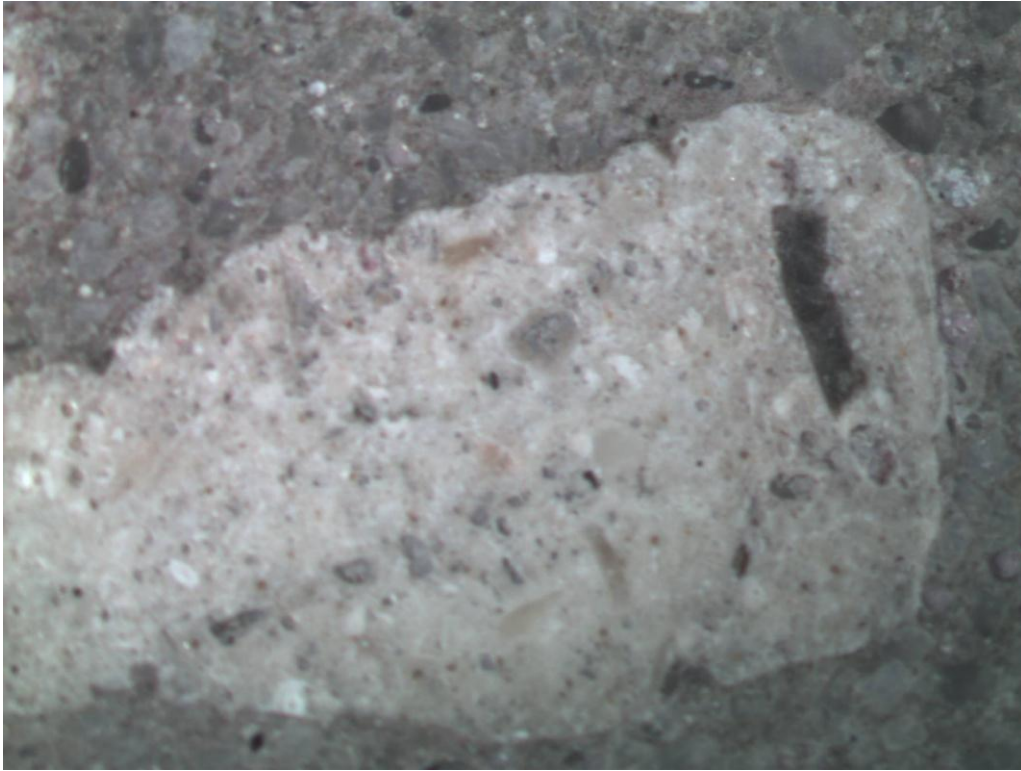
Photo 4 – Sample 2 – magnified view of typical coarse aggregate piece, note no signs of cement-aggregate reactions.

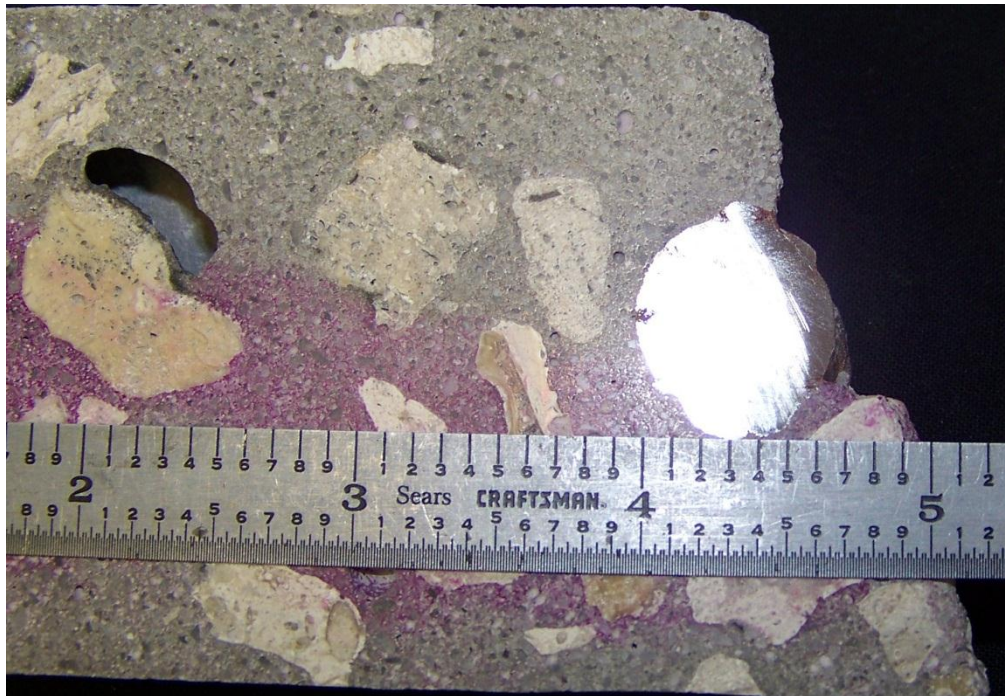
- A No 6 reinforcing steel bar was observed to be 2 ¾ inches down from the surface of the Core Sample 2.

Photo 5 – Sample 2 – No. 6 reinforcing steel bar, located 2 $\frac{3}{4}$ inch from surface. No evidence of corrosion noted on steel.

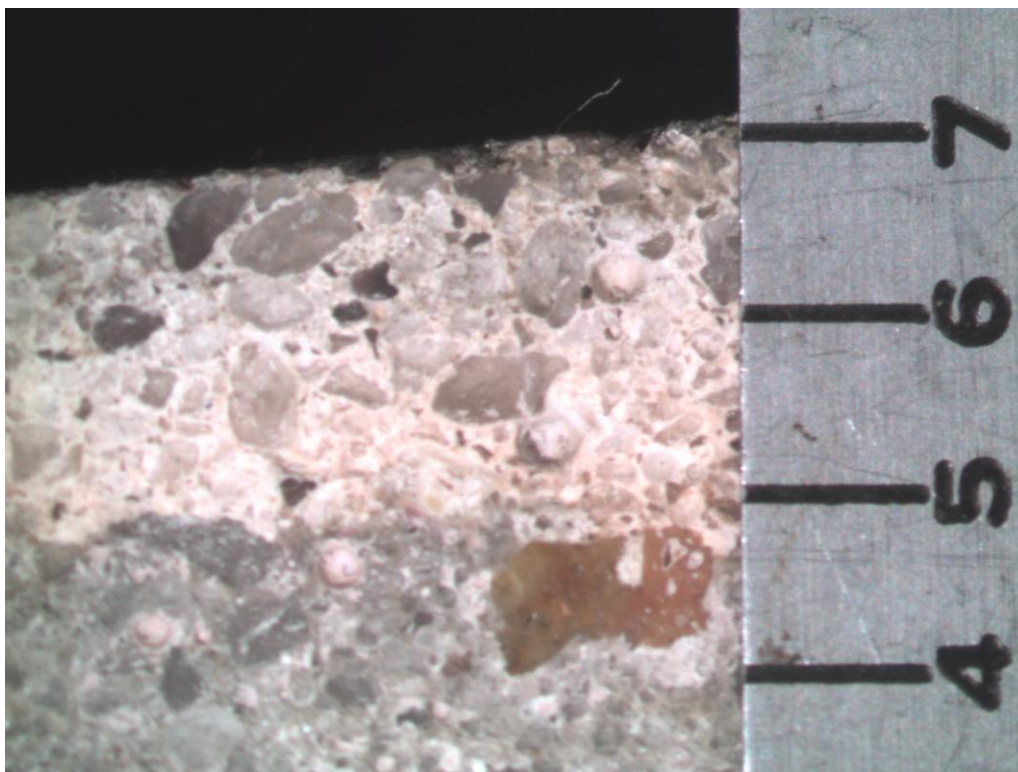
Photo 6 – Sample 1 – magnified view of surface, note light colored zone of carbonated concrete. Scale is 0.1 inch.

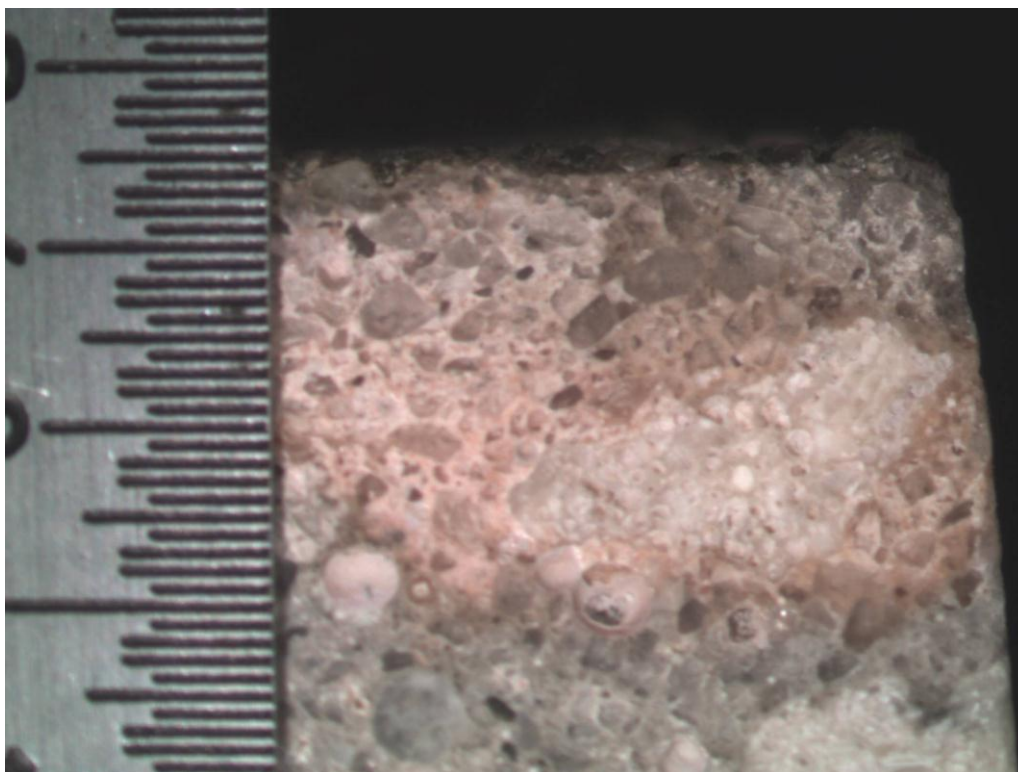
Photo 7 – Sample 1 – magnified view of surface, note light colored zone of carbonated concrete. Scale is 0.01 inch.

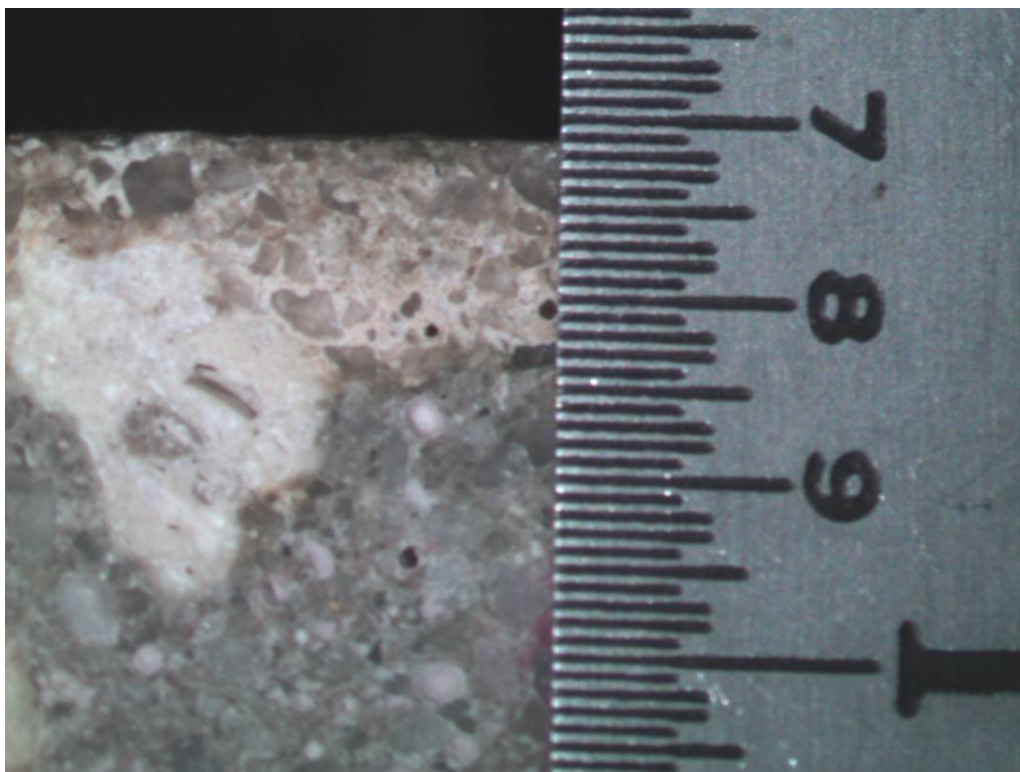
Photo 8 – Sample 2 – magnified view of surface, note light colored zone of carbonated concrete. Scale is 0.01 inch.

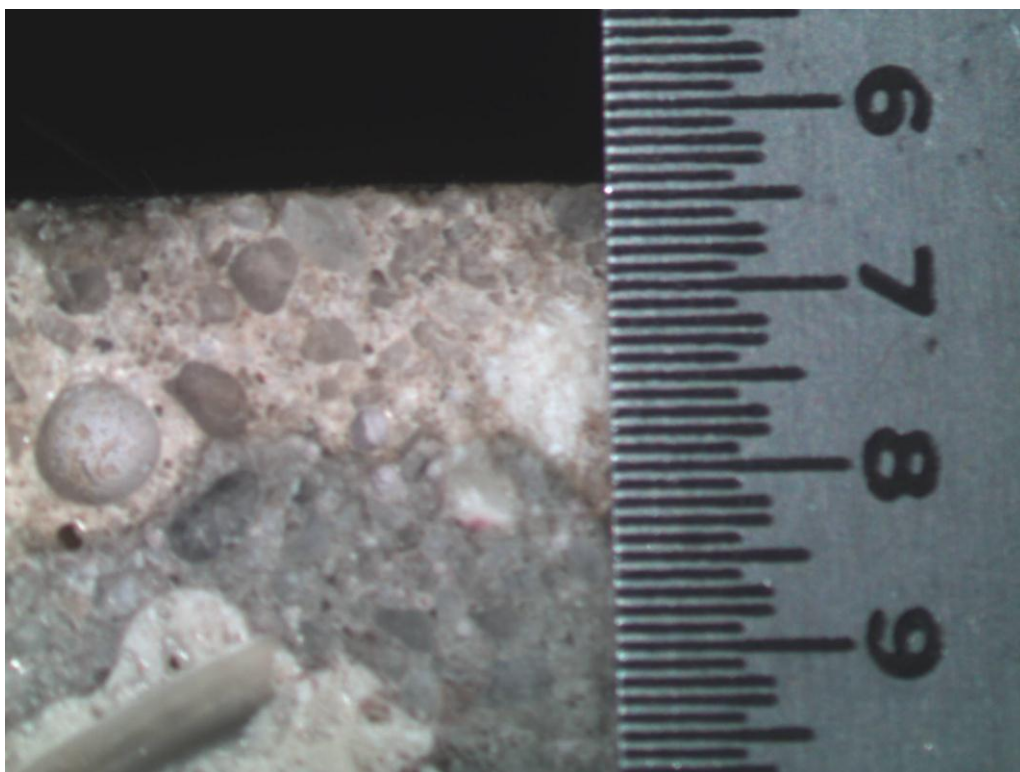
Photo 9 – Sample 2 – magnified view of surface, note light colored zone of carbonated concrete. Scale is 0.01 inch.

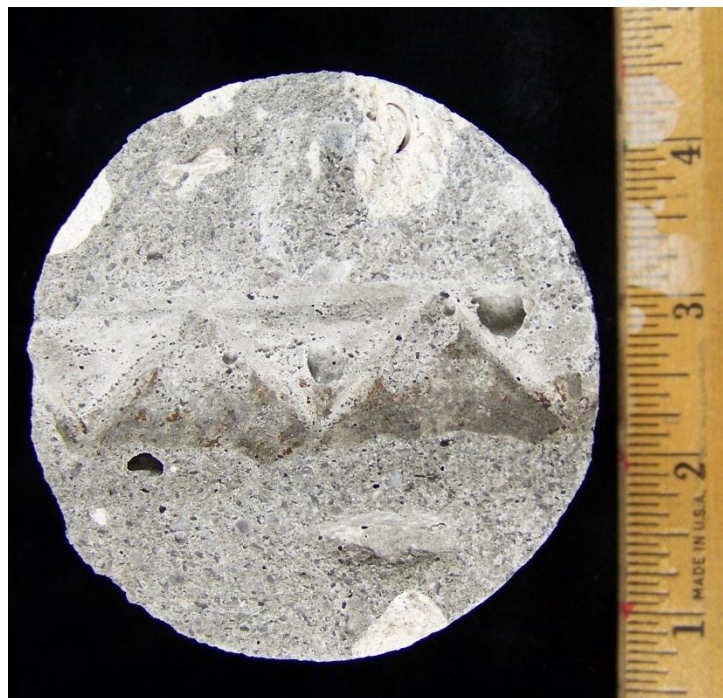
- No embedded reinforcing steel was observed in the samples, however the fractured end of core 3B did show a partial impression of a reinforcing bar. Based on the partial impression the bar size was estimated to be a No. 5 or No. 6 bar.

Photo 3 – Sample 3B – Inside fractured face (end) – note reinforcing bar impression.

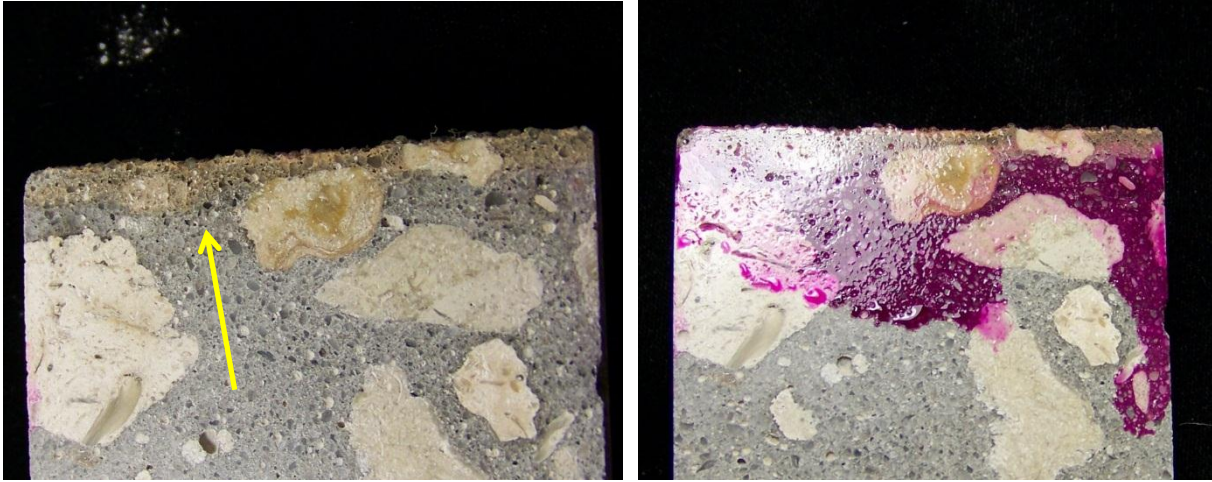
The results of the indicator solution and pH testing indicate that carbonation is minor and on the order of 0.2 inch from the surface of the concrete. Beneath the minor zone of carbonation, the pH of the concrete cores remains high and consistent with depth. These characteristics indicate that concrete within the areas explored has not undergone significant chemical attack.

Photos 8a & b – Sample 3B – Polished section showing zone of tan colored paste at surface. Application of a phenolphthalein indicator solution confirms the tan zone to be carbonated.

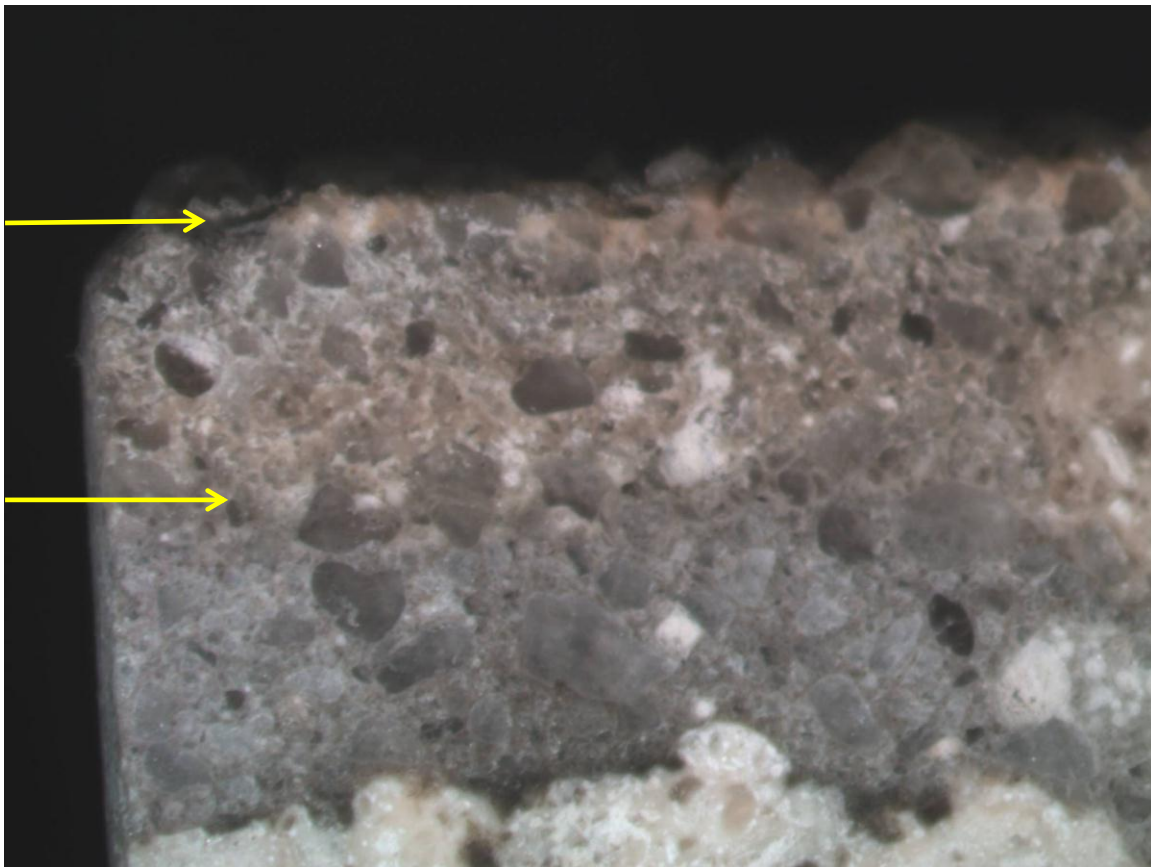
Photo 9 – Sample 3B – magnified view of carbonated paste at surface of core

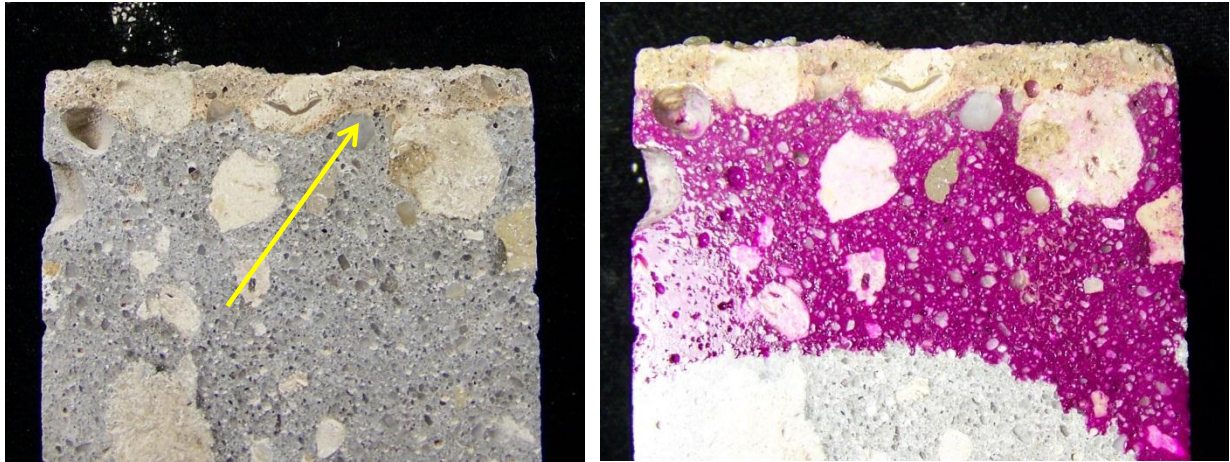
Photos 10a & b – Sample 6B – Polished section showing zone of tan colored paste at surface. Application of a phenolphthalein indicator solution confirms the tan zone to be carbonated.

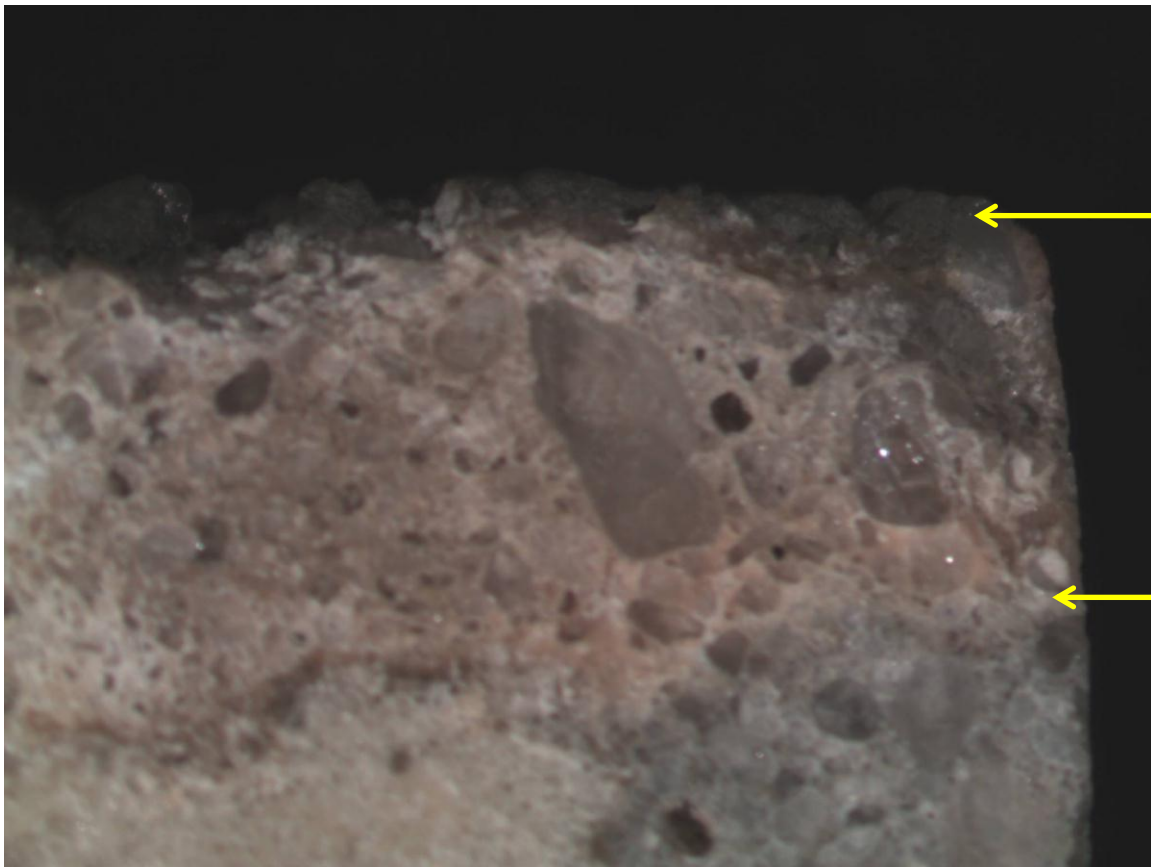
Photo 11 – Sample 6B – magnified view of carbonated paste at surface of core.
