**ASBESTOS PROJECT DESIGN
REGARDING
VACANT BUILDING
419 HAMPTON STREET
WALTERBORO, SOUTH CAROLINA**

Date of Design: October 08, 2019

**ASBESTOS SURVEY
REGARDING
VACANT BUILDING
419 HAMPTON STREET
WALTERBORO, SOUTH CAROLINA**

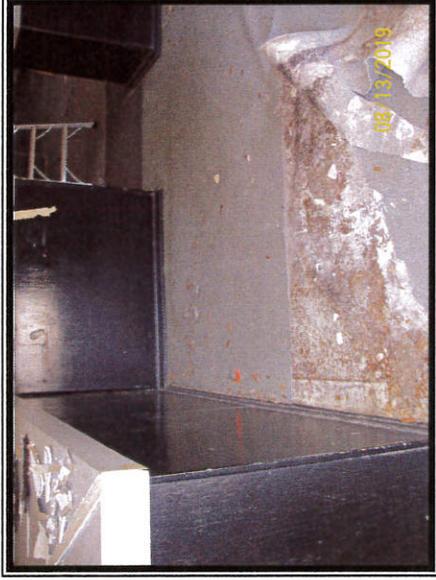
Photo #2
Asbestos Detected at >1% in Parquet Flooring;
No Asbestos Detected in Mottled Gray Flooring

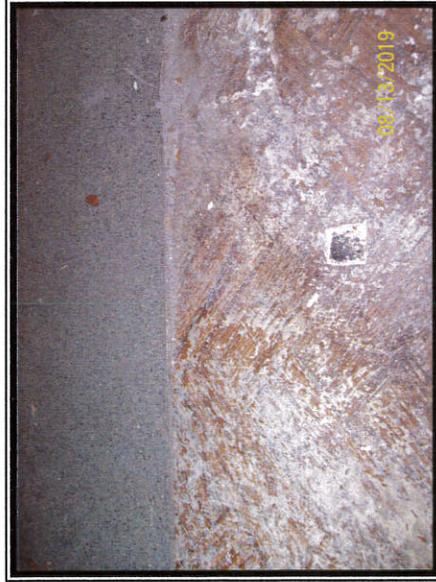
Photo #3
Asbestos Detected at >1% in Tan Floor Tiles
under Parquet Sheet Flooring at Counter Area

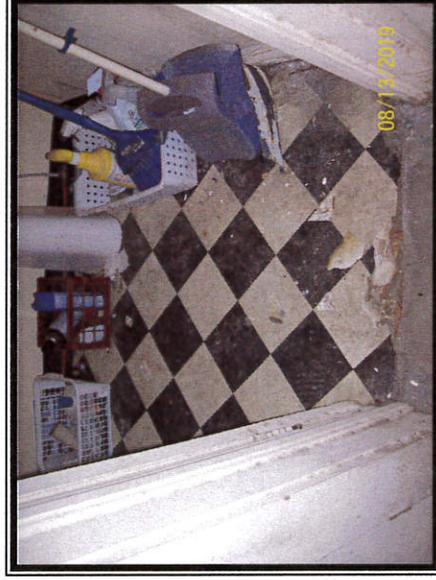
Photo #4
Parquet Sheet Flooring under non-asbestos
containing Checkerboard Sheeting in BR 2

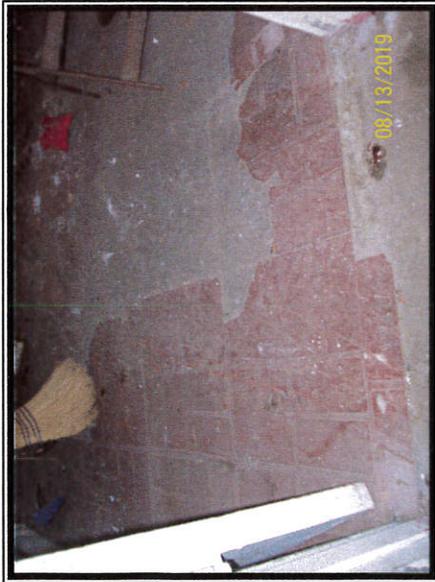
Photo #5
Asbestos Detected at >1% in Brick-patterned
Flooring Squares in Room 1

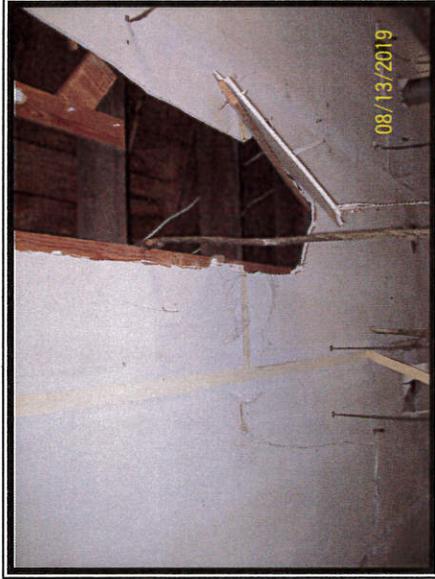
Photo #6
Asbestos Detected at >1% in Sheetrock with
Joint Compound Systems

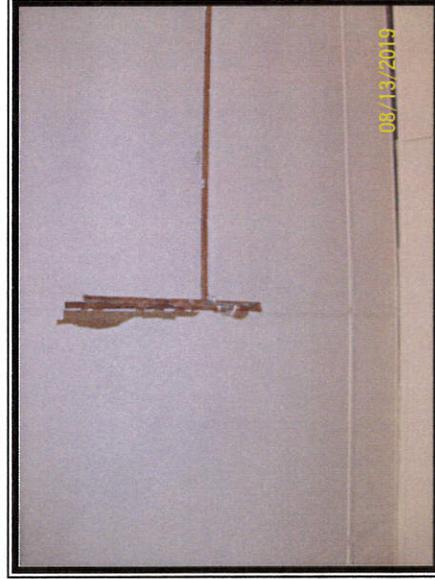
Photo #8
Asbestos Detected at >1% in Joint Compound
of Sheetrock with Furring Strips Systems

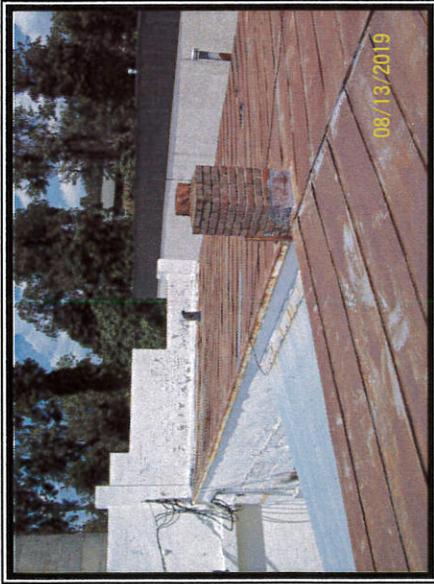
Photo #9
Northeast-facing view of Sheet Metal Roofing
System over Areas 1 & 2 (Rusted)

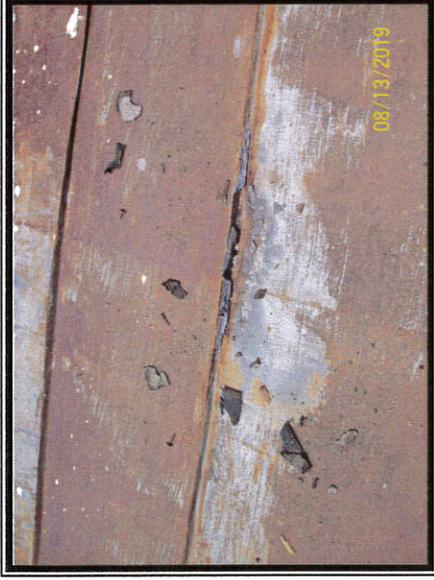
Photo #10
Asbestos Detected at >1% in Metal Roof Seam
Caulk of Areas 1 & 2

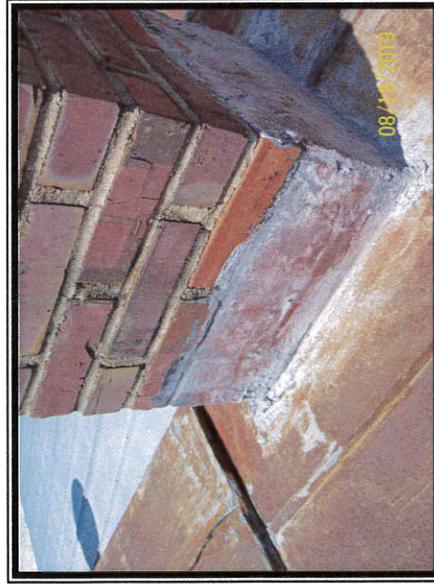
Photo #11
Asbestos Detected at >1% in Silver Roof
Sealant Material as Seen on Chimney

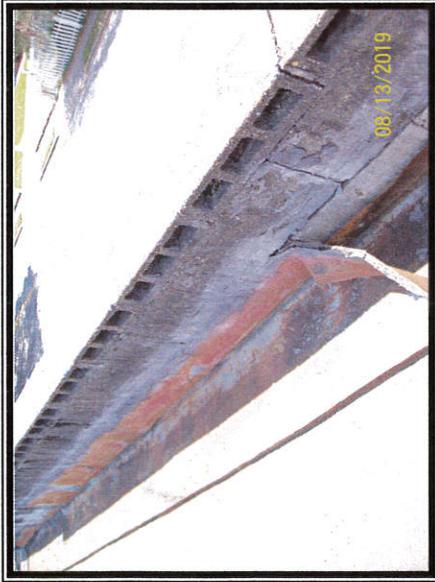
Photo #13
Asbestos Detected at >1% in Area 1 & 2 Roof
Parapet Flashing Sealant Materials

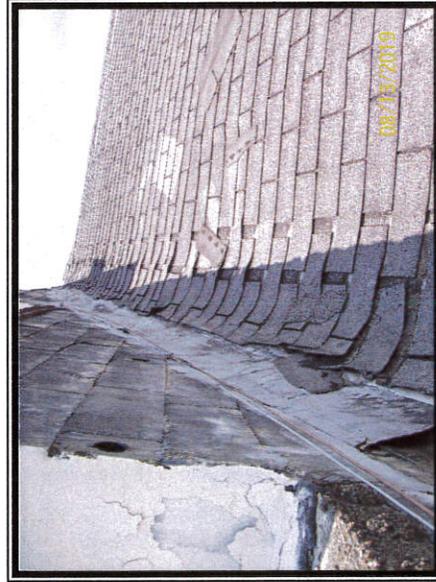
Photo #15
Asbestos Detected at >1% in Area 3 Parapet
Flashing Materials; No Asbestos in Shingles/Felt

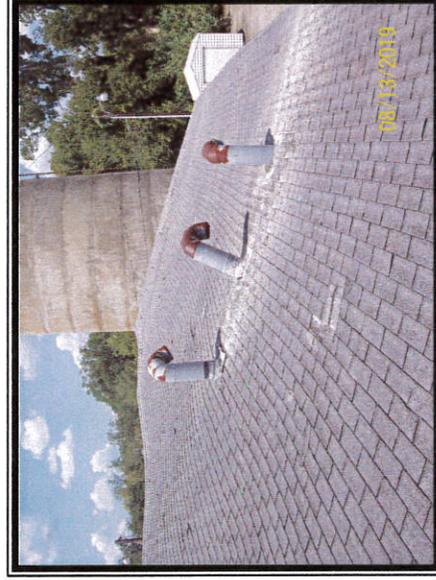
Photo #16
View of Area 3 Roof Vent Pipe with Asbestos-
containing Sealant Material

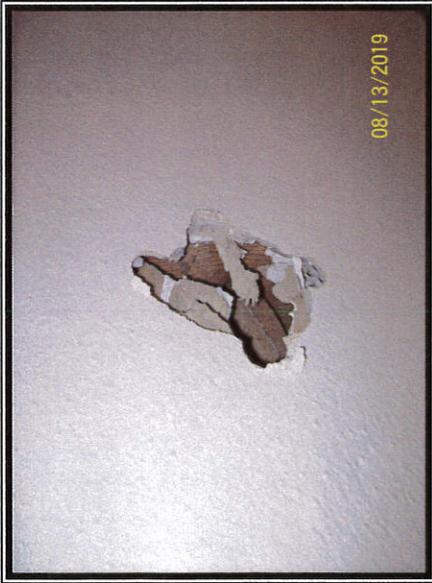
Photo #17

No Asbestos Detected in Cementitious Board and Sheetrock Combination Wall System

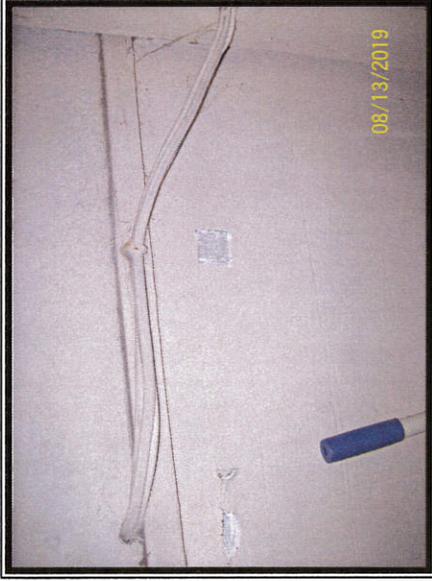
Photo #18

No Asbestos Detected in Simulated Tile Wall Surfacing in Bathrooms

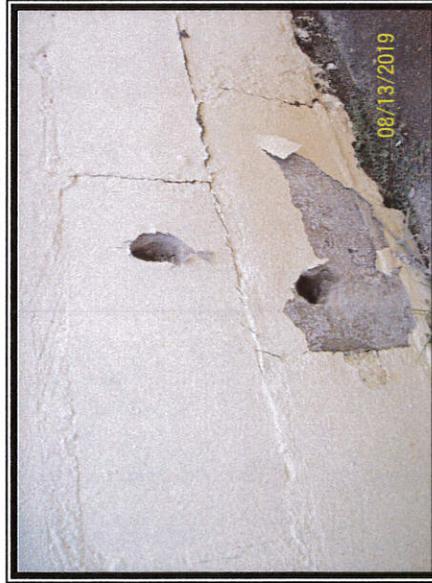
Photo #19

No Vermiculite in CMU; No Asbestos Detected in Exterior Paint or Block Fill Materials

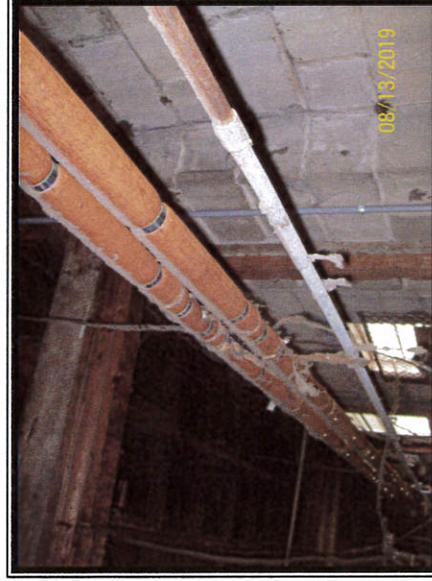
Photo #20

No Asbestos Detected in Any Pipe Wrap Materials
