Asbestos & Lead Based Paint Assessment

City of Spartanburg
218 North Forest Street
Spartanburg, South Carolina 29301

Project Number: 0120-17

July 10, 2020

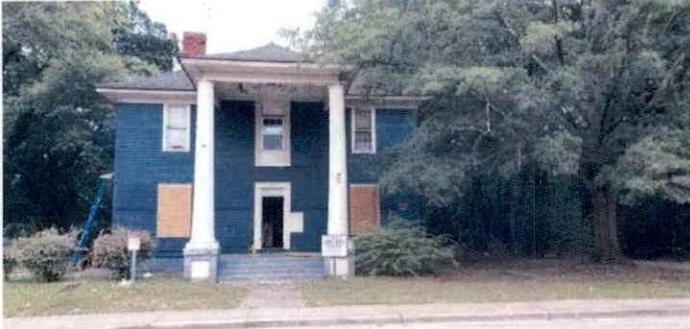
Photo 1 – 218 North Forest Street in Spartanburg, South Carolina 29301

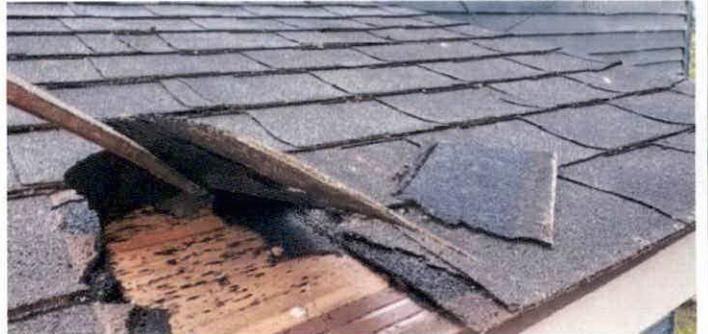
Photo 2 – Roof shingles & felt paper

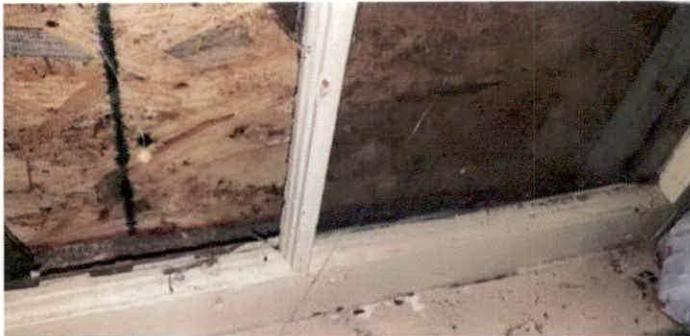
Photo 3 – Caulk on wooden window panes

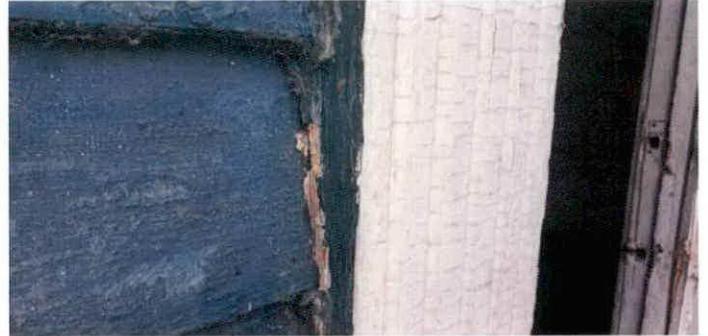
Photo 4 – Caulk on wooden window & door casings & on 1 vinyl window casing.

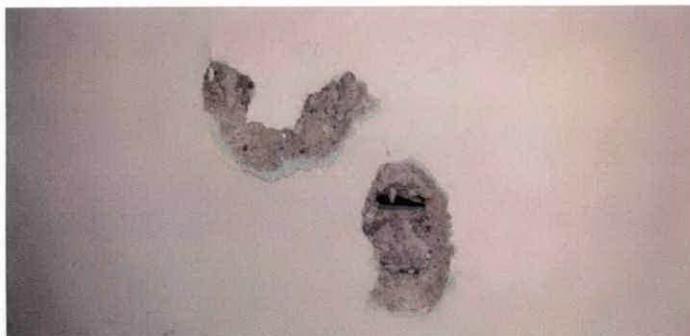
Photo 5 – Plaster with finish throughout walls & ceilings

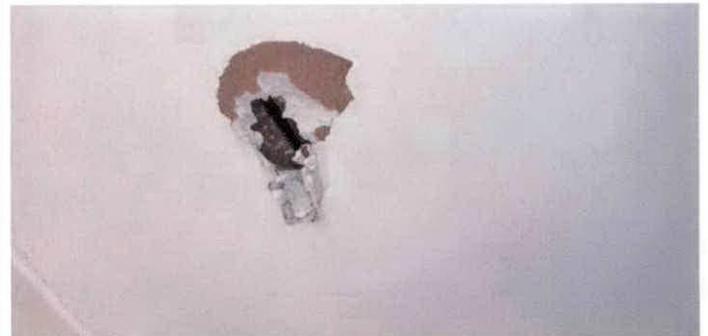
Photo 6 – Drywall with joint compound & no tape scattered throughout walls & ceilings

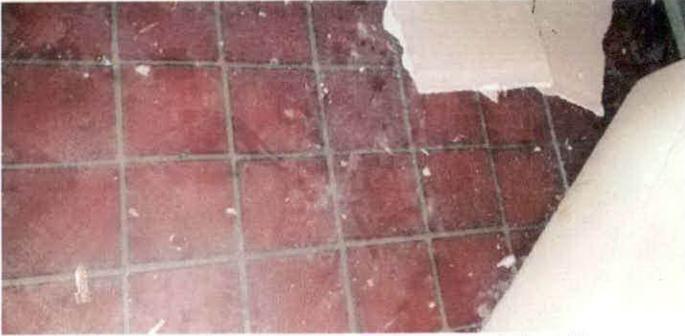
- Approximately 80 SF of the brown large square pattern vinyl floor in Apartment 1 kitchen (top layer).
- Approximately 80 SF of the brown small square pattern vinyl floor in Apartment 1 kitchen (2nd layer under wood).
- Approximately 20 LF of black tar on 2 chimneys and vent pipes – assumed positive

Photo 7 – Brown large square pattern vinyl floor & adhesive in Apartment 1 kitchen – top layer.

1. Abate the asbestos containing materials in the structure prior to renovation or demolition.

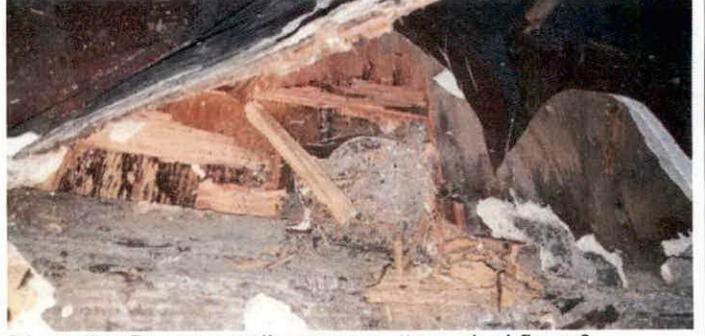
Photo 8 – Brown small square pattern vinyl floor & adhesive in Apartment 1 kitchen – 2nd layer under wood.

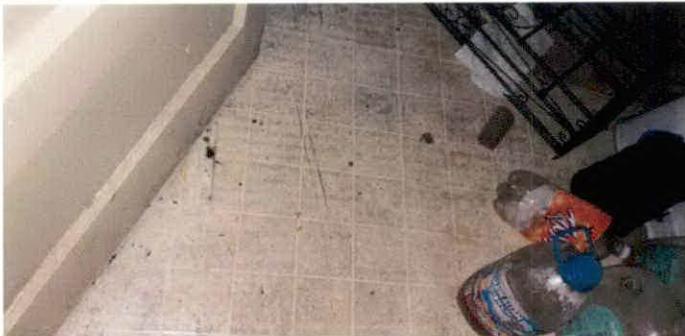
Photo 9 – Tan medium square pattern vinyl floor & yellow adhesive in Apartment 1 bathroom.

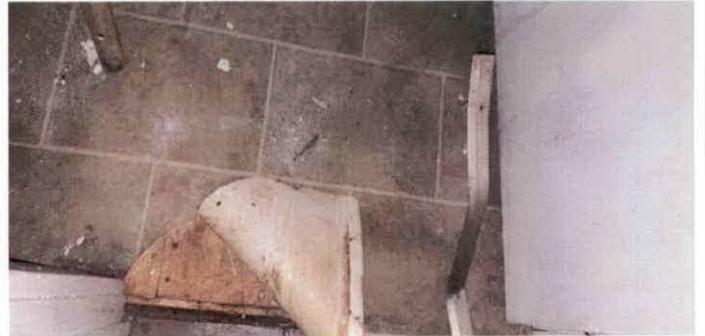
Photo 10 – Brown large rectangle pattern vinyl floor with no mastic/adhesive in Apartment 2 bathroom.

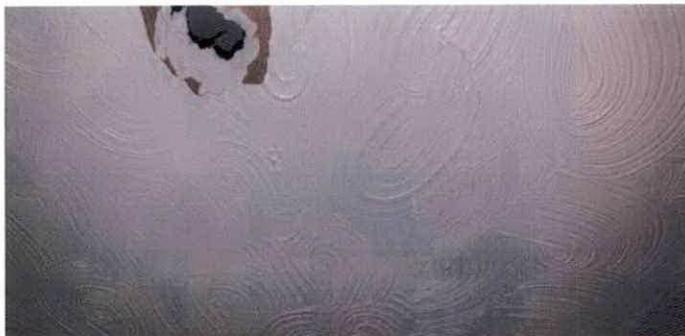
Photo 11 – Ceiling texture scattered throughout

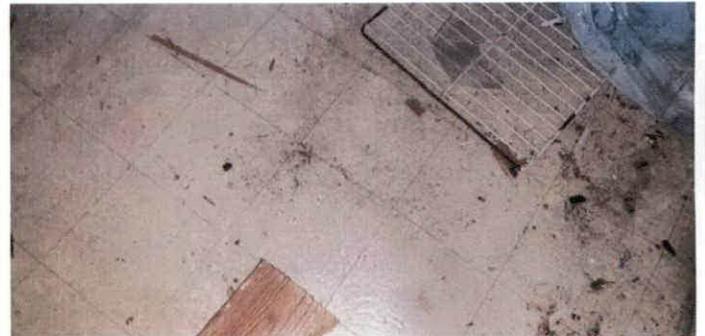
Photo 12 – Beige medium square pattern vinyl floor with no mastic/adhesive in Apartment 3 kitchen – top layer.

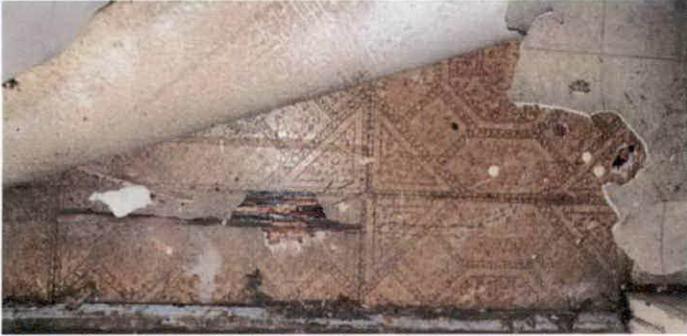
Photo 13 – 12" x 12" brown floor tile & mastic in Apartment 3 kitchen – 2nd layer.

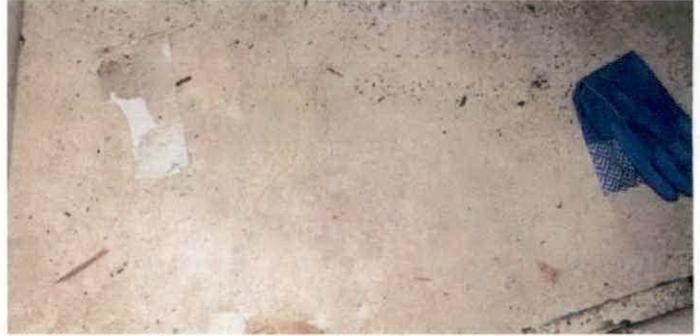
Photo 14 – Cream pattern vinyl floor with no mastic/adhesive in Apartment 3 bathroom – top layer.

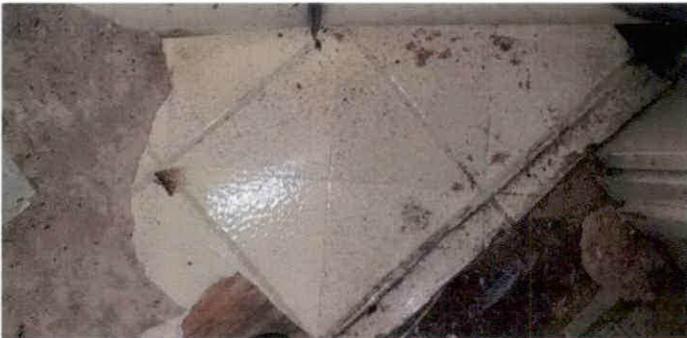
Photo 15 – White square pattern vinyl floor & adhesive in Apartment 3 bathroom – 2nd layer.

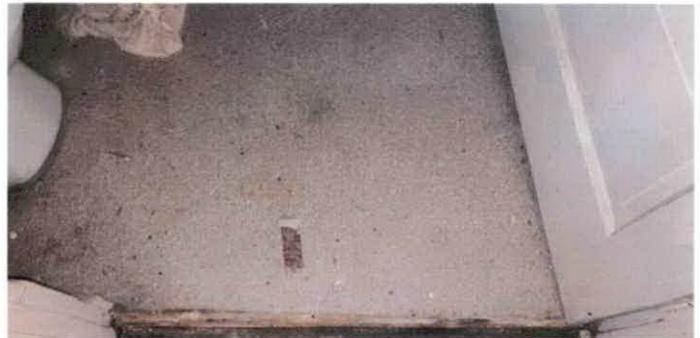
Photo 16 – Gray pebble pattern vinyl floor & adhesive in Apartment 4 bathroom – top layer.

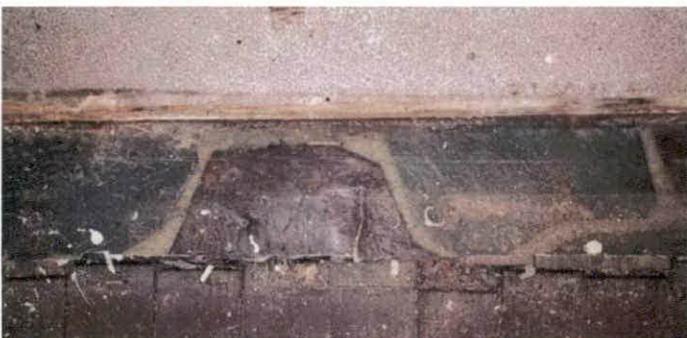
Photo 17 – Gray slate stone pattern vinyl floor with no mastic/adhesive in Apartment 4 bathroom – 2nd layer under wood.

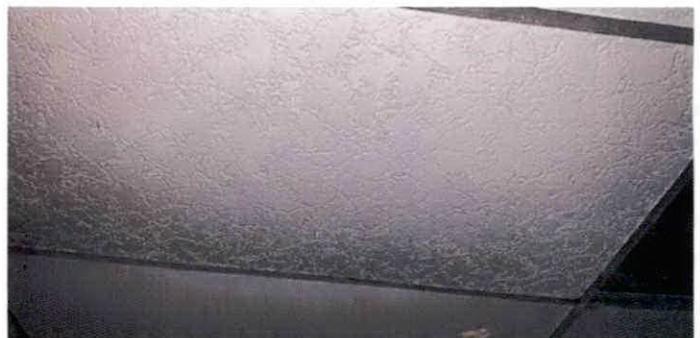
Photo 18 – 2' x 4' ceiling tiles in Apartment 1 bathroom.
