2.1 Architectural Significance and Construction History

3.0 Structure Condition Assessment

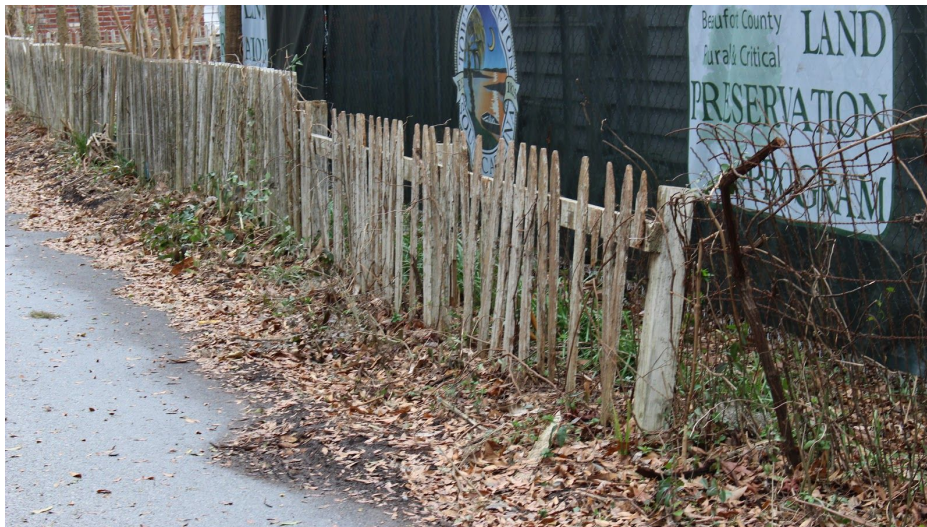
According to the survey done by the Surveying Consultants on 04/12/2017 there are 65 combined trees, shrubs, and other vegetation composed of 10 different species, including: Cedar, Cherry, Chestnut, Dogwood, Hackberry, Laurel Oak, Live Oak, Magnolia, Palmetto, and Red Bud. There is a wood and wire fence wrapping the property's perimeter and concrete walkway connecting Calhoun Street to the front porch. There are no sidewalks along the street.

3.1a Associated Landscape Features: Wood Fence

Recommend fence be removed, sidewalks installed at street edges, and remaining vegetation be preserved.

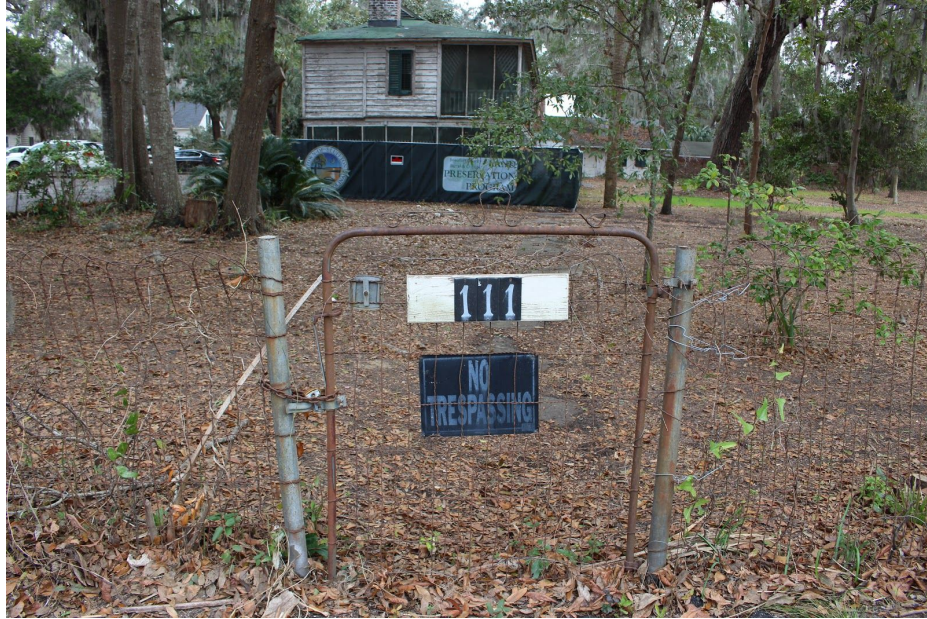
3.1a Associated Landscape Features: Wire Fence

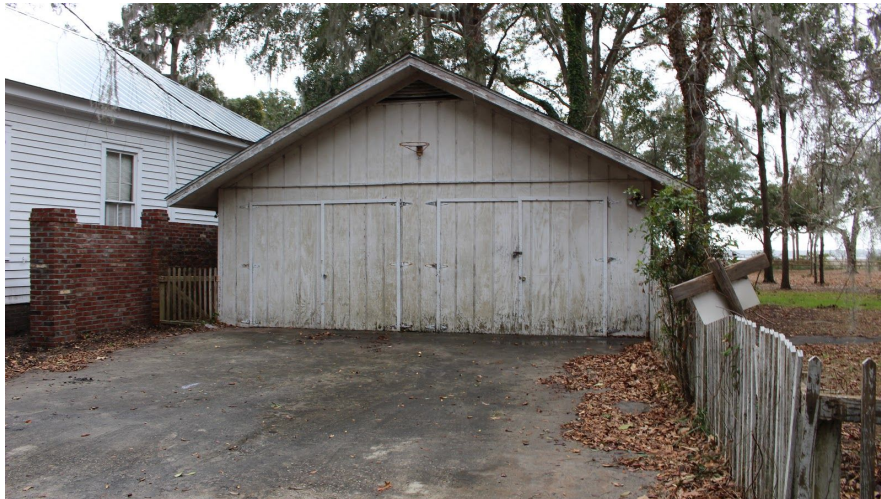
There is an existing concrete driveway in the north-east corner of the lot. There are no designated parking spaces along the streets.

3.1b Parking: Concrete Driveway

Recommend perpendicular parking spaces be constructed along Calhoun Street.

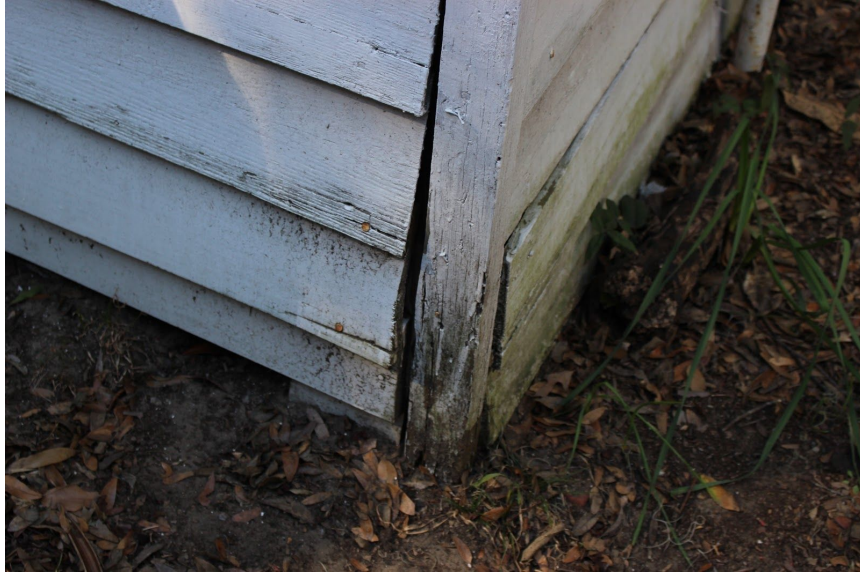
There is no existing visible foundation underneath the carriage house. The porch columns of the carriage house are supported by dry-stack bricks. The porch floor appears to slope dramatically away from the building. Wood posts at corner of house appear to be sitting on soil.

3.2a Foundation System: Wood Posts Sitting Directly on Soil

Recommend the house is lifted and new brick pier foundations be constructed.

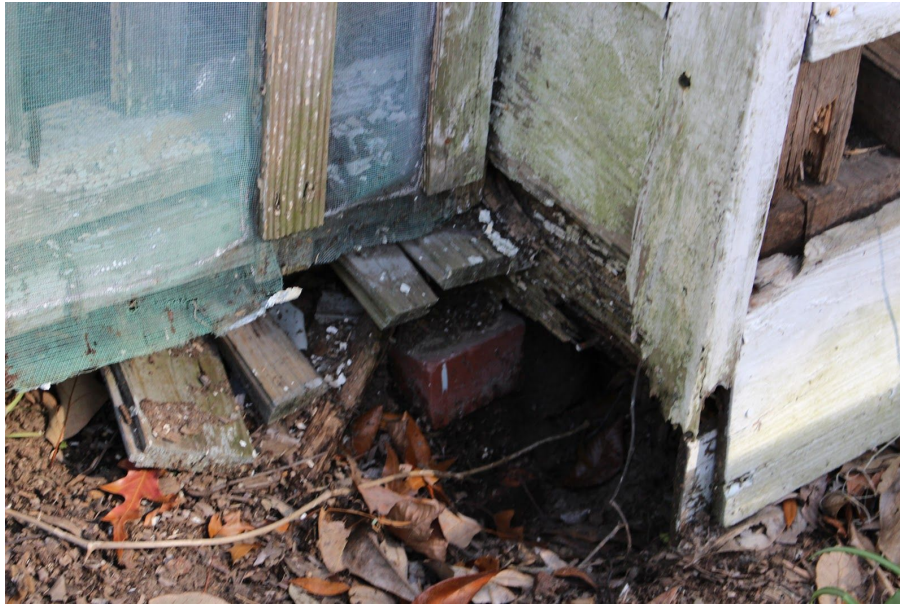
3.2a Foundation System: Dry-Stack Bricks Beneath House

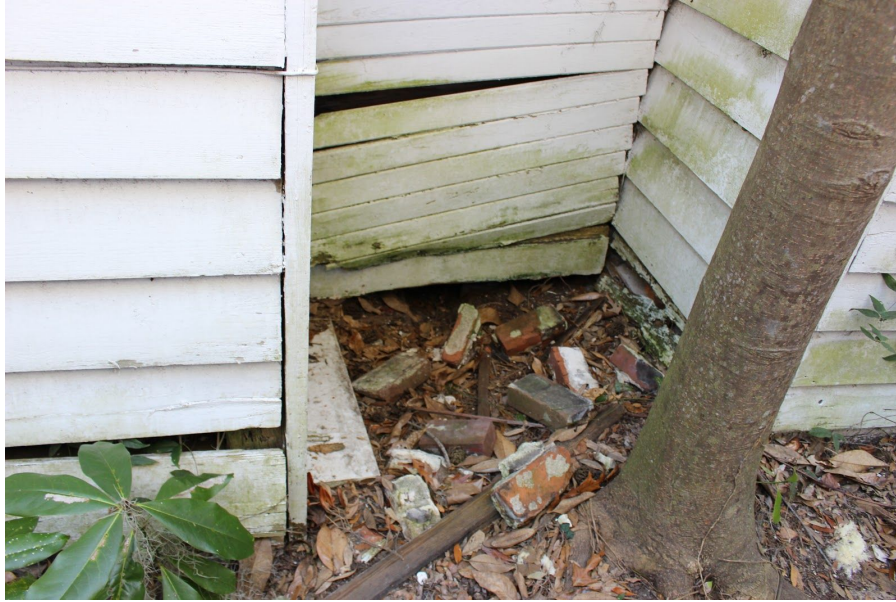
There are no drainage gutters visible. This is a flat lot and there appears to be no visible drainage problems. There is an indentation where the two structures meet where drainage could be a problem.

3.2b Perimeter Foundation Drainage: Drainage Problem Where Both Structures Meet

Recommend gutters be installed and the site be re-graded at the time of foundation construction.

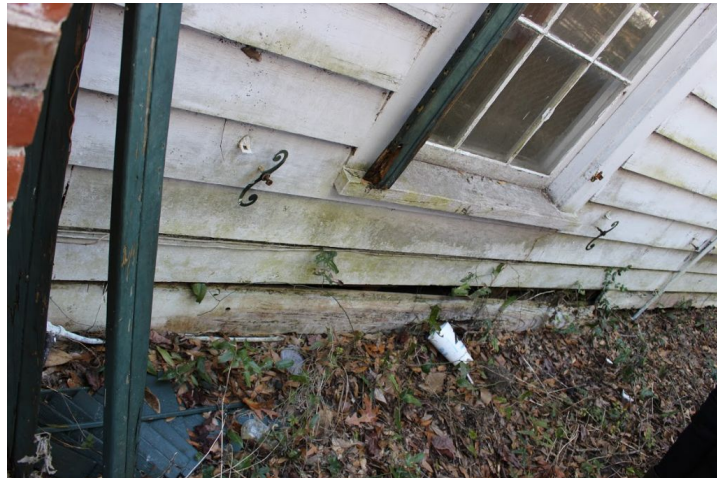
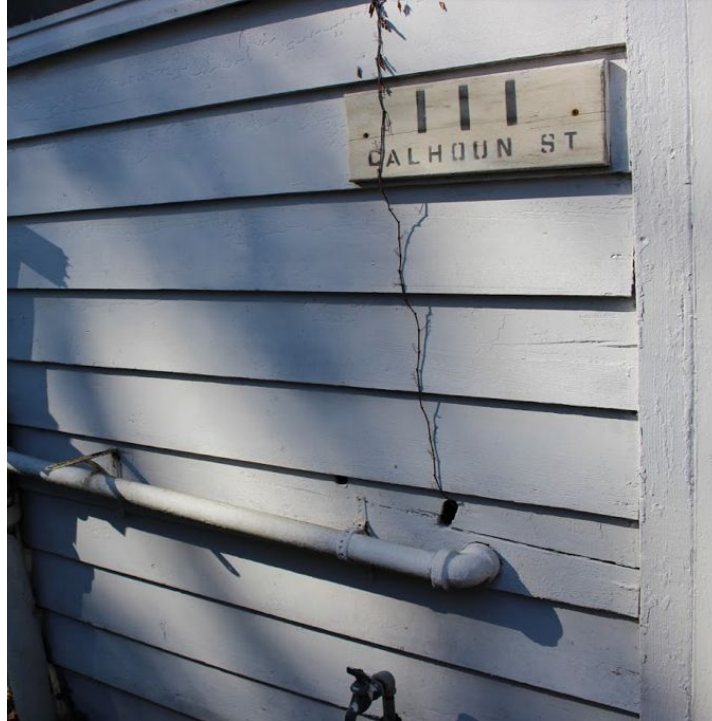
Exterior wall construction is painted wood clapboard. Deteriorated where water is present. Substrate is not visible at this time.

3.4a Exterior Wall Construction: Siding

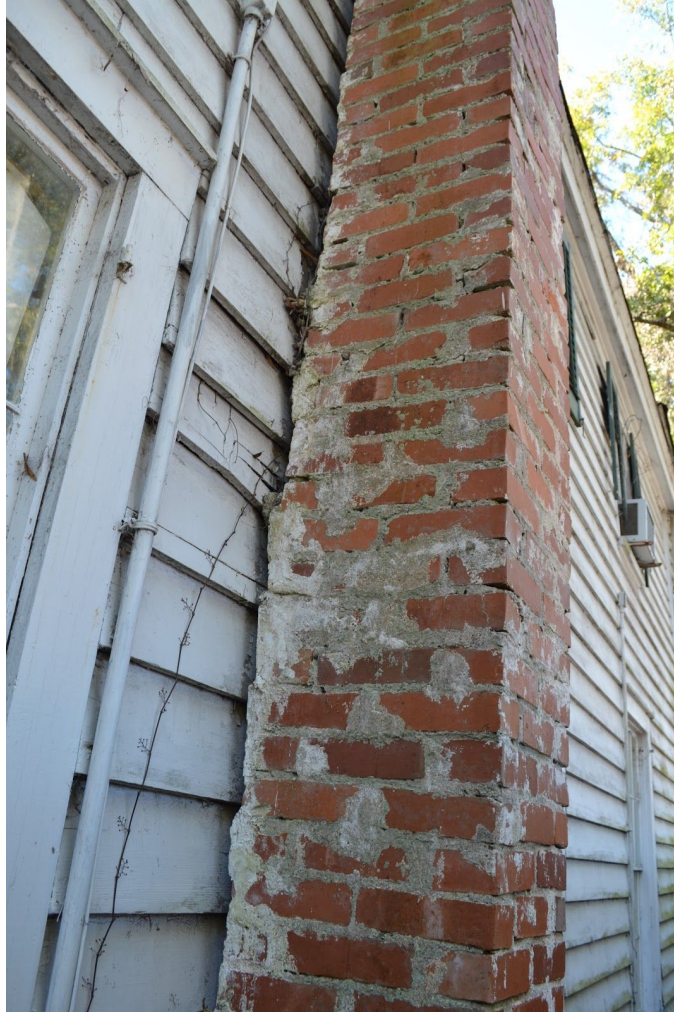
There are four chimneys on the structure, one is visible from the outside. There is a small brick fireplace in the rear of the house. It is the most recent, although abandoned because it provides ventilation of the stove pipe. The stack has separated from the house itself. The porch steps are made of brick

3.4c Exterior Masonry: Exterior Fireplace

Recommend either to be removed and rebuilt and/or reattached to the house. Recommend brick stairs be fixed for public use.

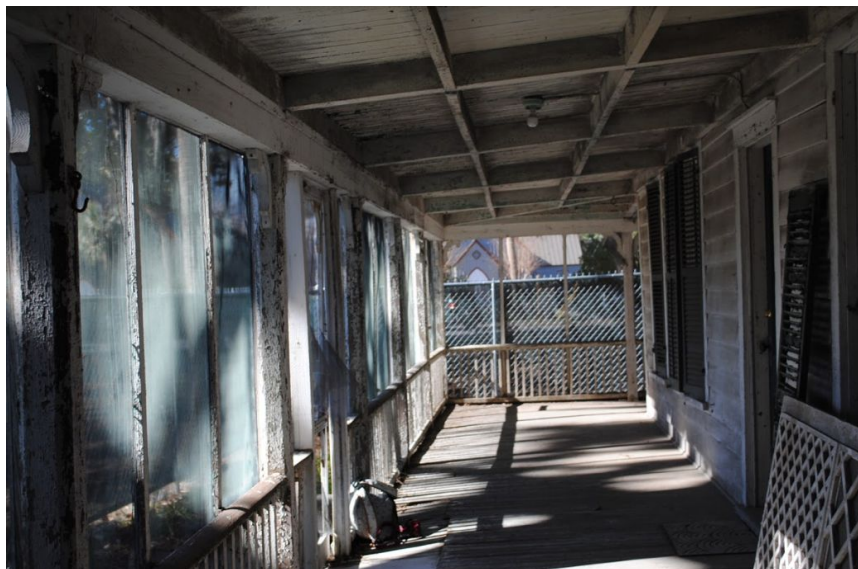
There is a screened-in porch on the North side of the main building. The porch may or may not be original to the building. On the second story the bump-outs are not original to the building. There is lattice on the porch. The floor of the porch is sloping away from the building.

3.4d Exterior Appendages: Porch

Recommend that the screens should be replaced or taken off. The porch railings are needing painting. Recommend that it be leveled with by repairing the foundation. Depending on the proposed use the porch may require restoration to remove bump-outs.

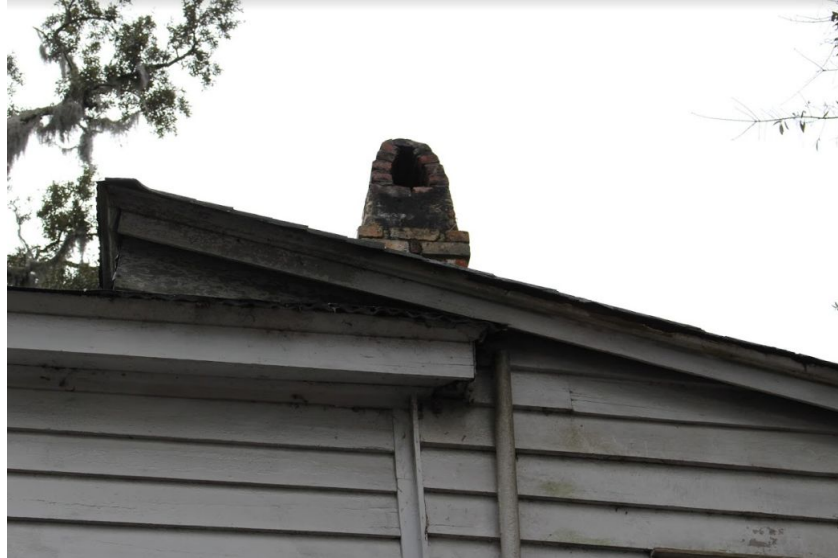
The main house and assumed kitchen building both have steep sloping roofs. The main building has green asphalt shingle. Damage to the roof is undetermined. There appears to be multiple

layers of roofing in some areas of the main building, where the connection of the two buildings come together. The kitchen building metal roof. The metal roof is rusted. Other damage is undetermined.

3.5a Roofing Systems: Main Building Roof

Recommend all roofing being replaced with a metal roof.

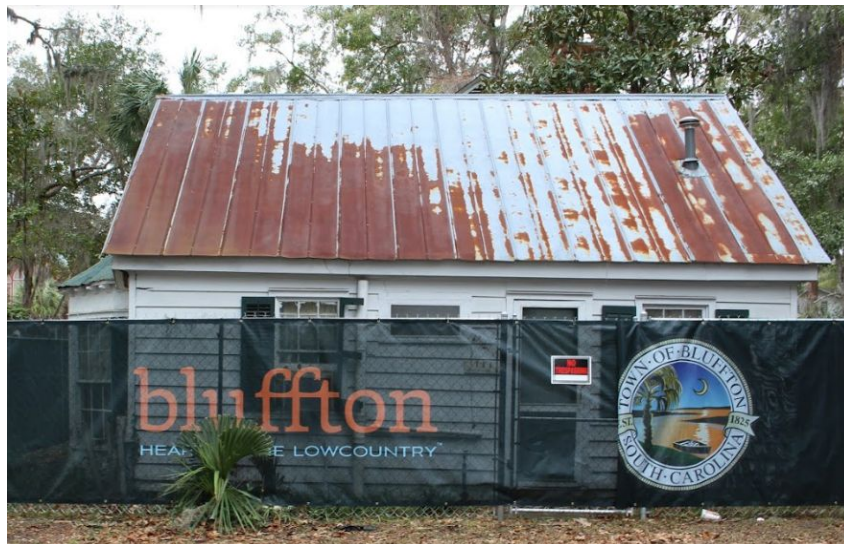
3.5a Roofing Systems: Secondary Building Roof

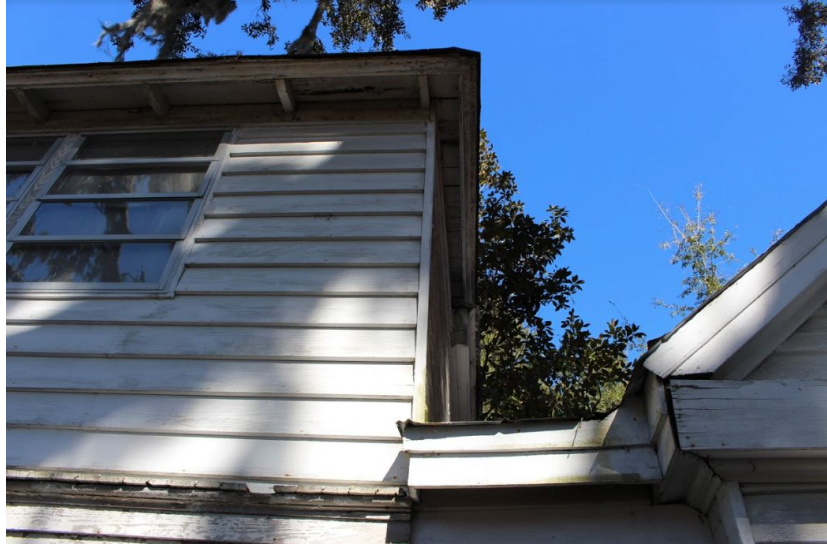
There does not appear to be a drainage system attached to the buildings.

3.5c Drainage System, Gutters, Downspouts: No sign of gutters

Recommend that gutters, downspouts, and drainage system be added.

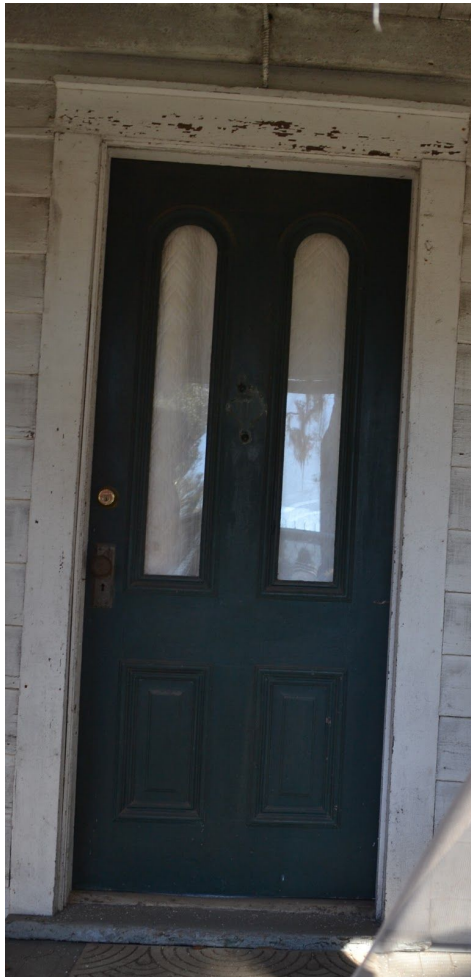
There are 3 doors that exit the building. There is a green front door on the North side of the building. There is green door on the smaller connected building. There is a door on the East side of the connected building. There is a screen door that leads on to the porch. *Reference section 4.1 for lead paint*

3.6a Doors: Front Door

Recommend doors be rehabilitated and reinstalled.

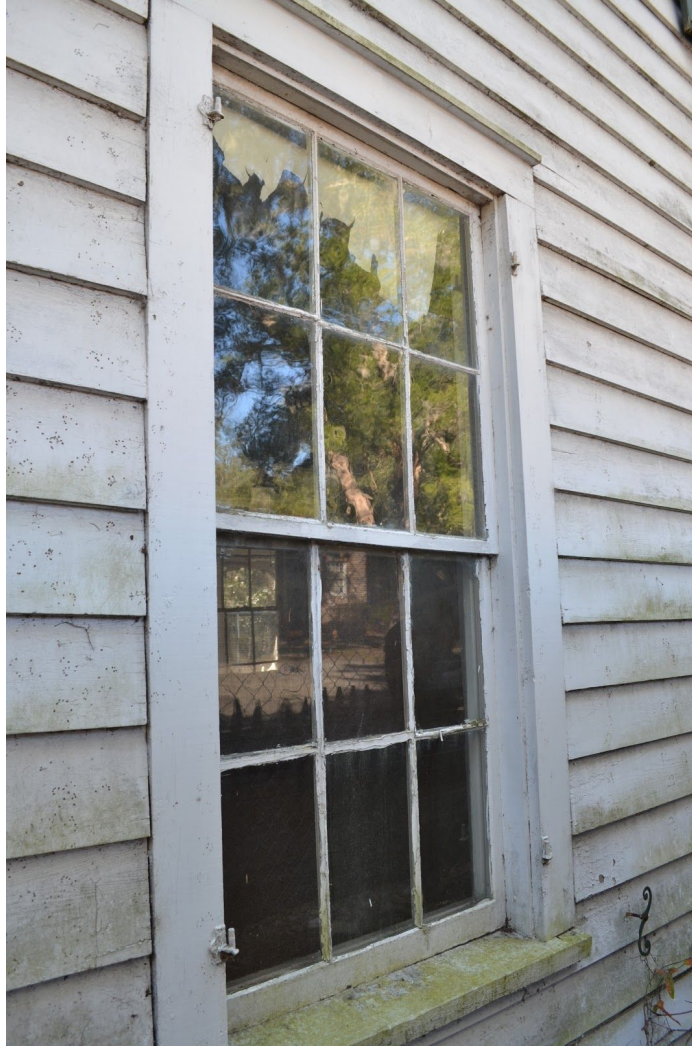
The windows are rectangular and single/double hung. The windows are 6/6. The material is wood. Second-floor windows on the South bump-out are mid-century, aluminum Jalousie. They are rectangular and have four horizontal panes. They do not appear to be broken. *Reference section 4.1 for lead paint*

3.6b Windows: Rear Window

Recommend minor repairs to make windows work. Recommend painting and cleaning.

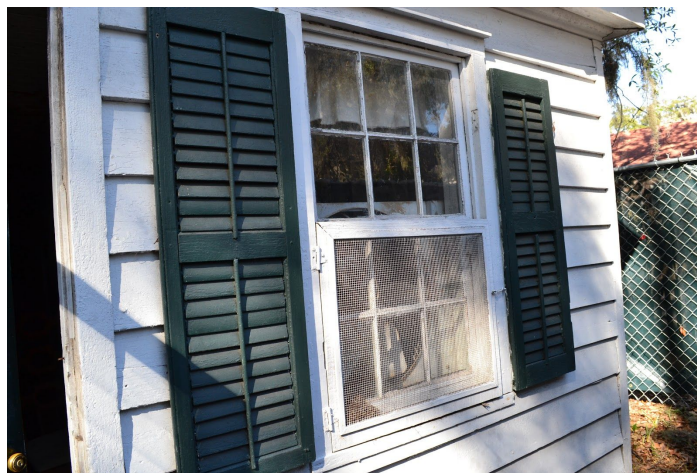
3.6e Finishes

All the windows appear to have had green wood shutters attached to them. Some are missing or broken off. *Reference section 4.1 for lead paint*

Recommend that shutters be replaced and repainted with like style shutters.

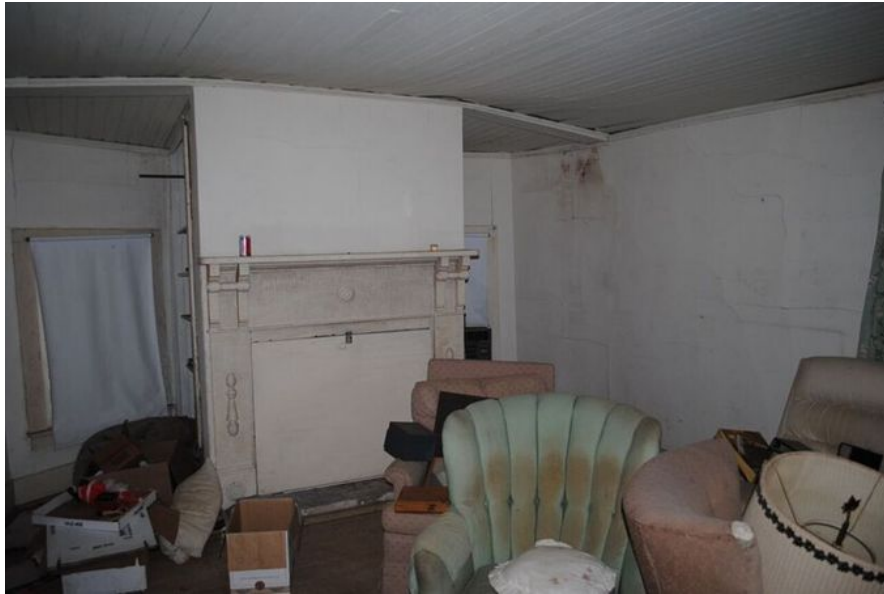
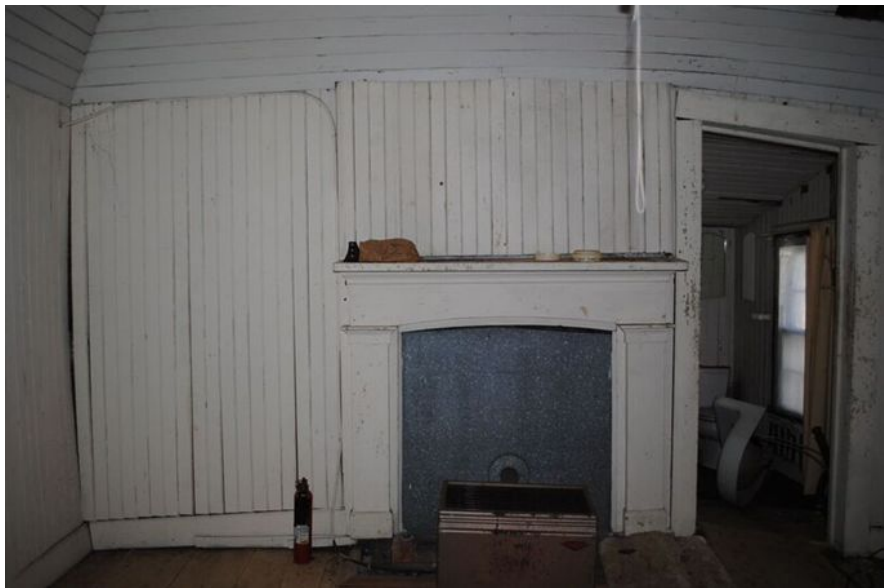
The main house features a vertical wood beadboard wainscot throughout with moth spaces also featuring vertical beadboard above the wainscot as well. In the kitchen, horizontal planks have been installed at an angle near the ceiling. Mostly discolored and deteriorating, the finishes are not in prime condition but do not show any serious structural flaws. In between the points where a connector joins the carriage house forming a small bridge and/or cubby hole, there is a space where exterior siding of the house is exposed, which seems to be in the roughest shape compared to the rest of the wooden board patterns throughout the main house. The kitchen does not feature a wainscot. In many places there is peeling paint and slight signs of mold and decay. The only change in the is in the second-floor bedroom, which is a more typical plaster and lathe wall with cracks and water damage, especially above the windows which appear to have been added or modified at some point (*reference section 4.1 for lead paint*).

3.7a Interior Finishes: Wall Finishes

Recommend removal of wood finishes as needed per new proposed use. Retain wood wainscot. Recommend plaster rather than gypsum board finish for historic integrity.

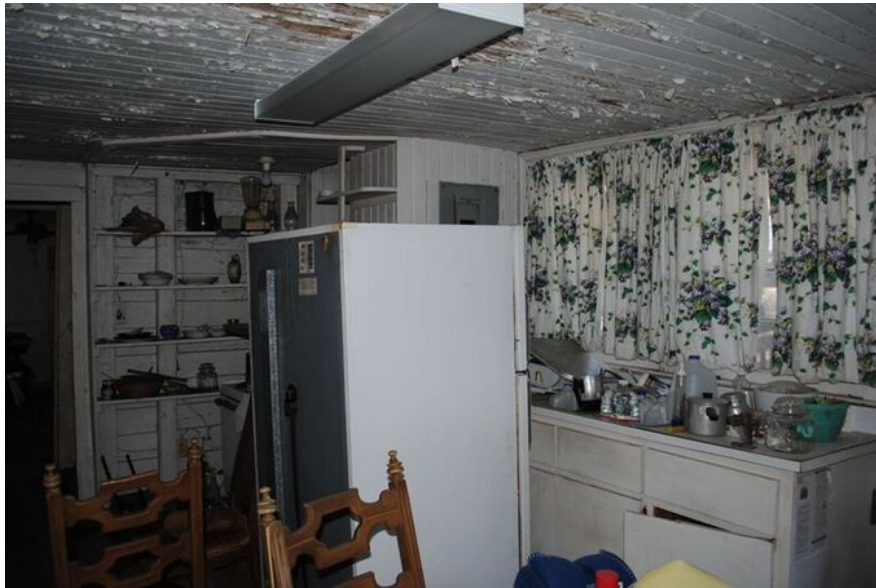
Like the walls, most of the ceiling finishes are also beadboard, painted white. There are a few structural issues where small holes show between the second-story and the first, especially prevalent near the stairs. In the kitchen area, most of the paint has peeled off the wood and hangs in open strips. There are points of structural integrity that are lacking within the property, as cracks in the ceiling and deterioration suggests instability (*reference section 4.1 for lead paint*).

3.7b Interior Finishes: Ceiling Finishes

Recommend removal and construct plaster ceilings.

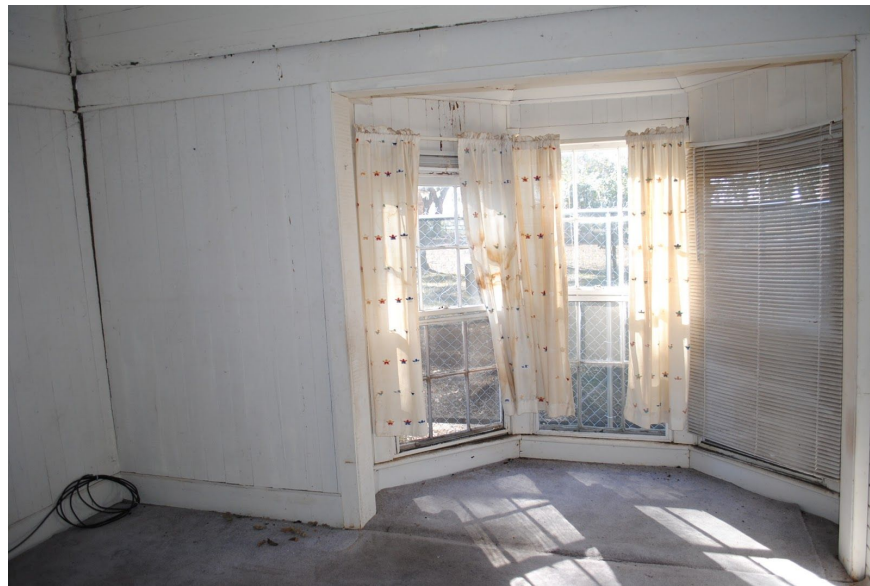
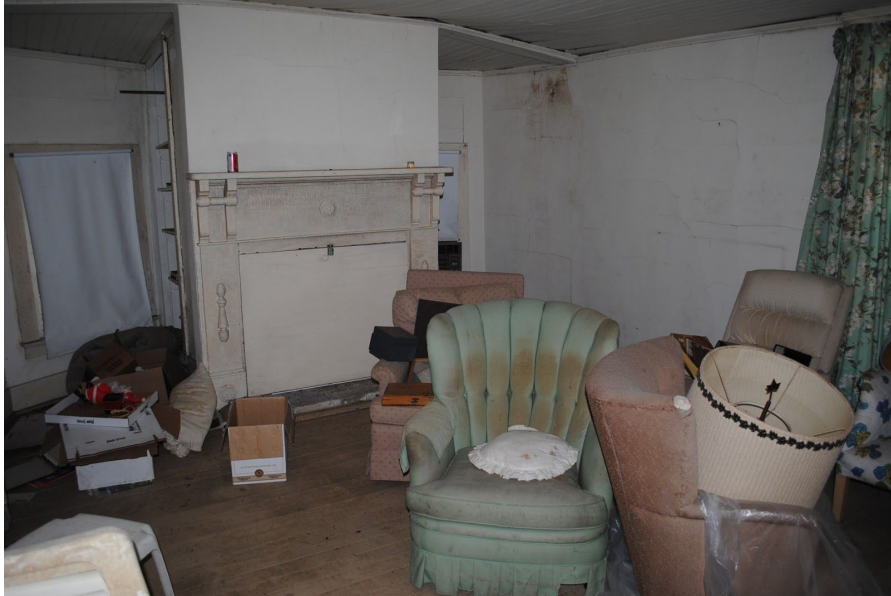
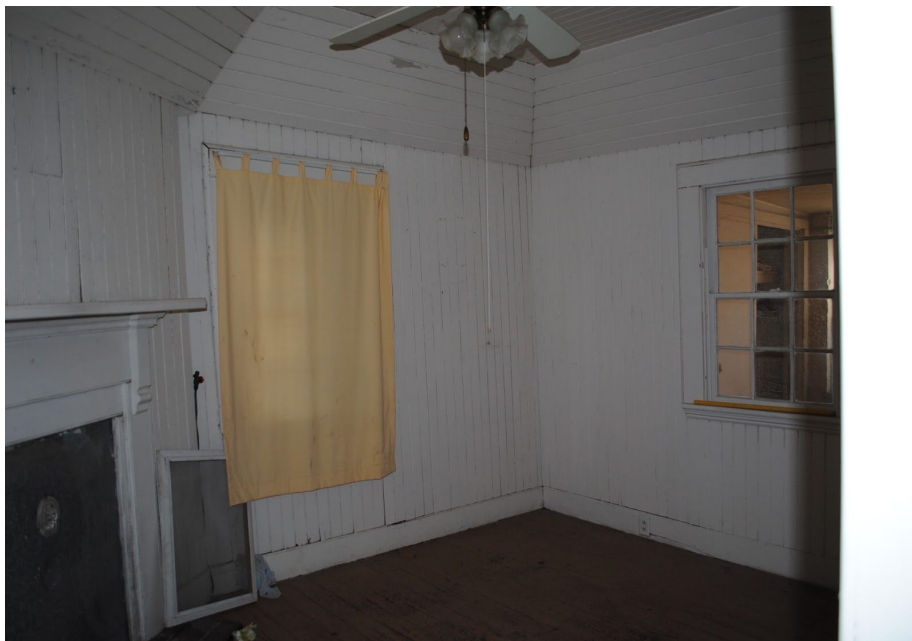
Throughout the interior, the floor is constructed of wood planks, worn and warped from humidity. There are apparent patches of damage, likely termites and deterioration. In the screened-in porch, there are severe structural issues in the wood floor boards; there are areas so rotted that if weight is placed on them, they may give way and crumble.

3.7c Interior Finishes: Floor Finishes

Immediate treatment should take place on the porch as it is currently not able to structurally support a person in some areas.

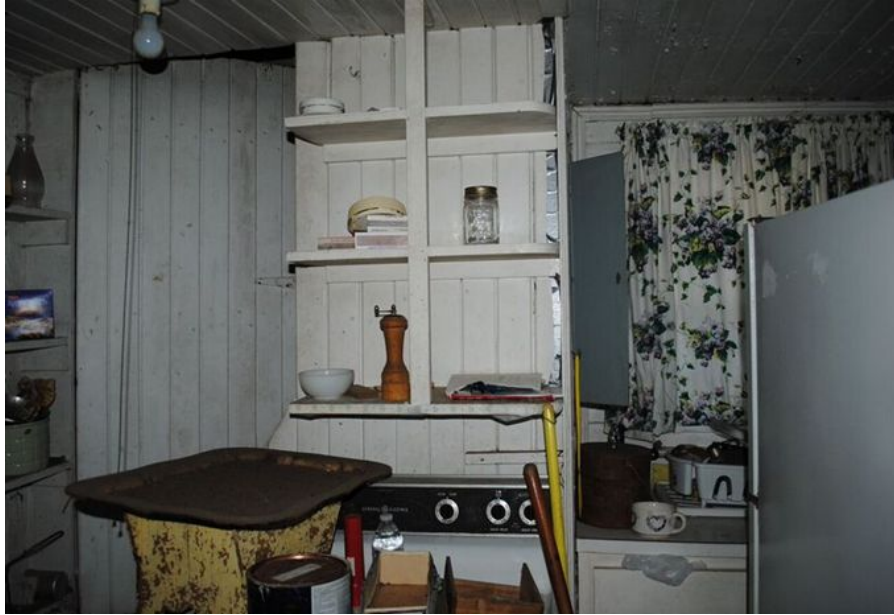
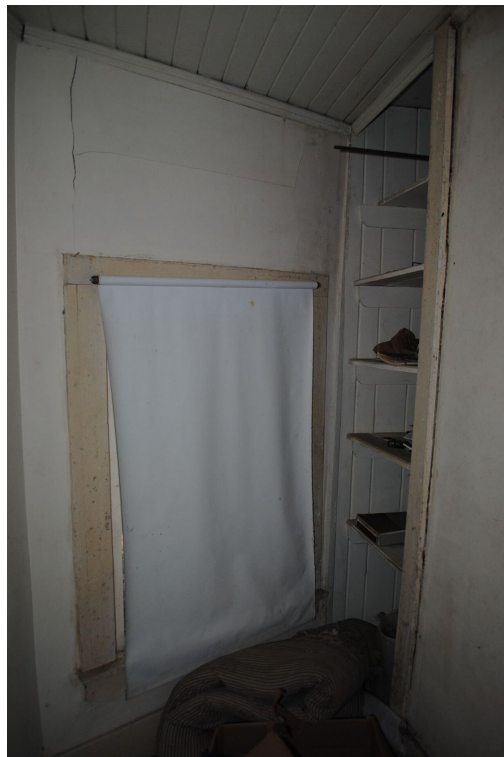
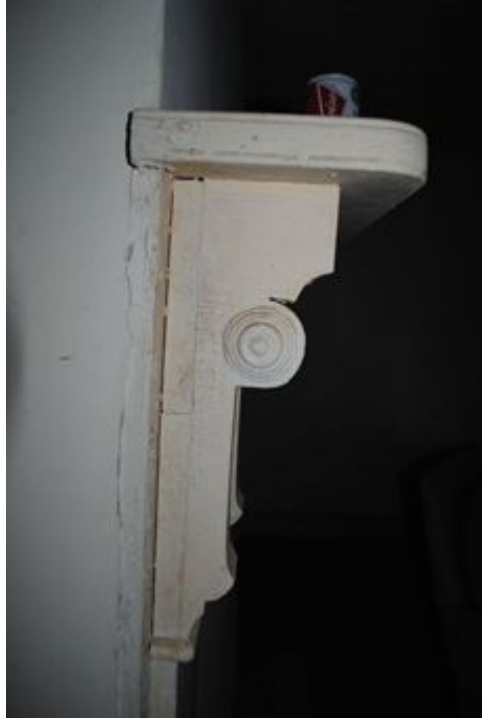
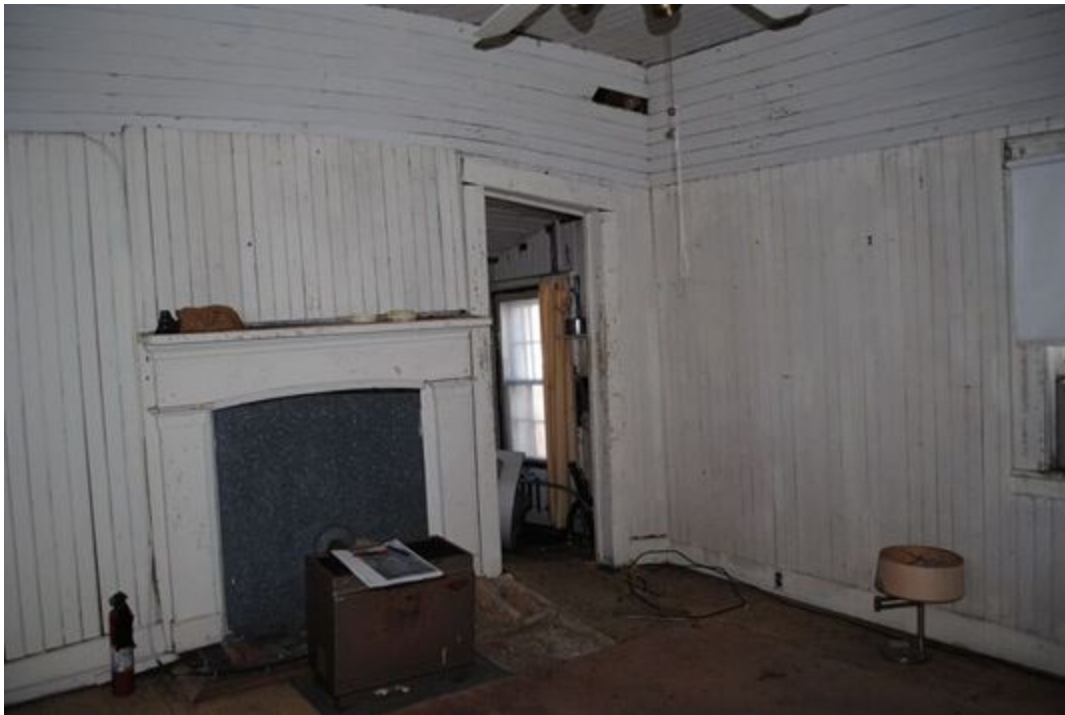
The interior trim of the building is comprised of a few decorative mantels, and a series of built-in shelves. All interior trim and built-in fixtures are wood. The cupboards and shelving are presumed to have been added in more recent years to accommodate limited storage, and are

most likely not original. The mantels are decorative containing carvings and scrollwork, but today have peeling paint and discoloration (*reference section 3.6d for exterior trim*).

3.7d Interior Finishes: Interior Trim and Built-Ins

3.7d Interior Finishes : Interior Trim and Built-Ins

Recommend removal of shelving per proposal and repainting mantels.

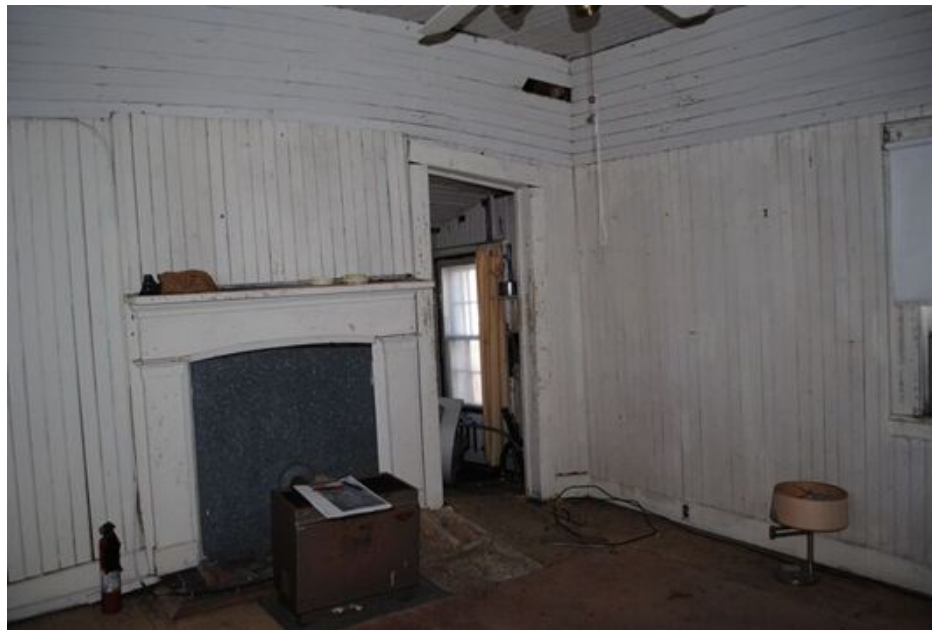
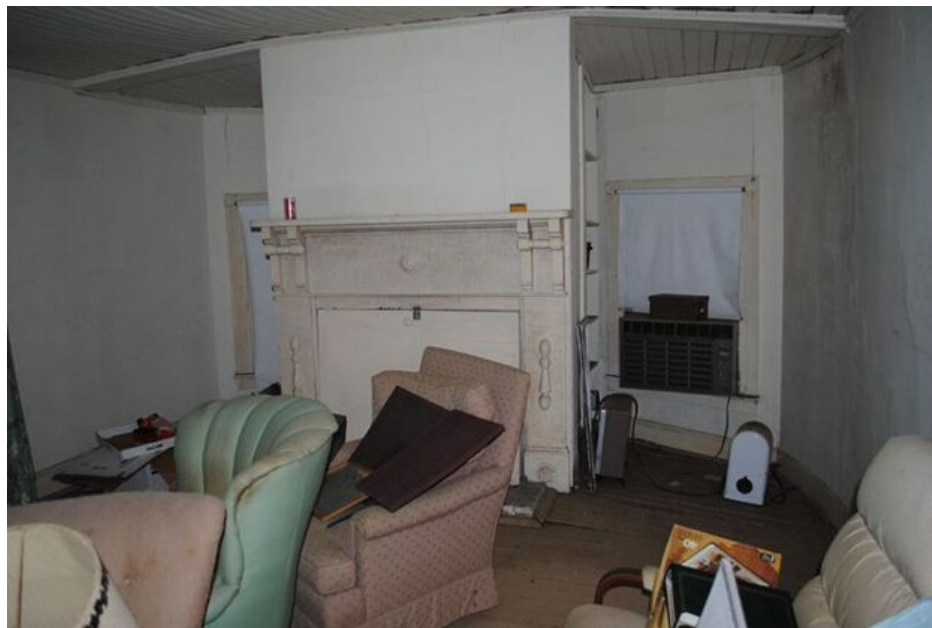
Heating and air conditioning units on the property are outdated and appear unsafe. The heating exists as units throughout the property that connect to the walls, or to the fireplaces, radiating heat in a central manner. The fireplaces in these spaces have been blocked off and the heating is ventilated through the old chimney flue that connect to the units downstairs. The air conditioning system in the house consists of window units upstairs and downstairs.

3.8a Mechanical Systems: Heating and Air Conditioning

Based on appearance and age of both systems, they likely are nonfunctional, and should be replaced with a central energy efficient system.

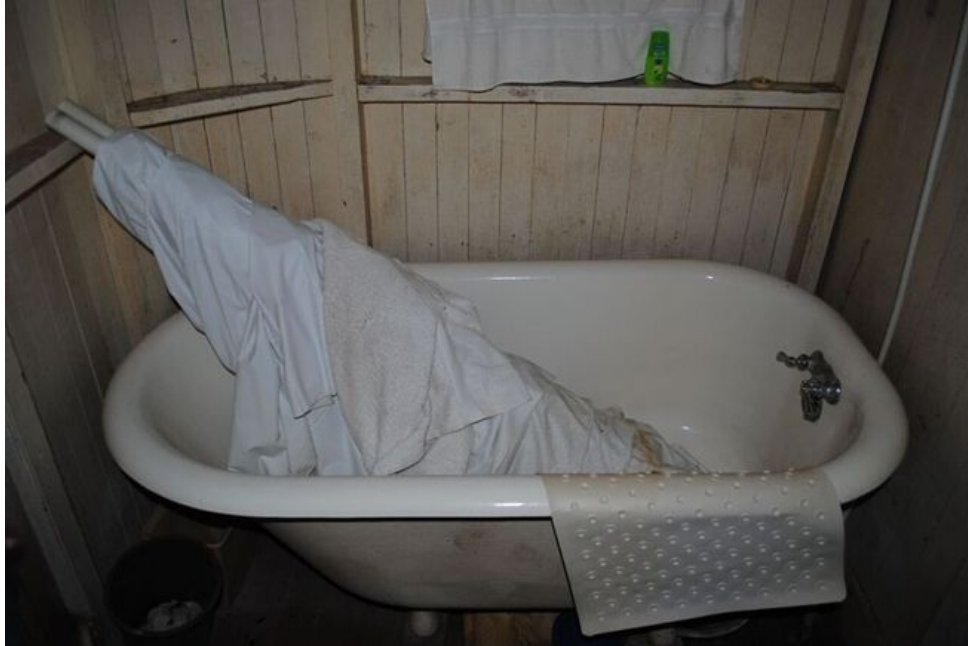
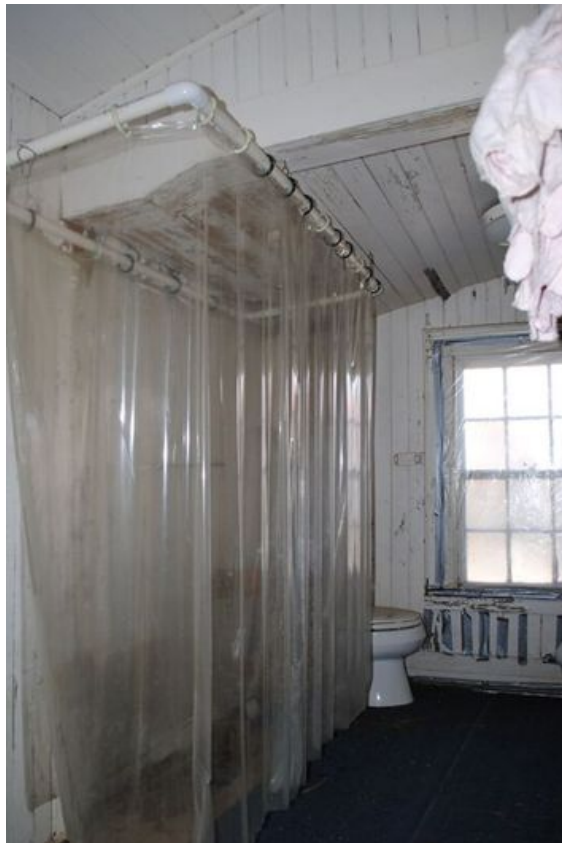
Water service in the property consists of a kitchen sink, two bathrooms, both with bathroom sinks, and one bath and a single shower. All these fixtures are long outdated, with the shower upstairs simply emptying out onto a floor where it drains. There are two toilets on the property, which both connect presumable to a septic tank. The bathtub is cracked and discolored. The plumbing infrastructure is located on the exterior of the house with all pipes visible.

3.8b Mechanical Systems: Water Service, Plumbing, and Sewer Utilities

Remove all plumbing and replace as needed per proposed use. Remove septic tank and connect system to municipal sewer.
