Harborwalk Structural Assessment for the City of Georgetown, SC

August 17th, 2017

COLLINS
ENGINEERS INC.

EMERGENCY ASSESMENT

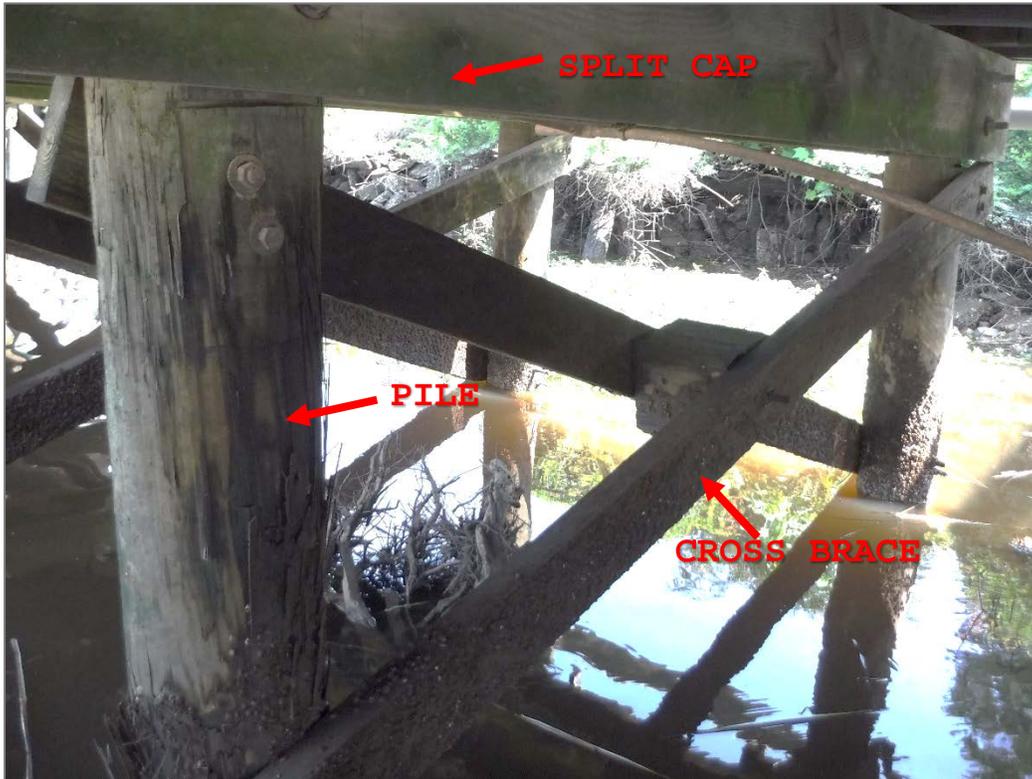
Photo 1: Typical Bent – Southeastern section, 12 foot wide (Sta. 0+30)

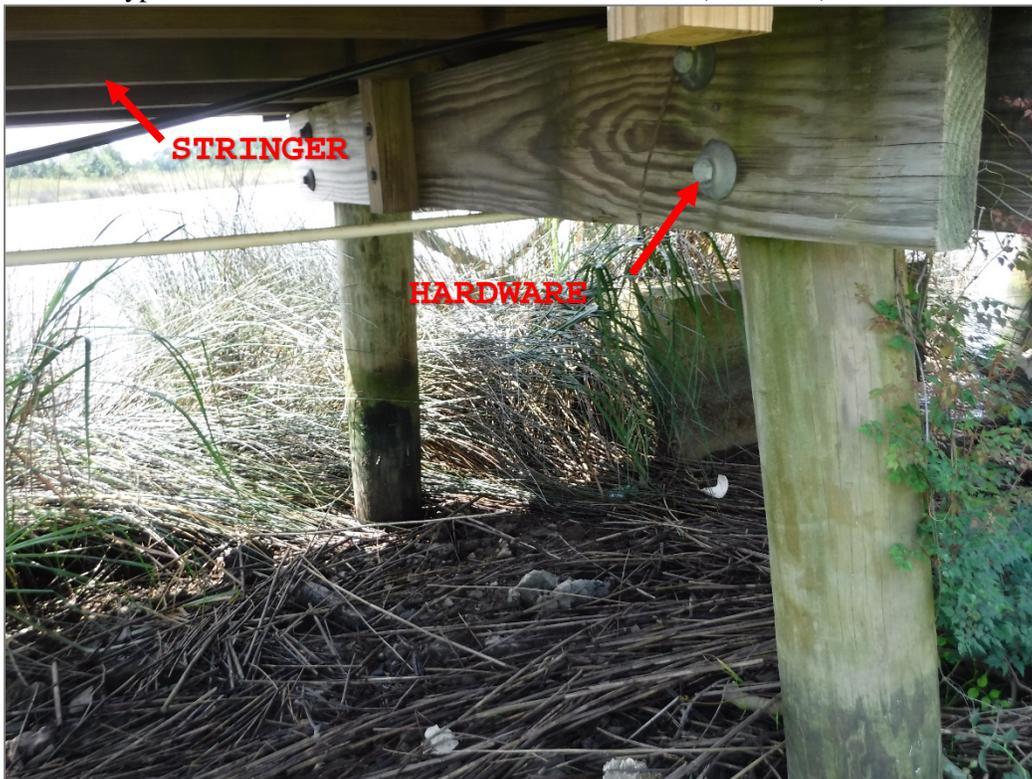
Photo 2: Typical Bent – Northwestern section, 8 foot wide (Sta. 13+70)

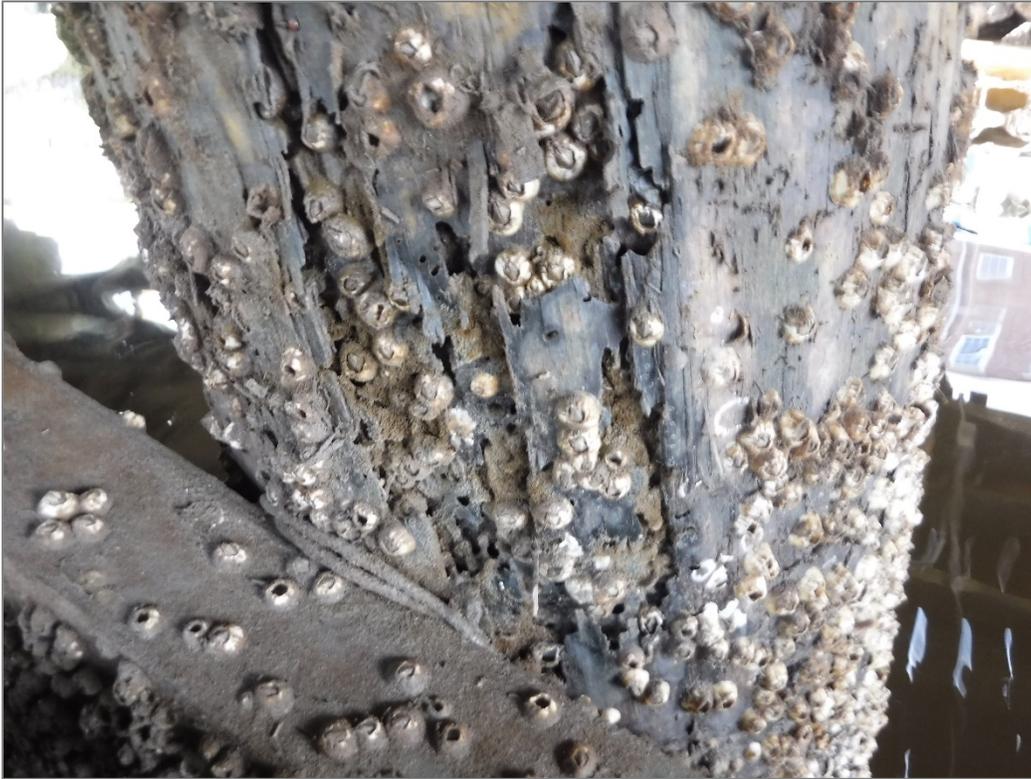
1. Timber Piles- approximately 90 percent of piles exhibited rot and/or fungal decay with less than 5 percent section loss (Minor Condition). Approximately 10 percent of the piles exhibited marine borer activity near the low water line. Marine borer activity was typically localized to a quadrant of the pile and estimated maximum section loss of approximately 15 percent (Moderate Condition, Photo 3). With the exception of the piles with observed marine borer activity, the wood treatment appears to be functioning.

Photo 3: Pile – Typical marine borer damage (Moderate, Sta. 0+10)

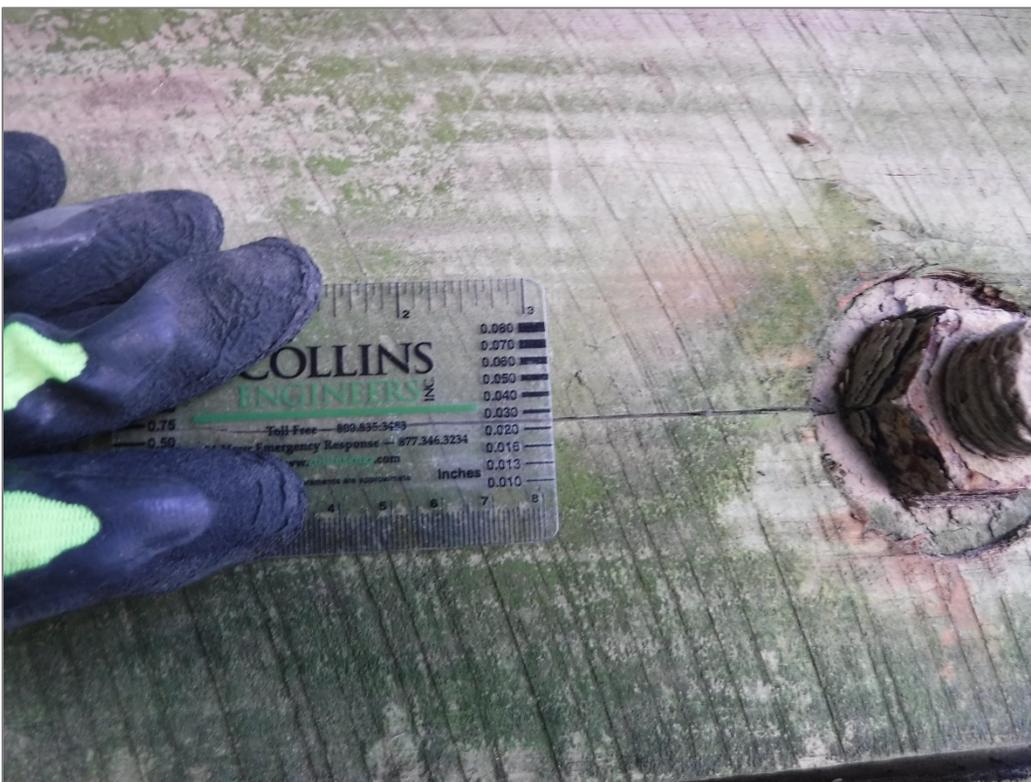
2. Split Cap/Pile Cap- Approximately 95 percent of the caps were in Minor Condition: all exhibited rot and/or fungal decay with less than 5 percent section loss. Approximately 20 percent of the caps also exhibited minor cracking less than 1/8 inch wide that had not penetrated through the entire member cross section (Photo 4). The remaining 5 percent (approximate) were in Major Condition with splits/cracks that penetrated the full depth of the member. The caps rated in Major Condition are outlined in Section 2.2.2.

Photo 4: Split Cap – Typical minor crack, typical fungal growth (Minor, Sta. 0+30)

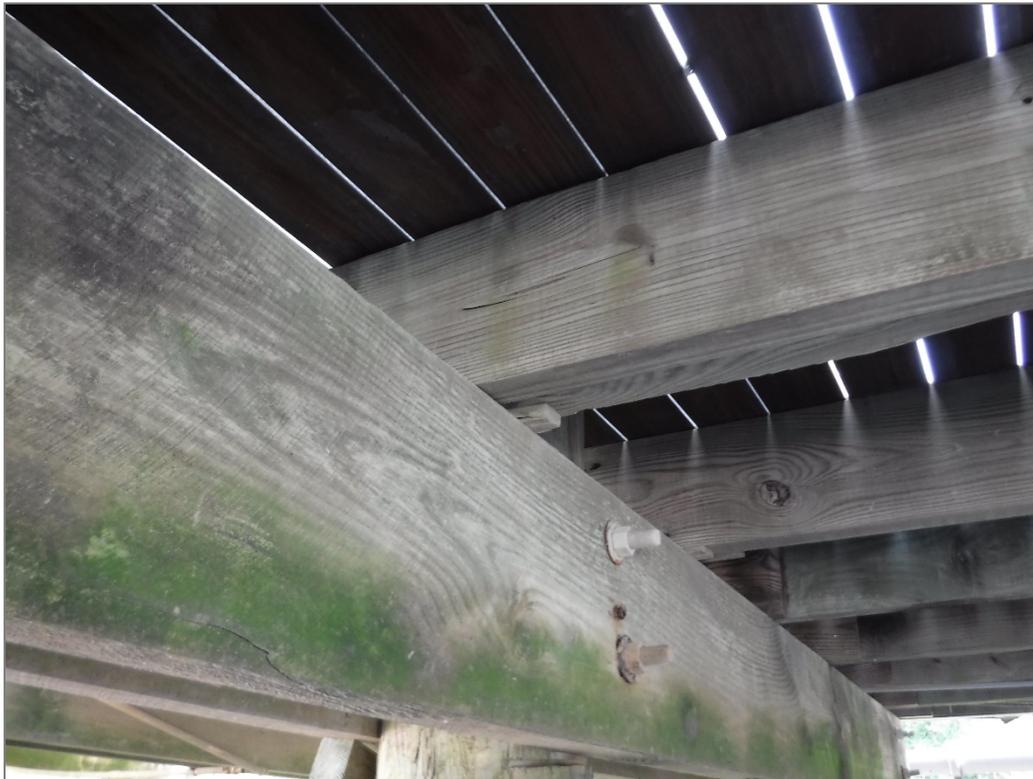
3. Stringers- Approximately 95 percent of stringers were in Minor Condition with minimal rot and fungal decay observed (Photo 5). Approximately 5 percent of stringers were observed to have cracks up to 1/2 in wide (Minor to Moderate Condition, Photo 6); these cracks were all located on fascia stringers and do not appear to affect the structural capacity of the Harborwalk.

Photo 5: Underside – Typical condition stringer and pile cap

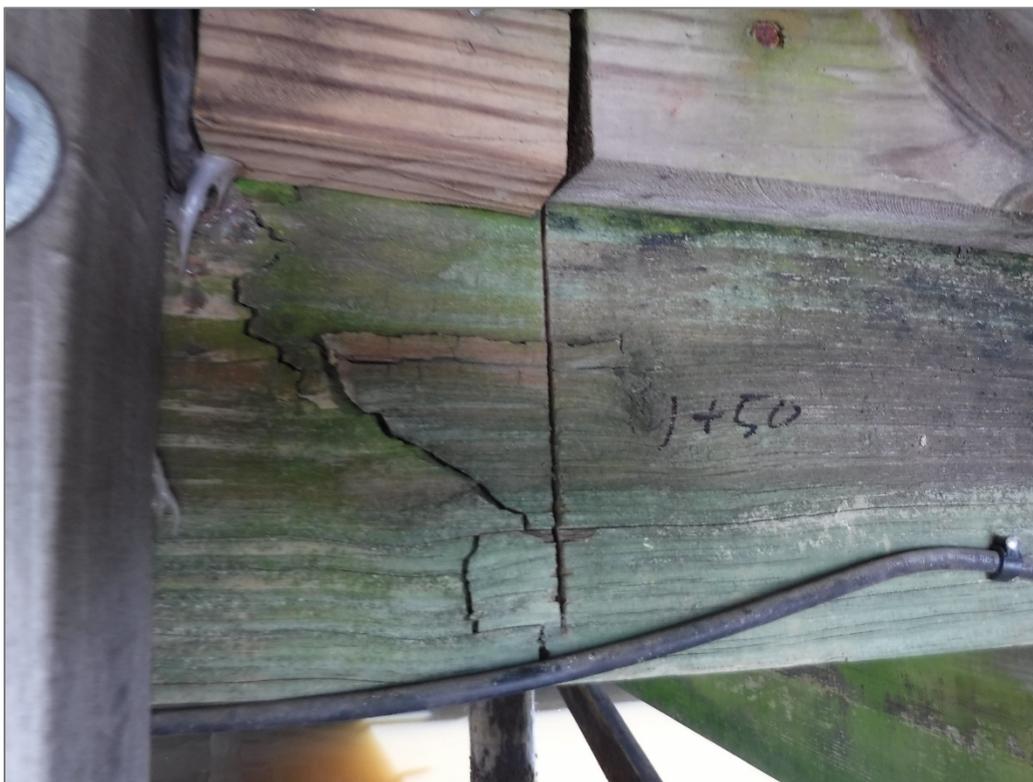
Photo 6: Stringer – Cracking on fascia (Minor, Sta. 1+50)

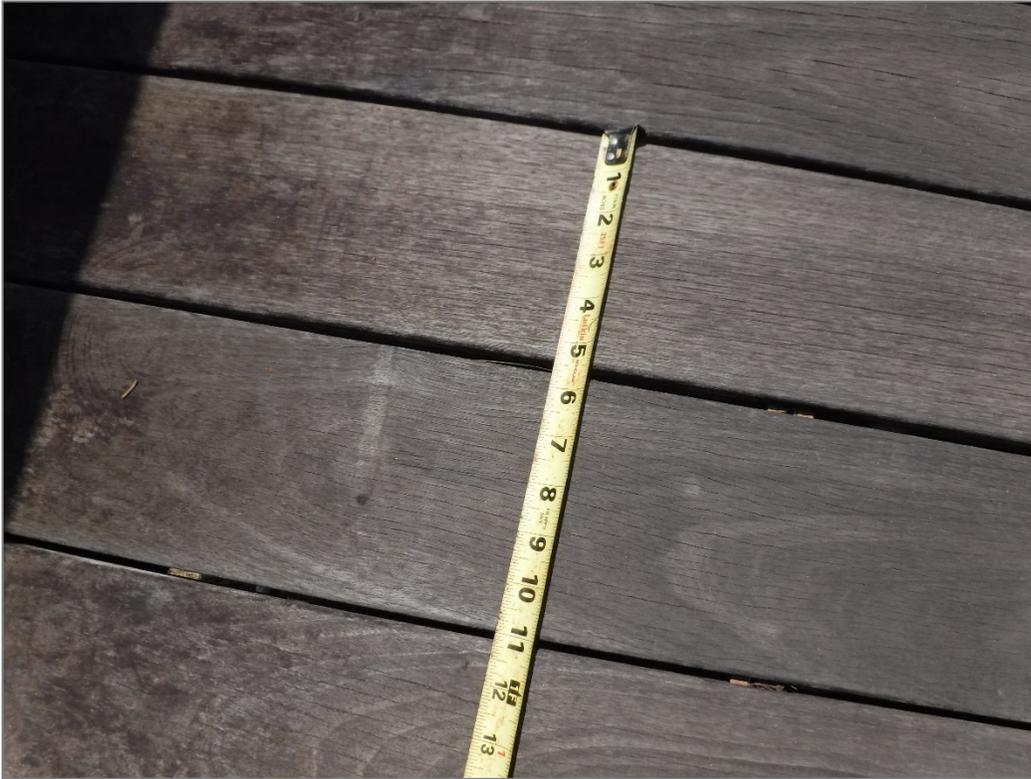
4. Decking- all decking was observed to have minimal ultraviolet (UV) damage and isolated areas of surface fungal growth (No Defects, Photo 7).
5. Connection Hardware- Approximately 75 percent of the connection hardware was in Minor Condition with surface rust and oxidation of the galvanized coating. Approximately 20 percent of the connection hardware was in Moderate Condition with pitting and flaking corrosion that was typically localized to the washer and bolt (Photo 8). The remaining 5 percent (approximate) was in Major Condition with 25-to-50 percent section loss; the significantly corroded hardware was typically located within the tidal/splash zone and was connecting cross bracing to piles (not a primary structural connection).

Photo 7: Deck – Typical deck condition (Sta. 13+50)

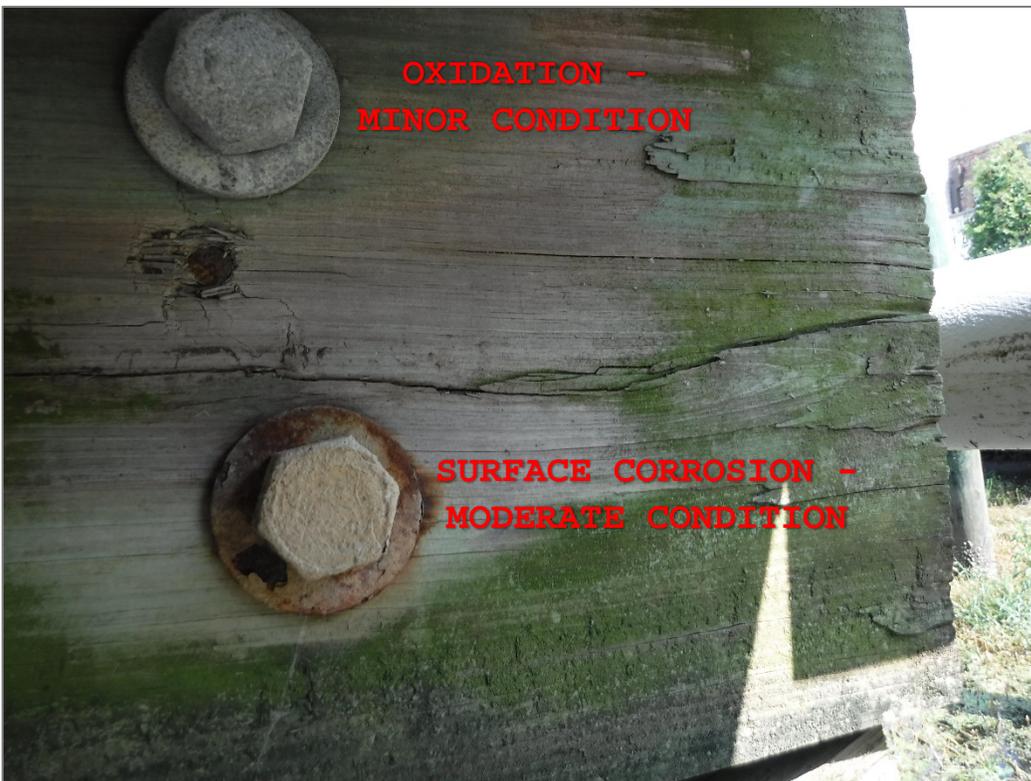
Photo 8: Hardware – Typ. surface corrosion (bottom) and oxidation of galvanization (top)

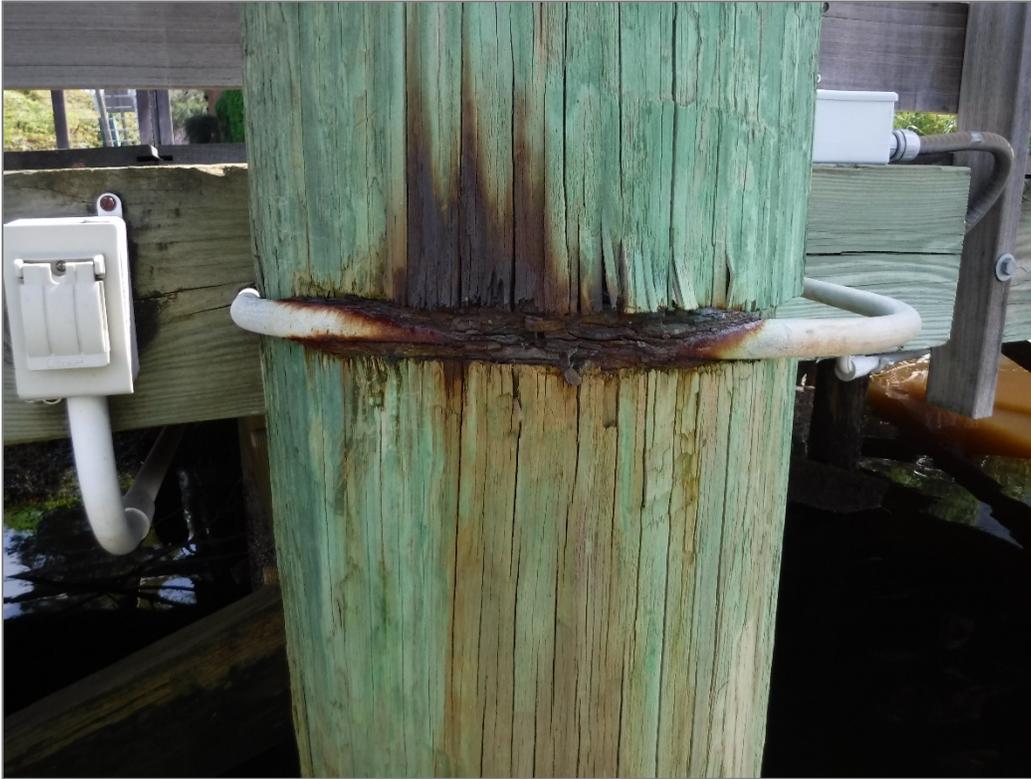
6. Fender Pile Connection Hardware- Approximately 80 percent of the fender connection hardware was in Minor Condition with surface rust and oxidation of the galvanized coating. Approximately 15 percent of connection hardware was in Major Condition with corroded hardware exhibiting pitting and flaking corrosion that was typically localized to the washer and bolt (Photo 8). The remaining 5 percent (approximate) was in Severe Condition with 50 to 100 percent section loss (Photo 10); while these hardware connections were often completely failed, they do not affect the structural capacity of the Harborwalk, as the connection is simply a restraint for fender piles.

Photo 9: Fender Pile Hardware – Severe Condition

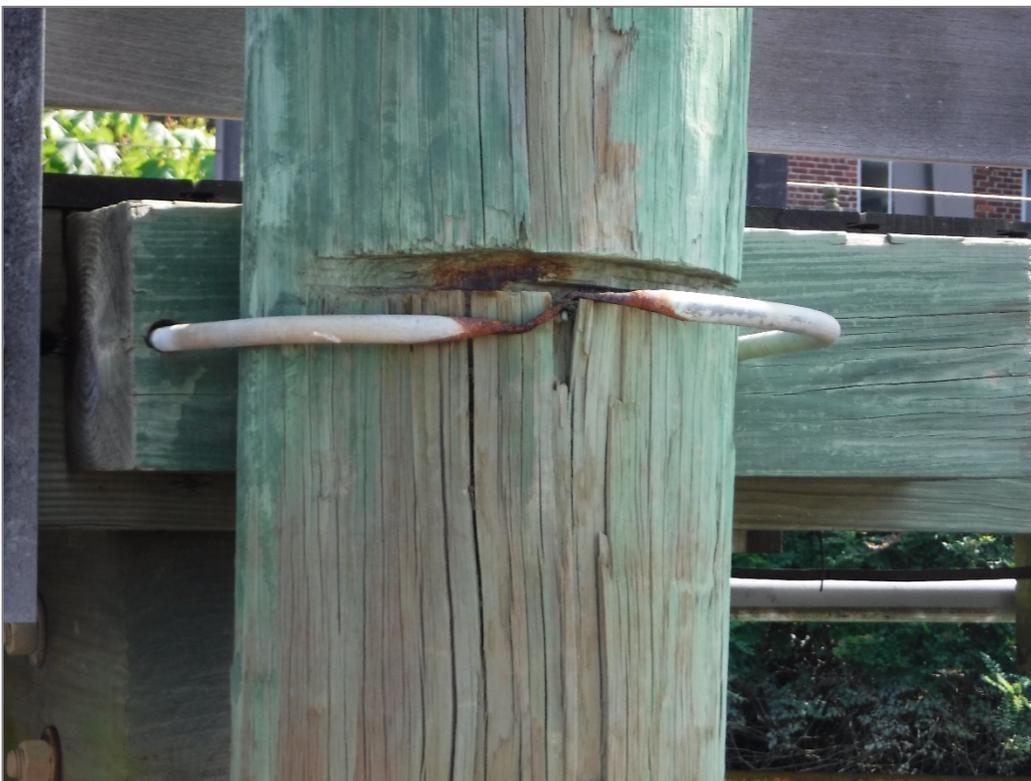
Photo 10: Fender Pile Hardware – Severe Condition (Failed, Sta. 0+49)

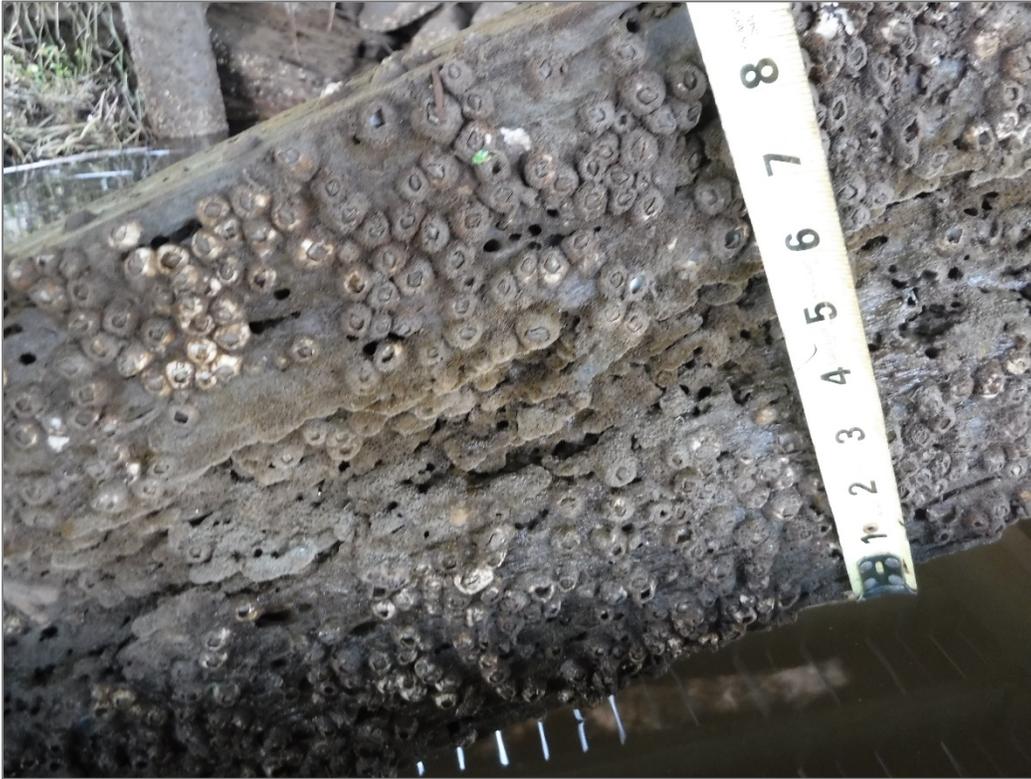
7. Cross Bracing- Approximately 15 percent of the braces were observed to have marine borer activity with section loss up to 25-to-40 percent of the cross section (Major Condition, Photo 11). The remaining 85 percent (approximate) exhibited rot and/or fungal decay primarily within the tidal/splash zone; approximately 5-to-10 percent section loss was typically observed in this zone (Moderate Condition, Photo 12).

Photo 11: Cross Brace – Major marine borer damage (Major, Sta. 0+10)

- Restrict pedestrian loading from Stations 2+50 to 2+65 (verify in field) until repairs are made to the damaged split caps.
- Pile Caps – Repair the deficient split caps listed in Table 1, with priority given to the split caps at Stations 2+60 and 10+80. Cracks in the caps with minor and moderate ratings should be monitored on a two year above-water inspection cycle.
- Cross Bracing – Repair deficient cross bracing and cross bracing connections.

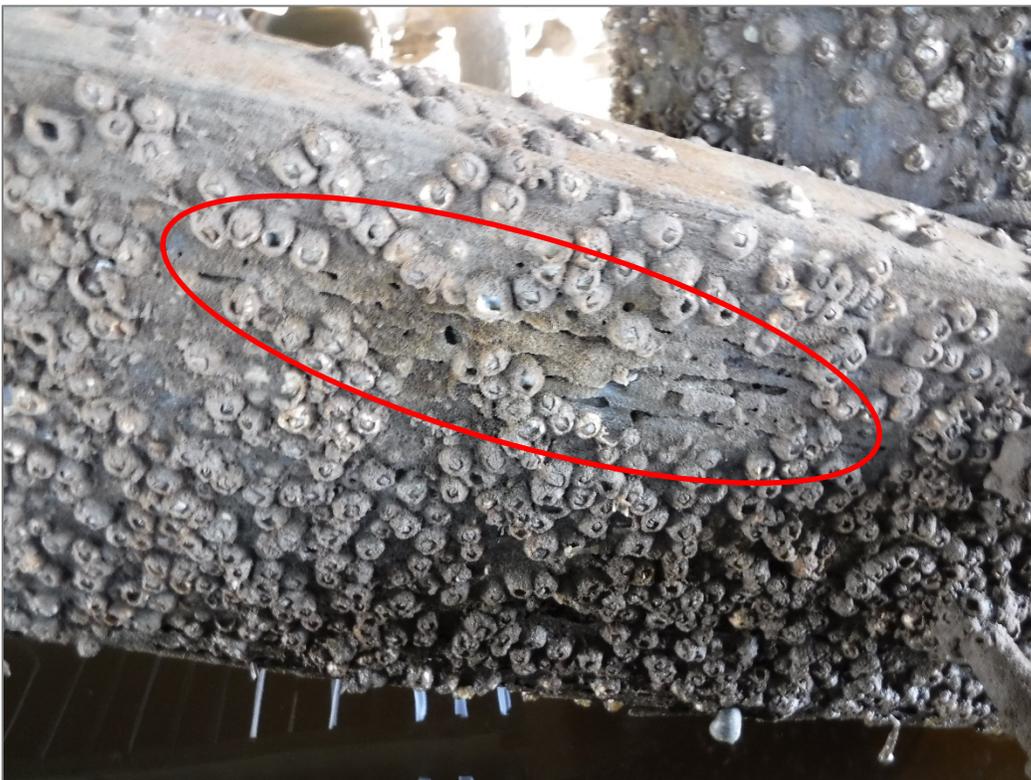
Photo 12: Cross Brace – Typical marine borer damage (Moderate, Sta. 0+15)

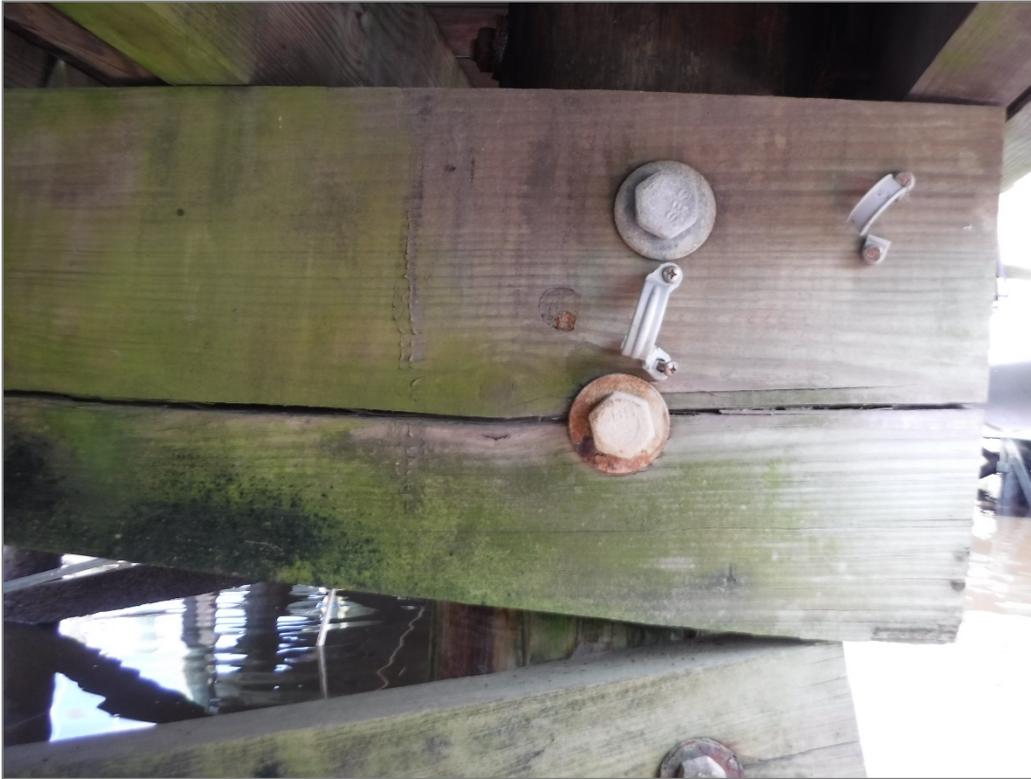
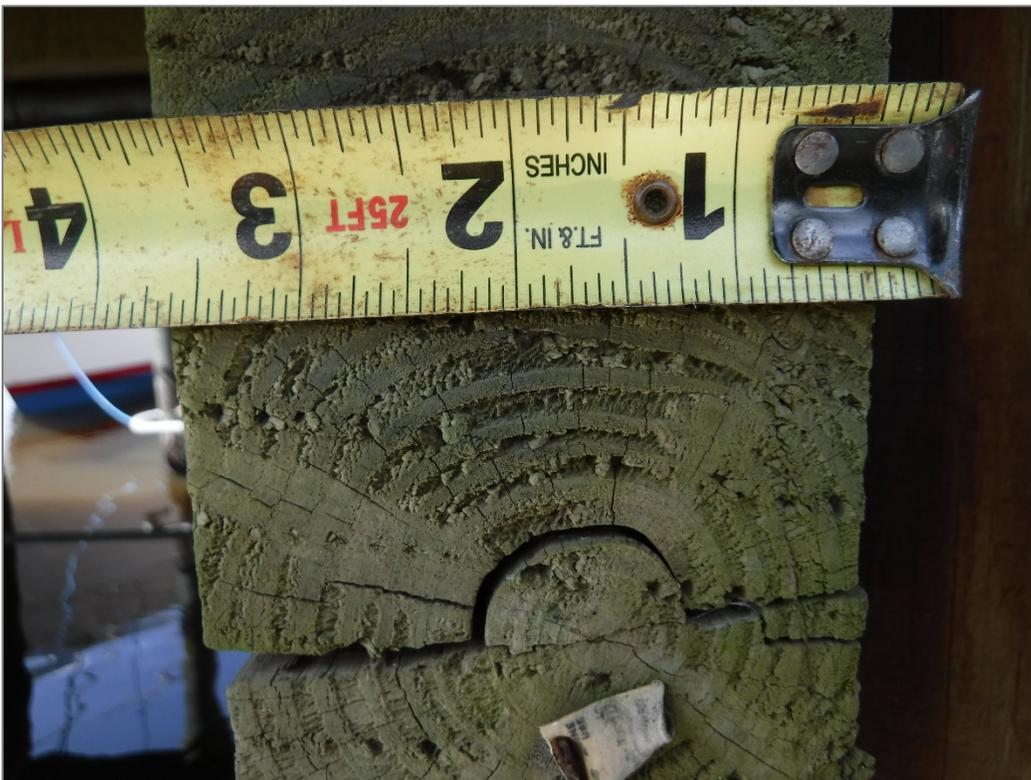
- The load rating for the fixed walkways and landings indicated that the boardwalk has a capacity of 100 pounds per square foot (psf), which is a typical load capacity for a public access area with pedestrian traffic. **The load rating for the span supported by the defect at Station 2+60 is 60 psf**, which is reduced due to a full-penetration crack in the stringer which passes through the bottom bolt.

Photo 13: Split Cap – Face View, Full penetration crack (Major, Sta. 2+60)

Photo 14: Split Cap – End View, Full penetration crack (Major, Sta. 2+60)

STATION	DEFECT	APPROX. LOCATION	LOAD RATING
2+50 to 2+65	2+60 - Crack/Split in Split Cap	Directly between Broad St. and Screven St. (In front of empty lot)	60 PSF (for the span supported by the deteriorated cap)

Loading should be restricted near Station 2+60 until the stringer is repaired, and it is recommended that other deteriorated stringers and cross bracing be repaired within a year of the date of the inspection. An underwater inspection to monitor and determine the severity of marine borer activity in the piles and cross bracing should be conducted as soon as possible to further assess the Harborwalk's structural capacity and establish a baseline for future inspections.

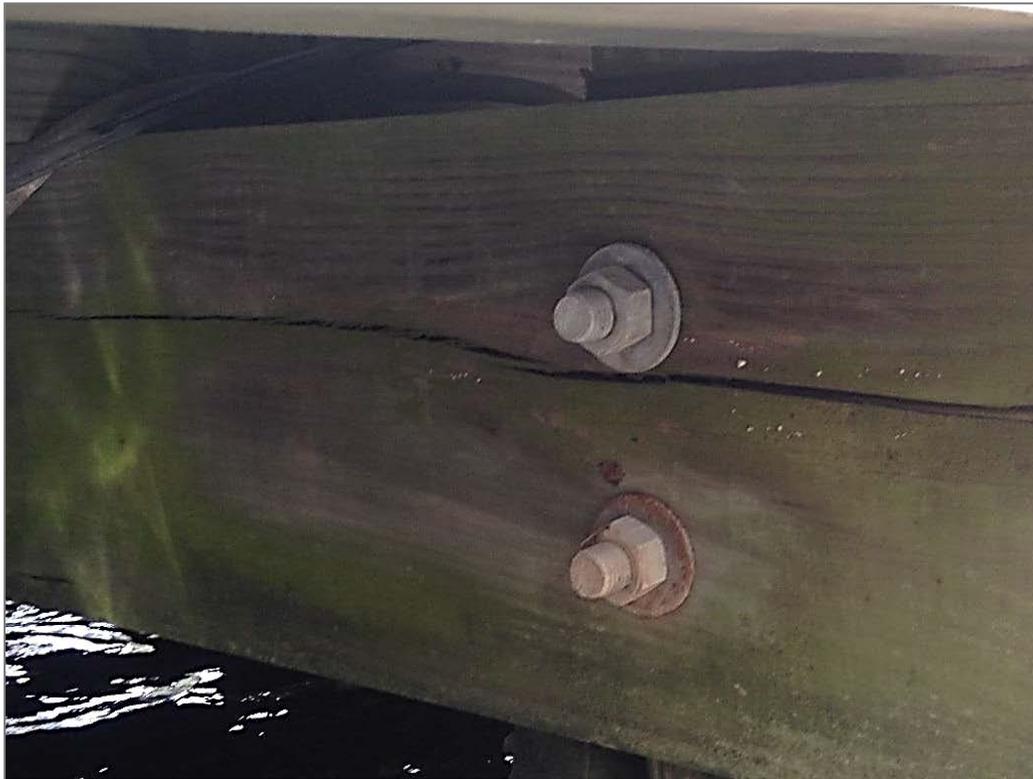
Photo 15: Split Cap – End View, Full penetration crack (Major, Sta. 2+90)

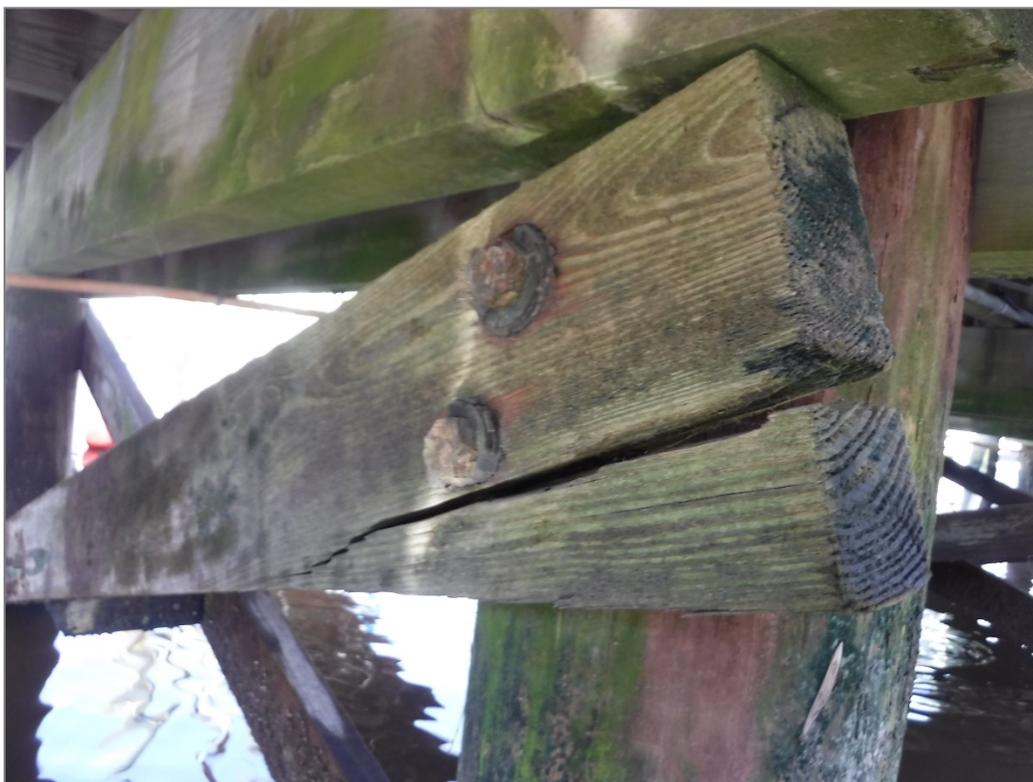
Photo 16: Cross Brace – Split at end with heavily corroded hardware (Major, Sta. 4+95)

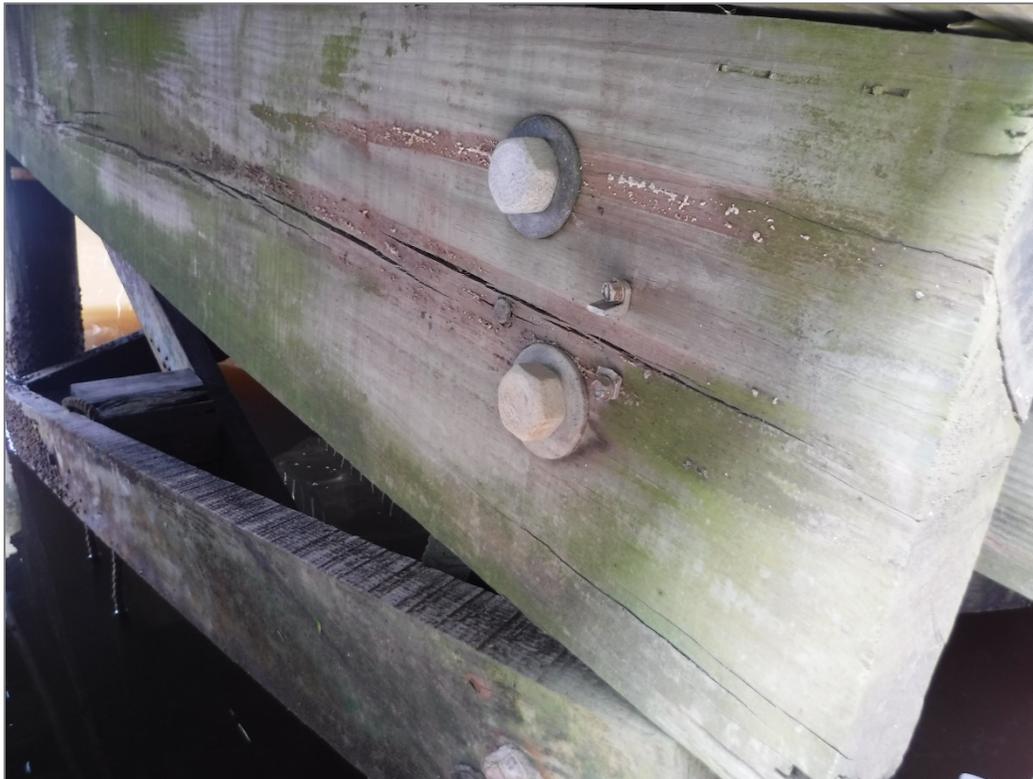
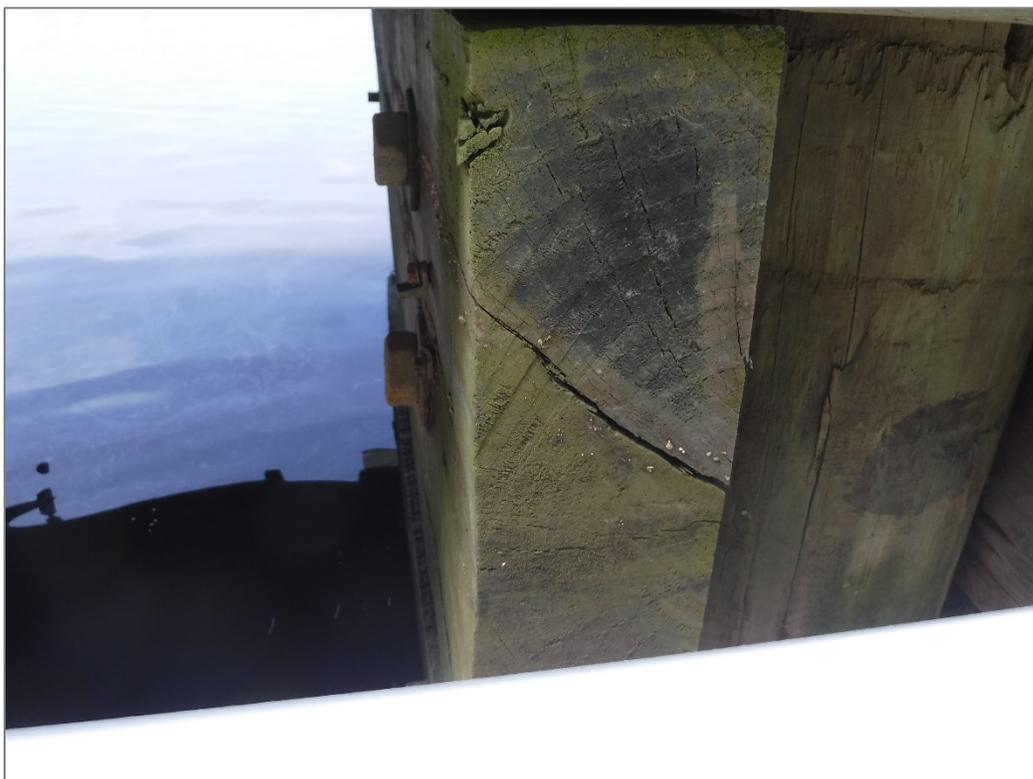
Photo 17: Split Cap – Face View, Full penetration crack (Major, Sta. 6+15)

Photo 18: Split Cap – End View, Full penetration crack (Major, Sta. 6+15)

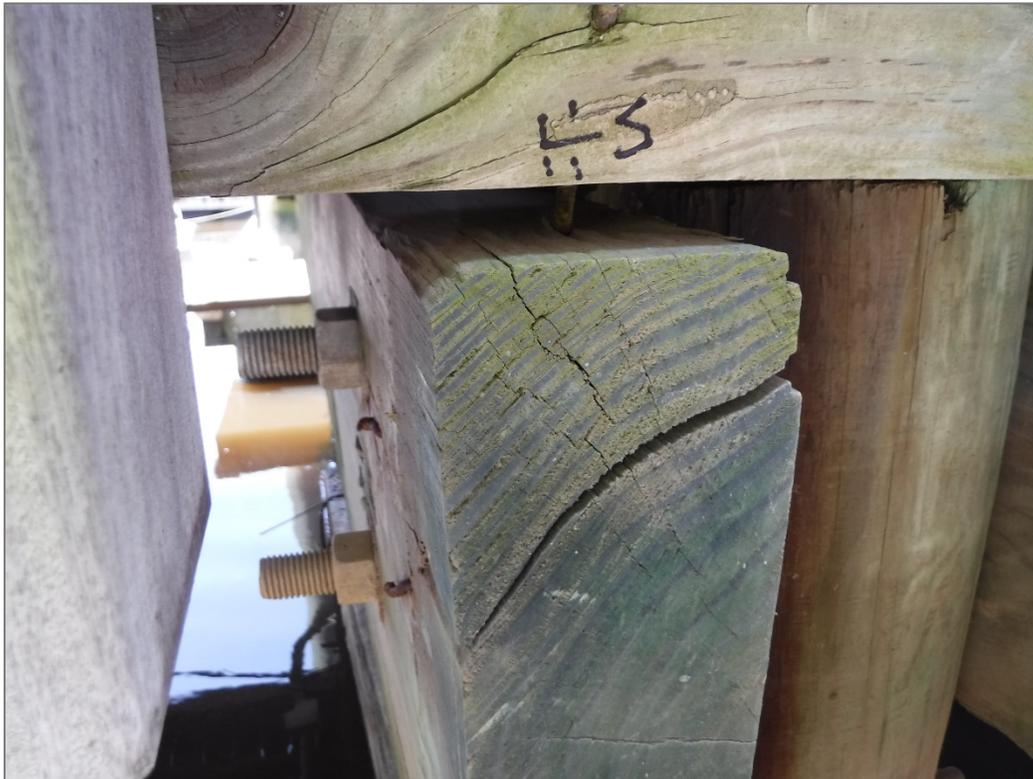
Photo 19: Split Cap – Full penetration crack (Major, Sta. 7+65)

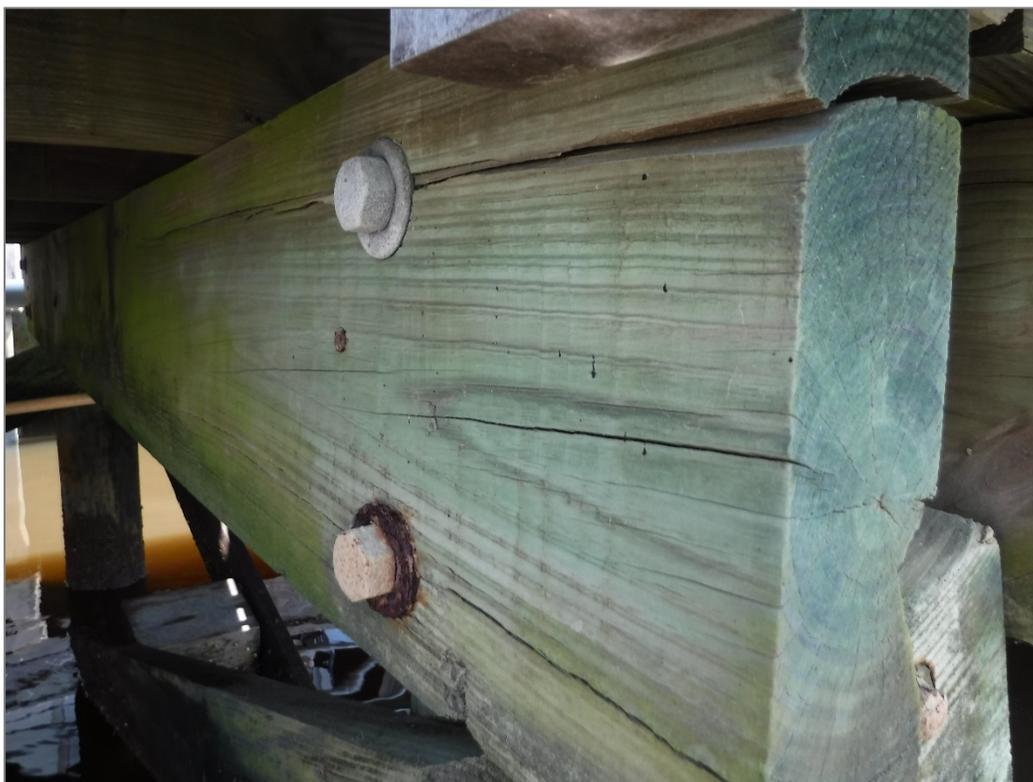
Photo 20: Split Cap – Full penetration crack (Major, Sta. 8+15)

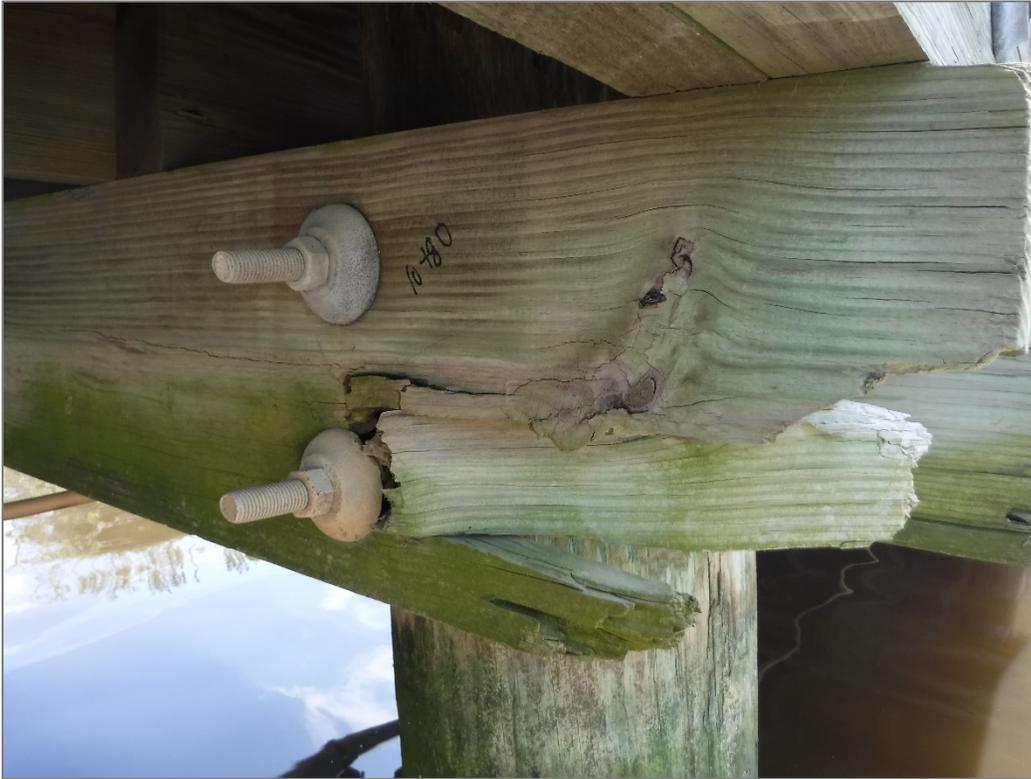
Photo 21: Split Cap – Impact damage on outboard end (Major, Sta. 10+80)

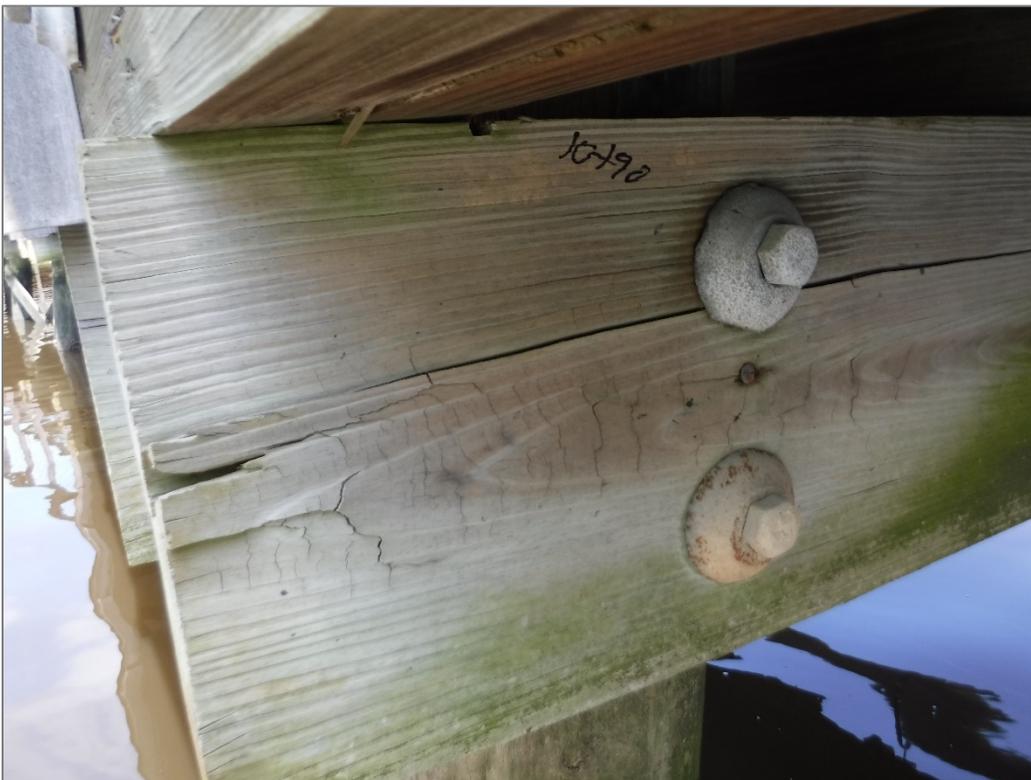
Photo 22: Split Cap – Full penetration crack (Major, Sta. 10+90)
