REPORT DATE: September 19, 2023

NESHAP ASBESTOS SURVEY REPORT

WILSON MALL

1501 Ward Boulevard, Wilson, Wilson County, North Carolina

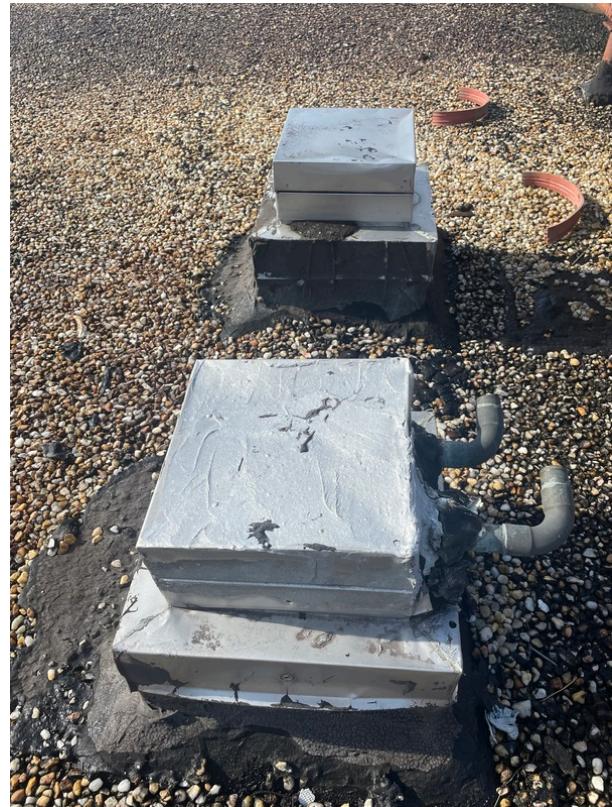
View of asbestos-containing Silver Penetration Coating (HA 4)

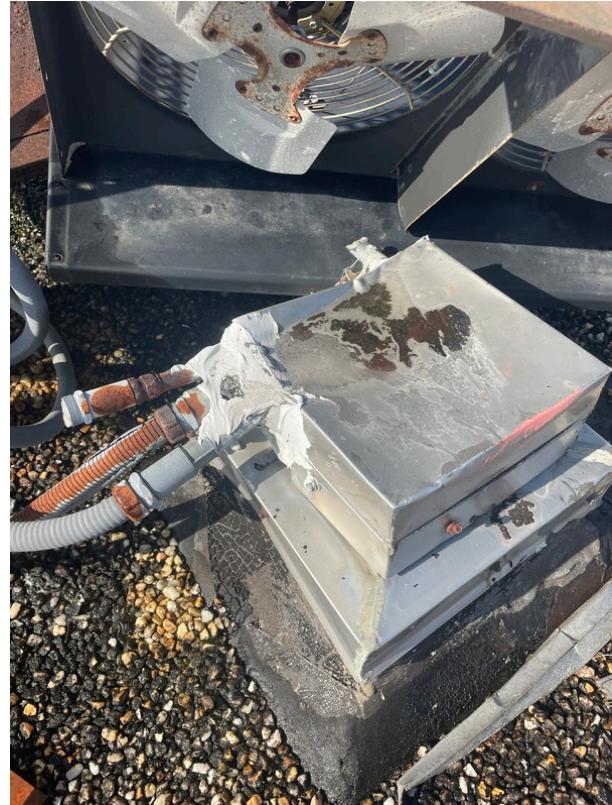
View of asbestos-containing White Penetration Caulk (HA 6)

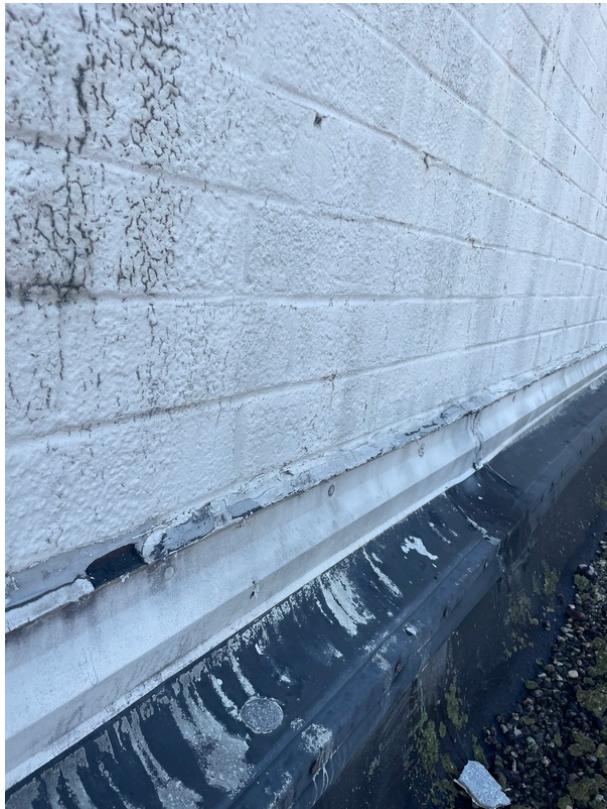
General view of asbestos-containing Black Tar beneath Grey Seam Caulk (HA 9)

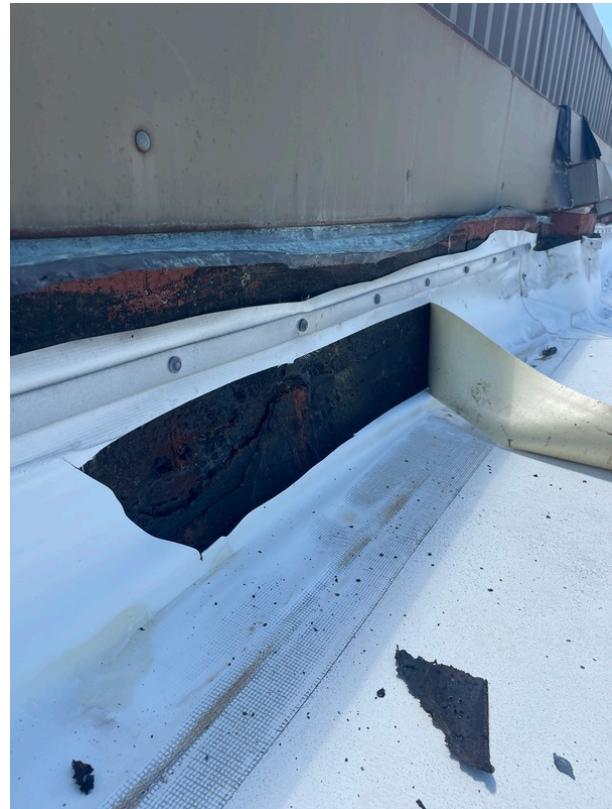
General view of asbestos-containing Black Backing beneath Black Tar (HA 12)

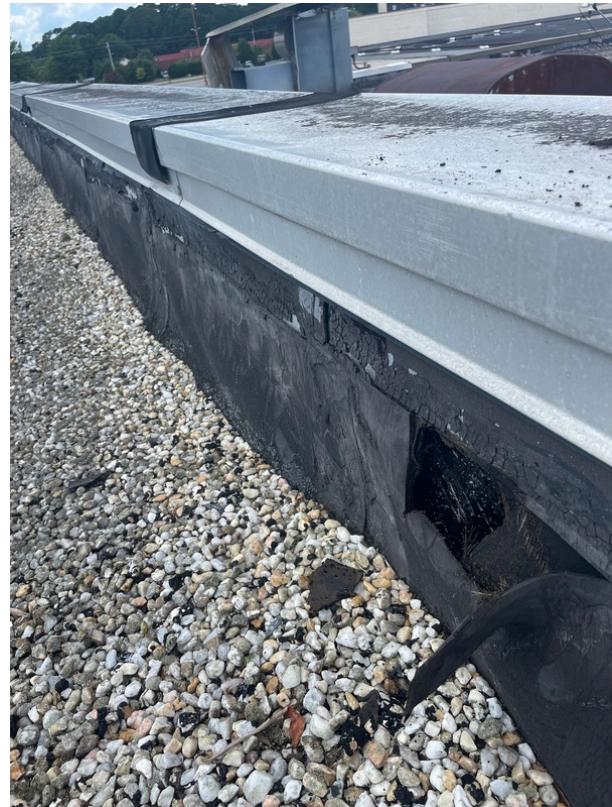
General view of asbestos-containing Black
Tarpaper beneath Black Tar (HA 20)

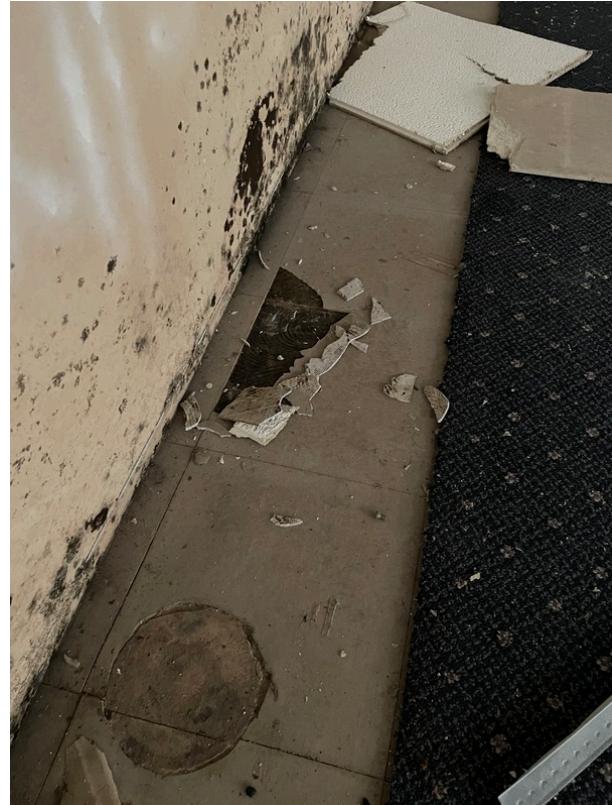
View of asbestos-containing Black/Tan Mastic beneath 12" x 12" Dark Grey Floor Tile (HA 35)

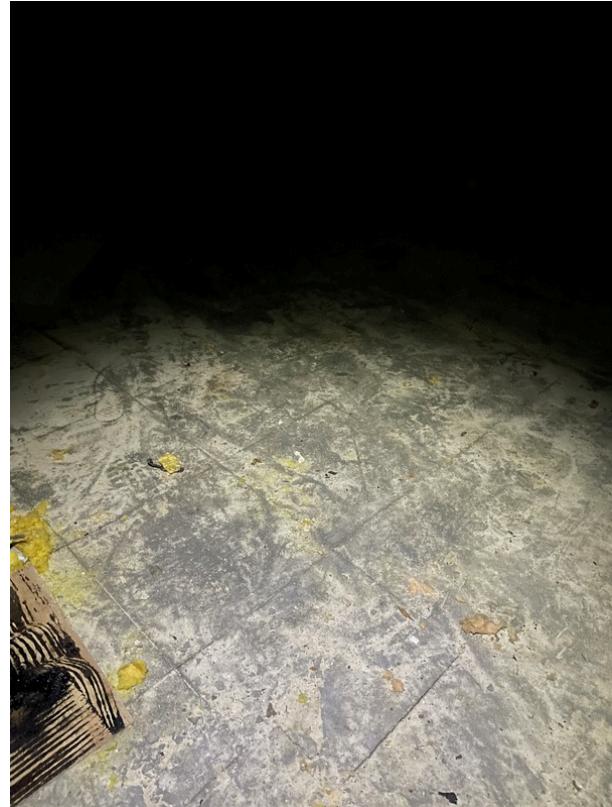
View of asbestos-containing 12" x 12"
Grey/Brown Floor Tile and its associated
Black Mastic (HA 37)

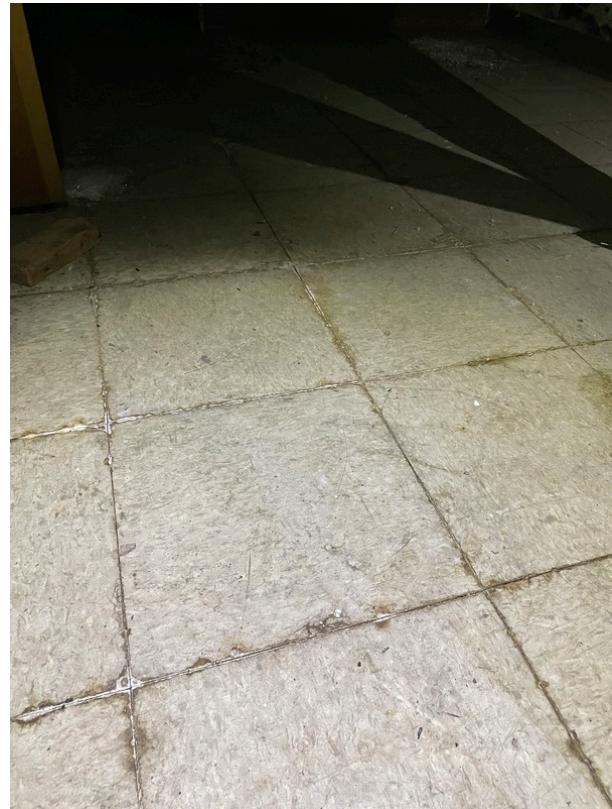
View of asbestos-containing 9" x 9" Grey/
Off-White Floor Tile and its associated
Black Mastic (HA 38)

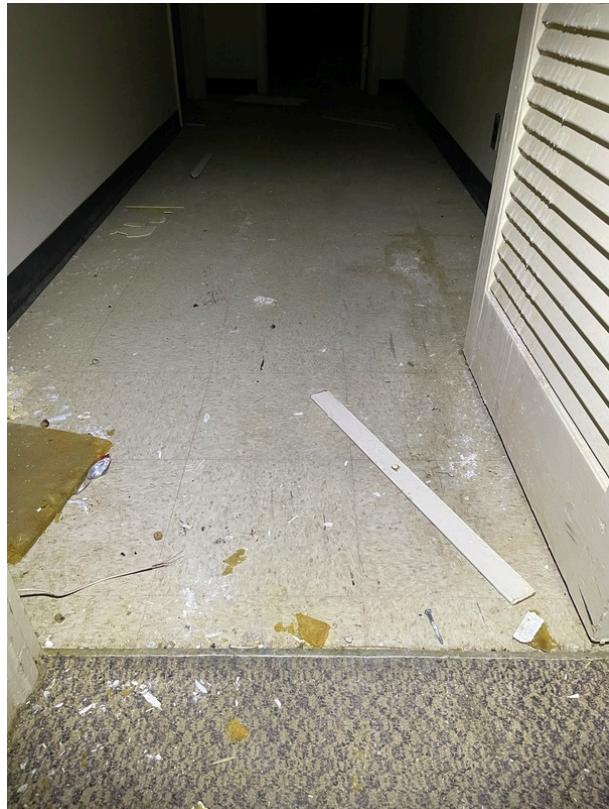
General view of asbestos-containing 12" x
12" Yellow/Off-White Floor Tile and Black
Mastic beneath 12" x 12" Tan Floor Tile
(HA 45)

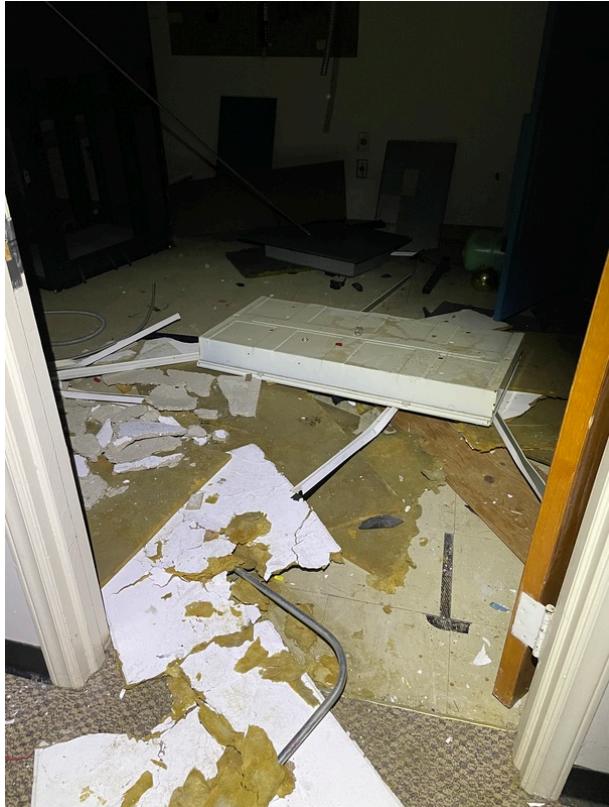
View of asbestos-containing 12" x 12" Tan with Dark Streaks Floor Tile and its associated Black Mastic (HA 46)

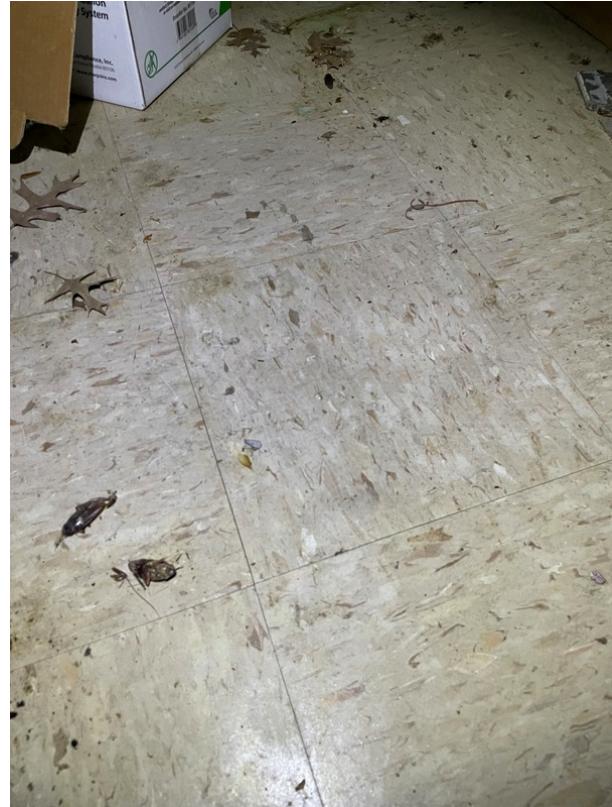
General view of asbestos-containing Black Mastic beneath 12" x 12" Tan with White Specks Floor Tile (HA 50)

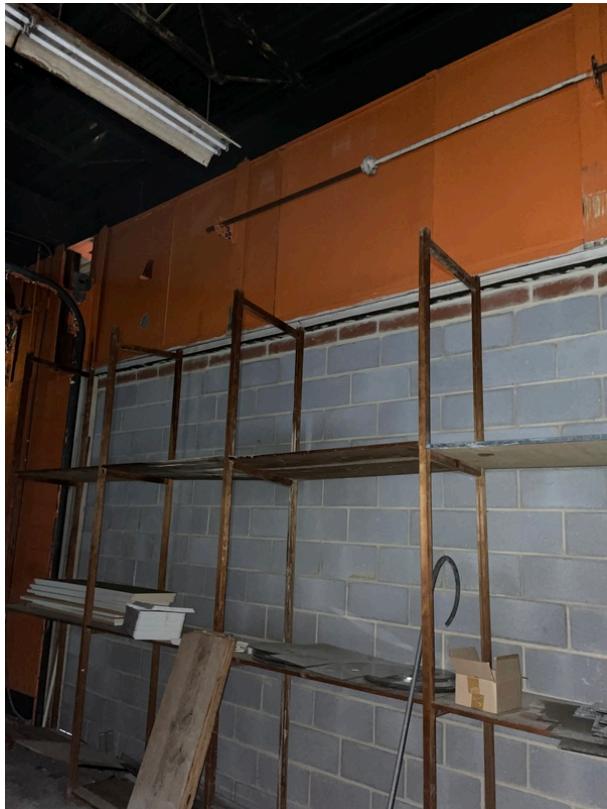
View of Transite Panels assumed to be asbestos-containing (HA 225)

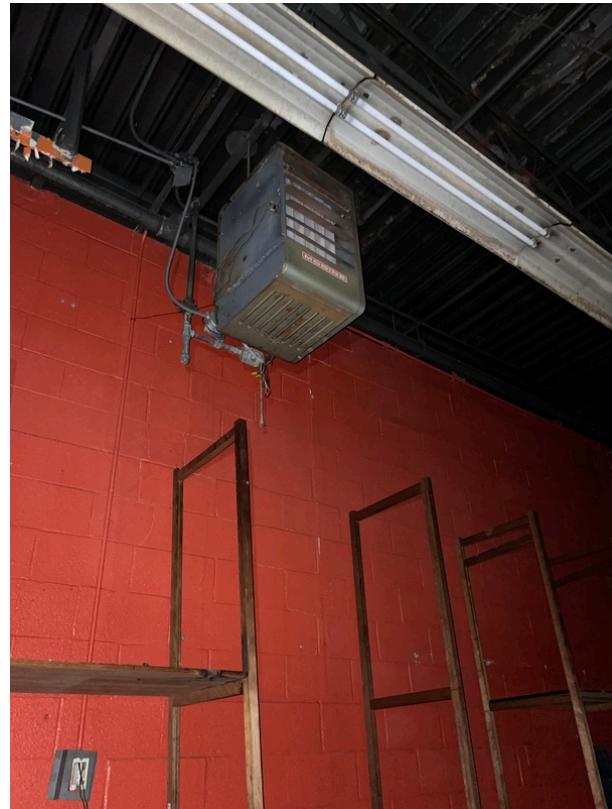
View of a ceiling-mounted space heater assumed to be asbestos-containing (HA 226)

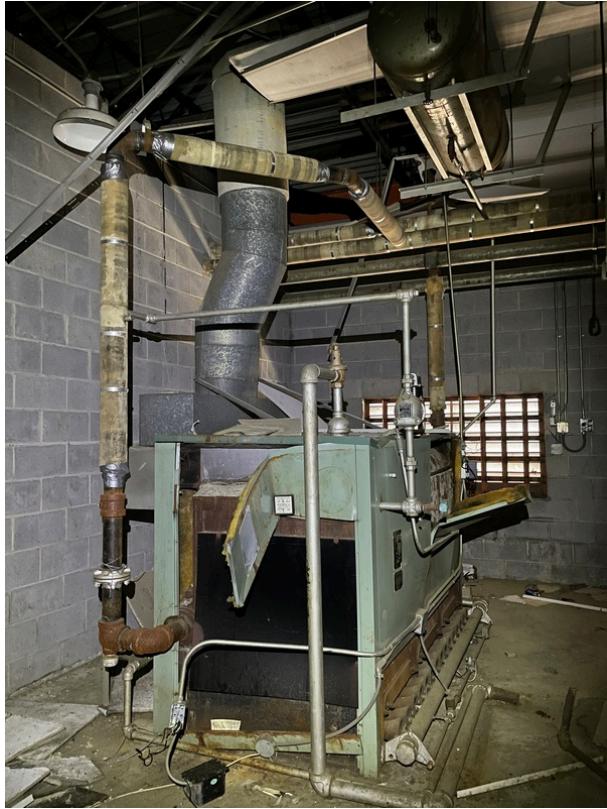
View of a boiler assumed to be asbestos-containing (HA 227)

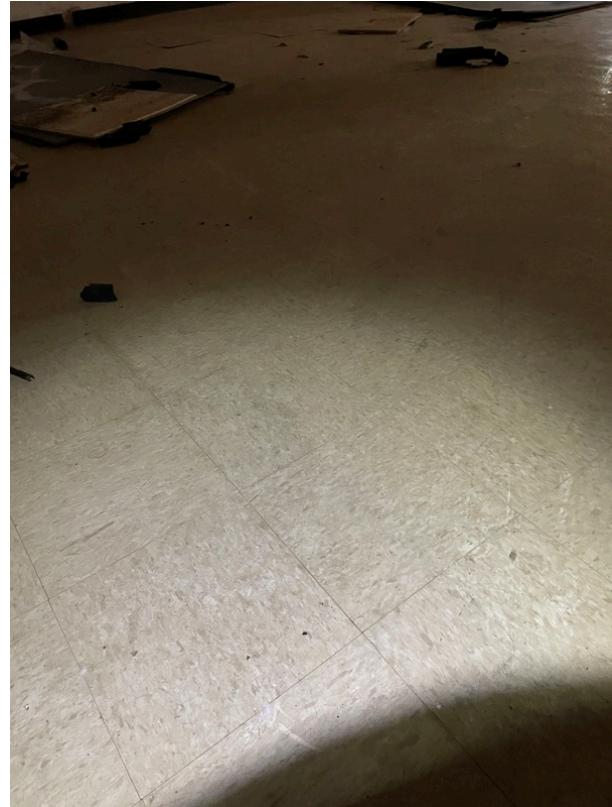
General view of asbestos-containing 9" x 9" Tan Floor Tile and Black Mastic beneath 12" x 12" Tan with Brown Specks Floor Tile (HA 76)

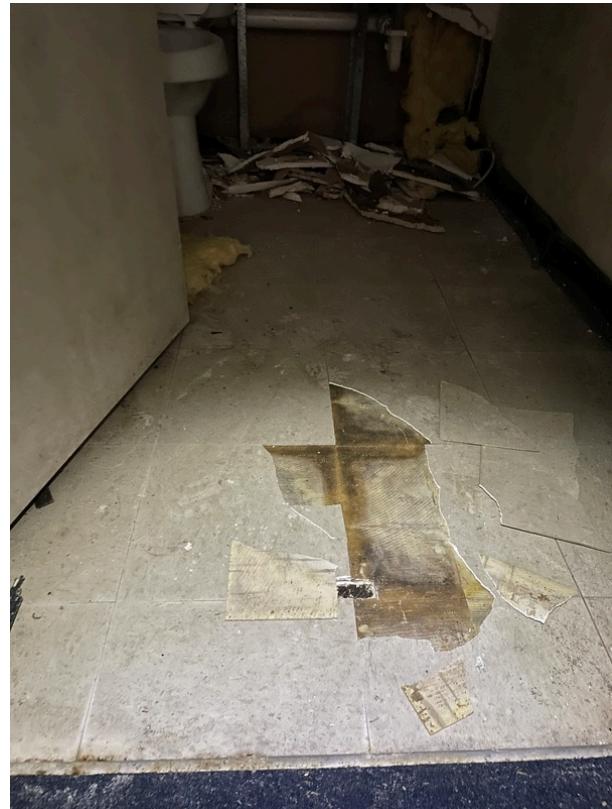
General view of asbestos-containing Black Mastic beneath 12" x 12" Tan Floor Tile and a second Floor Tile layer (HA 79)

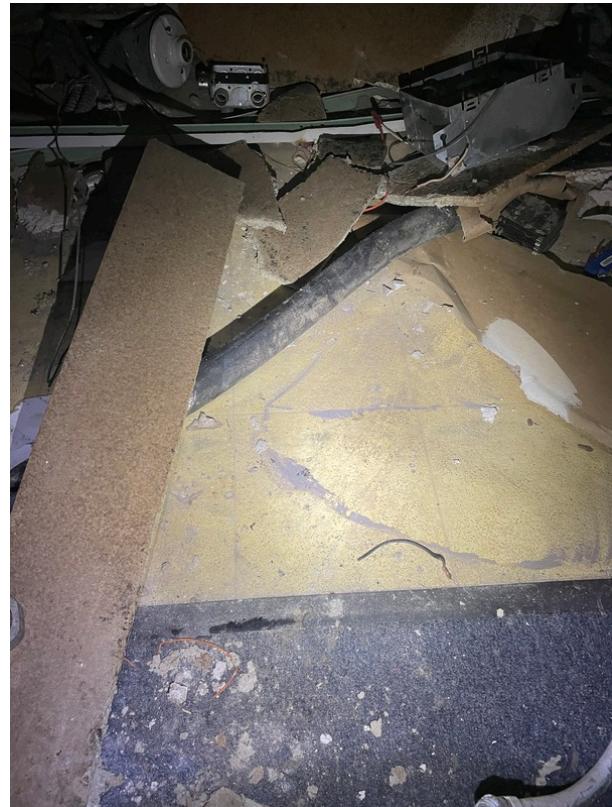
General view of asbestos-containing Tan Floor Tile and Black Mastic beneath Tan Sheet Flooring (HA 97)

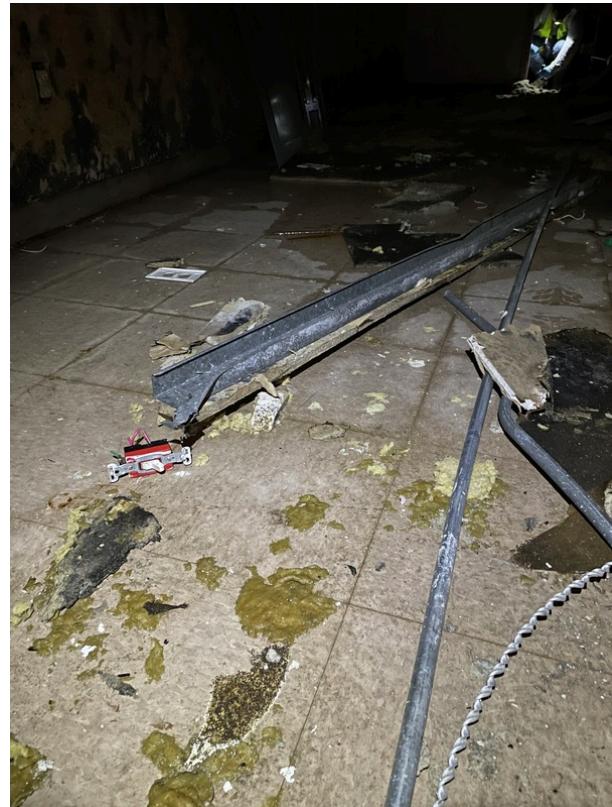
General view of asbestos-containing Black Mastic beneath 12" x 12" Tan Floor Tile and Grey Leveling Compound (HA 107)

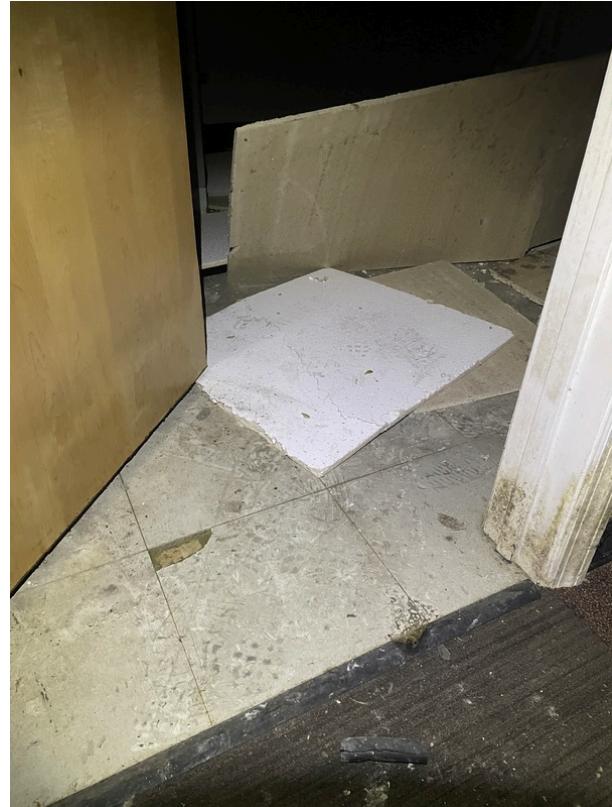
General view of asbestos-containing Black Mastic beneath 12" x 12" Tan Floor Tile
(HA 116)

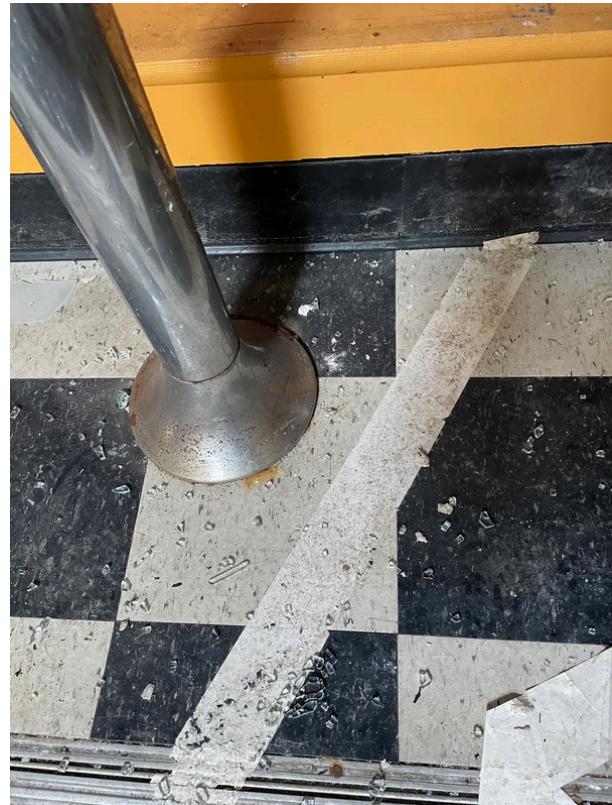
General view of asbestos-containing Black Mastic beneath 12" x 12" Off-White Floor Tile and Grey/Black Leveling Compound (HA 121)

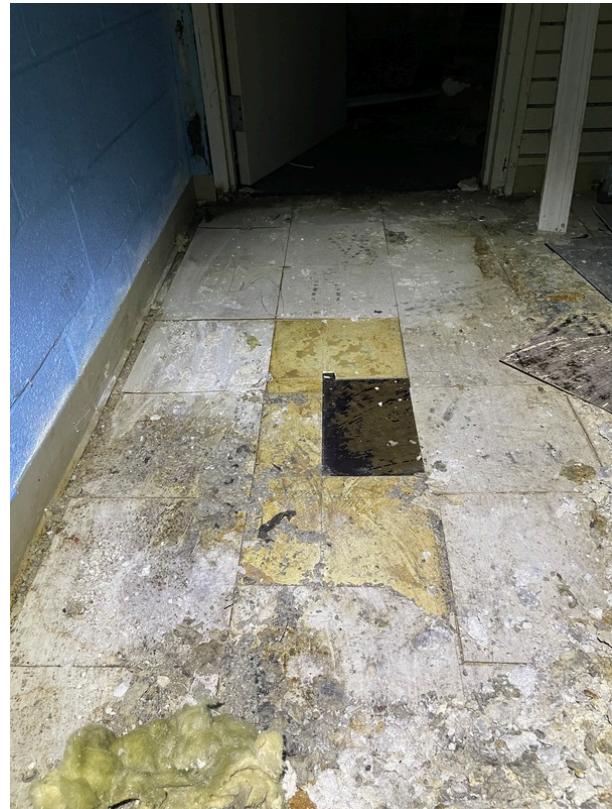
General view of asbestos-containing 12" x 12" Tan Floor Tile and Black Mastic beneath 12" x 12" Off-White Floor Tile (HA 126)

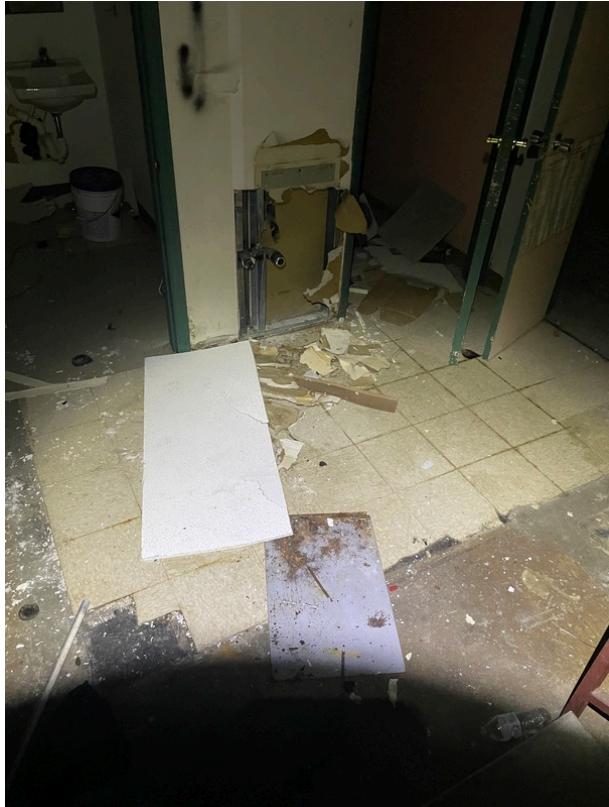
General view of asbestos-containing Black Mastic beneath 12" x 12" Tan Floor Tile
(HA 138)

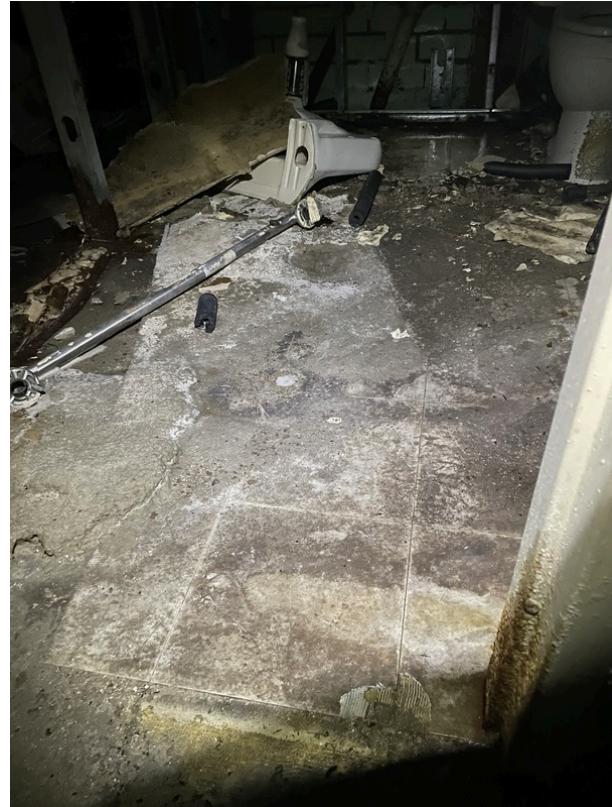
General view of asbestos-containing Black Mastic beneath 12" x 12" Grey Floor Tile
(HA 139)

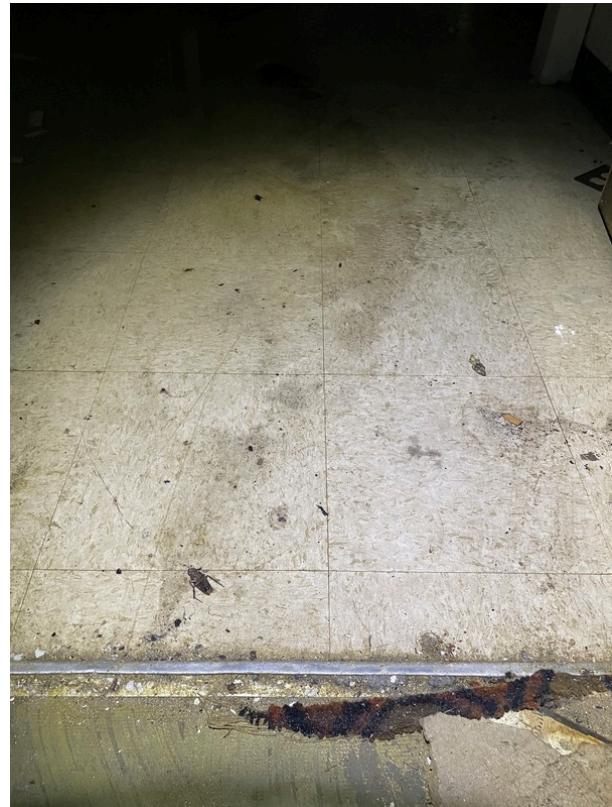
General view of asbestos-containing Black Mastic beneath 12" x 12" Off-White Floor Tile (HA 146)

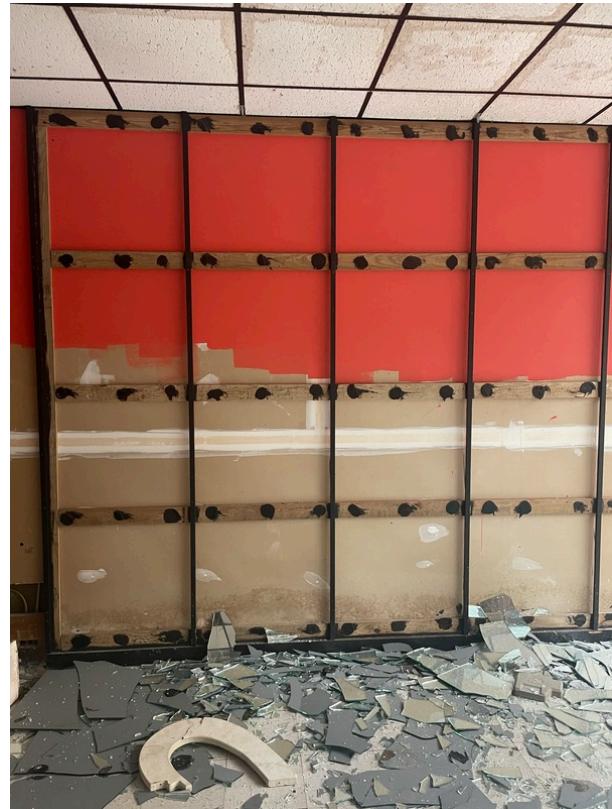
View of asbestos-containing Black Mastic Dot (HA 152)

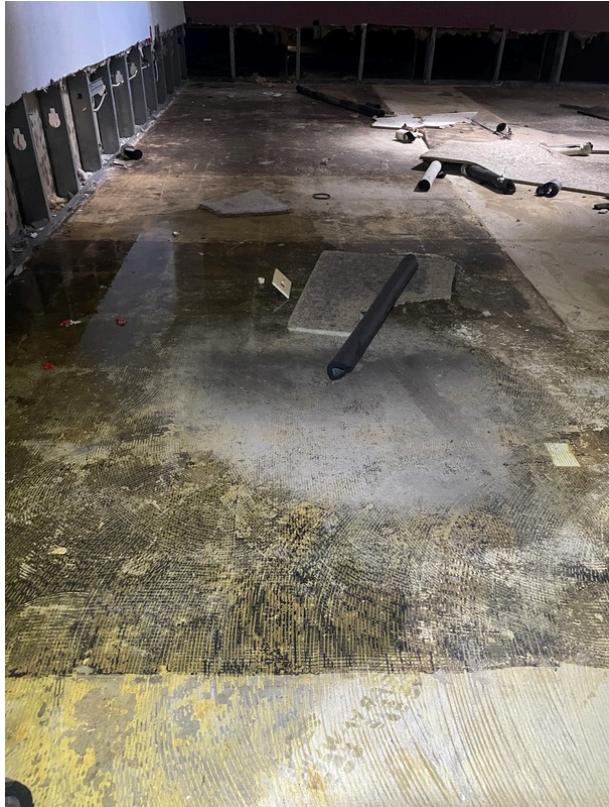
View of asbestos-containing Black/Yellow Mastic (HA 160)

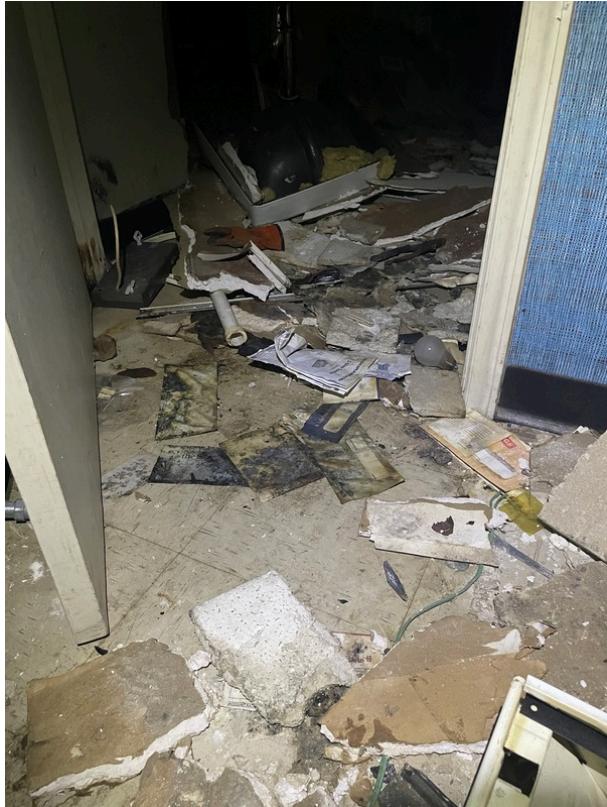
View of asbestos-containing 12" x 12"
Off-White Floor Tile and its associated
Black Mastic (HA 164)

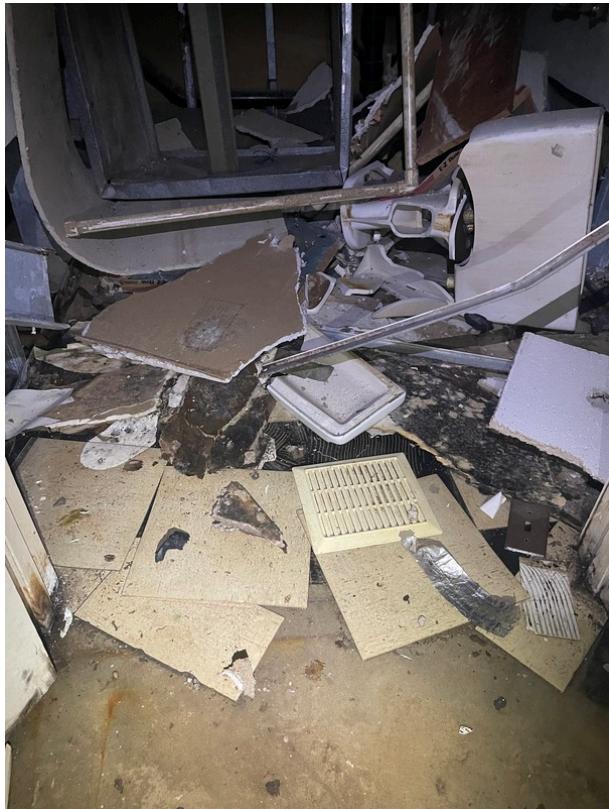
View of asbestos-containing 12" x 12" Tan Floor Tile and its associated Black Mastic (HA 165)

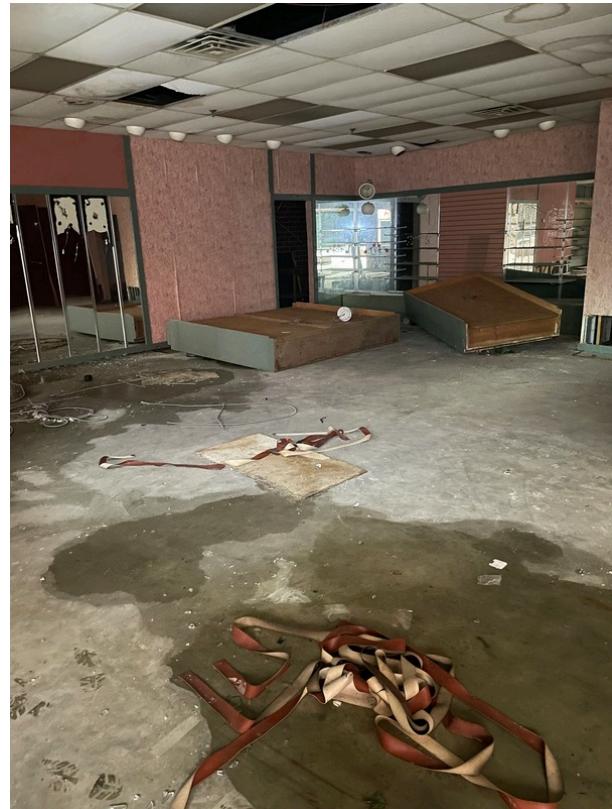
View of asbestos-containing Black Mastic Dot (HA 166)

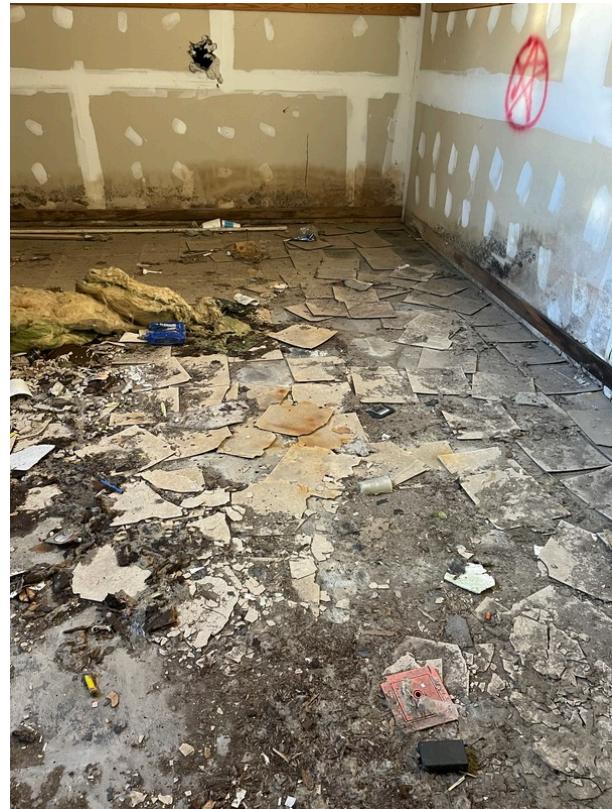
General view of asbestos-containing Black Mastic beneath 12" x 12" Tan Floor Tile
(HA 178)

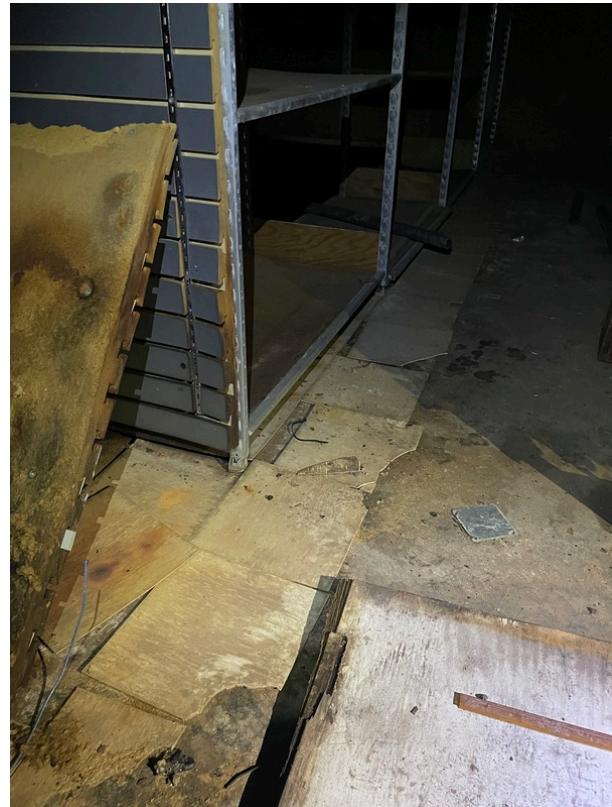
View of asbestos-containing 12" x 12" Tan Floor Tile and its associated Black Mastic (HA 180)

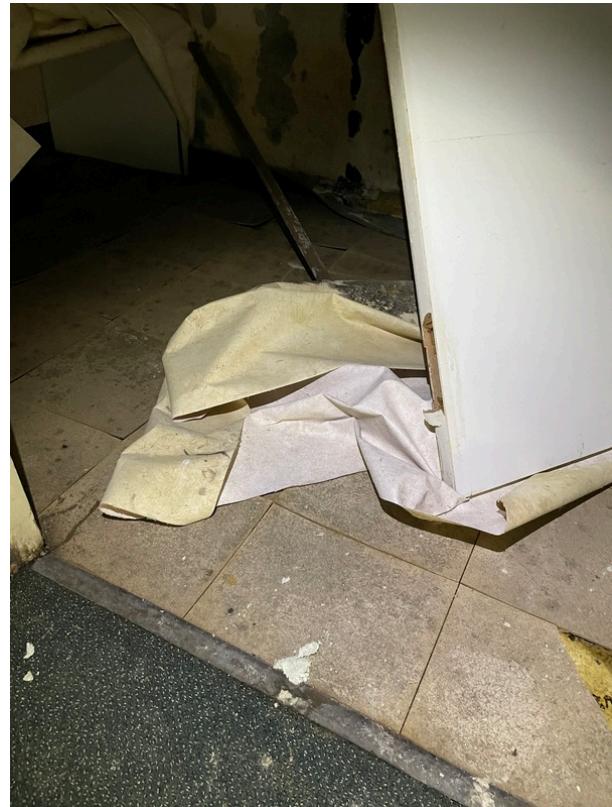
General view of asbestos-containing
Yellow/Black Mastic beneath 12" x 12"
Tan Floor Tile (HA 183)

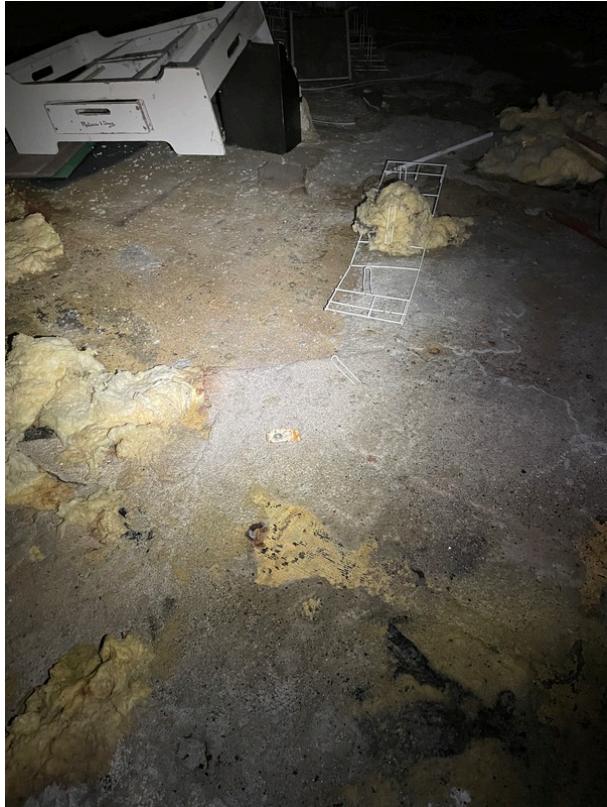
View of asbestos-containing Yellow/Black Carpet Glue (HA 188)

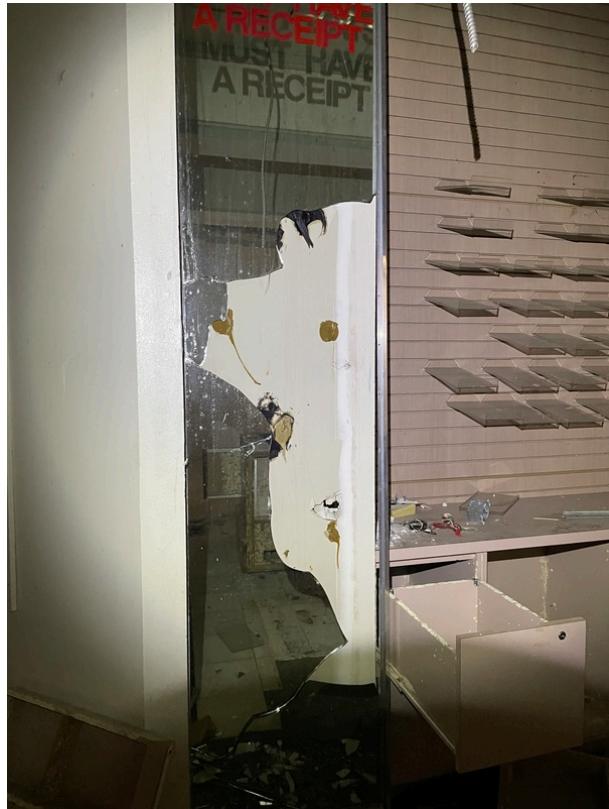
View of asbestos-containing Black Mastic Dot (HA 199)

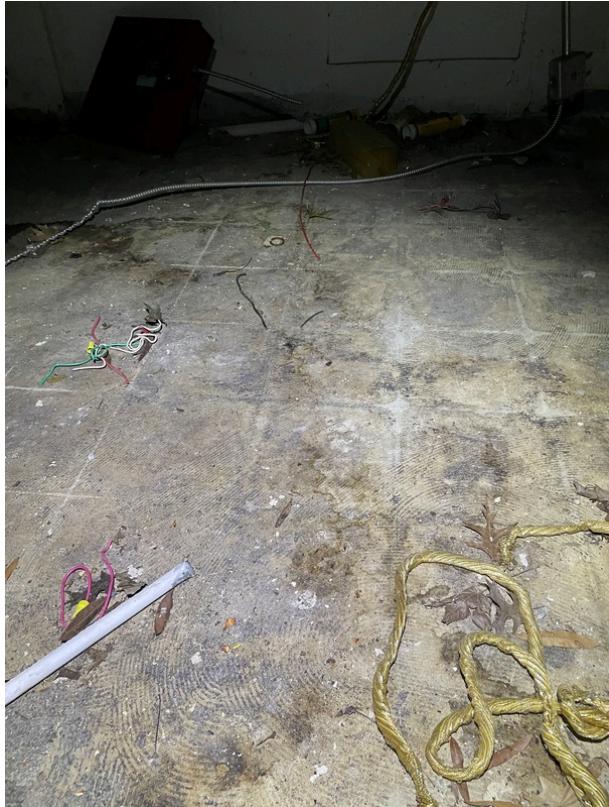
View of asbestos-containing Black Mastic (HA 204)

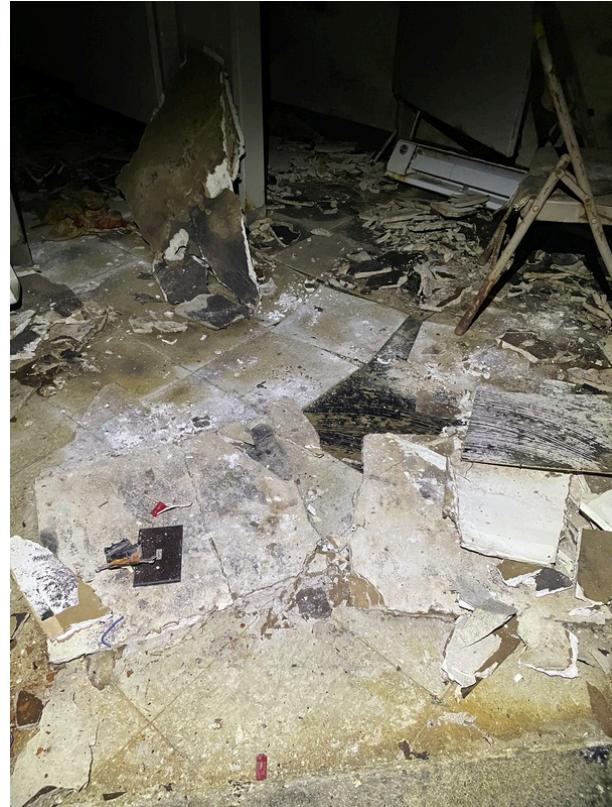
General view of asbestos-containing Black Mastic beneath 12" x 12" Tan Floor Tile (HA 206)

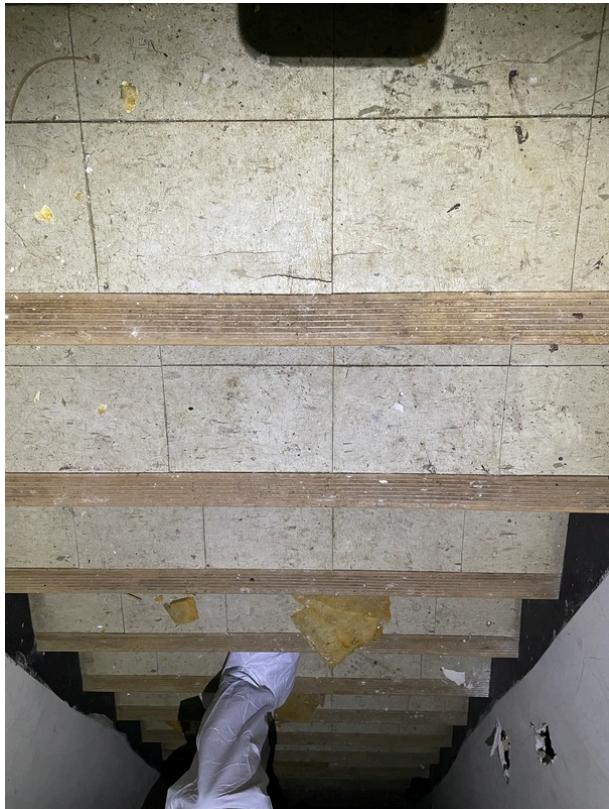
View of asbestos-containing 9" x 9" Tan Floor Tile and its associated Black Mastic (HA 207)

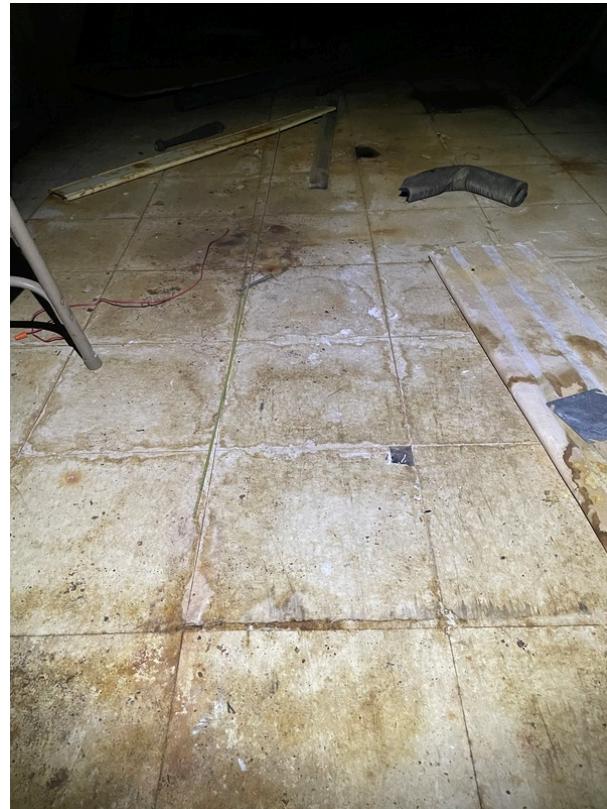
General view of asbestos-containing Black Mastic beneath 12" x 12" Off-White with Brown Specks Floor Tile (HA 208)

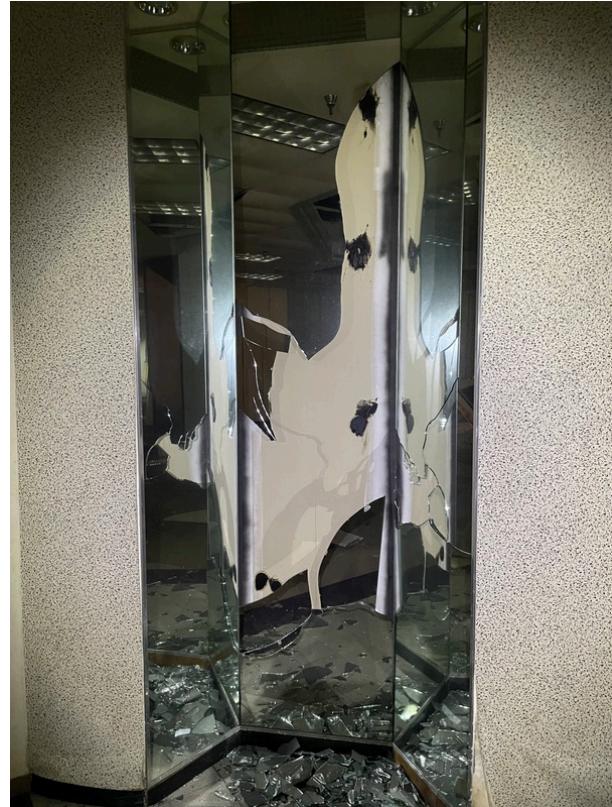
View of asbestos-containing Black Mastic Dot (HA 210)

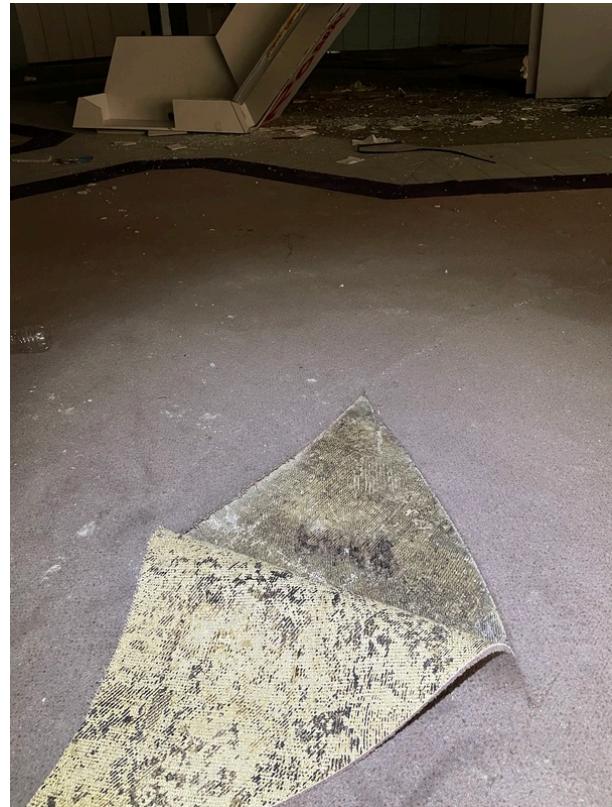
View of asbestos-containing Yellow/Black Carpet Glue (HA 213)

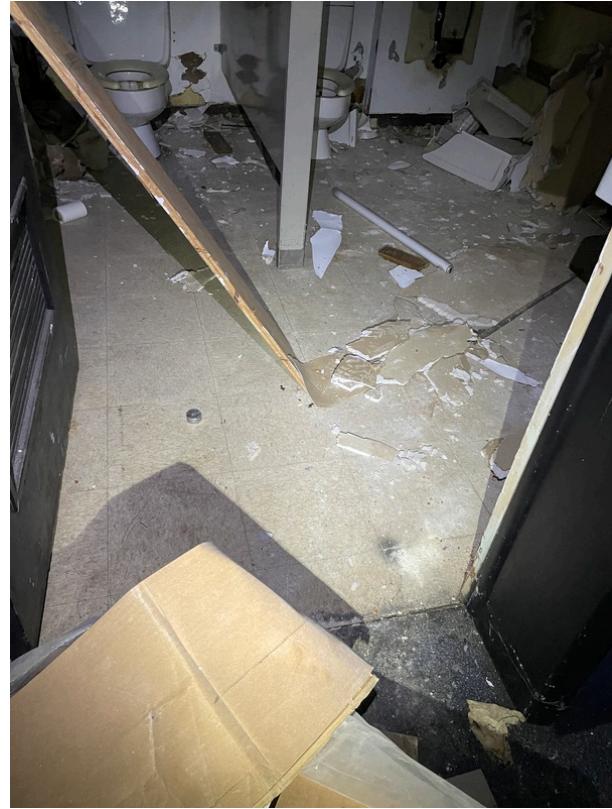
General view of asbestos-containing Black Mastic beneath 12" x 12" Tan Floor Tile
(HA 215)

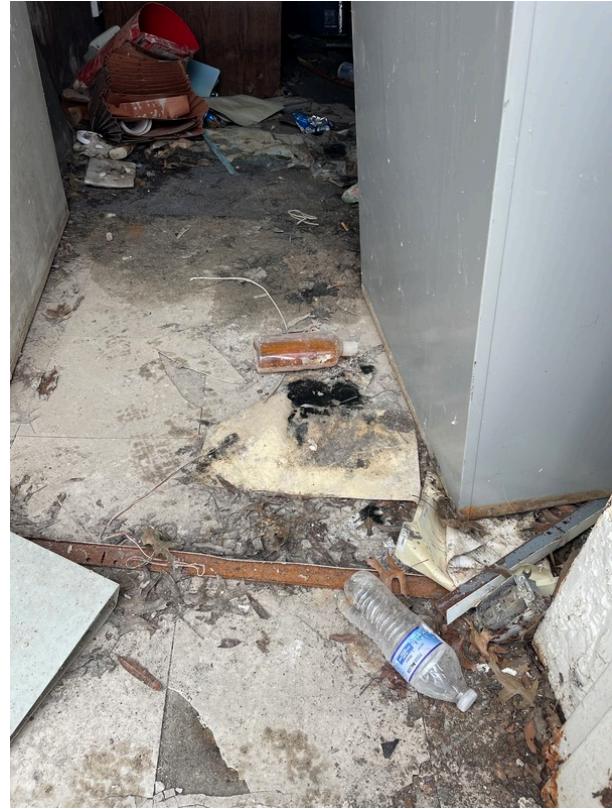
General view of asbestos-containing Black Mastic beneath 12" x 12" Brown Floor Tile
(HA 217)
