9th Street Salt Storage Facility Renovations GP 1371

Exhibit B – Site Photos

*Phase I ESA Middle Branch Re-Development
Photographed April 09, 2021*

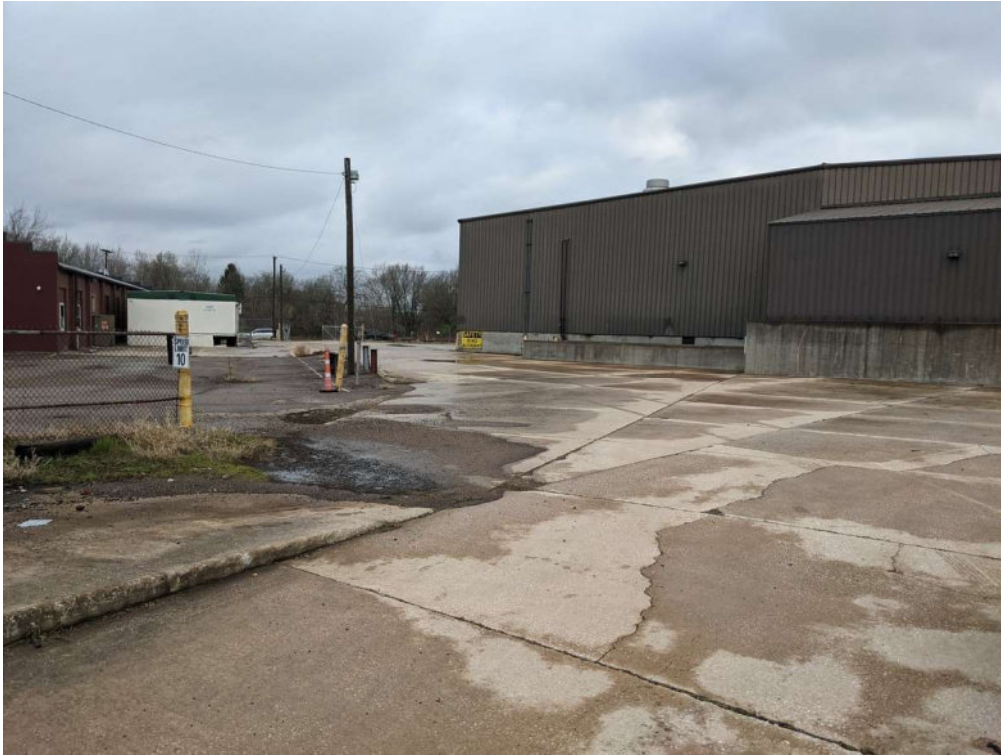
Photo 1. Facing entrance of north central side of Site A.

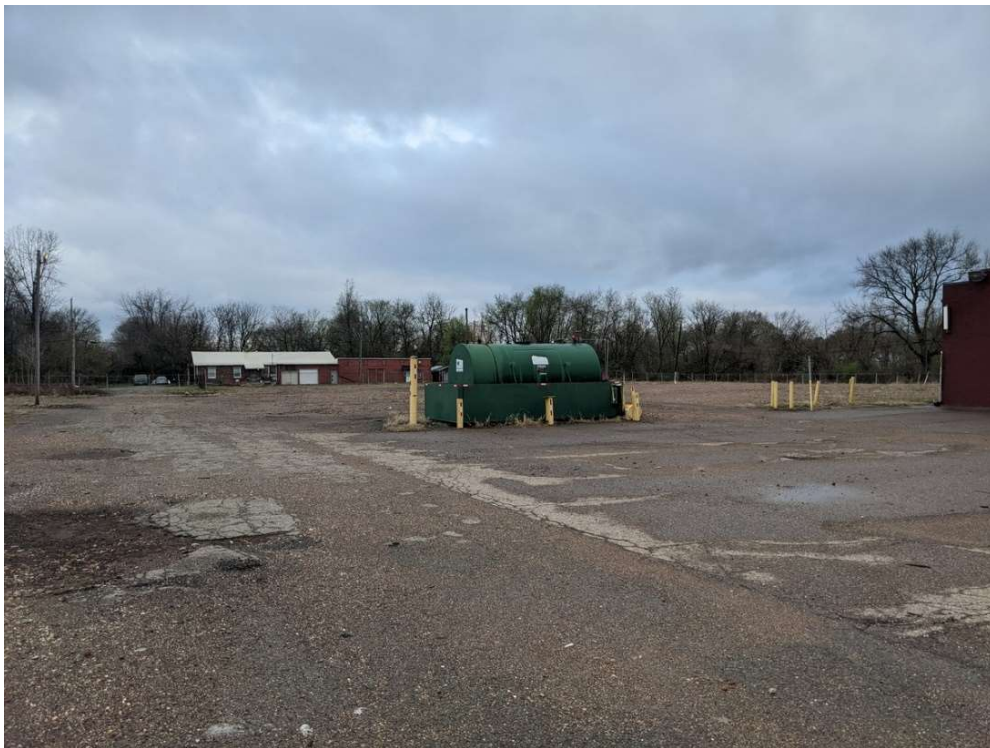
Photo 2. 6,000-gallon diesel AST located south of maintenance building-Site A.

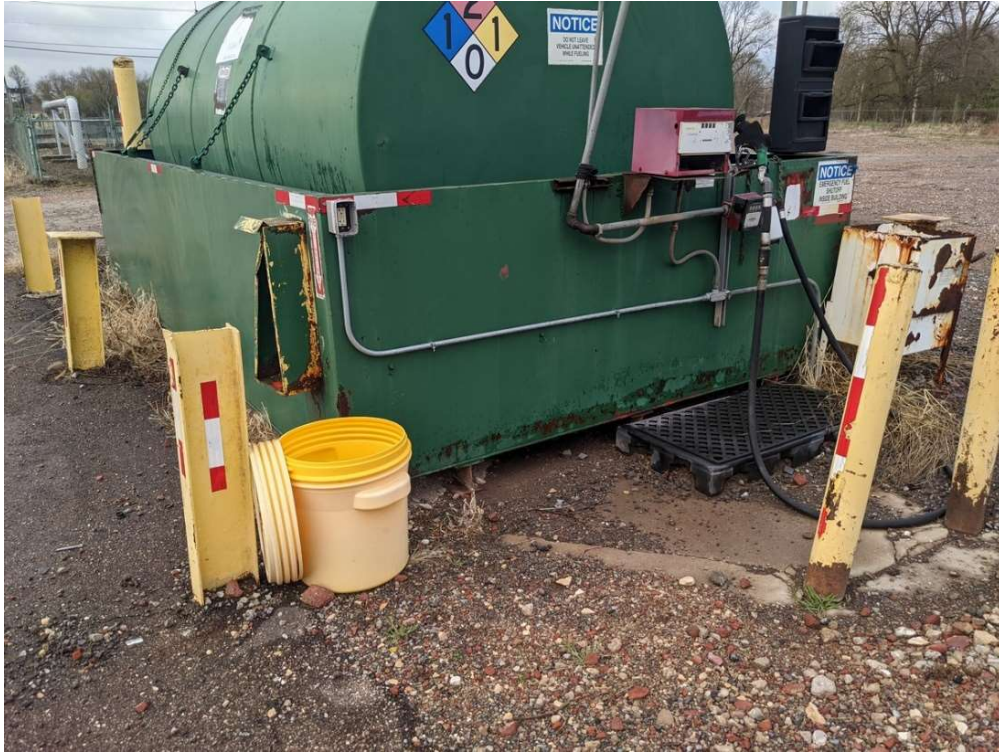
Photo 3. Close up of AST with spill kit present, some staining in area is present.

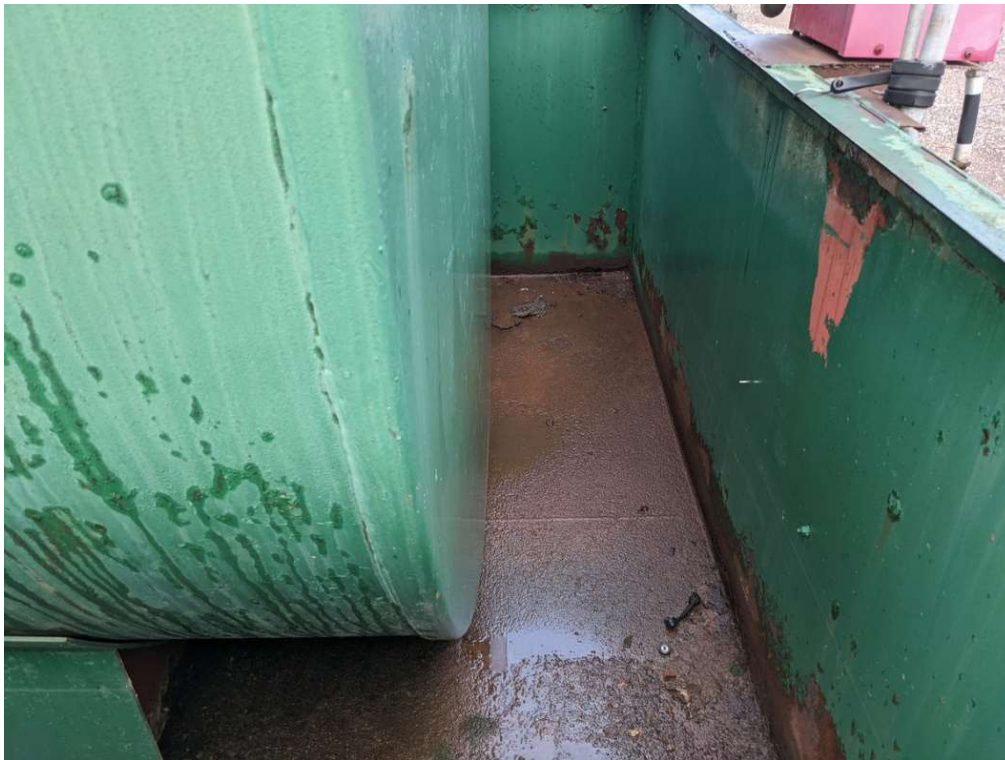
Photo 4. No sheen present in secondary containment of AST.

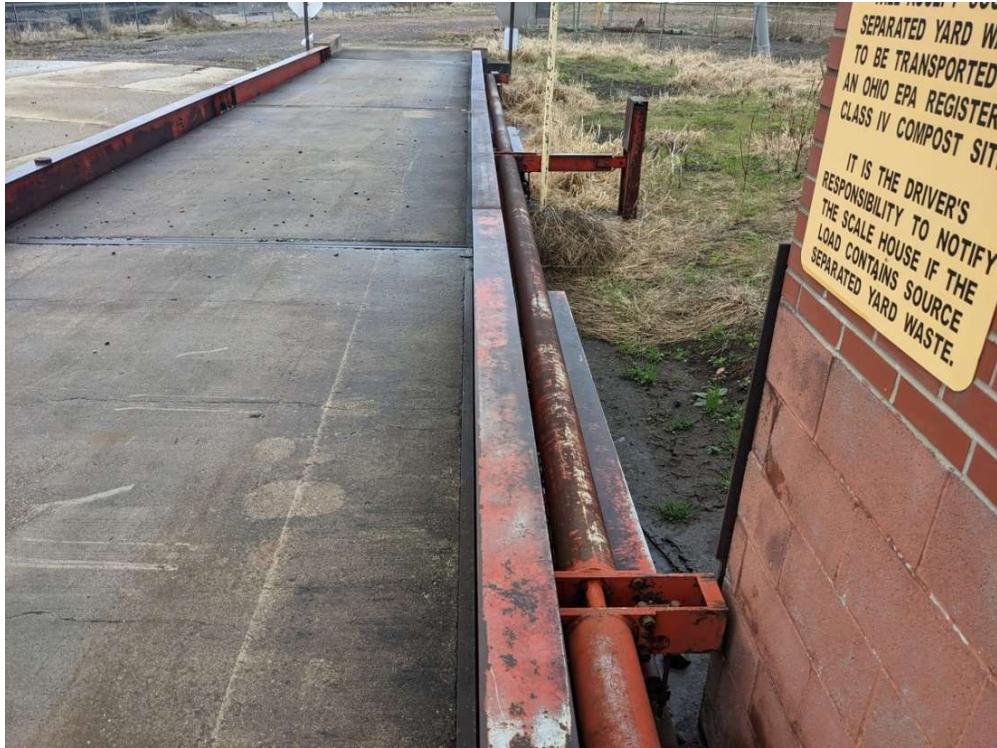
Photo 5. Scale (mechanical lever system) located on the southside of Site A. petroleum odor and stressed vegetation present.

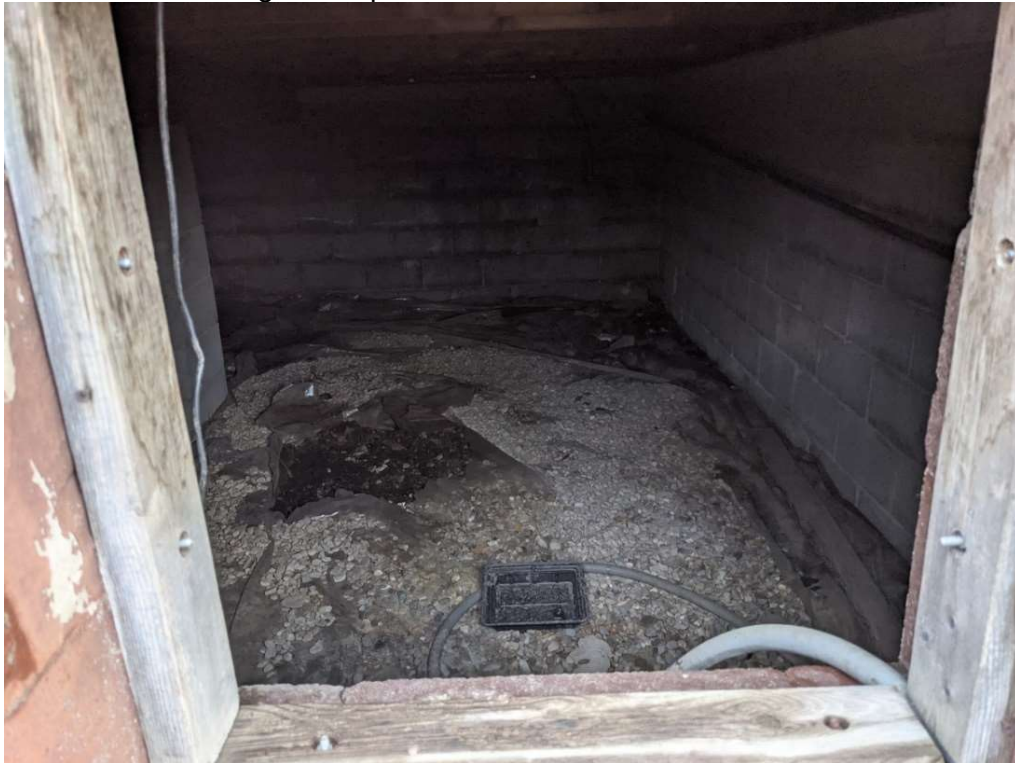
Photo 6. View inside the Scale Building-Site A.

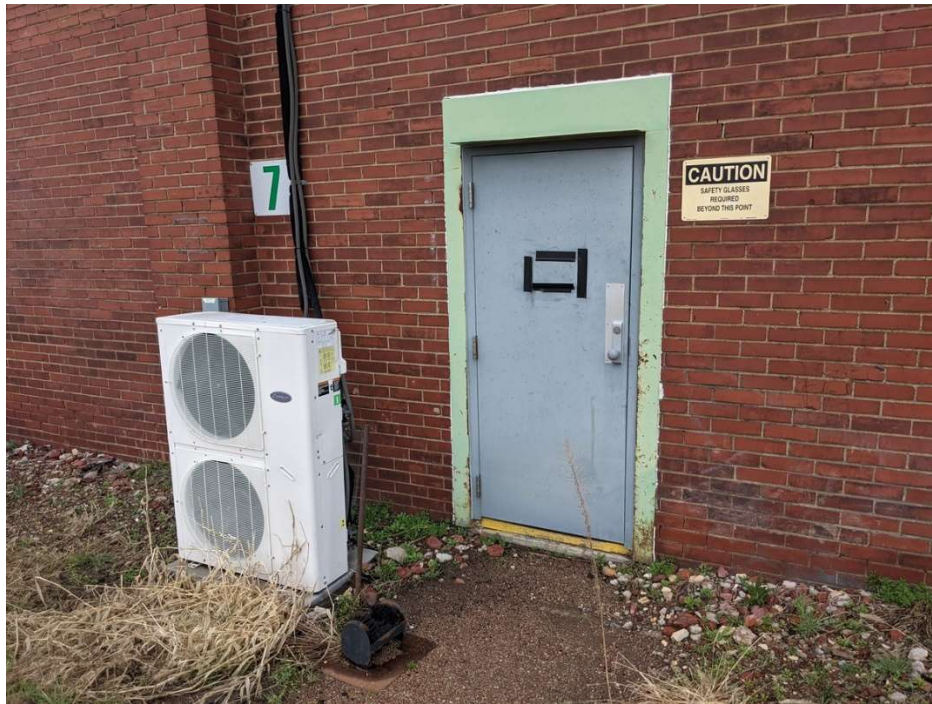
Photo 7. Air conditioning unit on southside of Maintenance Building. Site A

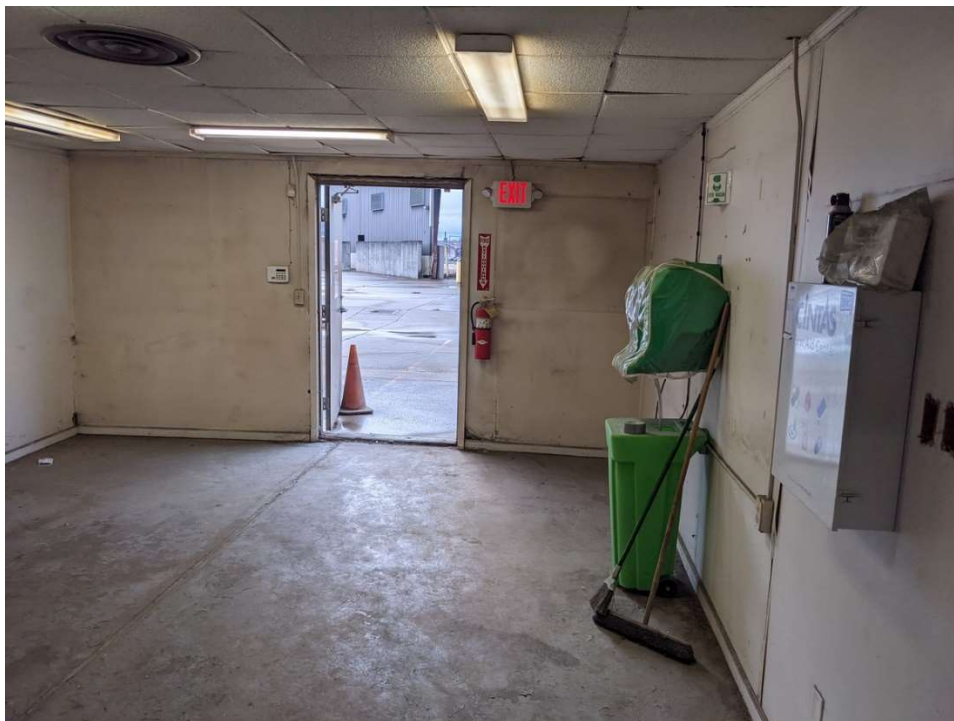
Photo 8. East side entrance of Maintenance Building. ACM potential in ceiling and walls. Site A.

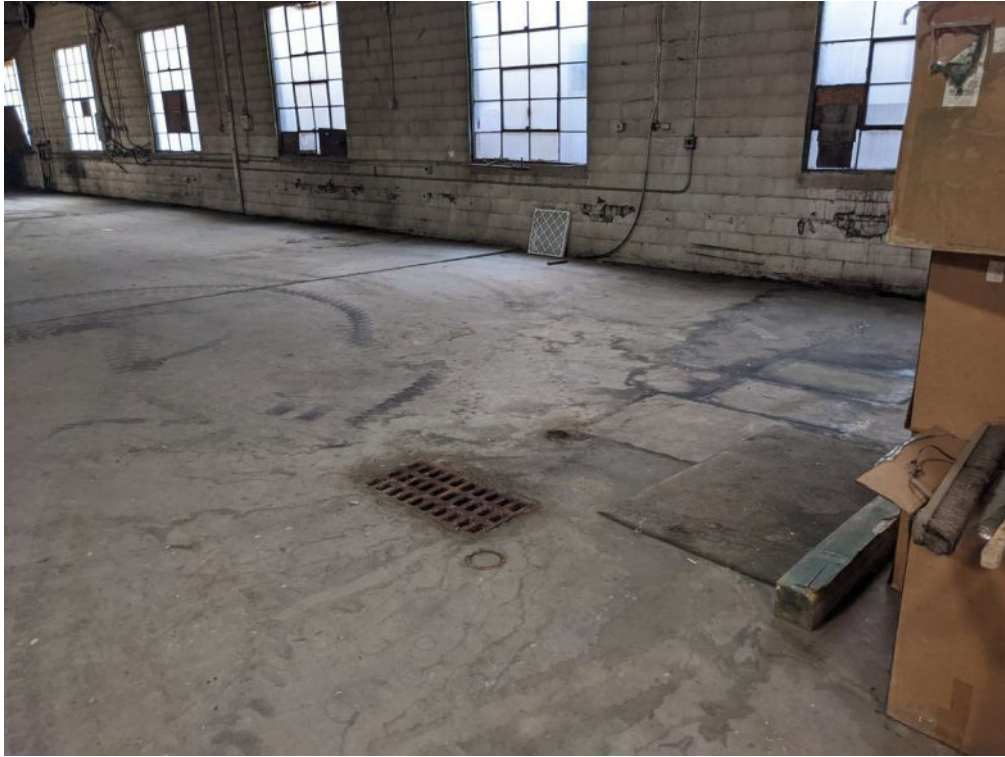
Photo 9. Floor drain inside Maintenance Building, drain to wastewater. Site A.

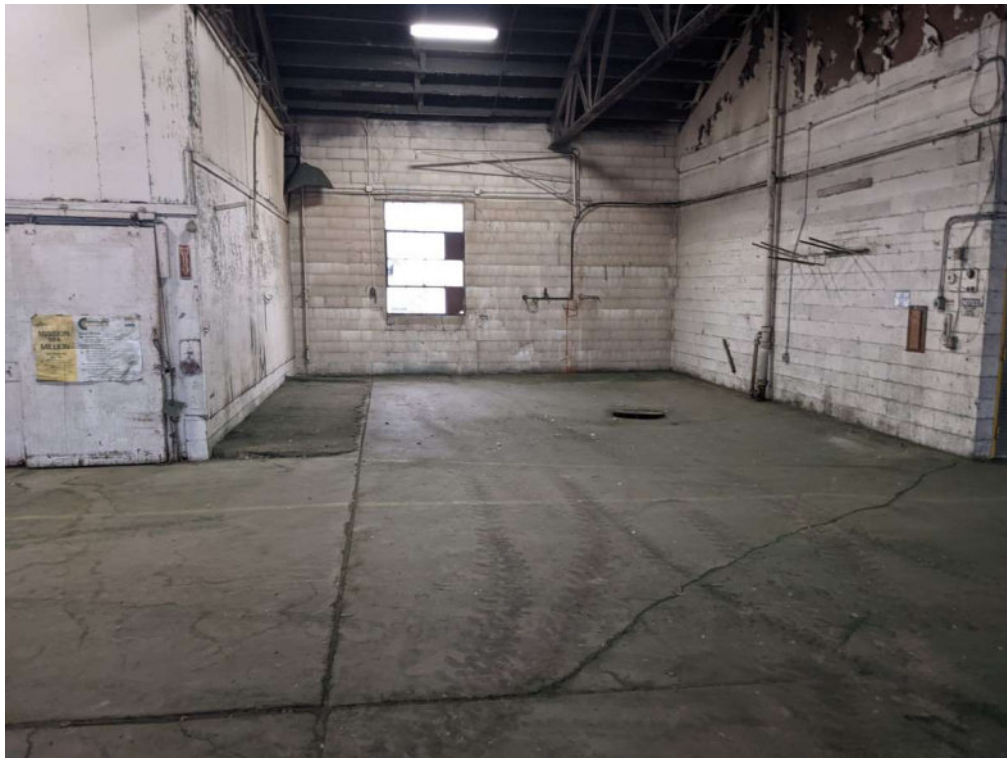
Photo 10. Oil/Water Separator in northwest section of the Maintenance Building. Outlet is unknown. Site A.

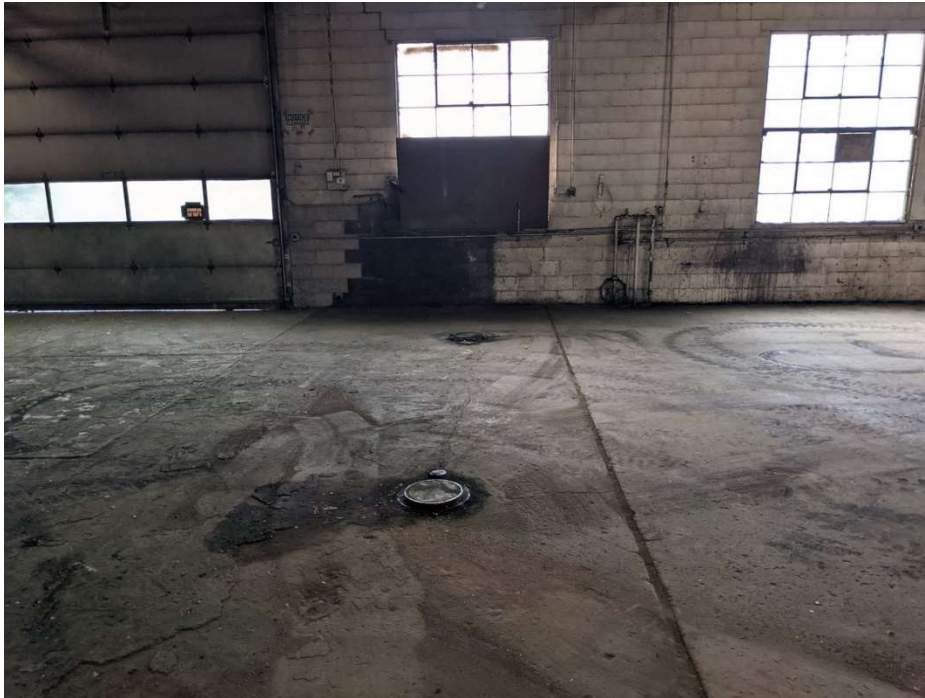
Photo 11. Hydraulic lift pistons inside Maintenance Building. Staining present. Site A

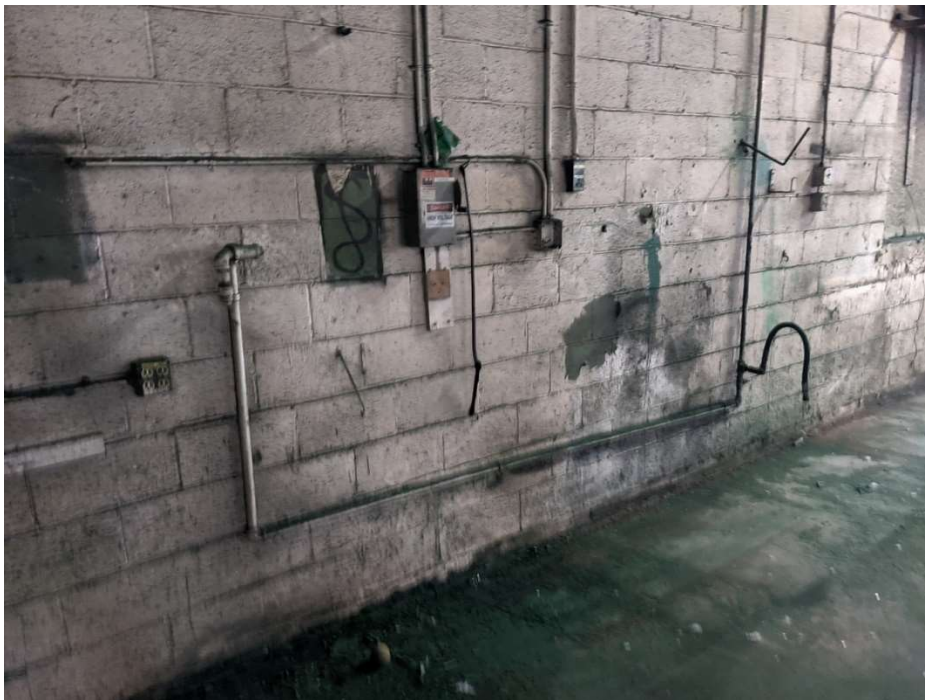
Photo 12. Hydraulic air compressor located on the northside of the Maintenance Building. Potential for PCBs. Site A

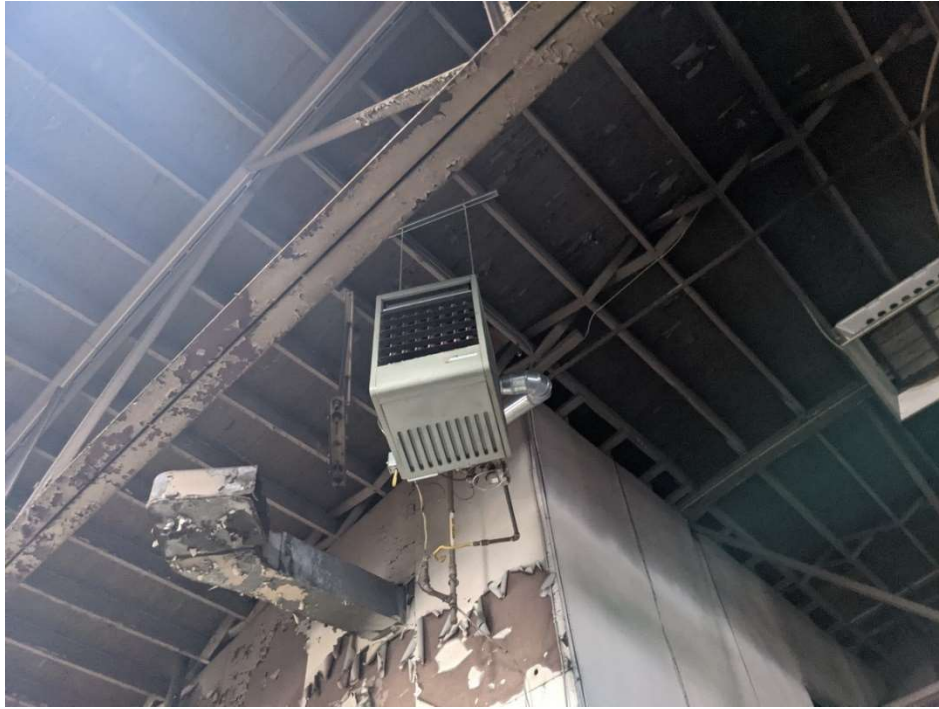
Photo 13. Overhead natural gas heaters in the Maintenance Building. Wall is for the refrigerated rooms. Potential ACM in walls. Site A.

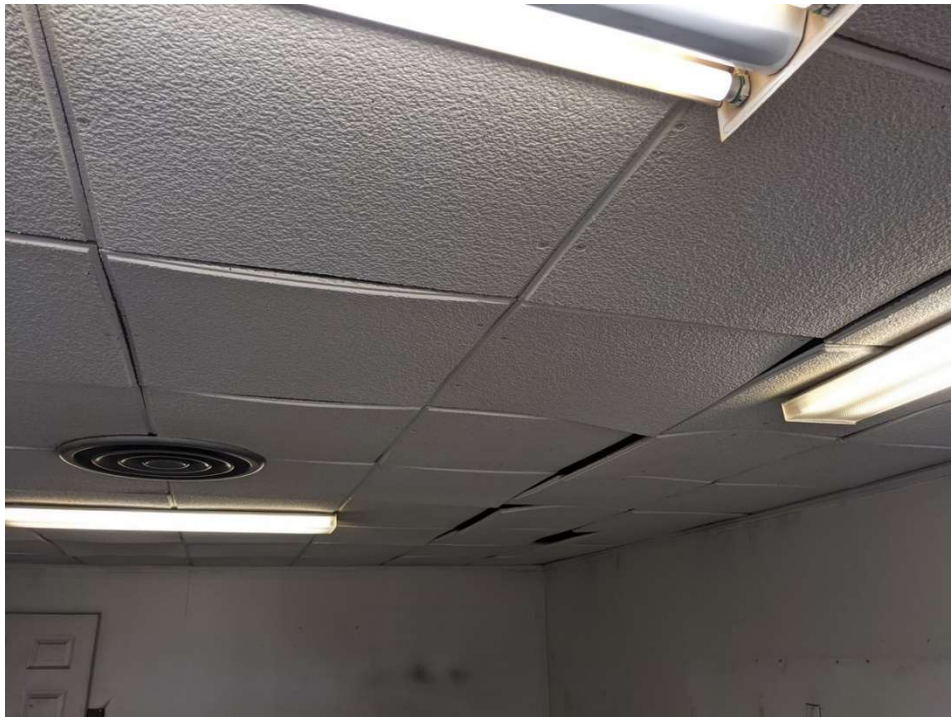
Photo 14. Potential ACM in ceiling tiles inside the Maintenance Building. Site A

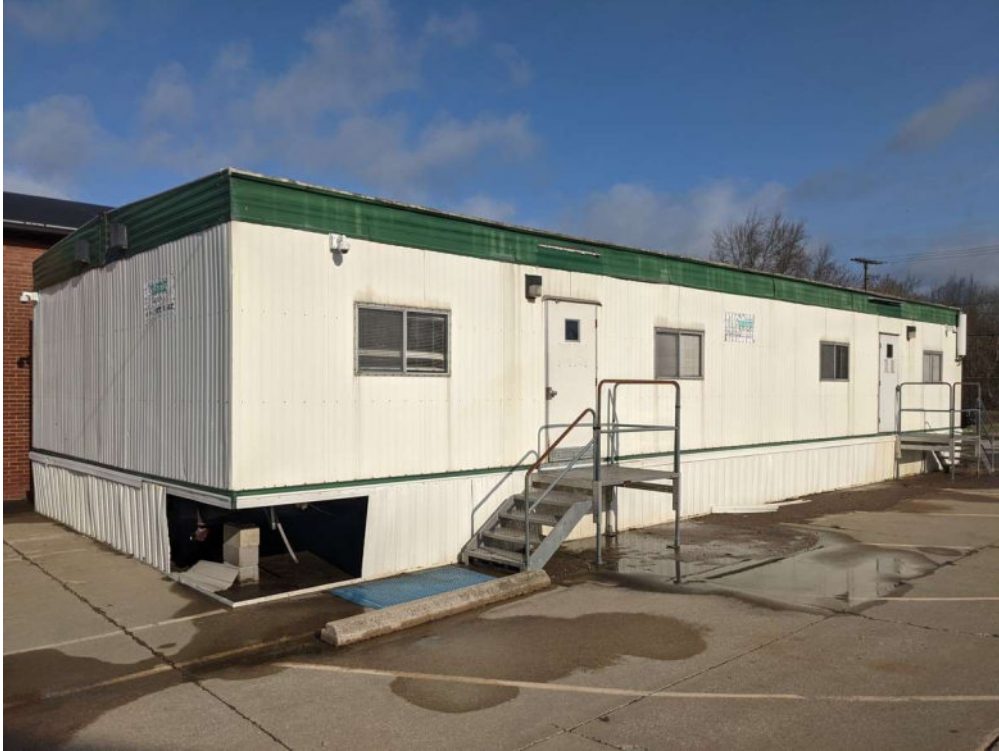
Photo 15. Pop up trailer on east side of Maintenance Building used for offices. No access was provided during assessment. Site A.

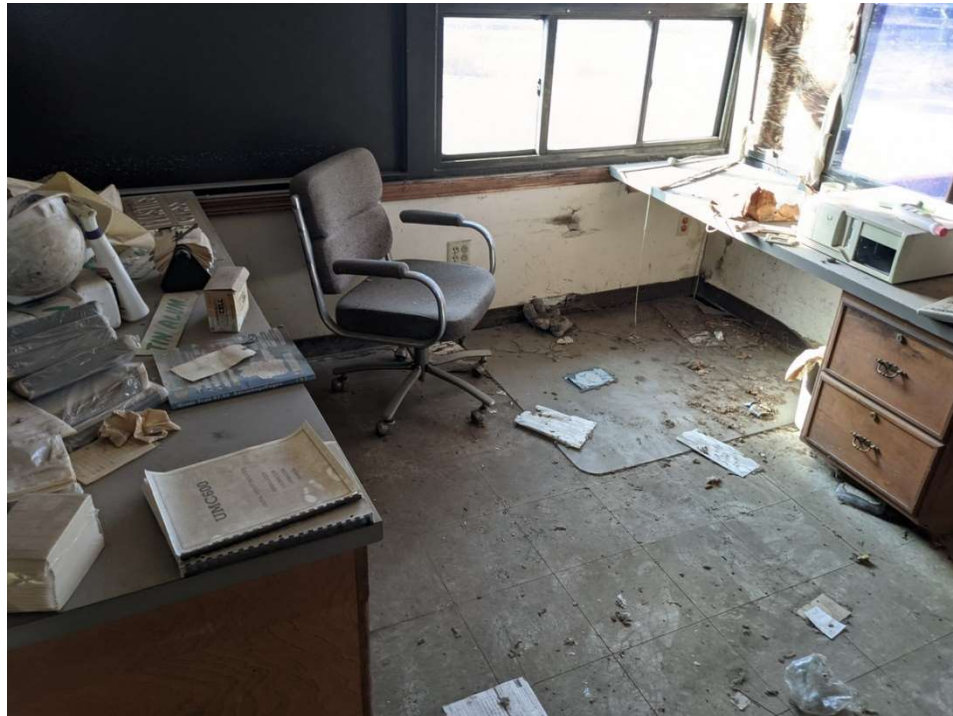
Photo 16. Inside Scale Building, potential ASM in tile floor. Site A.

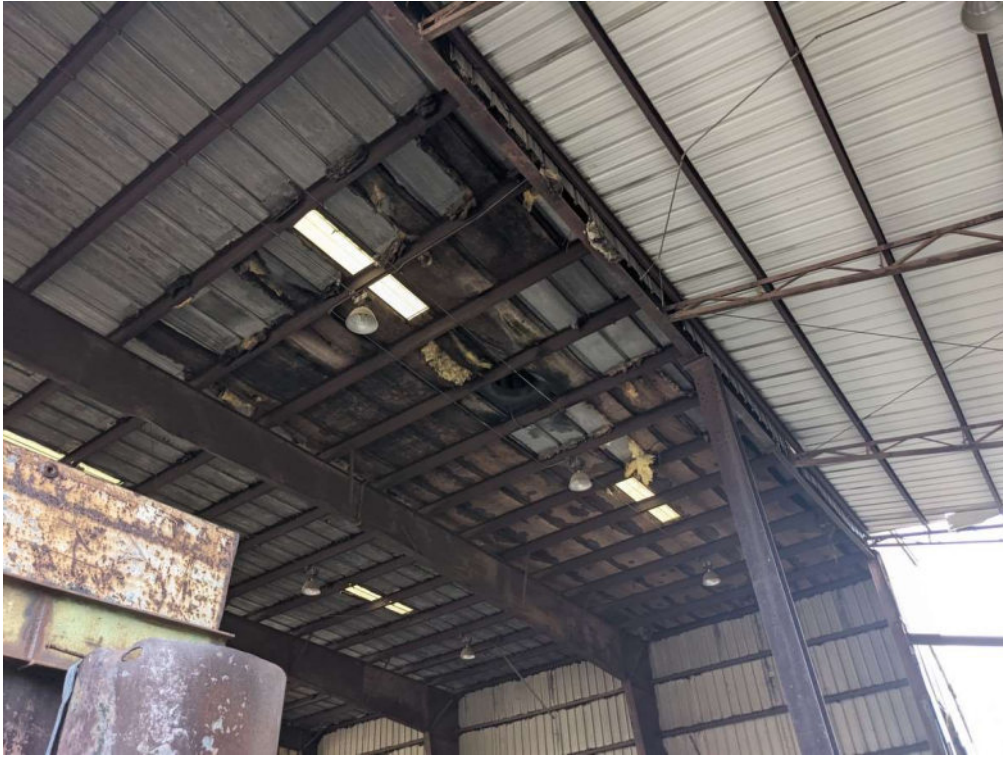
Photo 17. Ceiling in Sorting Building. Site A

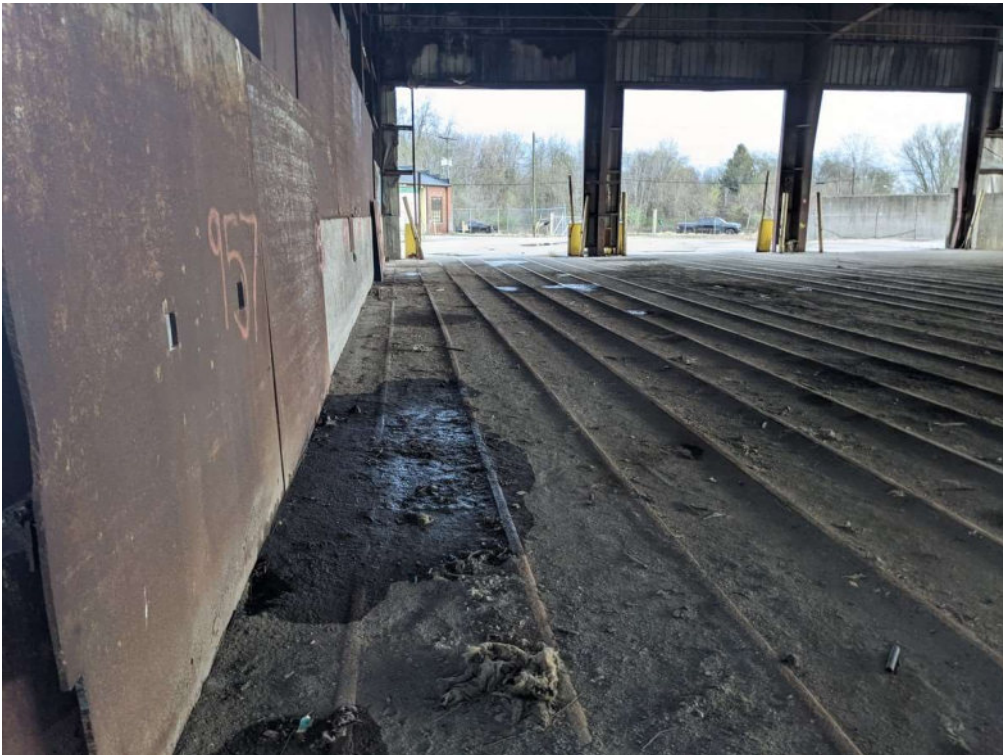
Photo 18. Inside Sorting Building, rails for trash dumpster. Staining present. Site A

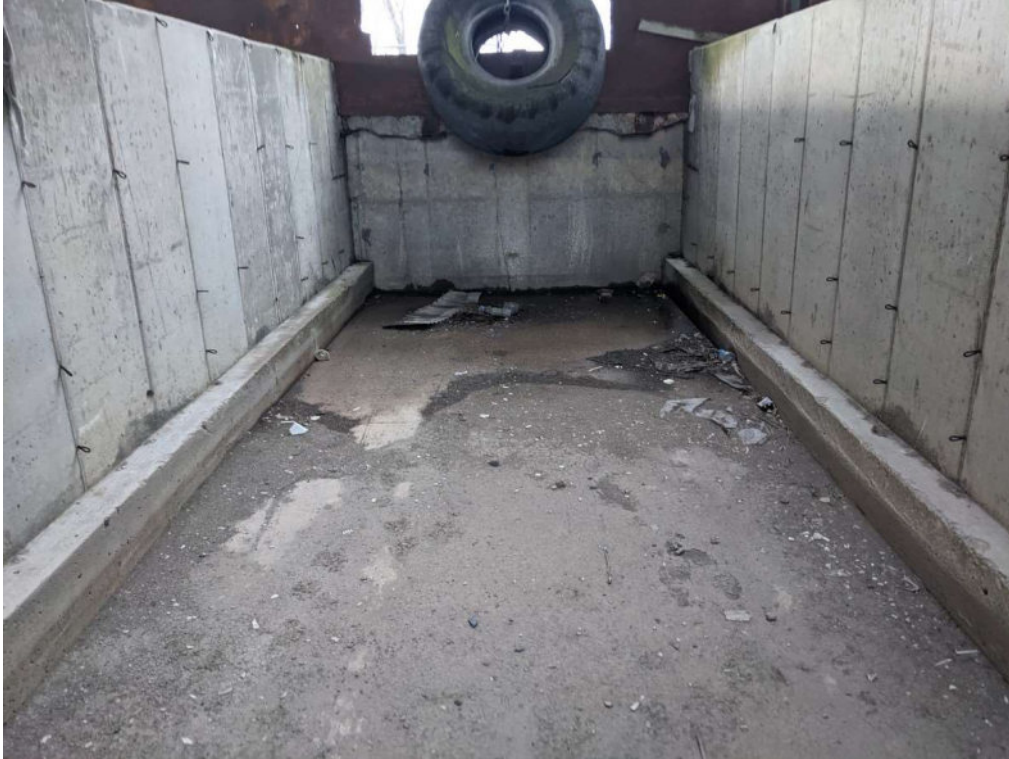
Photo 19. In Sorting Building, where trucks drive into to unload. Site A

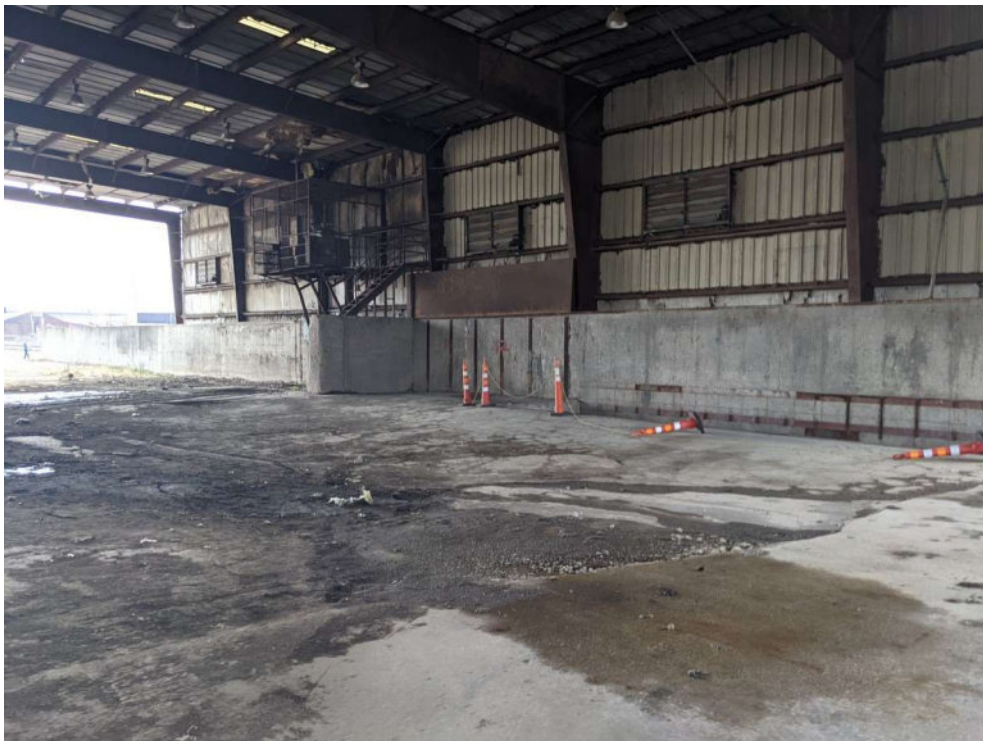
Photo 20. Transformers in cage on wall in the Sorting Building. Potential for PCBs. Staining present on floor. Site A

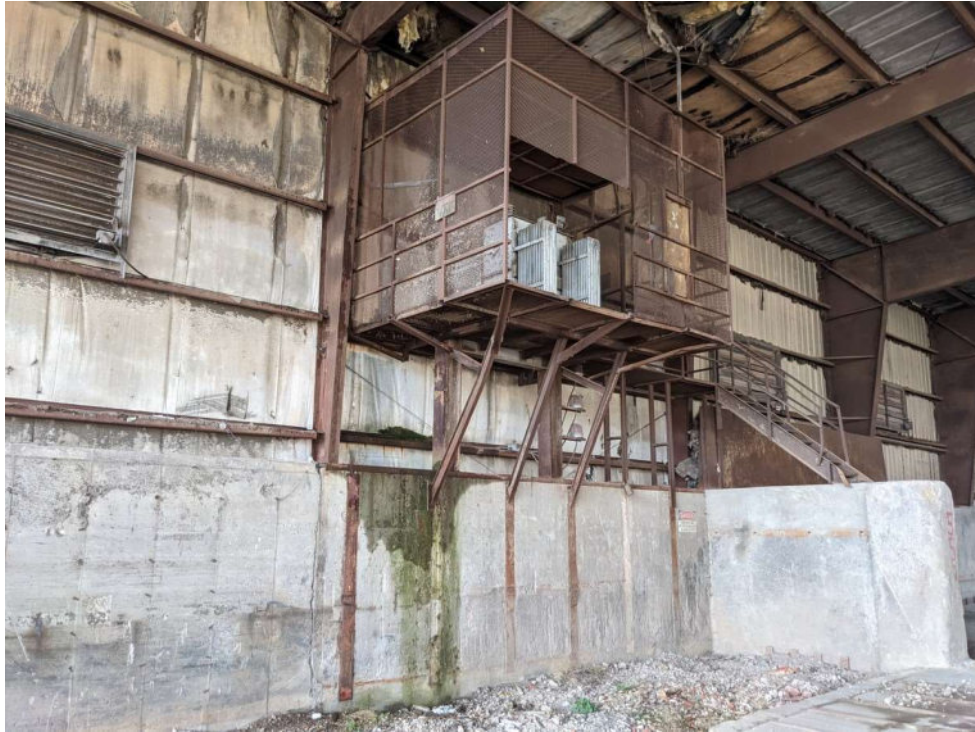
Photo 21. Closeup of transformers in Sorting Building. Staining present on wall and floor. Site A

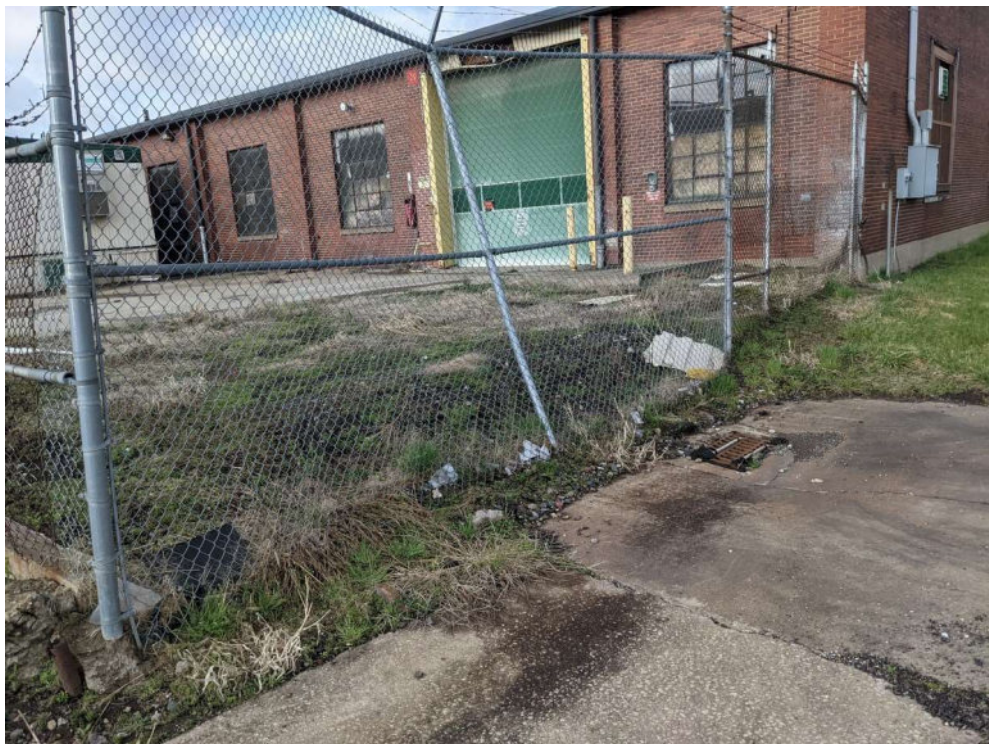
Photo 22. Drain offsite of property on the northside. Filter bag is present.

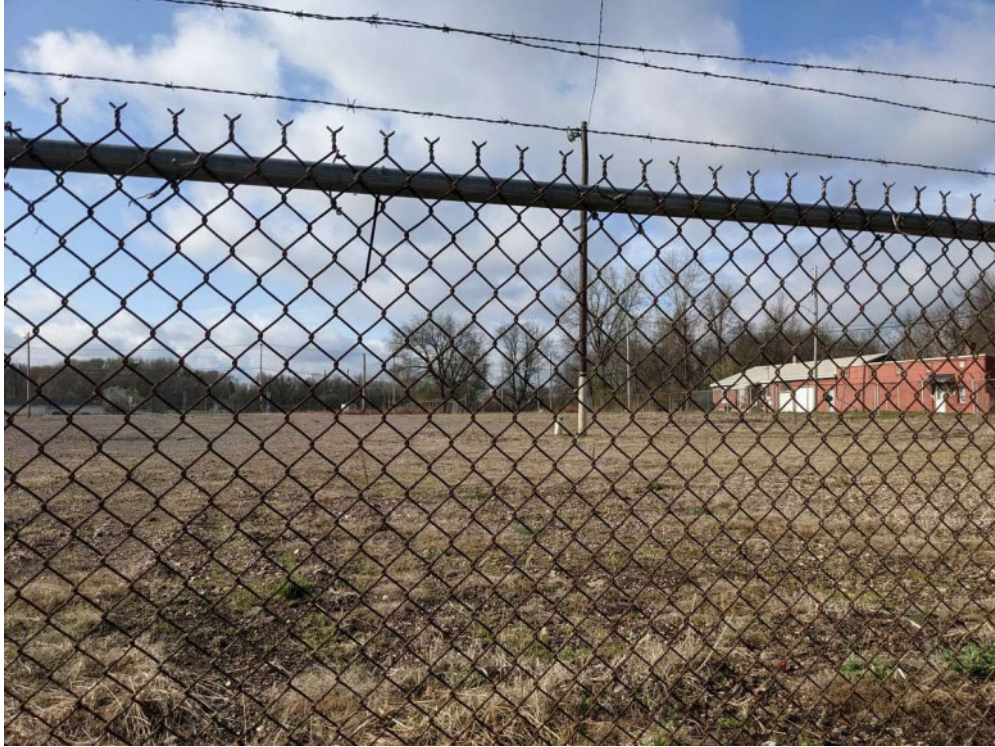
Photo 23. Well located on northwest side of Site A at base of electric pole part of the onsite natural gas transfer station.

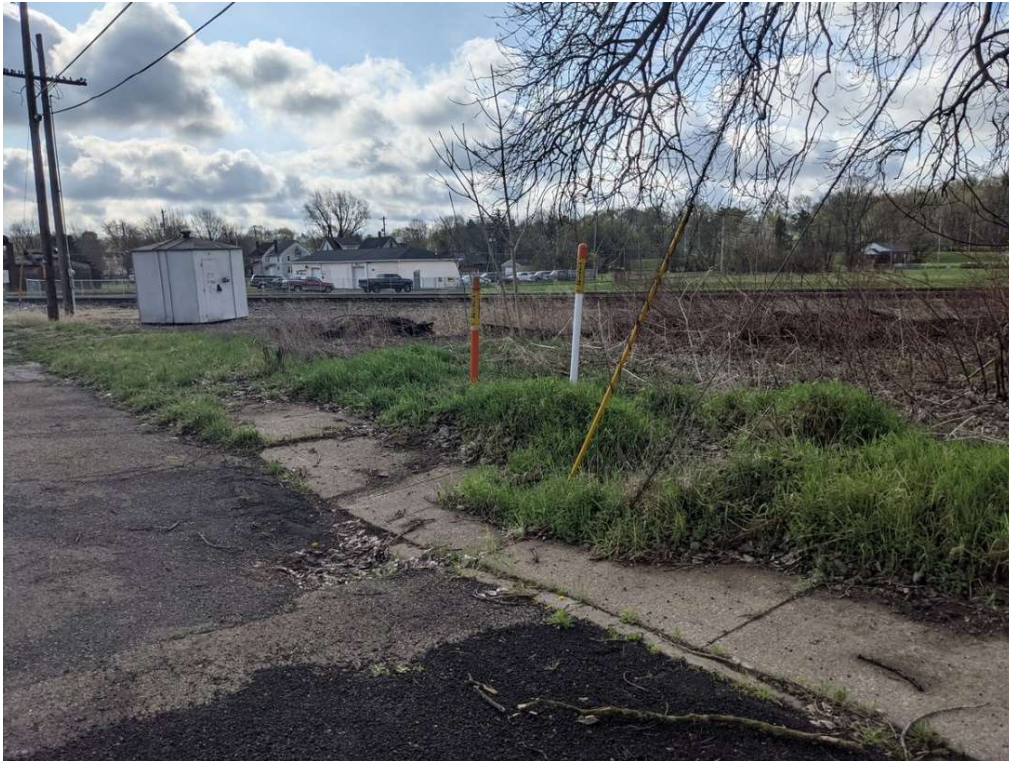
Photo 24. At Warner and 8th Street intersection facing railroad tracks (east). Site B

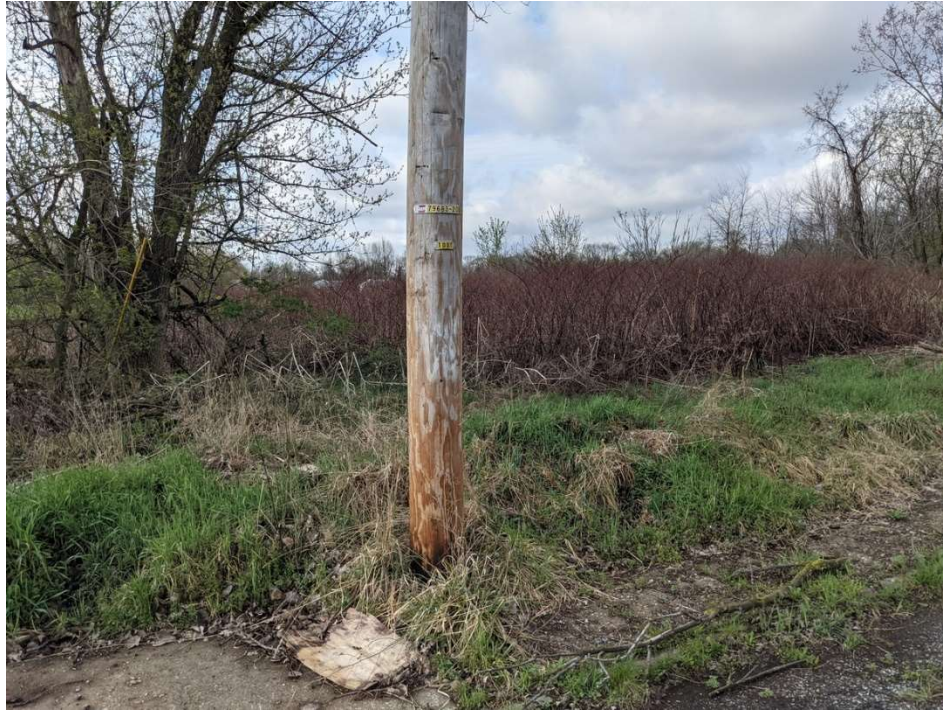
Photo 25. Southwest parcel (PN 218899), Japanese Knotweed present a known invasive species. Site B

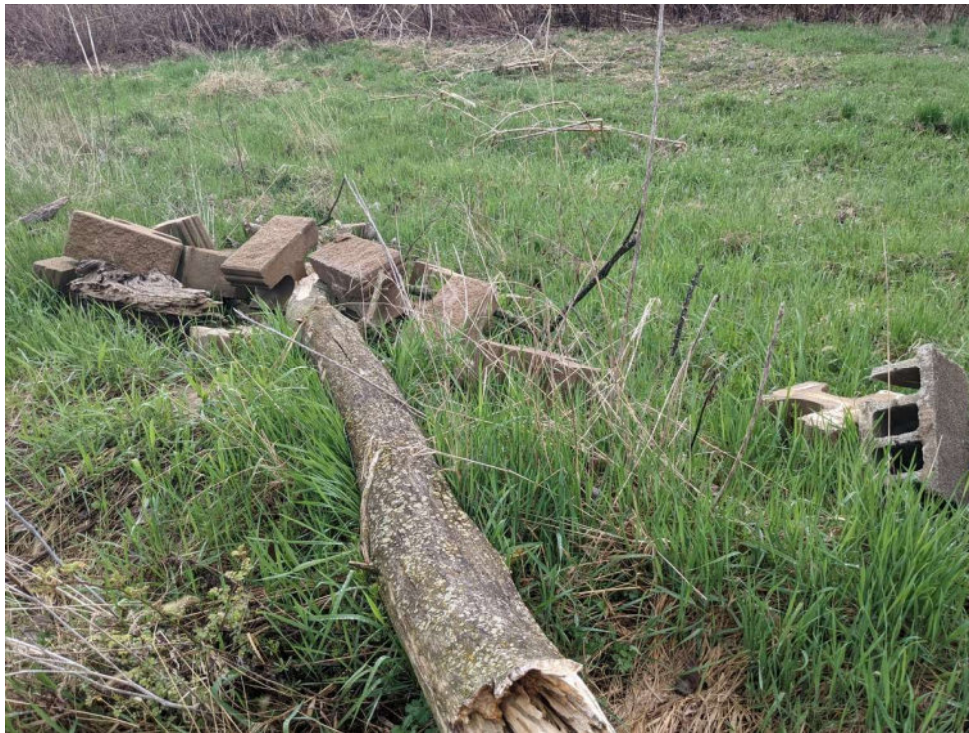
Photo 22. Construction debris present on southwestern parcels. Site B.

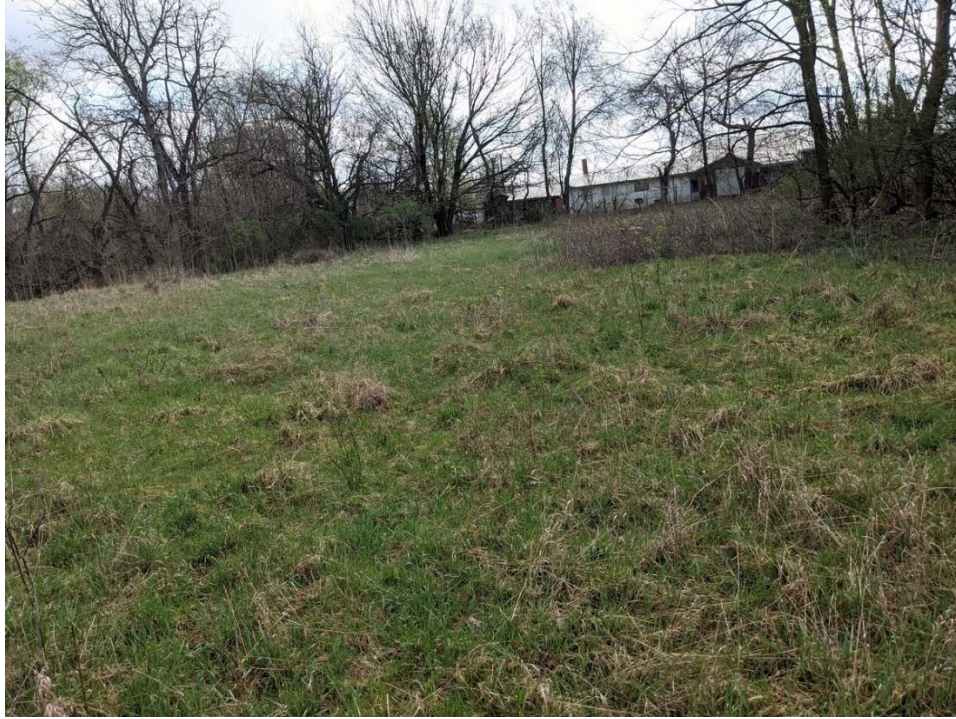
Photo 27. View of PN 246333, no issues noted. Site B

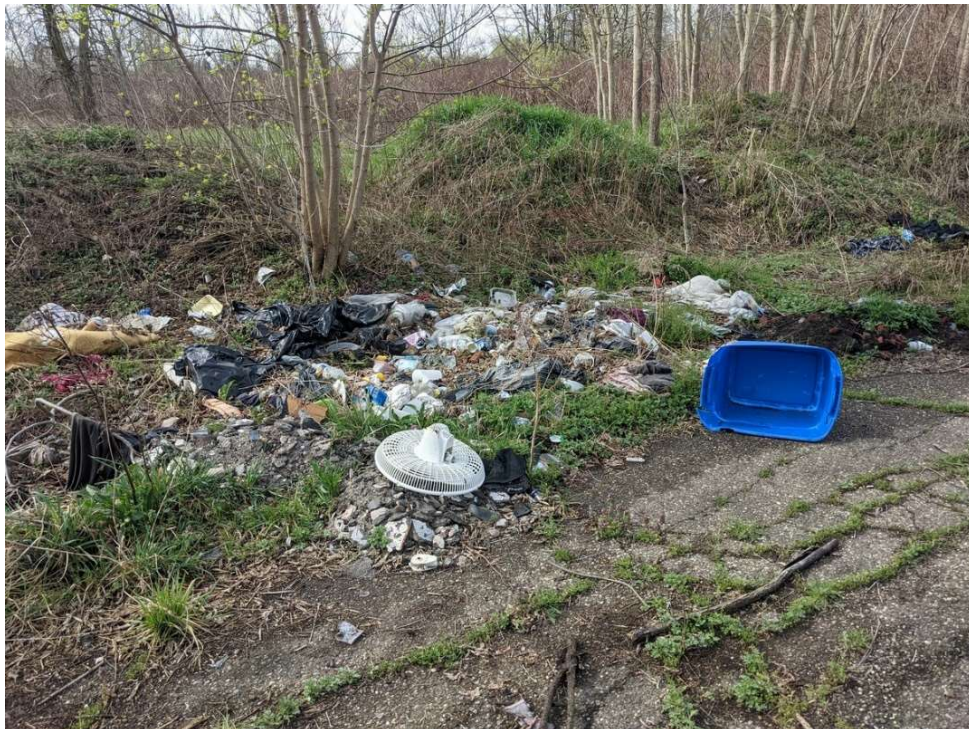
Photo 28. Trash present on south west of site. Site B.

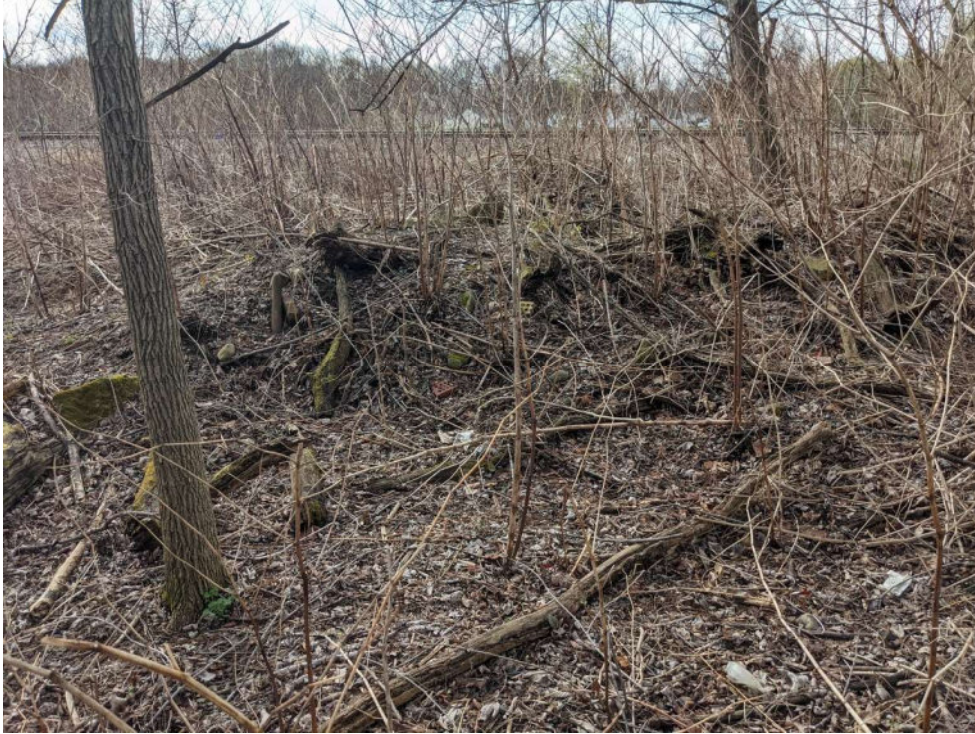
Photo 29. Southwest parcel (PN 218899), trash, stone and brick. Site B

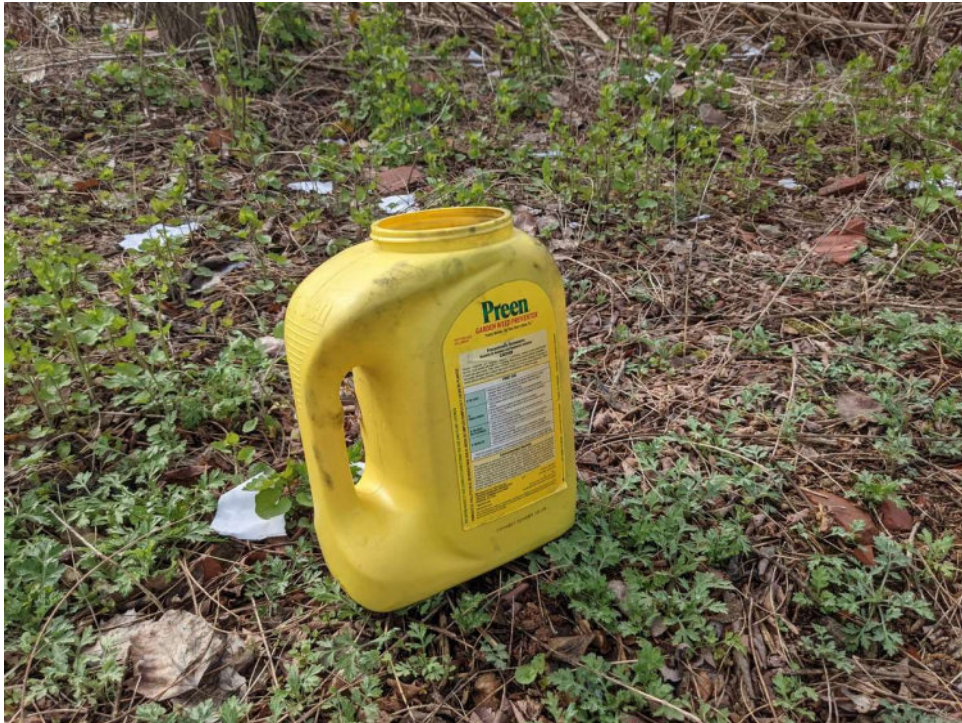
Photo 30. Empty herbicide container. Site B.

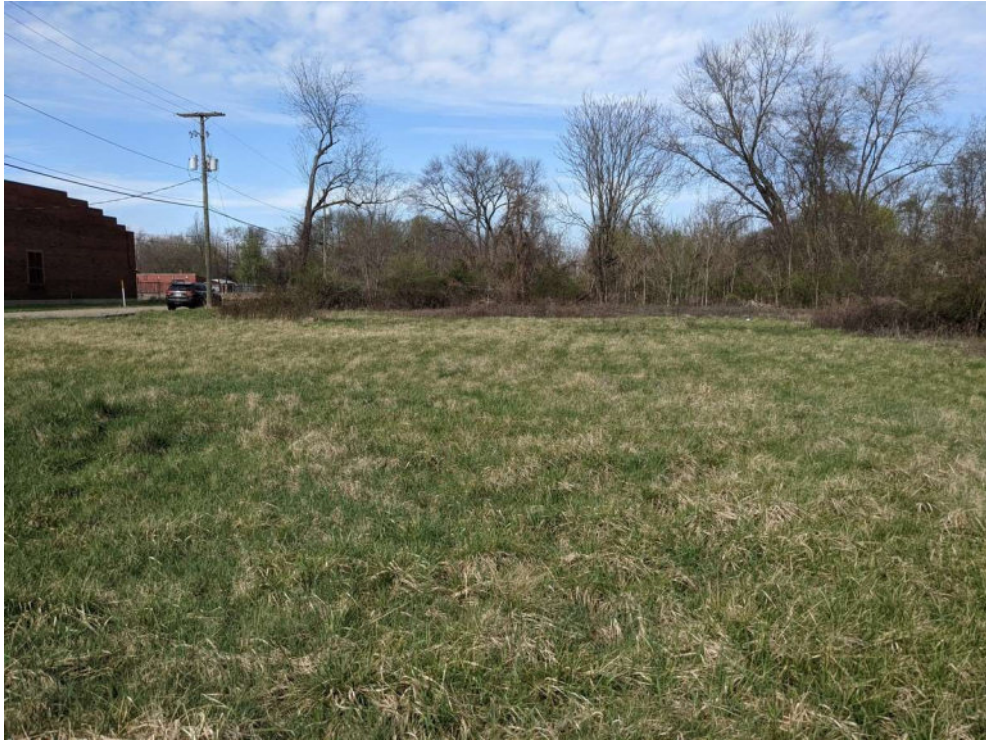
Photo 31. Northeast section of Site B parcel (PN 246328) maintained lawn.
