9th Street Salt Storage Facility Renovations GP 1371

Exhibit B – Site Photos

*Phase I ESA Middle Branch Re-Development
Photographed April 09, 2021*

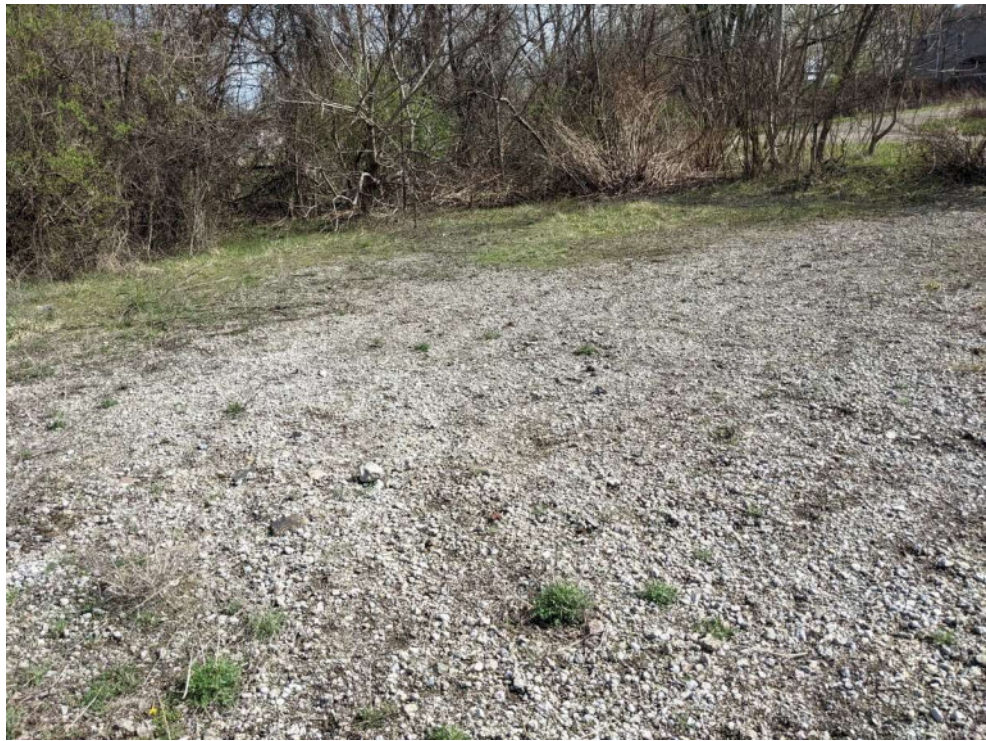
Photo 32. Gravel pad located at PN 246327. Site B.

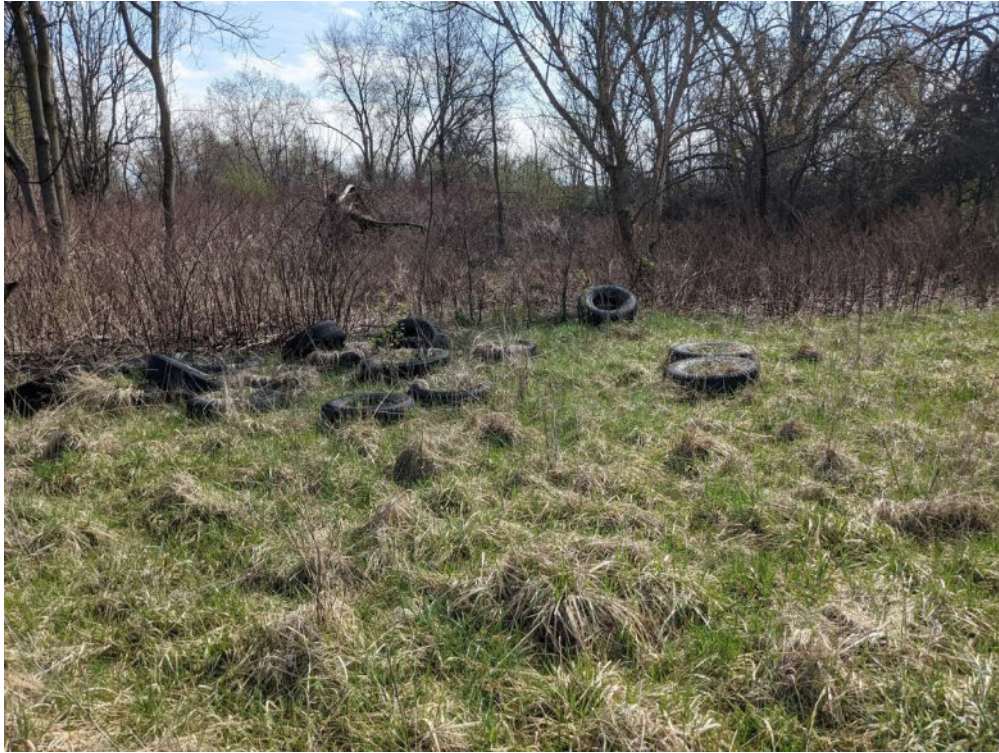
Photo 33. Southwest side of parcel 246327, tire pile present. Site B

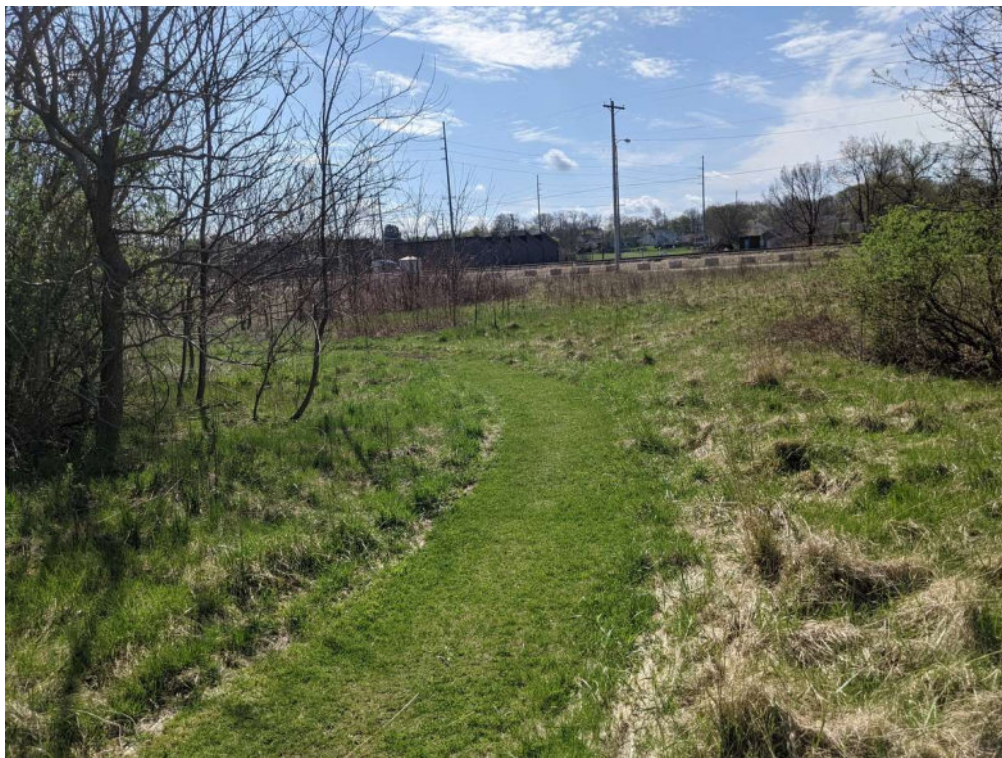
Photo 34. Mowed path located on parcel 246326. Site B.

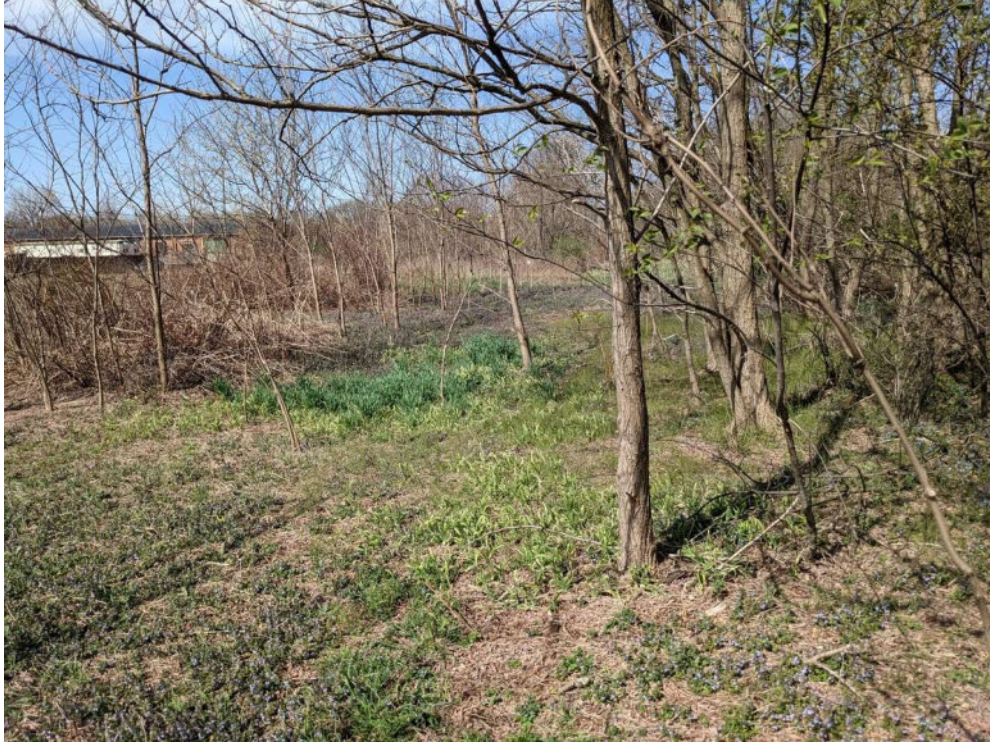
Photo 35. Parcel 234777, no issues observed. Site B

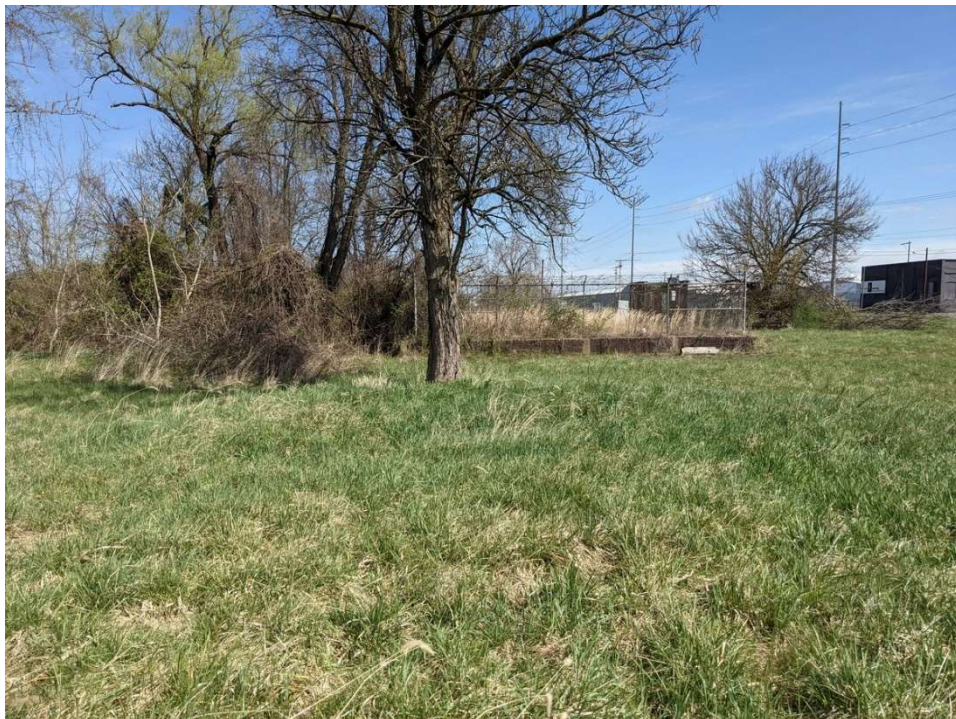
Photo 36. Parcel 208436 looking north, no issues observed. Site B.

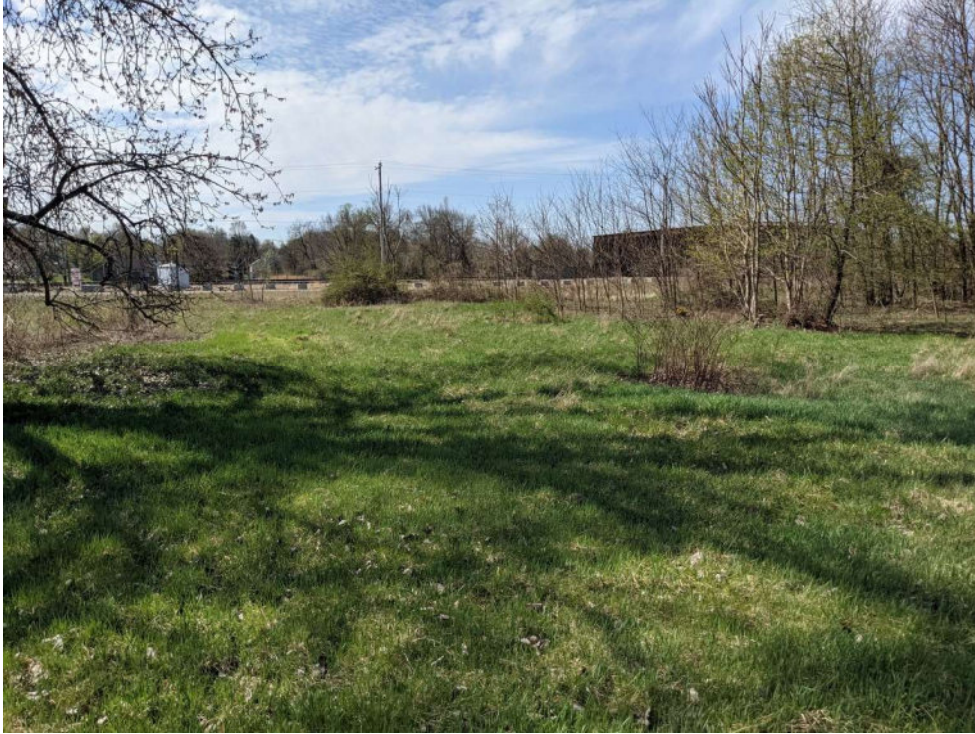
Photo 37. Parcel 200743, facing south, no issues observed. Site B
