LIMITED ASBESTOS INSPECTION REPORT
BOBBY ALFORD CENTER AT EAST BAY PARK

Georgetown, South Carolina

Asbestos Inspections, LLC Project # 2017-94

Inspection Completed On – April 19, 2017

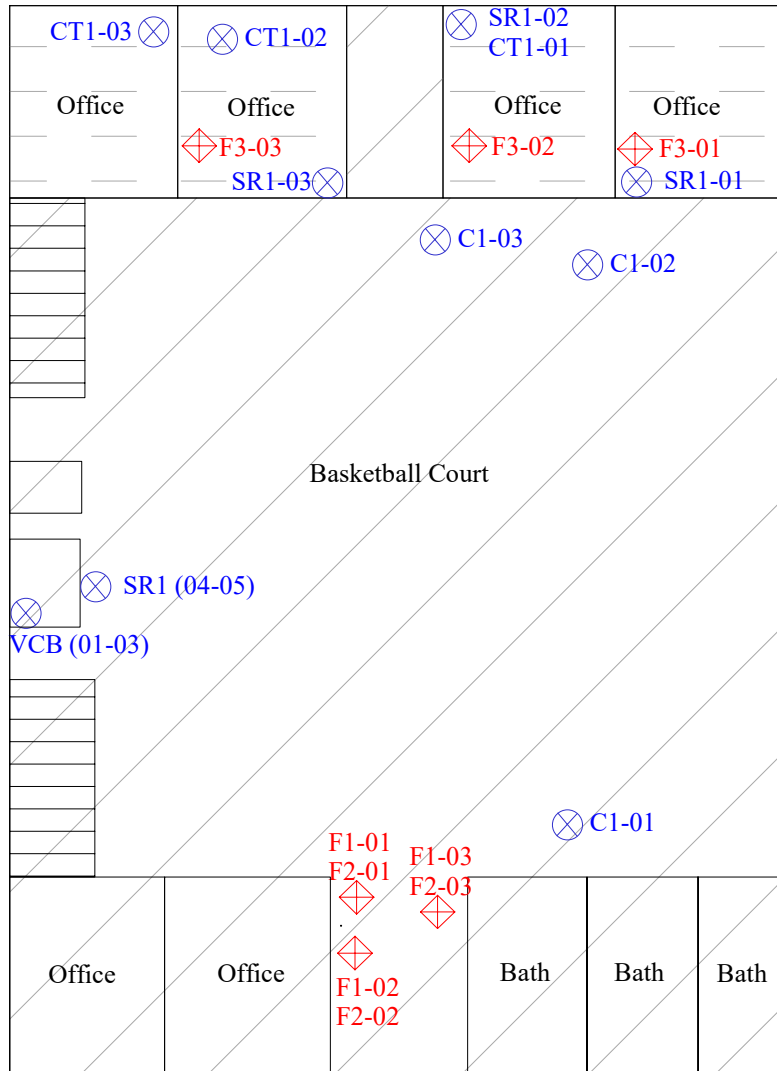
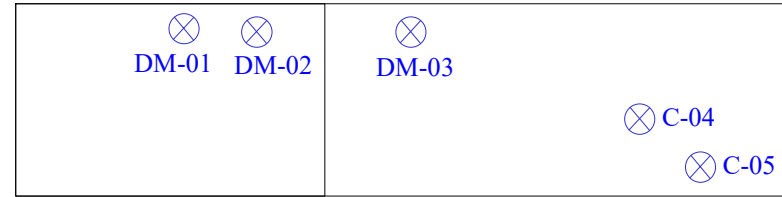
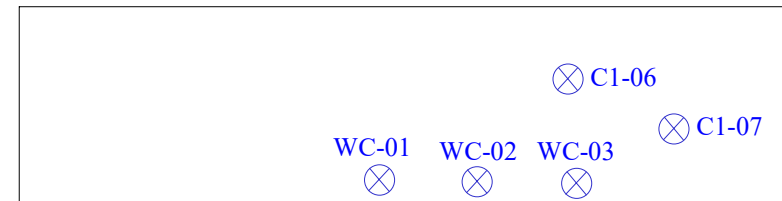
Figure 2

- ⊗ Sample Location
- ⊠ Asbestos Containing Sample Location
- Asbestos containing mastic associated with non-asbestos containing floor tile underlying carpet in the front offices (Approx. 6,220 sf total)
- Asbestos containing floor tile and mastic underlying carpet (approx. 1,000 sf)

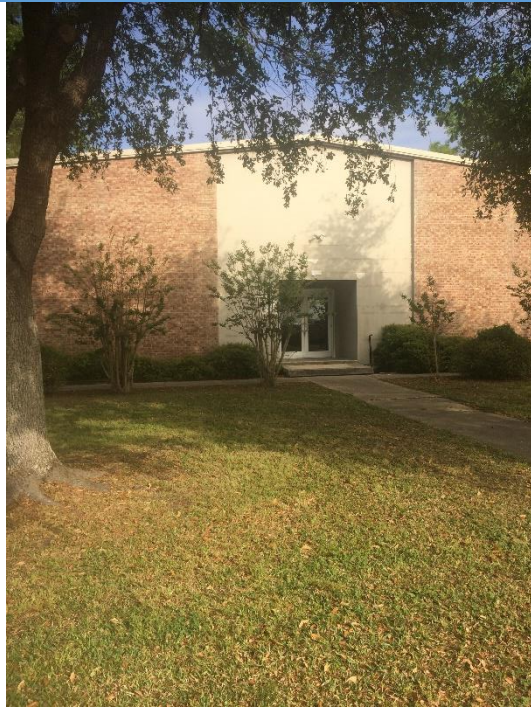
Front of building

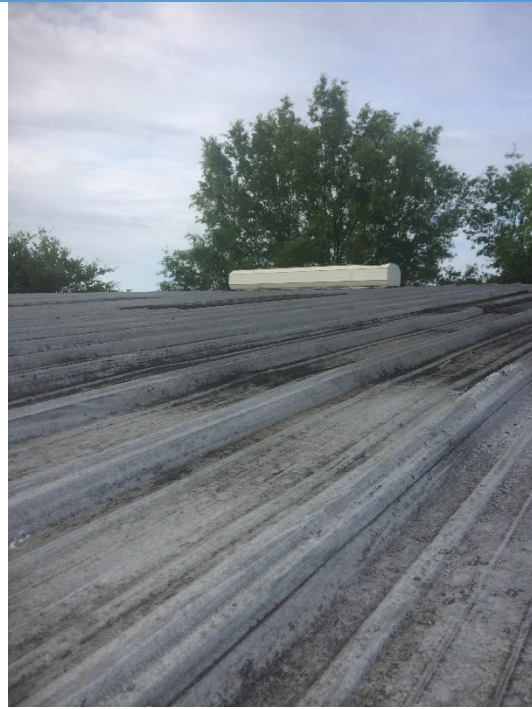
Roof

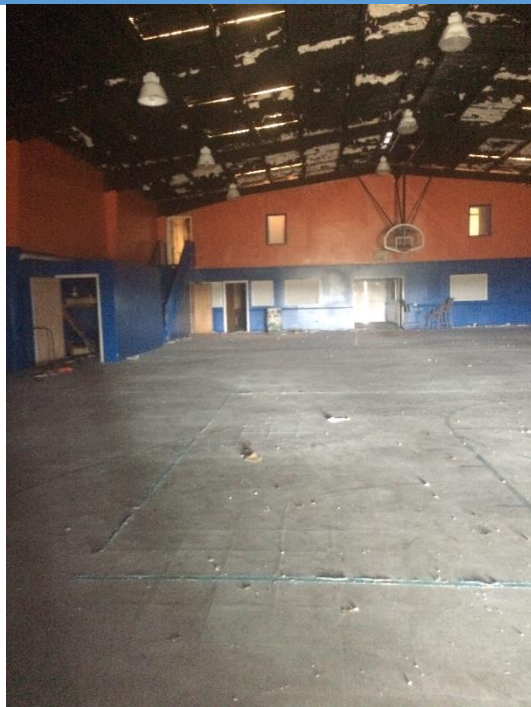
Interior view of main portion of building
(basket ball court)

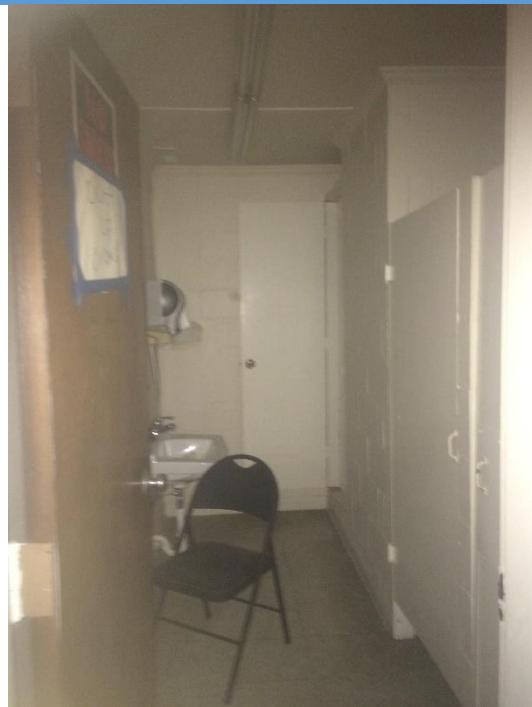
Bathroom

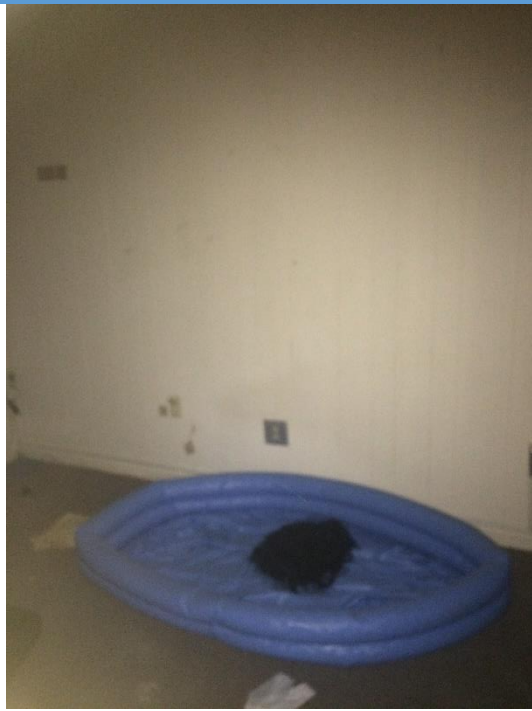
Typical office area

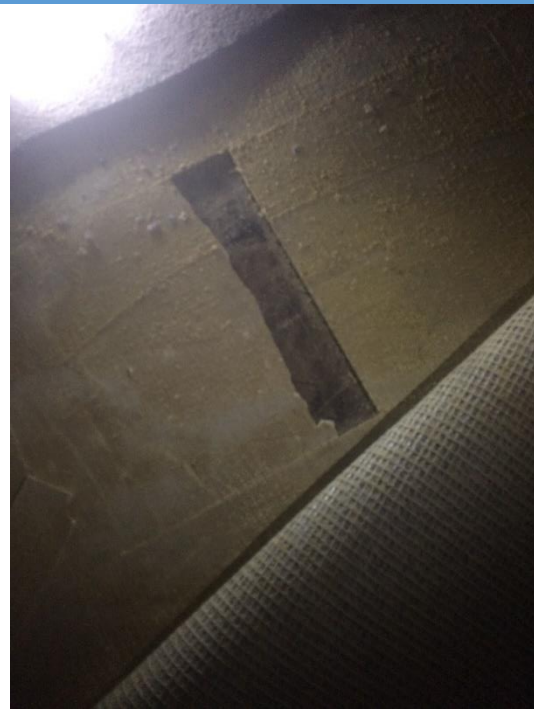
- F1 – Black mastic associated with non-asbestos containing light gray 12”x12” floor tile throughout the main portion of the building and under carpet in the front office areas (approximately 6,200 sf).
- F2 – Black mastic associated with non-asbestos containing white 12”x12” floor tile at front door (approximately 20 sf).
- F3 – Beige 9”x9” floor tile with associated black mastic in rear office areas under carpet (approximately 1,000 sf).

Floor tile under carpet in office areas

Should the above identified ACMs be disturbed, it should be removed by a licensed abatement contractor prior to any disturbance. A copy of this report along with an application for abatement and demolition must be submitted to SCDHEC 10 working days prior to any abatement activities. Additionally, a copy of this report should be provided to the contractors to assist with compliance with applicable State and Federal regulations.

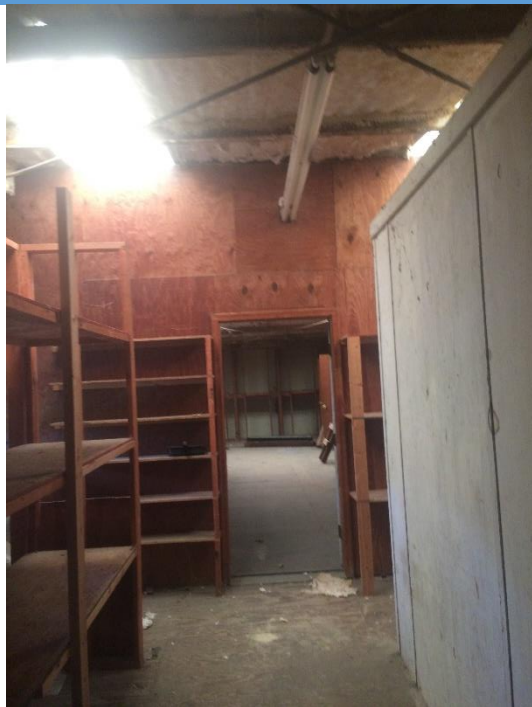
2nd floor above offices

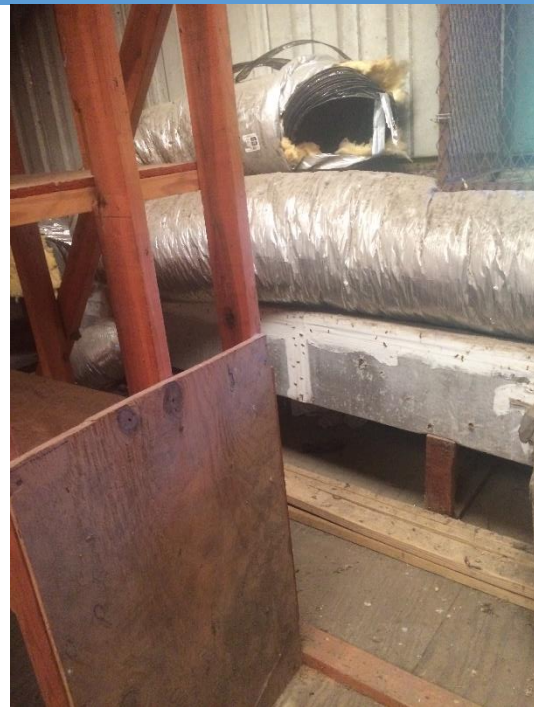
HVAC duct on 2nd floor
