Asbestos & Lead Based Paint Assessment

City of Spartanburg
30 Varner Street
Spartanburg, South Carolina 29306

Project Number: 0118-14

September 6, 2018

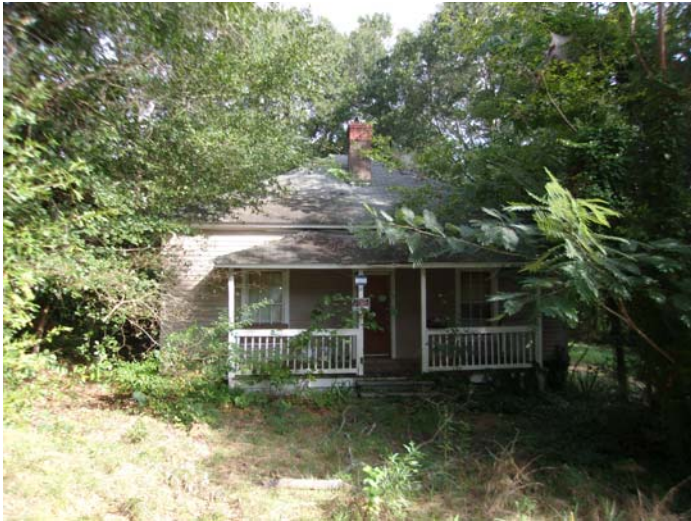
Photo 1 – 30 Varner Street in Spartanburg, South Carolina

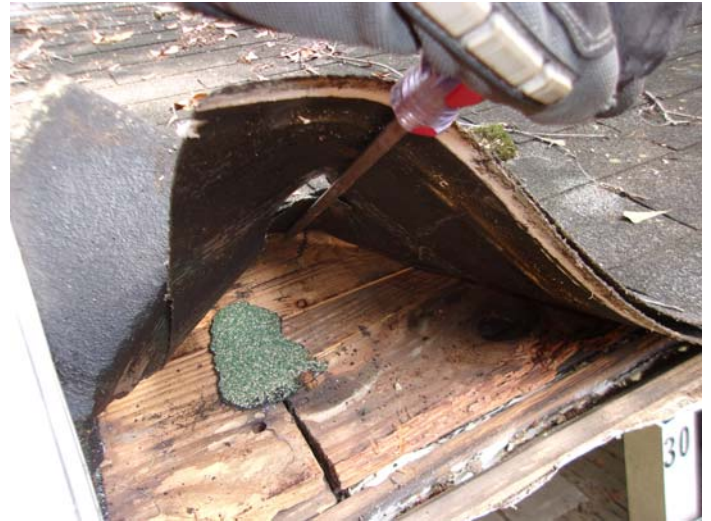
Photo 2 – Roof shingles & no felt

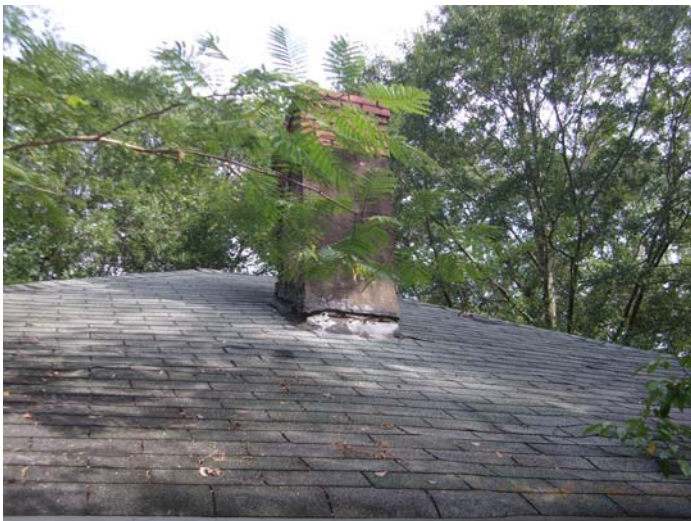
- Approximately 6 LF of chimney mastic/tar on 1 chimney - assumed positive.

Photo 3 – 1 chimney wit mastic/tar – assumed positive

1. Abate the asbestos containing materials in the structure prior to renovation or demolition.

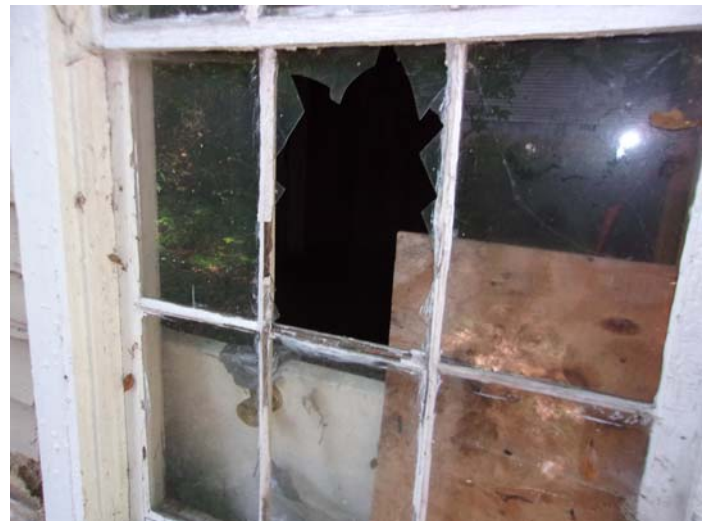
Photo 4 – Wooden windows with glazing & caulk

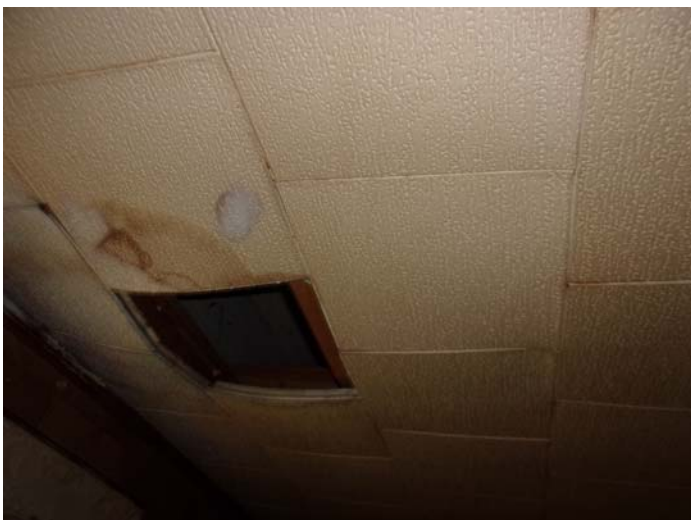
Photo 5 – 12" x 12" ceiling tiles with no mastic throughout

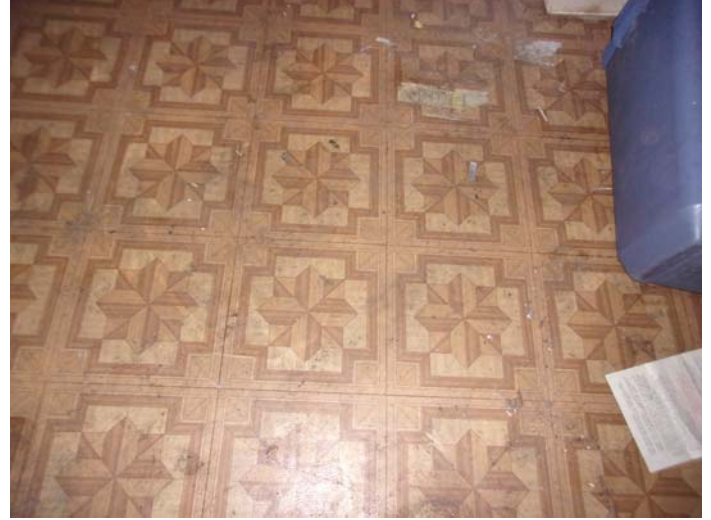
Photo 6 – 12" x 12" wooden pattern self-stick floor tiles in the kitchen & bathroom threshold

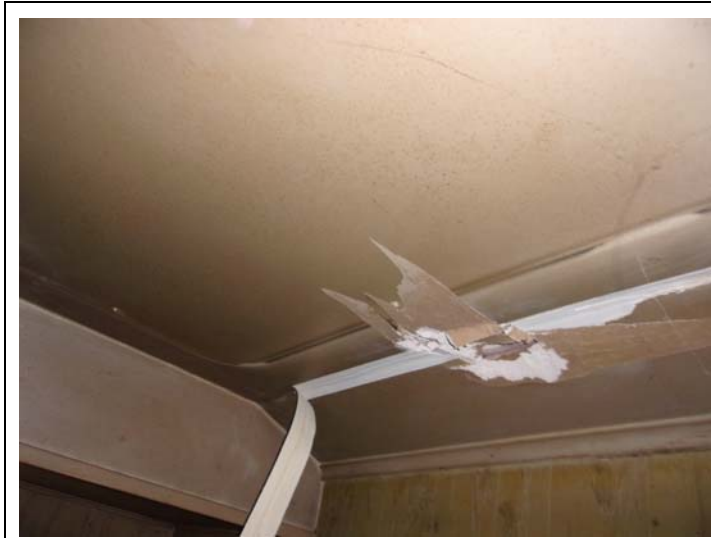
Photo 7 – Drywall with joint compound & tape in the bathroom ceiling
