Asbestos & Lead Based Paint Assessment

City of Spartanburg
423 Springwood Drive
Spartanburg, South Carolina 29302

Project Number: 0118-14

September 6, 2018

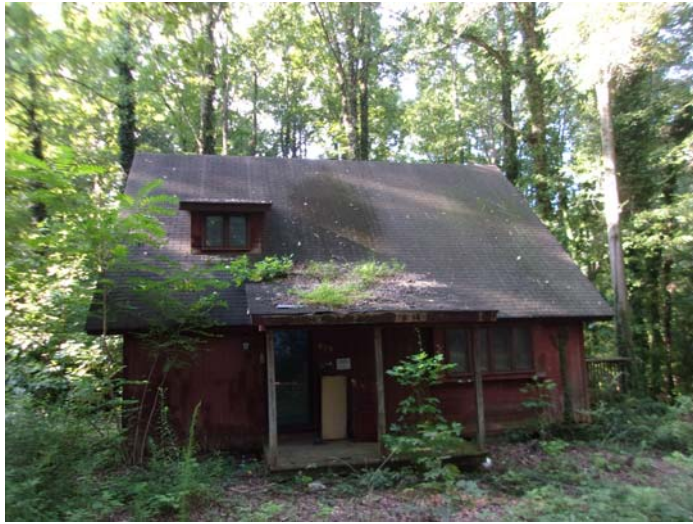
Photo 1 – 423 Springwood Drive in Spartanburg, South Carolina

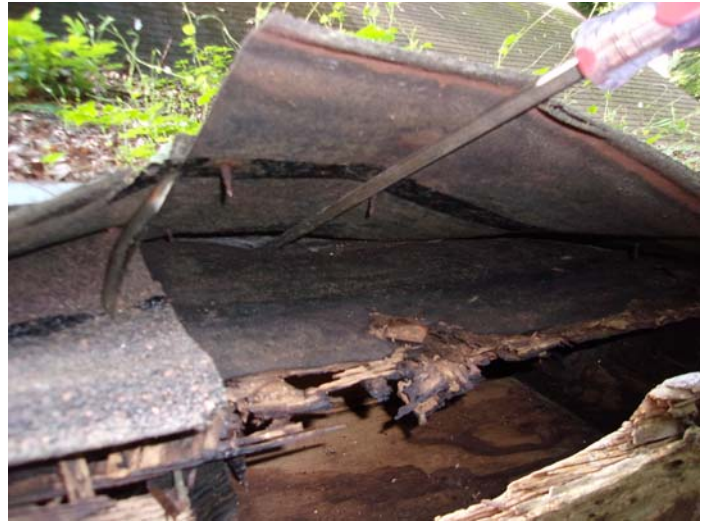
Photo 2 – Roof shingles & felt

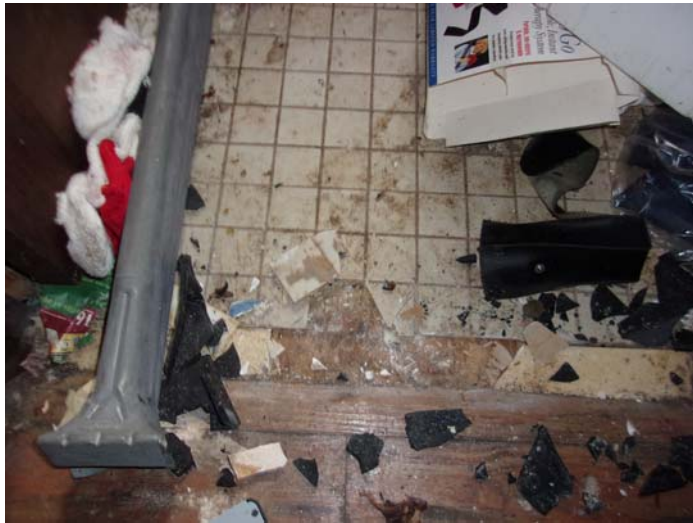
Photo 3 – Ceramic floor tile with mastic in the downstairs & upstairs bathrooms

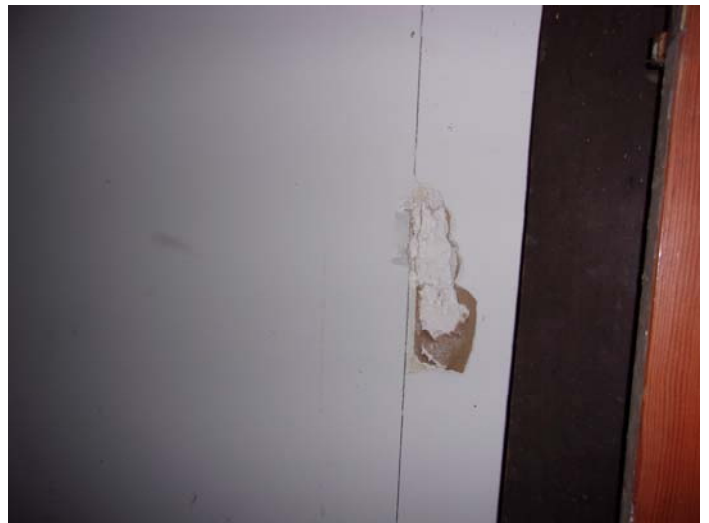
Photo 4 – Drywall with joint compound & tape throughout
