Asbestos & Lead Based Paint Assessment

City of Spartanburg
457 Bethlehem Street
Spartanburg, South Carolina 29306

Project Number: 0118-14

September 6, 2018

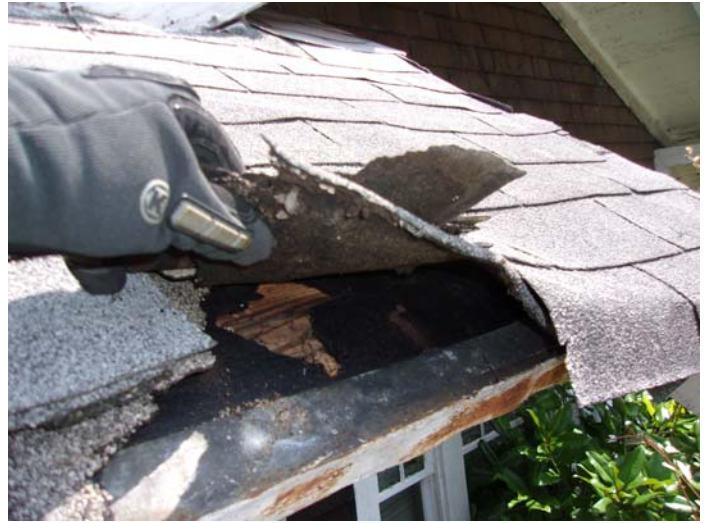
| Sample No. | Location | Sample Description | Analytical Results | Friable/Non Friable | Condition | Quantity |
|---|---|--|--|---|---|---|
| 1 | Roof | Roof shingles (2 layers) & felt (1 layer) | PLM - NAD | Non-Friable | Damaged | 3,400 SF |

Photo 2 – Roof shingles & felt

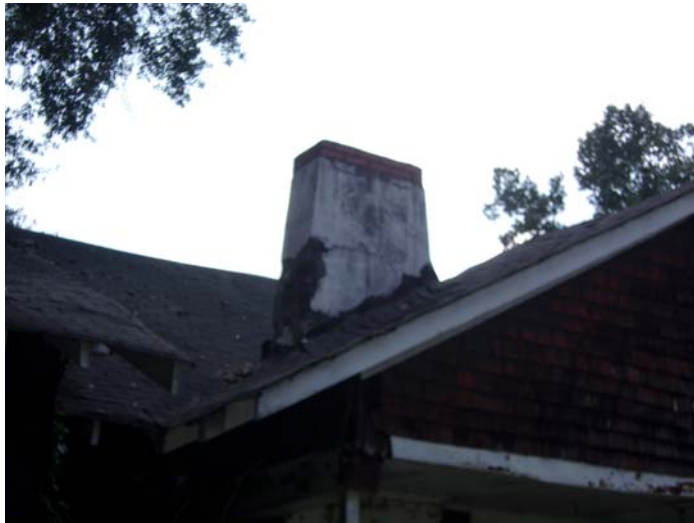
| Sample No. | Location | Sample Description | Analytical Results | Friable/Non Friable | Condition | Quantity |
|---|---|--|--|---|---|---|
| Assumed | Roof/chimneys | Mastic/tar on 3 chimneys & 2 roof penetrations | Assumed | Non-Friable | Good | 20 LF |

Photo 3 – Chimney assumed positive

1. Abate the asbestos containing materials in the structure prior to renovation or demolition.

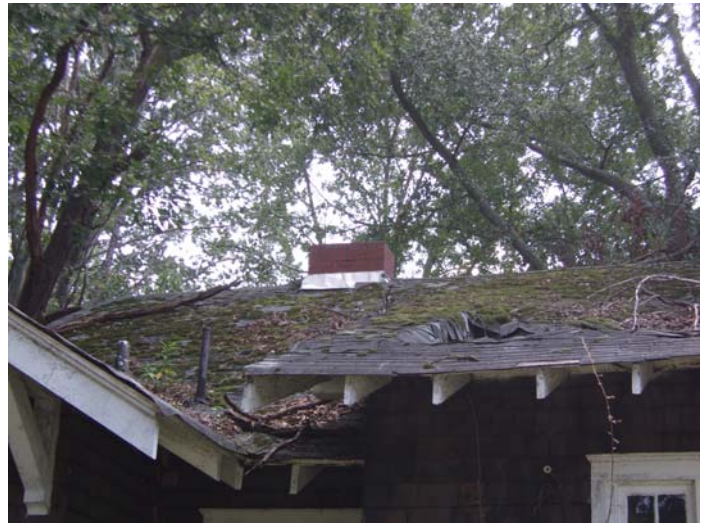
Photo 4 – Chimney assumed positive

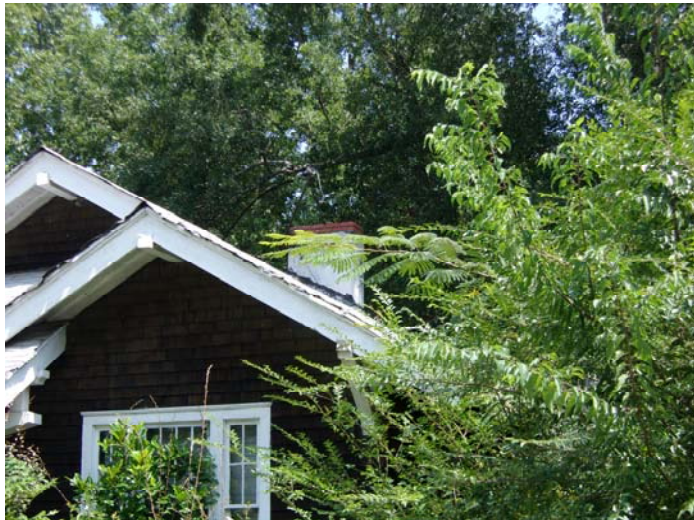
Photo 5 – Chimney assumed positive

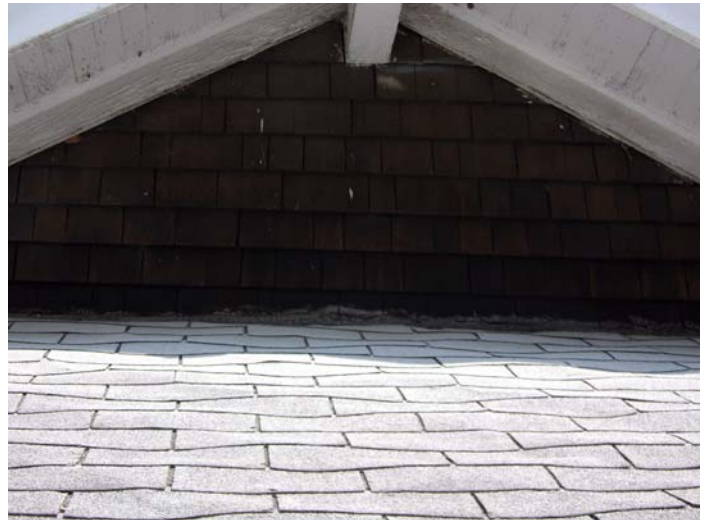
| Sample No. | Location | Sample Description | Analytical Results | Friable/Non Friable | Condition | Quantity |
|---|---|--|--|---|---|---|
| Assumed | Roof/flashing | Tar of roof flashing | Assumed | Non-Friable | Good | 50 LF |

Photo 6 – Roof tar on flashing assumed positive

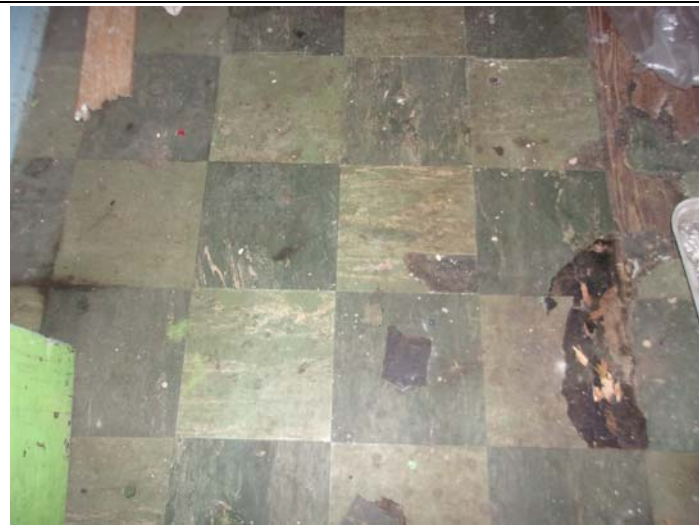
| Sample No. | Location | Sample Description | Analytical Results | Friable/Non Friable | Condition | Quantity |
|---|---|--|--|---|---|---|
| 14 | Right bedroom & hallway | 9" x 9" green/black checker pattern floor tile with mastic & felt | PLM - NAD | Non-Friable | Good | 300 SF |

Photo 7 – 9" x 9" green/black checker pattern floor tile with mastic & felt in the right bedroom & hallway

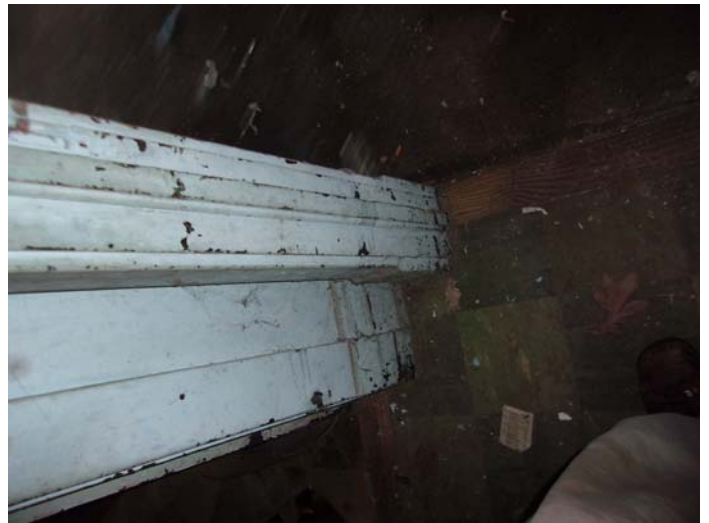
| Sample No. | Location | Sample Description | Analytical Results | Friable/Non Friable | Condition | Quantity |
|---|---|--|--|---|---|---|
| 4 | Wooden windows | Window glazing | PLM - 2% chrysotile | Non-Friable | Good | 20 EA |

Photo 8 – Wooden window glazing

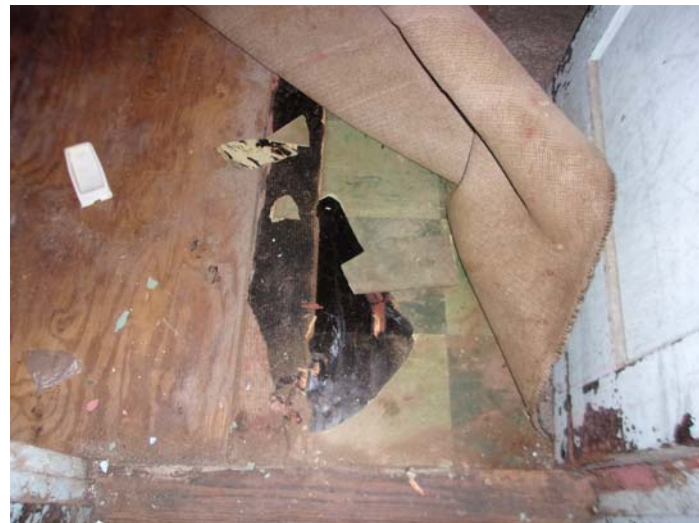
| Sample No. | Location | Sample Description | Analytical Results | Friable/Non Friable | Condition | Quantity |
|---|---|--|--|---|---|---|
| 17 | Bathroom | 9" x 9" green & off-white checker pattern floor tiles with mastic & felt | PLM - NAD (green FT, mastics & felt); 3% chrysotile (off-white FT) | Non-Friable | Good | 25 SF |

Photo 9 – 9" x 9" green & off-white checker pattern floor tiles with mastic & felt in the bathroom

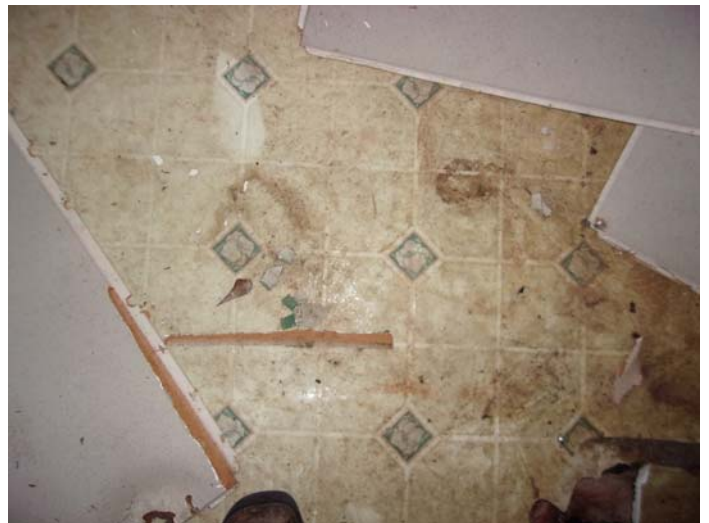
Photo 10 – Yellow square pattern roll vinyl with no mastic in the kitchen & pantry – top layer

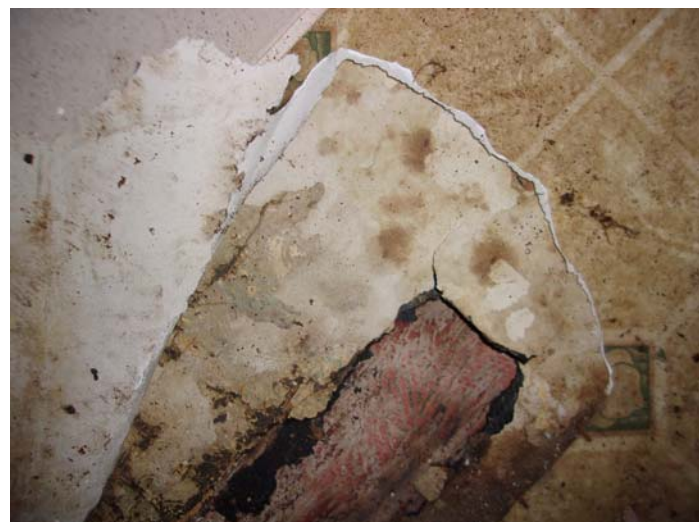
| Sample No. | Location | Sample Description | Analytical Results | Friable/Non Friable | Condition | Quantity |
|---|---|--|--|---|---|---|
| 23 | Kitchen & pantry (2 layers in kitchen; top layer in only in pantry) | Yellow square pattern roll vinyl with no mastic over tan roll vinyl floor with no mastic | PLM - NAD (yellow square pattern vinyl floor); 3% chrysotile (tan vinyl floor) | Non-Friable | Good | 165 SF |

Photo 11– Tan roll vinyl floor with no mastic in the kitchen & pantry – bottom layer
