Asbestos & Lead Based Paint Assessment

City of Spartanburg
106 Norris Street
Spartanburg, South Carolina 29306

Project Number: 0120-17

April 29, 2020

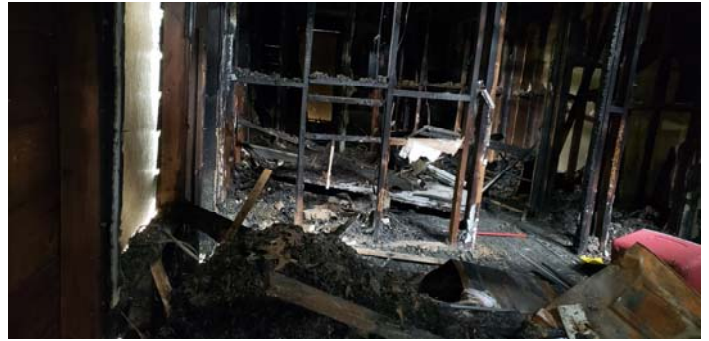
- Interior building materials were not assessed due to fire & structural damage within the residence.
- Due to safety concerns no asbestos samples were collected from within the residence.
- Debris throughout the residence is considered to be contaminated with ACM.

Photo 2 – Typical view of fire & structural damage throughout the interior.

1. Demolish the residence with ACM in place and dispose of the waste stream as friable Regulated Asbestos Containing Materials (RACM) and delivered to an asbestos approved hazardous waste landfill for disposal.
2. Follow applicable asbestos regulations during renovation or demolition of the structure. You should be aware that stringent requirements are imposed upon anyone renovating or demolishing a structure in which ACM will be disturbed. This work must be performed in accordance with OSHA asbestos regulations, 29 CFR 1910 & 1926, and NESHAP asbestos regulations 40 CFR 61, subpart M. South Carolina regulations require the accreditation of personnel who work in the asbestos field and notification and permitting fees for asbestos removal projects. There is a 10 working day notification period required prior to abatement of

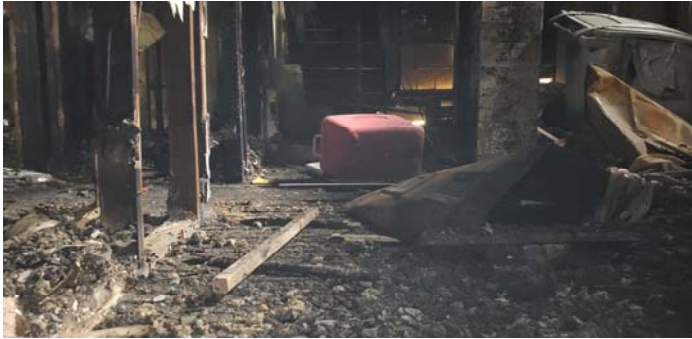
Photo 3 – Typical view of fire & structural damage throughout the interior.

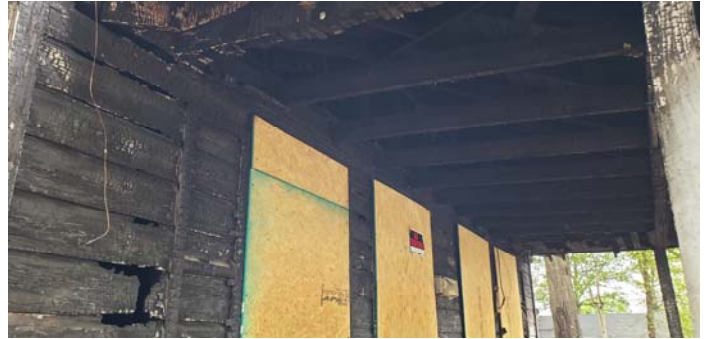
- Pitched wooden roof with shingles & felt.
- Wooden siding.
- Aluminum siding.
- Wooden windows.
- Wooden doors.
- Windows & doors are covered by wooden boards.
- Fire damage throughout the exterior.
- Limited sampling was performed.

Photo 4 – Typical view of fire & structural damage throughout the exterior.

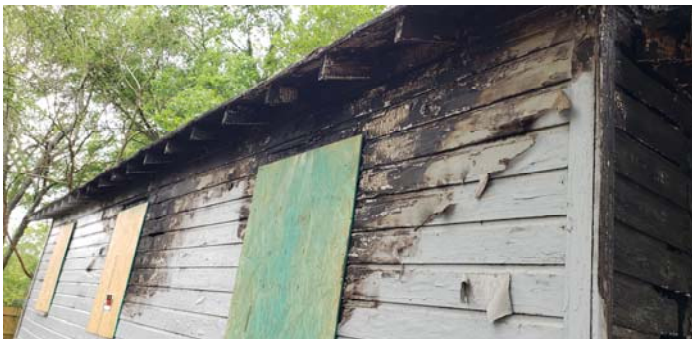
Photo 5 – Typical view of fire & structural damage throughout the exterior.

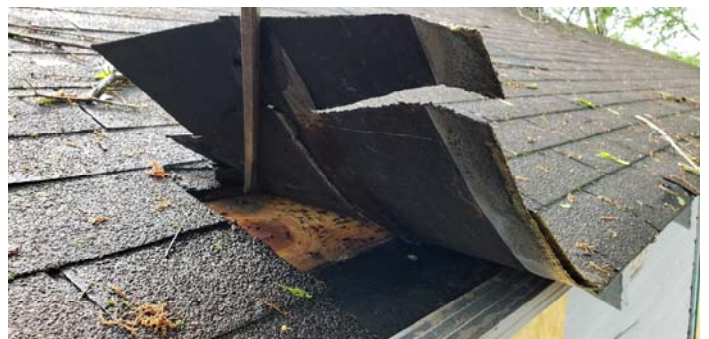
Photo 6 – Roof shingles & felt

Sample No.	Location	Sample Description	Analytical Results	Friable/Non Friable	Condition	Quantity
1	Roof	Roofing shingles (2 layer) & felt (1 layer)	PLM - NAD	Friable	Significantly Damaged	1,350 SF
2			TEM - NAD			
3						
Assumed	House/debris piles	House/debris piles	Assumed	Friable	Significantly Damaged	1,100 SF
