Asbestos & Lead Based Paint Assessment

City of Spartanburg
214 Westover Drive
Spartanburg, South Carolina 29306

Project Number: 0120-17

March 26, 2020

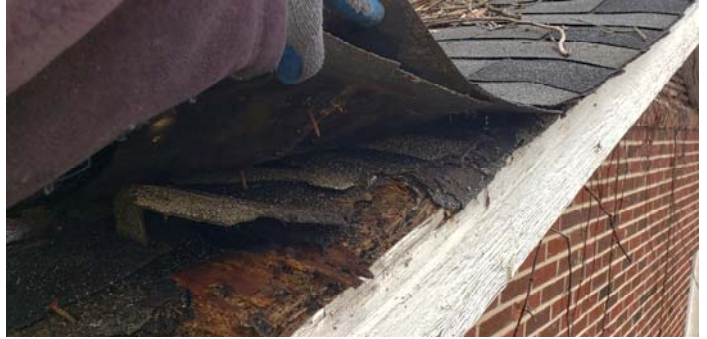
Photo 2 – One layer of black felt under four layers of shingles.

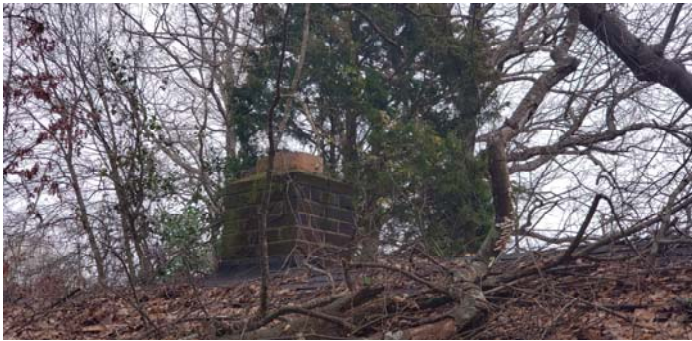
Photo 3 – Tar on chimney is assumed to be asbestos containing material.

1. Abate the asbestos containing materials in the structure prior to renovation or demolition.
2. Follow applicable asbestos regulations during renovation or demolition of the structure. You should be aware that stringent requirements are imposed upon anyone renovating or demolishing a structure in which ACM will be disturbed. This work must be performed in accordance with OSHA asbestos regulations, 29 CFR 1910 & 1926, and NESHAP asbestos regulations 40 CFR 61, subpart M. South Carolina regulations require the accreditation of

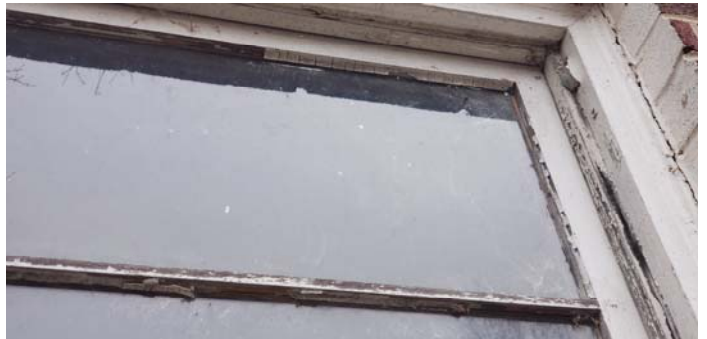
Photo 4 – Wooden windows with glazing.

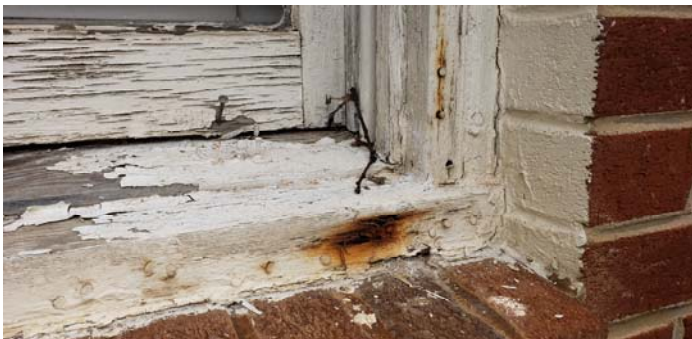
Photo 5 – Caulk located on exterior wood window frame.

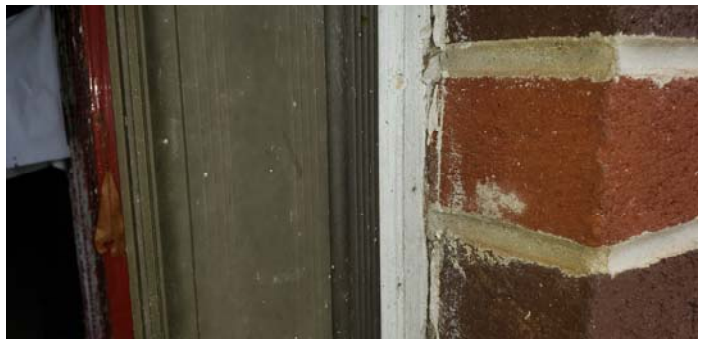
Photo 6 – Caulk located on exterior metal door frame.

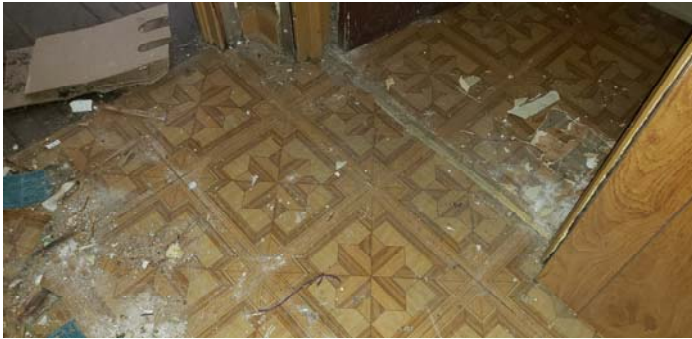
Photo 7 – 12"x12" wood star pattern self-stick flooring tile with adhesive located in hallway, top layer in bathroom and top layer in kitchen.

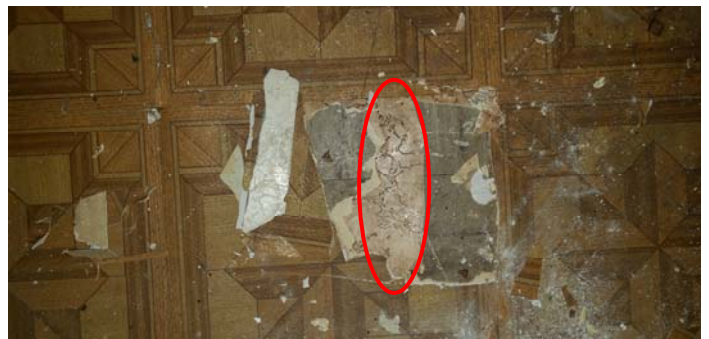
Photo 8 – Second layer of flooring in the bathroom is a tan rock fissure pattern with no mastic.

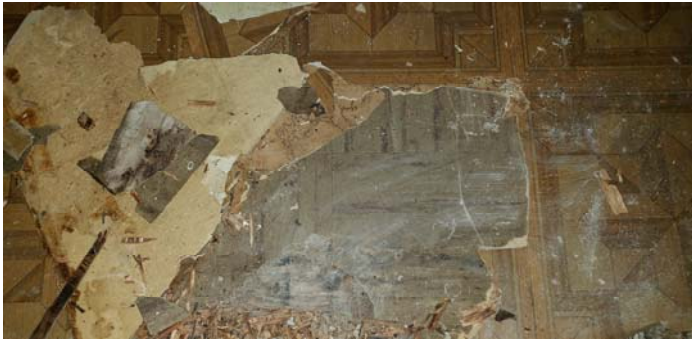
Photo 9 – Third layer of flooring in the bathroom is a 9"x9" gray tile and mastic.

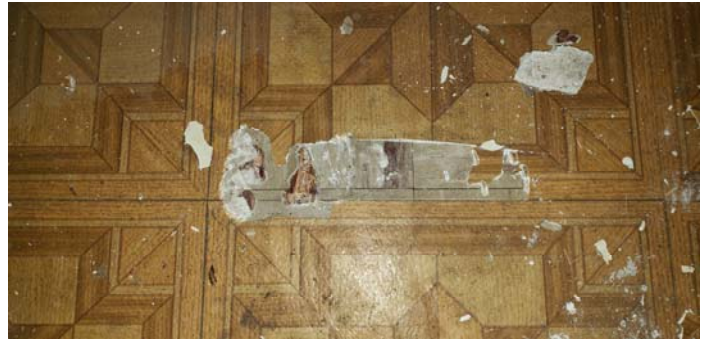
Photo 10 – Second layer of flooring in the kitchen is a thin tan/green tile and mastic.

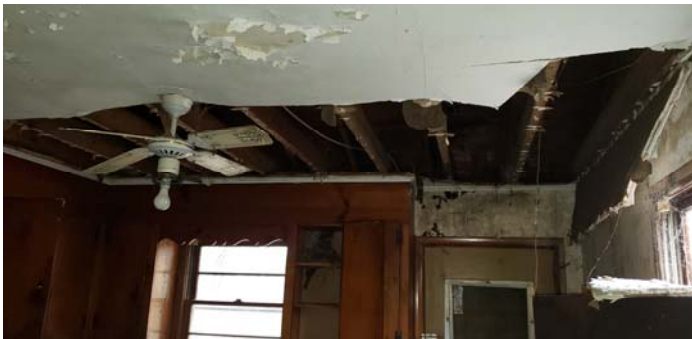
Photo 11 – Swirl ceiling texture over drywall and plaster with finish. Collapsed ceiling in areas of structure.

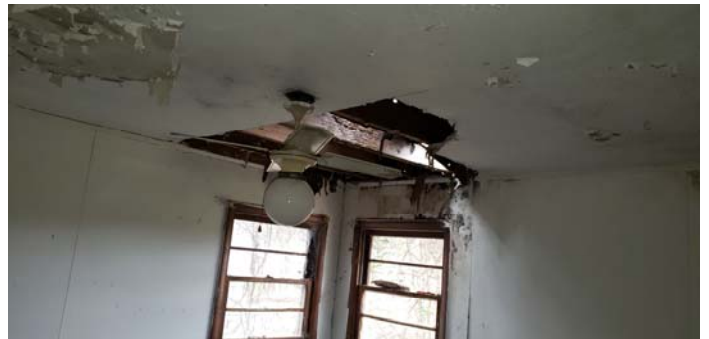
Photo 12 – Two layers of unfinished drywall walls throughout the structure.

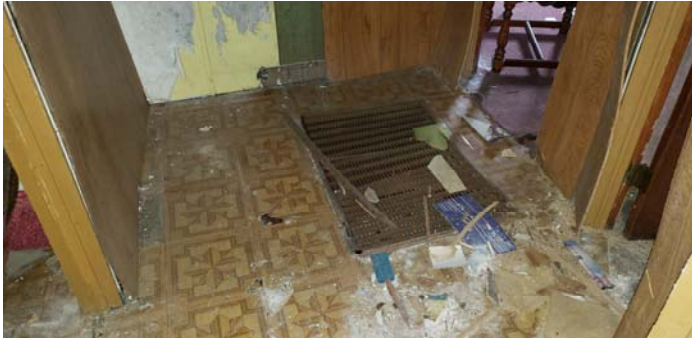
Photo 13 – Hallway with floor return that may be unstable.
