Asbestos & Lead Based Paint Assessment

City of Spartanburg
627 Farley Avenue
Spartanburg, South Carolina 29301

Project Number: 0120-17

August 12, 2020

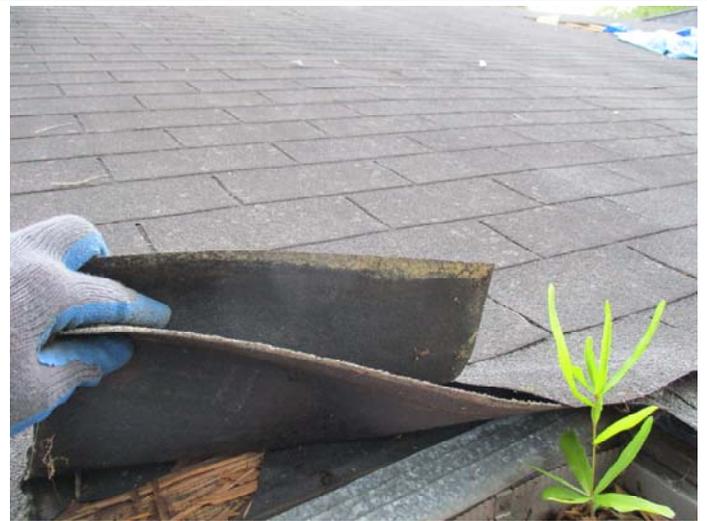
Photo 2 – Roof shingles & felt paper

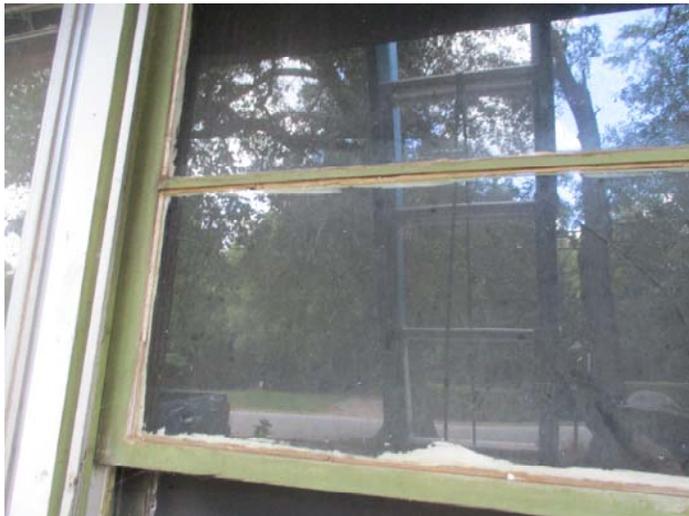
Photo 3 – Wooden windows – caulk on glass panes

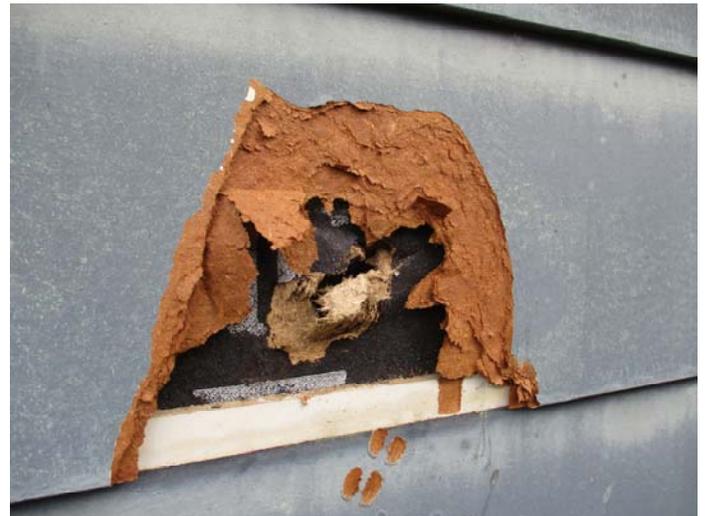
Photo 4 – OSB wooden boards with felt layer beneath wooden siding

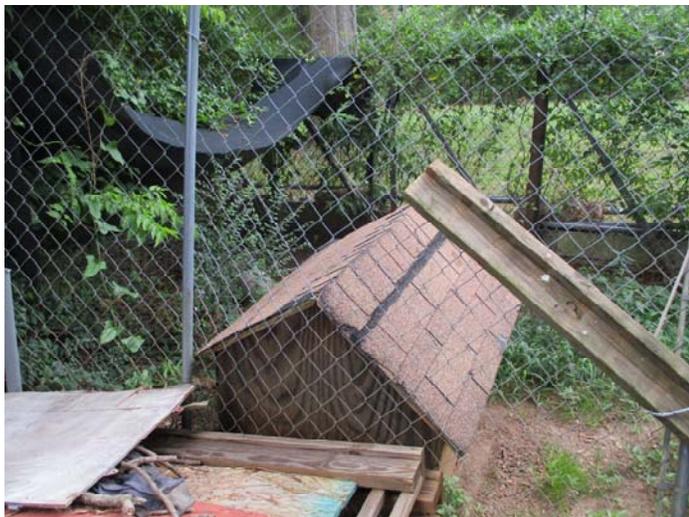
Photo 5 – Roof shingles with no felt on the dog house in the back corner of the yard

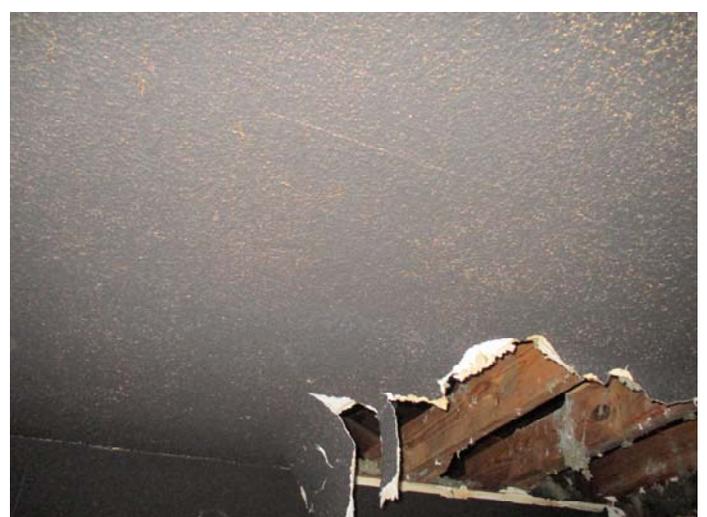
- Approximately 950 SF of popcorn ceiling texture throughout.
- Approximately 2,400 SF of drywall wall & ceiling systems throughout.
- Household items, trash, debris, etc. contaminated by ceiling texture and drywall wall & ceiling systems throughout

Photo 6 – Popcorn ceiling texture throughout

1. Abate the asbestos containing materials in the structure prior to renovation or demolition.
2. Follow applicable asbestos regulations during renovation or demolition of the structure. You should be aware that stringent requirements are imposed upon anyone renovating or demolishing a structure in which ACM will be disturbed. This work must be performed in accordance with OSHA asbestos regulations, 29 CFR 1910 & 1926, and NESHAP asbestos regulations 40 CFR 61, subpart M. South Carolina regulations require the accreditation of personnel who work in the asbestos field and notification and permitting fees for asbestos removal projects. There is a 10 working day notification period required prior to abatement of asbestos in a facility. Failure to take proper precautions and actions to protect human health and the environment can result in penalties, danger to personnel, and construction delays.

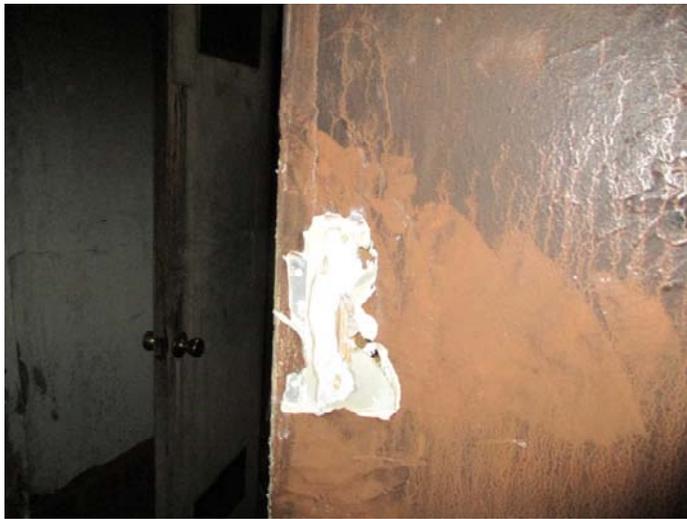
Photo 7 – Drywall with joint compound & tape throughout

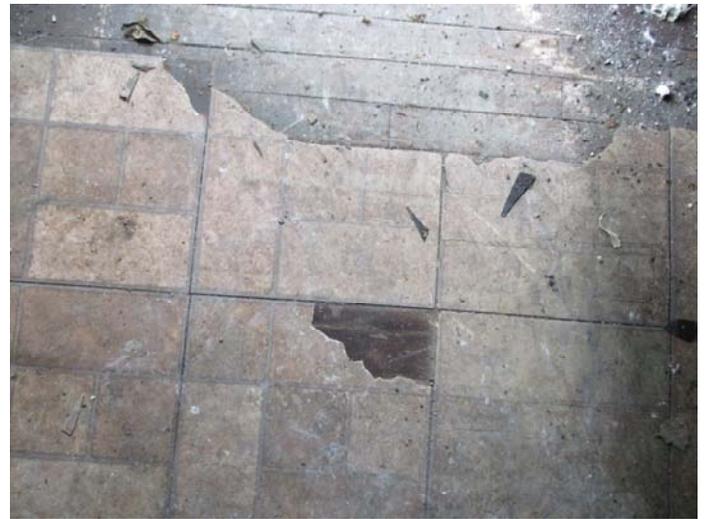
Photo 8 – 12" x 12" brown/tan square/rectangle pattern floor tile & mastic in the living room & hallway

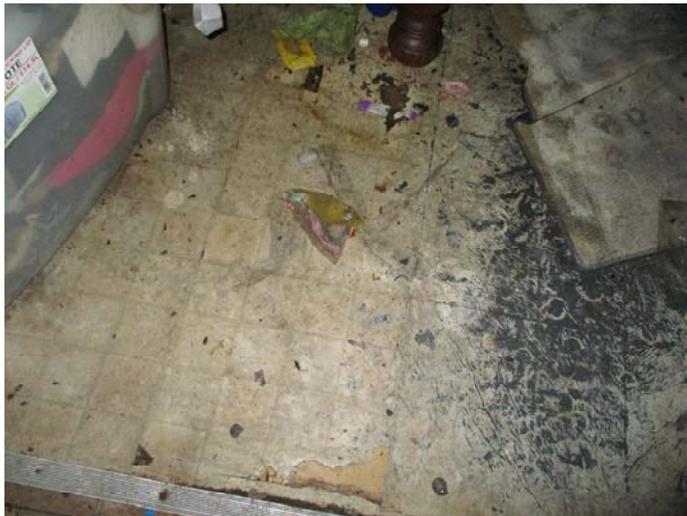
Photo 9 – Tan square pattern vinyl floor & mastic over yellow vinyl floor & mastic in the kitchen

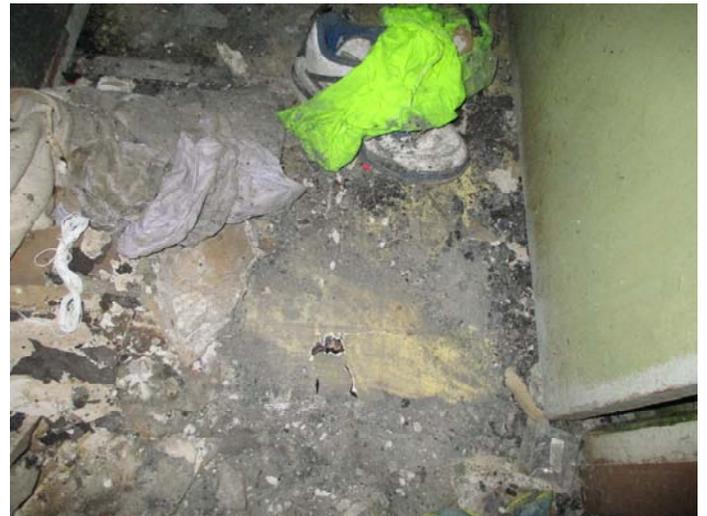
Photo 10 – Orange square pattern vinyl floor & adhesive over felt in the bathroom

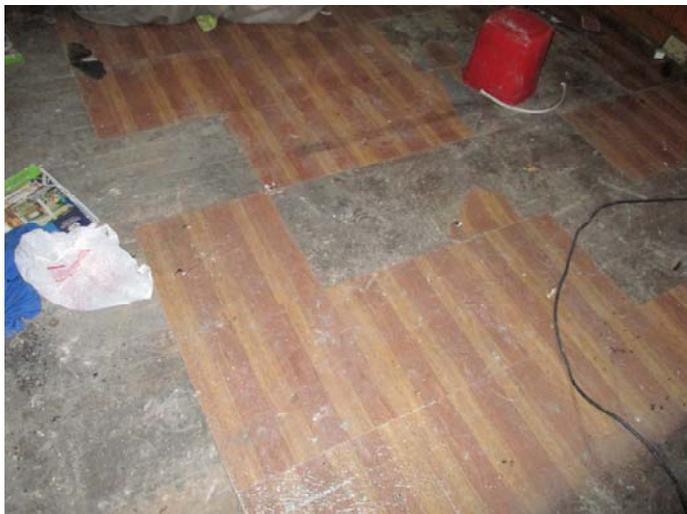
Photo 11 – 12" x 12" brown pattern self-stick floor tile in the back right bedroom

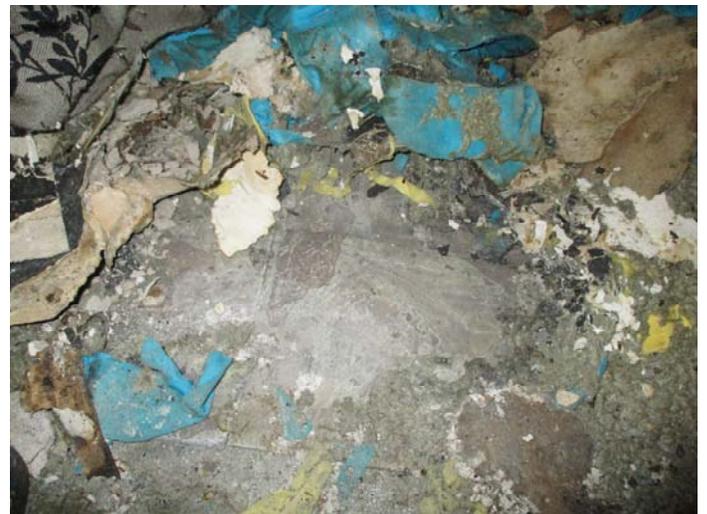
Photo 12 – 12" x 12" gray slate/stone pattern self-stick floor tile in the front 2 bedrooms

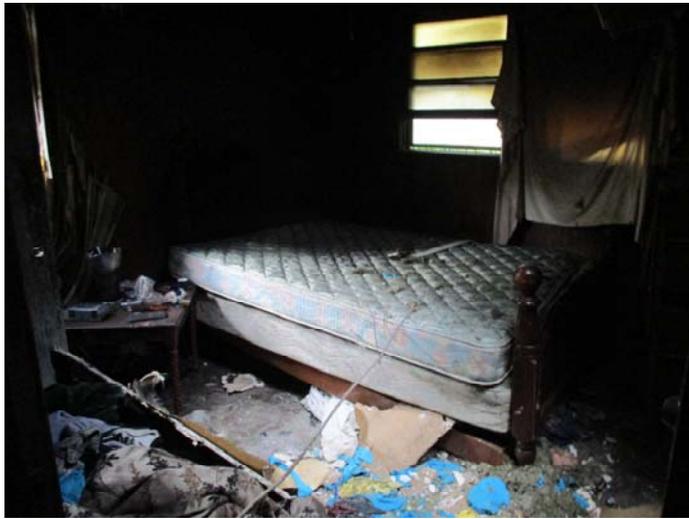
Photo 13 – Typical view of household items & debris contaminated with disturbed ACM throughout

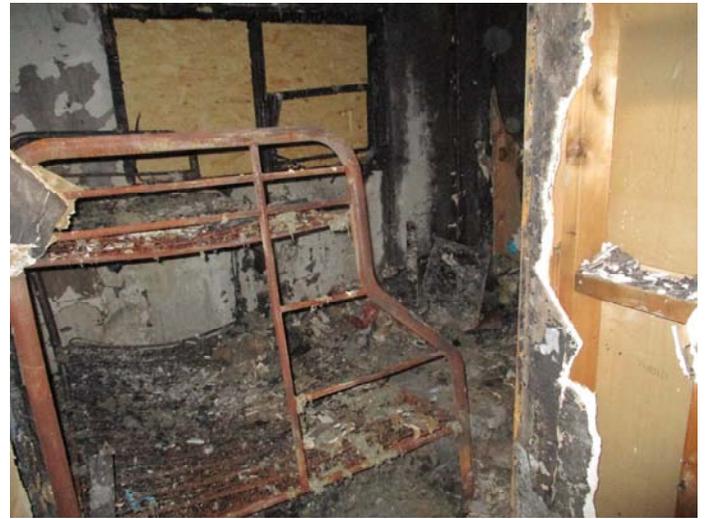
Photo 14 – Typical view of household items & debris contaminated with disturbed ACM throughout

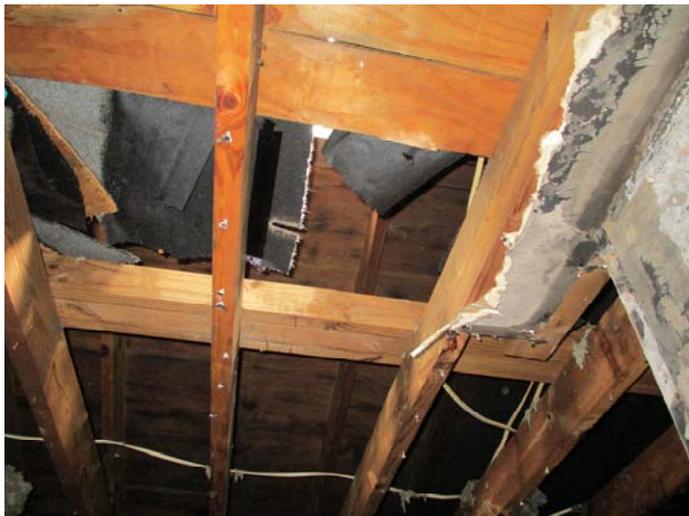
Photo 15 – Typical view of fire damage to the walls & ceilings throughout

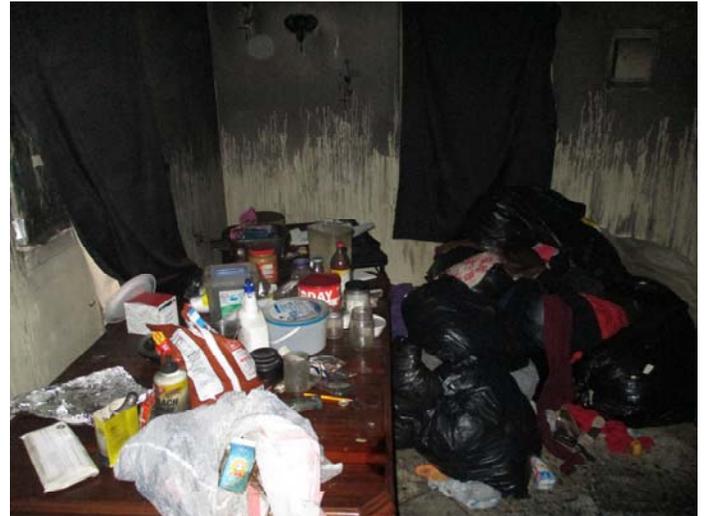
Photo 16 – Typical view of household items & debris contaminated with disturbed ACM throughout

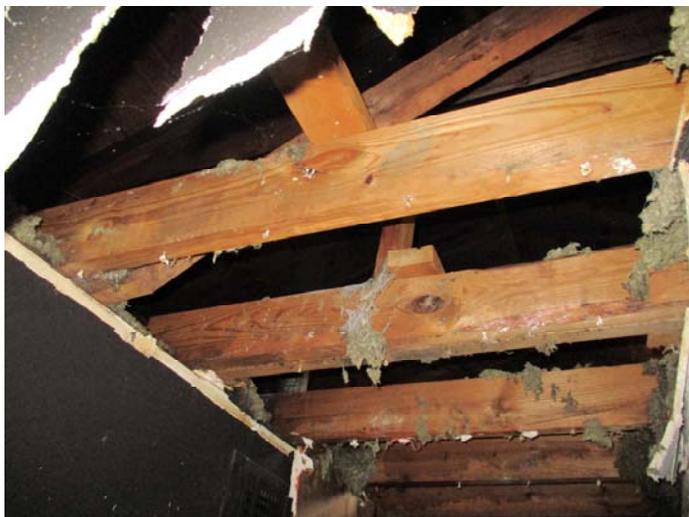
Photo 17 – Typical view of fire damage to the walls & ceilings throughout
