## **Asbestos & Lead Based Paint Assessment**

City of Spartanburg  
319 Caudler Avenue  
Spartanburg, South Carolina 29306

Project Number: 0120-17

August 12, 2020

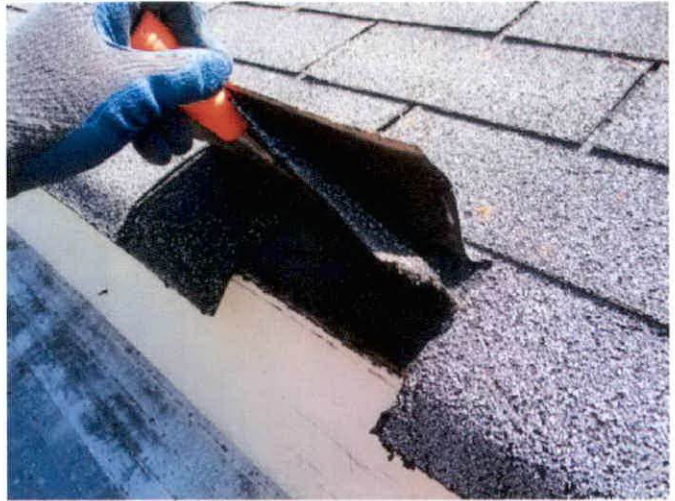
Photo 2 – Roof shingles & felt paper

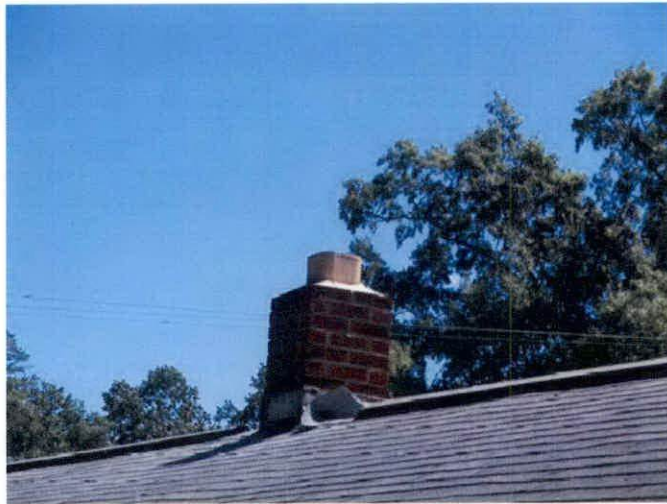
- Approximately 15 LF caulk/glazing on the metal awning over the front porch.
- Approximately 215 SF of the 5<sup>th</sup> layer (2<sup>nd</sup> layer under wood) of floor tile in the kitchen.
- Approximately 25 SF of the 3<sup>rd</sup> layer (1<sup>st</sup> layer under wood) of beige vinyl floor in the bathroom.
- Approximately 6 LF of tar on 1 chimney – assumed positive.

Photo 3 – 1 chimney with tar – assumed positive

1. Abate the asbestos containing materials in the structure prior to renovation or demolition.

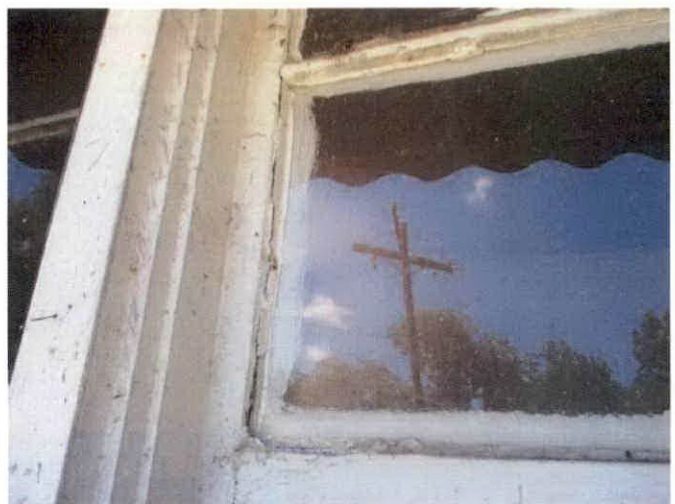
Photo 4 – Wooden window glazing

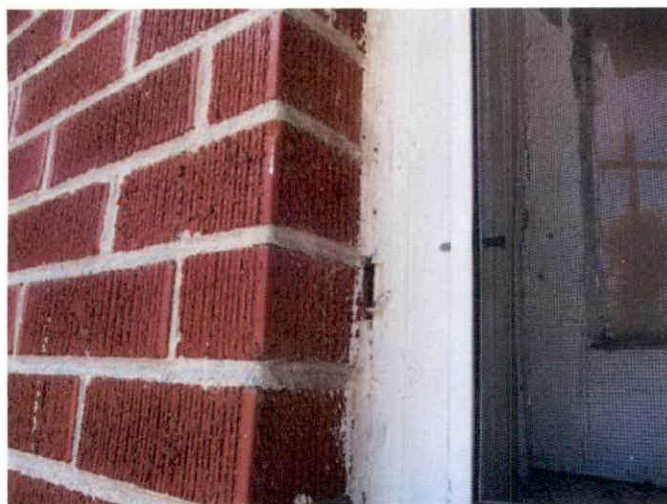
Photo 5 – Window & door casing caulk

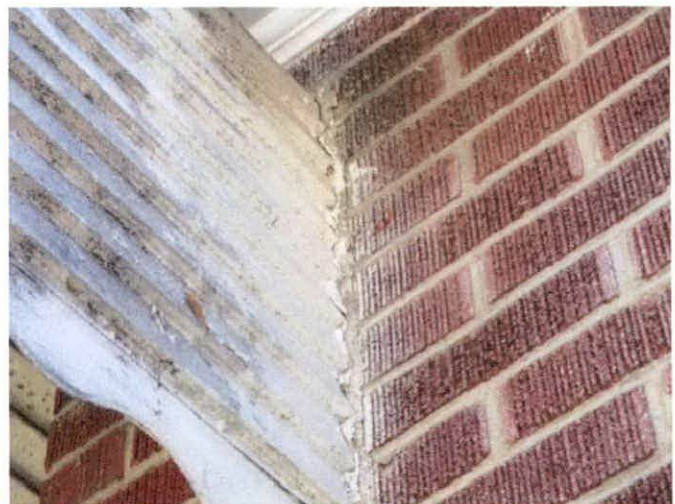
Photo 6 – Caulk/glazing on the metal awning over the front porch

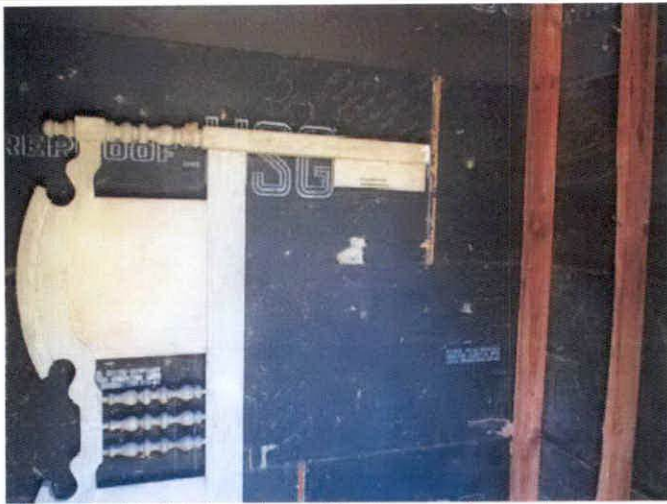
Photo 7 – Unfinished drywall in the exterior back storage room

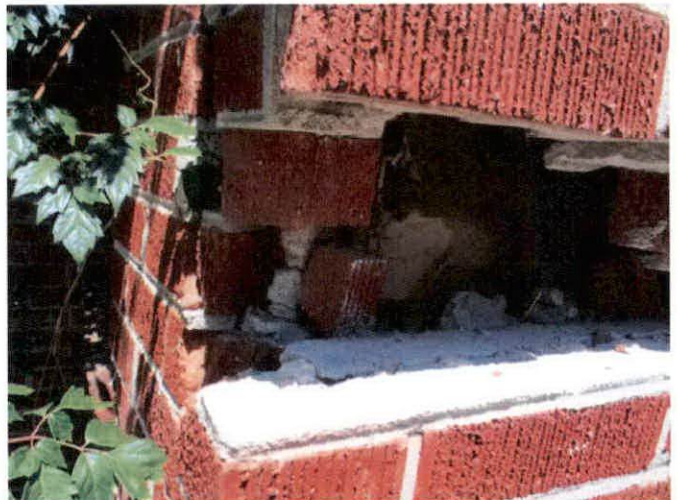
Photo 8 – Unfinished drywall throughout under brick siding

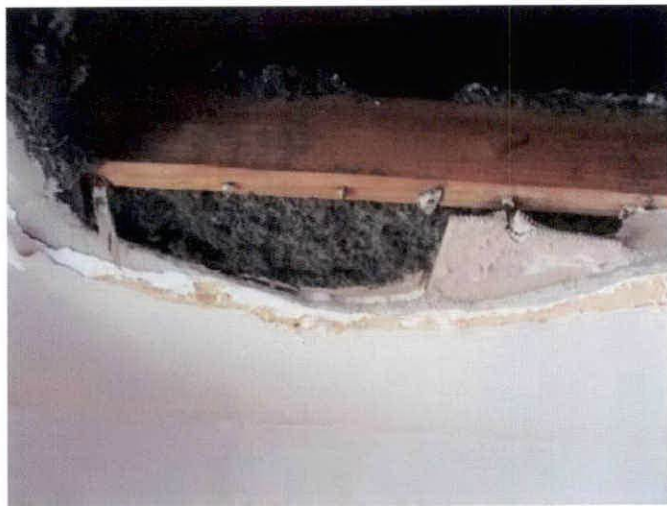
Photo 9 – Plaster with finish over unfinished drywall ceilings throughout

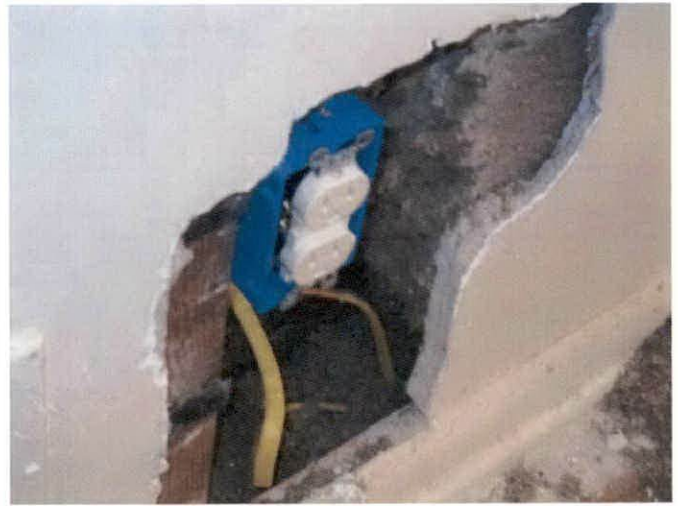
Photo 10 – Plaster with finish over unfinished drywall walls throughout

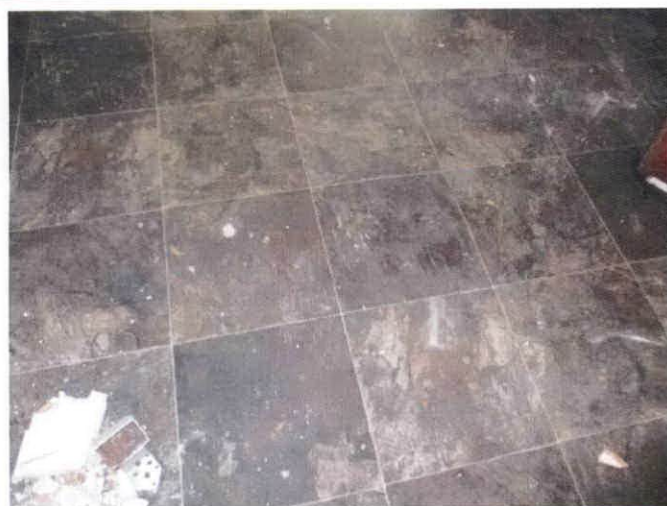
Photo 11 – Green large square pattern vinyl floor & adhesive in the kitchen & in the hallway closet (top layer)

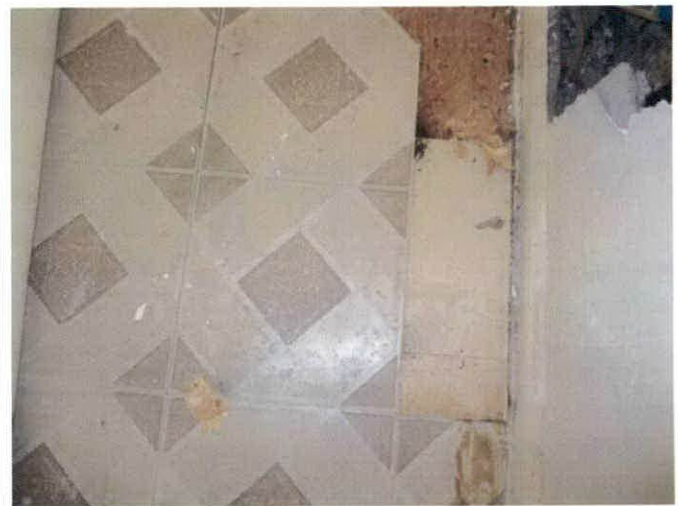
Photo 12 – 12" x 12" gray square pattern self-stick floor tile over floor tile & adhesive in the kitchen (2<sup>nd</sup>/3<sup>rd</sup> layers)

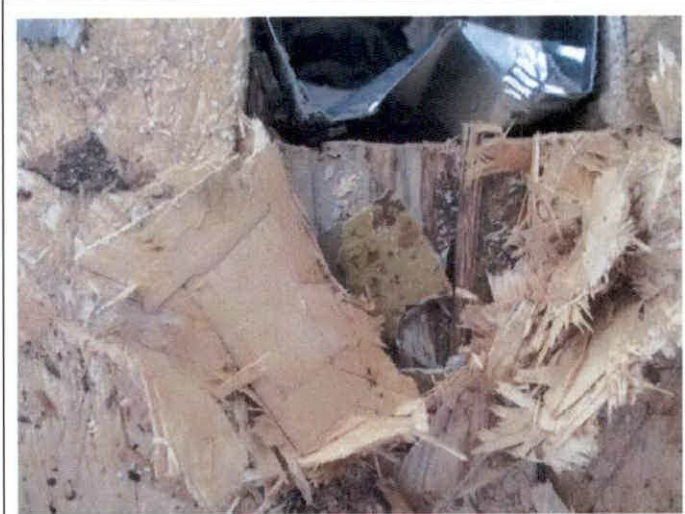
Photo 13 – 12" x 12" brown floor tile & mastic over floor tile & mastic in the kitchen (4th & 5th layers under wood)

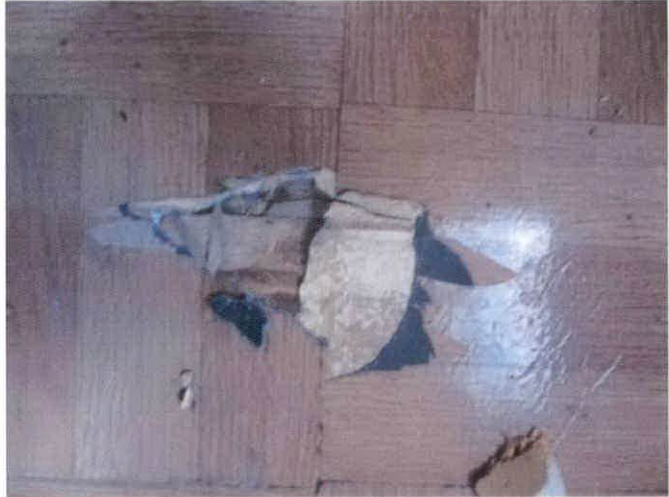
Photo 14 – 12" x 12" wooden pattern self-stick floor tile over tan vinyl floor & mastic in the bathroom (1<sup>st</sup> & 2<sup>nd</sup> layers)

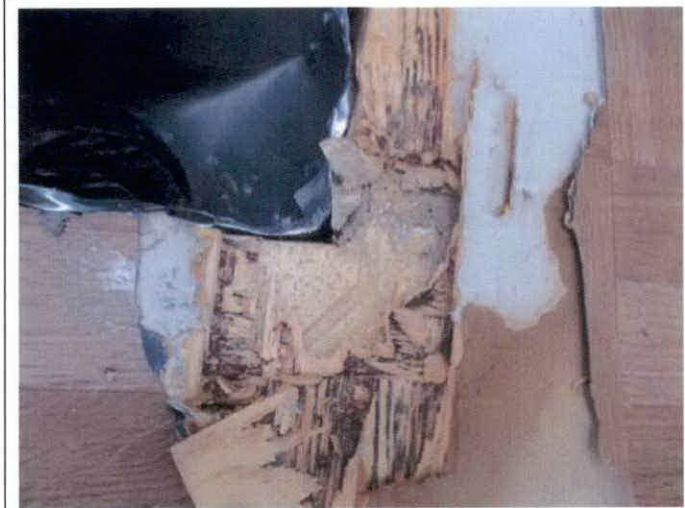
Photo 15 – Beige vinyl floor with no mastic in the bathroom (3rd layer under wood)
