SITEX Project No.: 13243

**PHASE II ENVIRONMENTAL SITE ASSESSMENT
(ESA)**

**FRANKLIN COUNTY SHERIFF'S DEPARTMENT
1 BRUNS LANE
UNION, MISSOURI 63084**

February 19, 2019

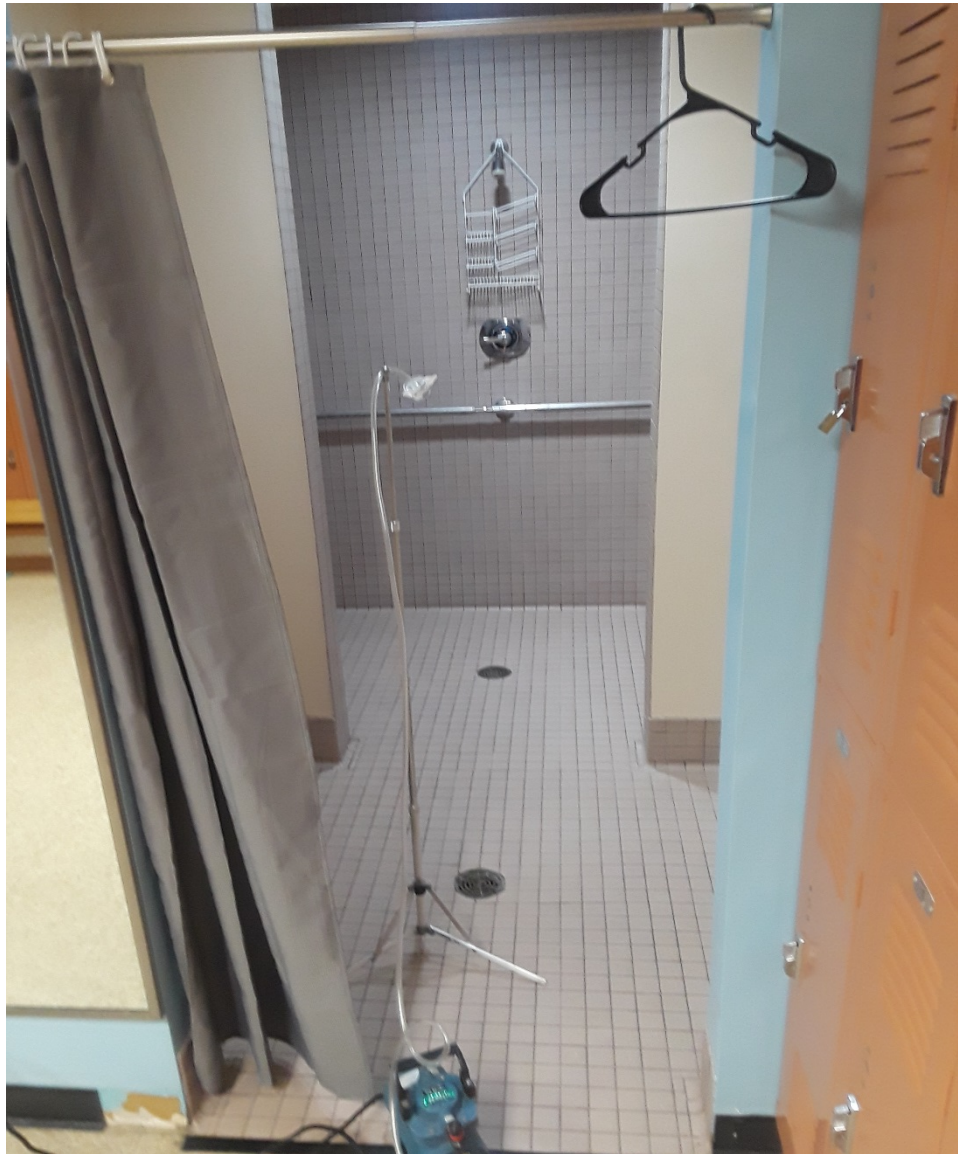
Photograph 1

Mold air sample (AIR01) collected in Men's Locker Room administration area.

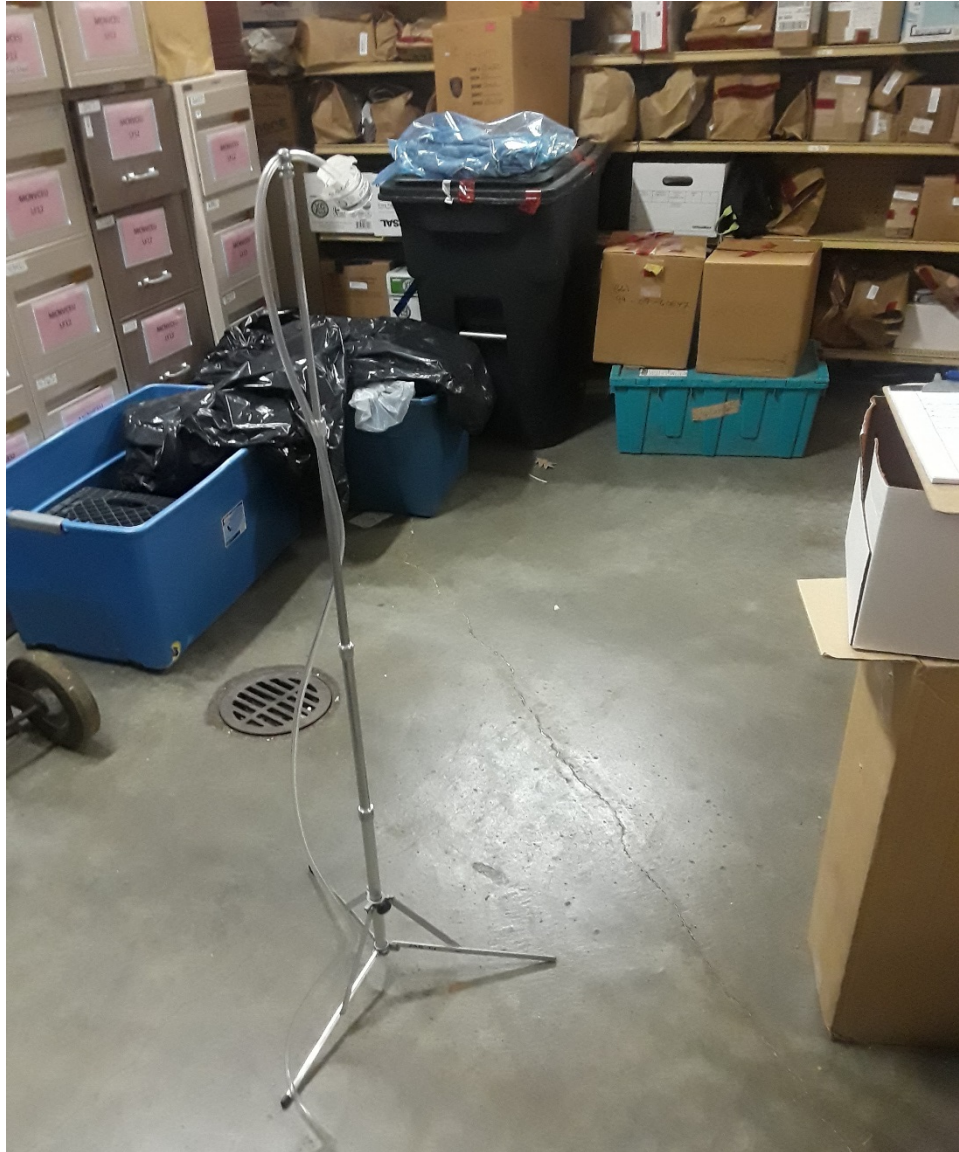
Photograph 2

Mold air sample (AIR02) collected in Evidence Room administration area.

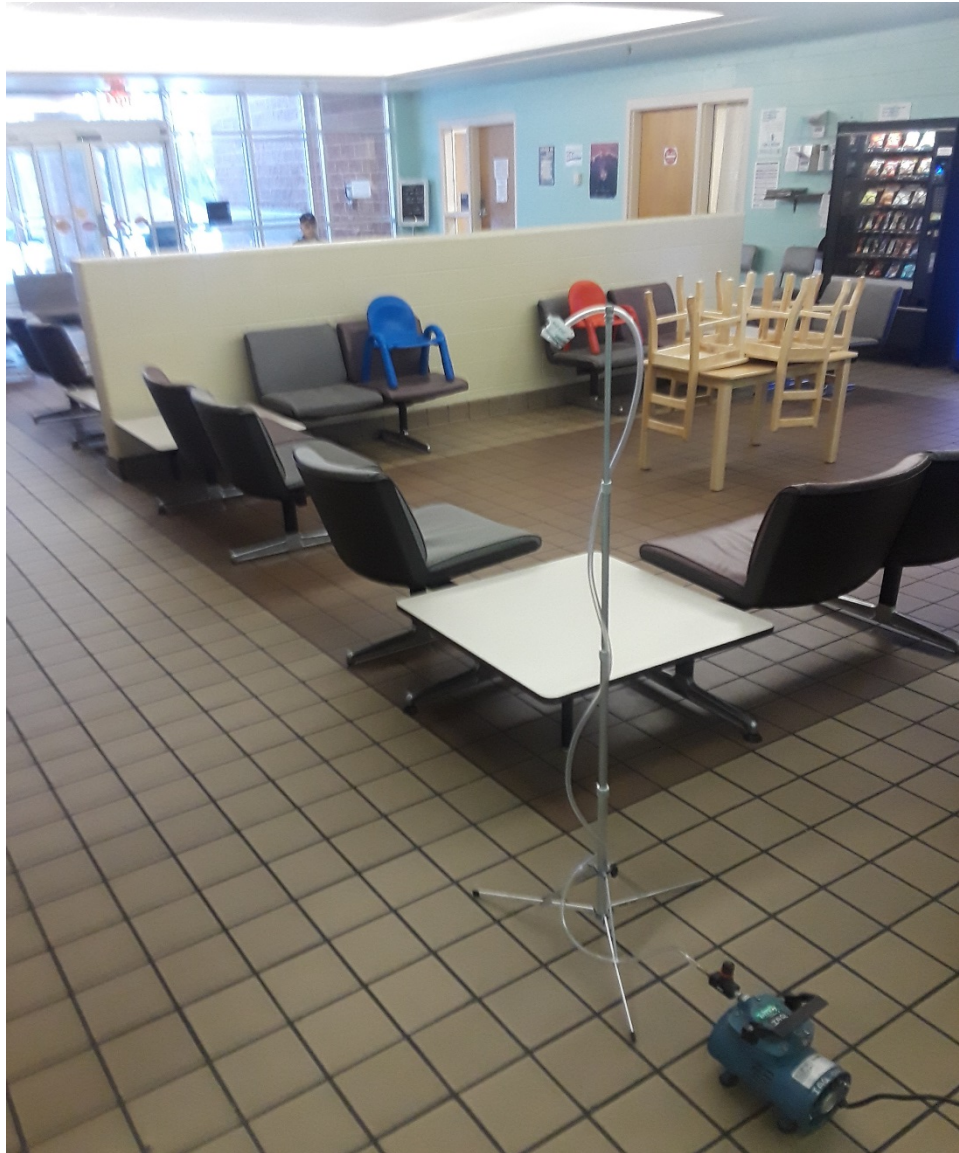
Photograph 3
Mold air sample (AIR03) collected in Lobby at main entrance.

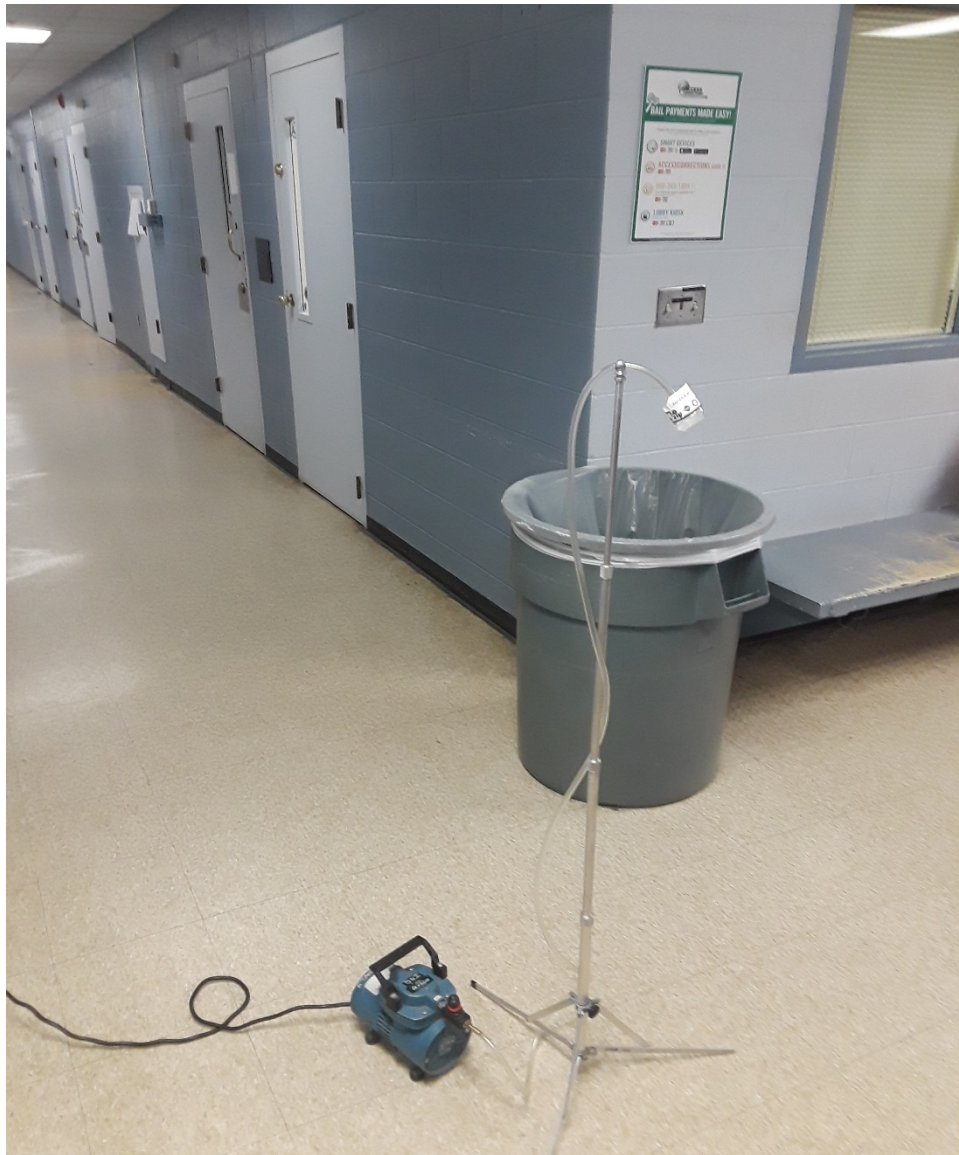
Photograph 4
Mold air sample (AIR04) collected in Booking located in the jail area.

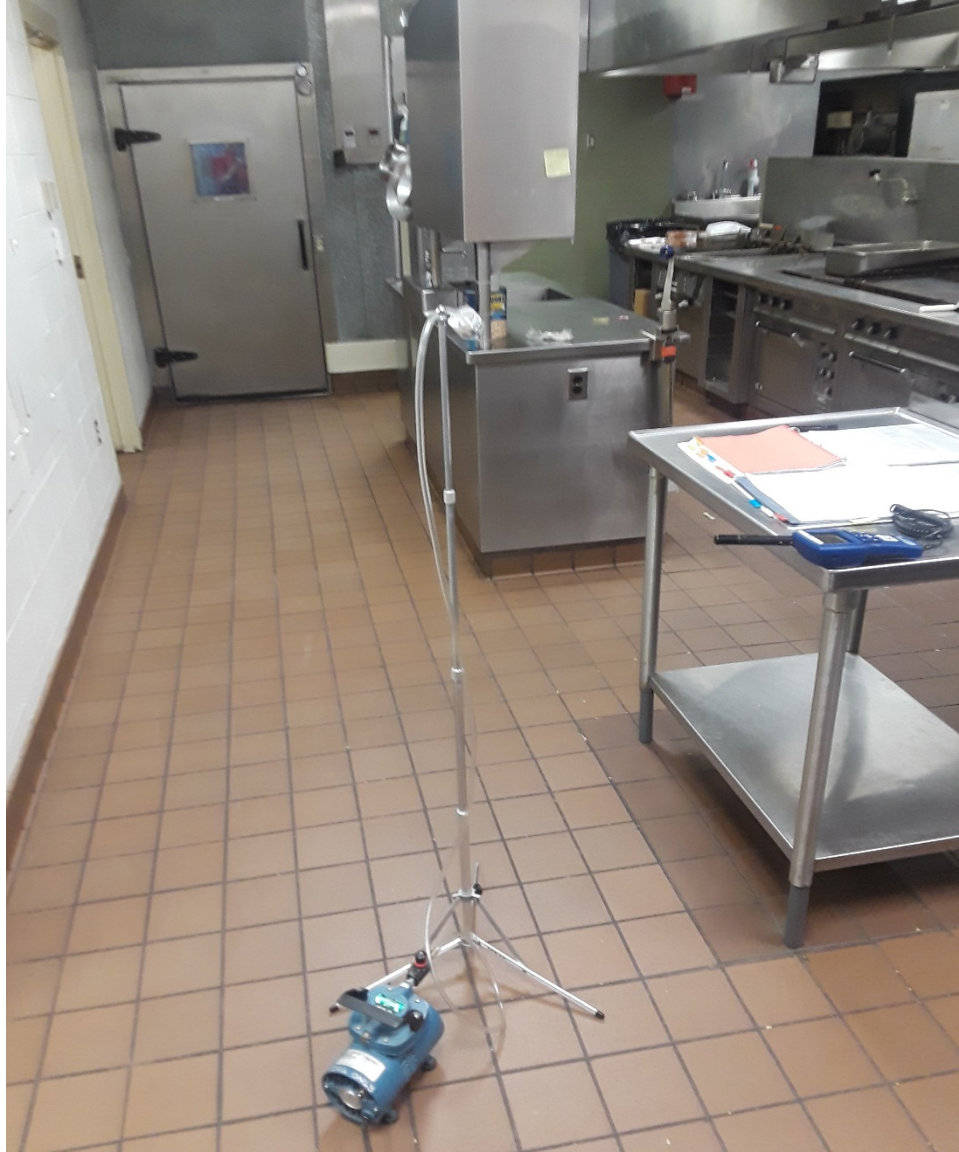
Photograph 5
Mold air sample (AIR05) collected in the Kitchen located in the jail area.

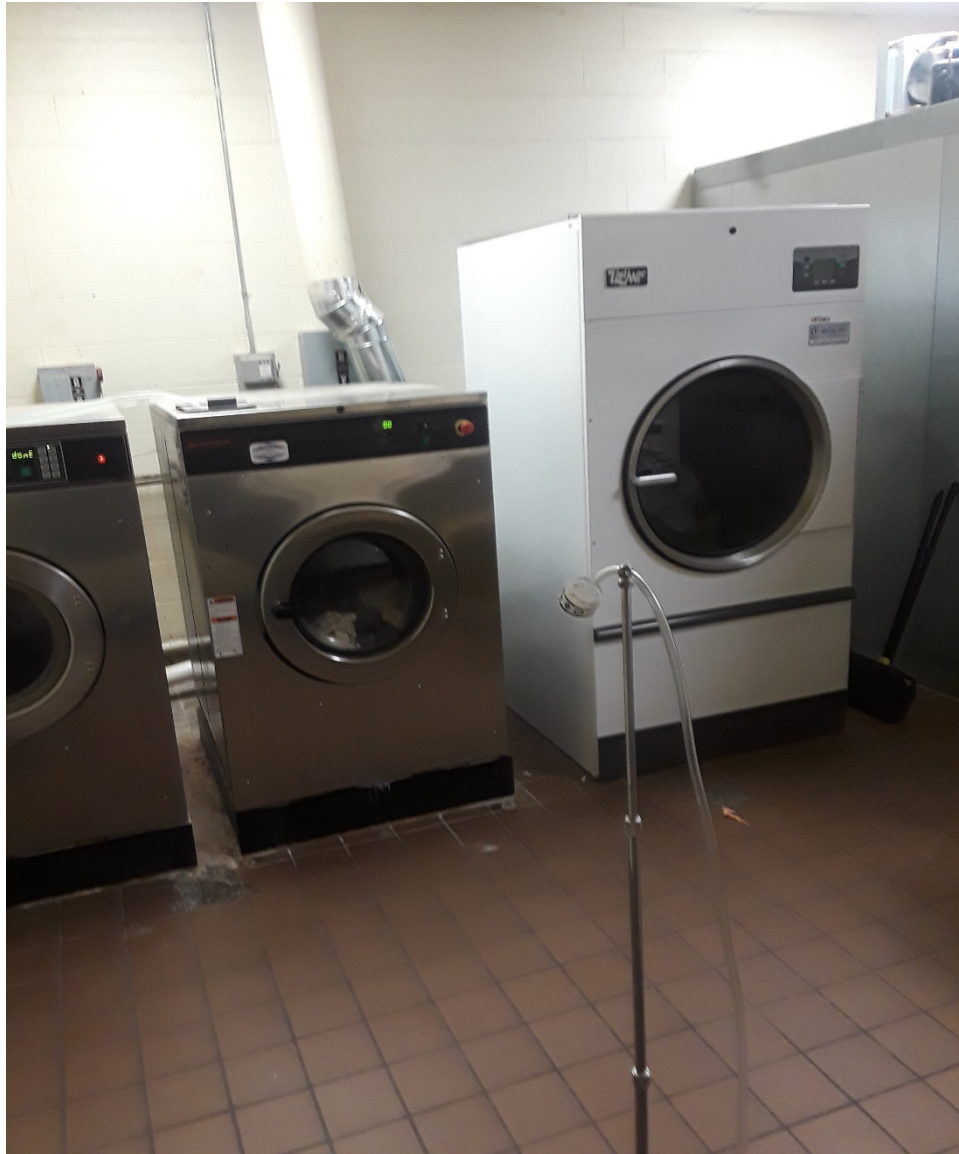
Photograph 6

Mold air sample (AIR06) collected in the Laundry Room located in the jail area.

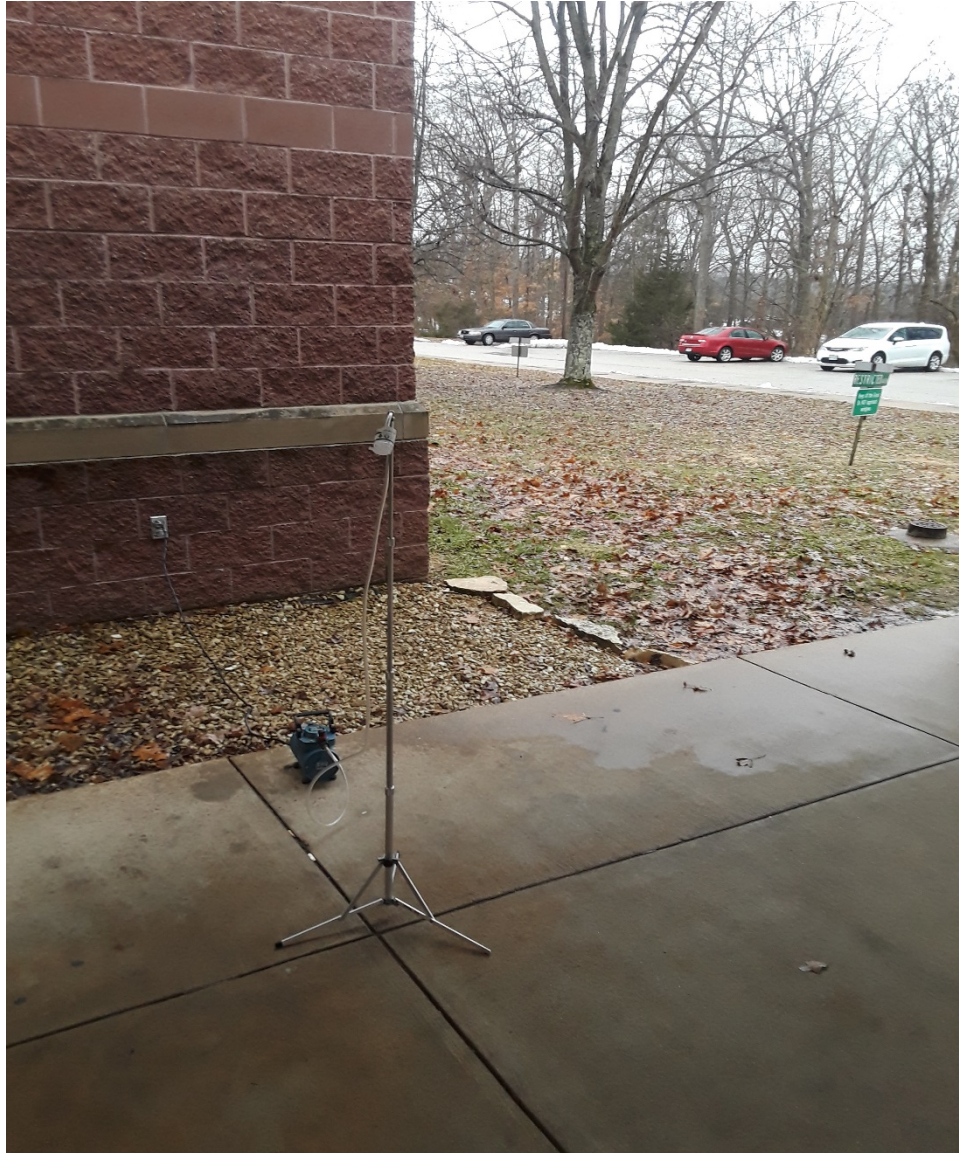
Photograph 7

Mold air sample (AIR08) collected outside building west main entrance.

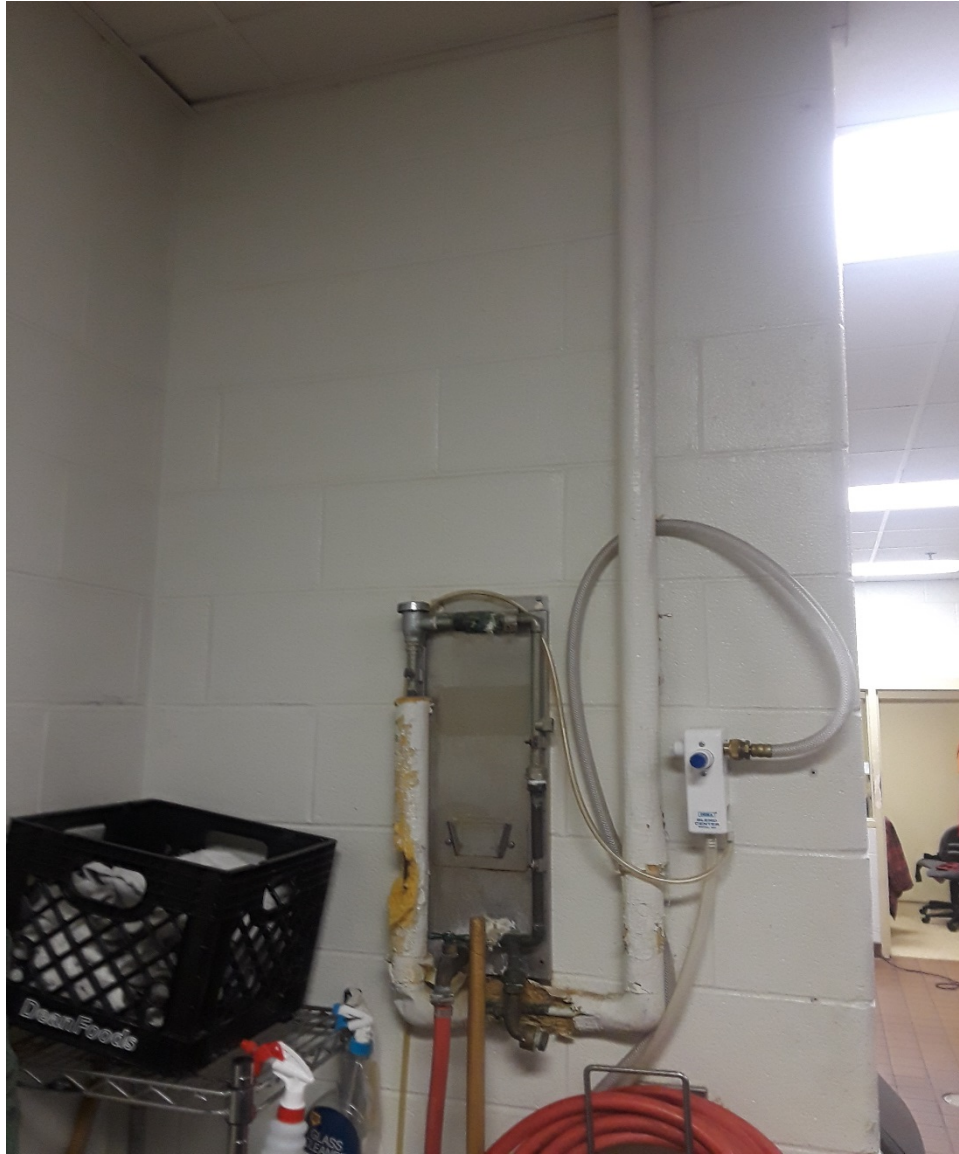
Photograph 8
Non-asbestos fiberglass pipe insulation and elbows in jail kitchen area.

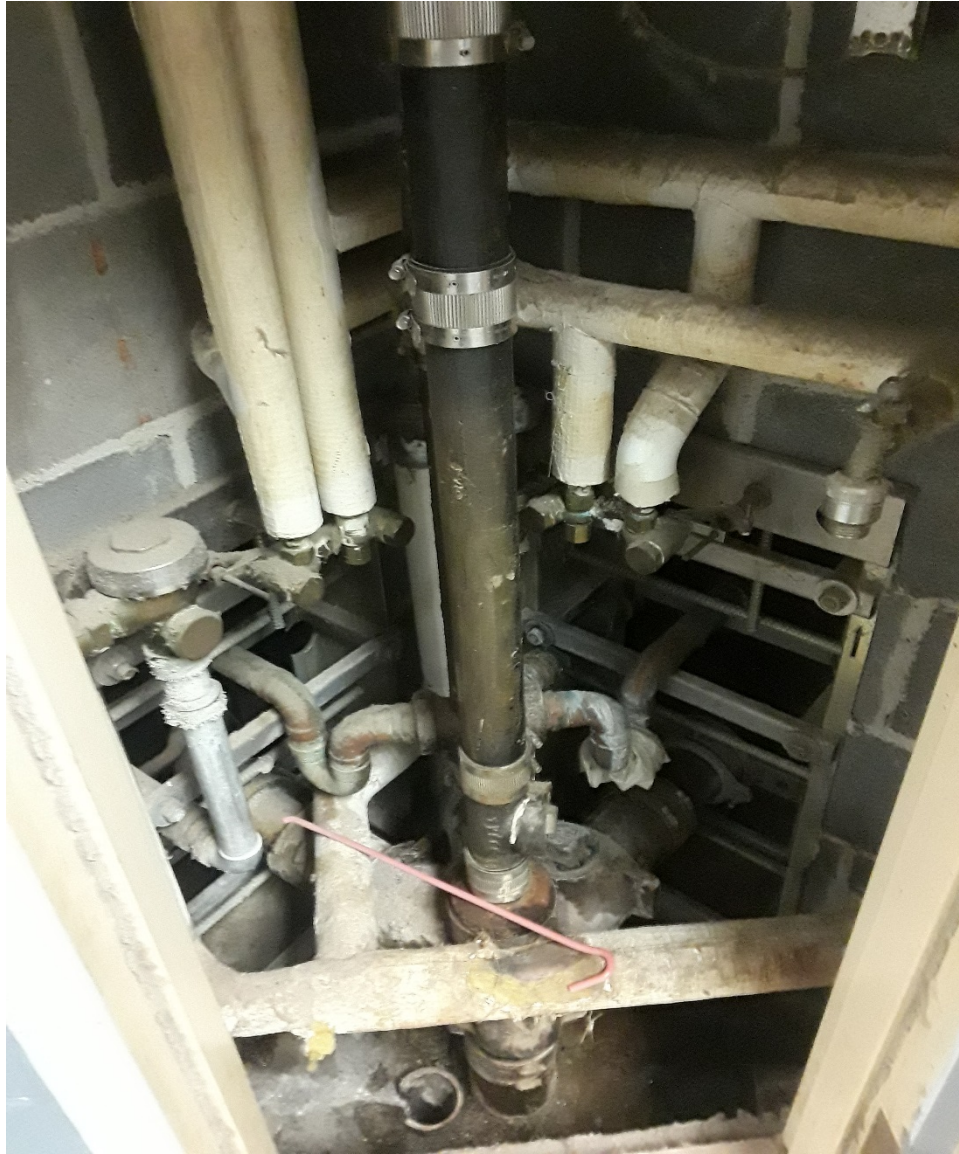
Photograph 9
Non-asbestos fiberglass pipe insulation and elbows in jail water closet.

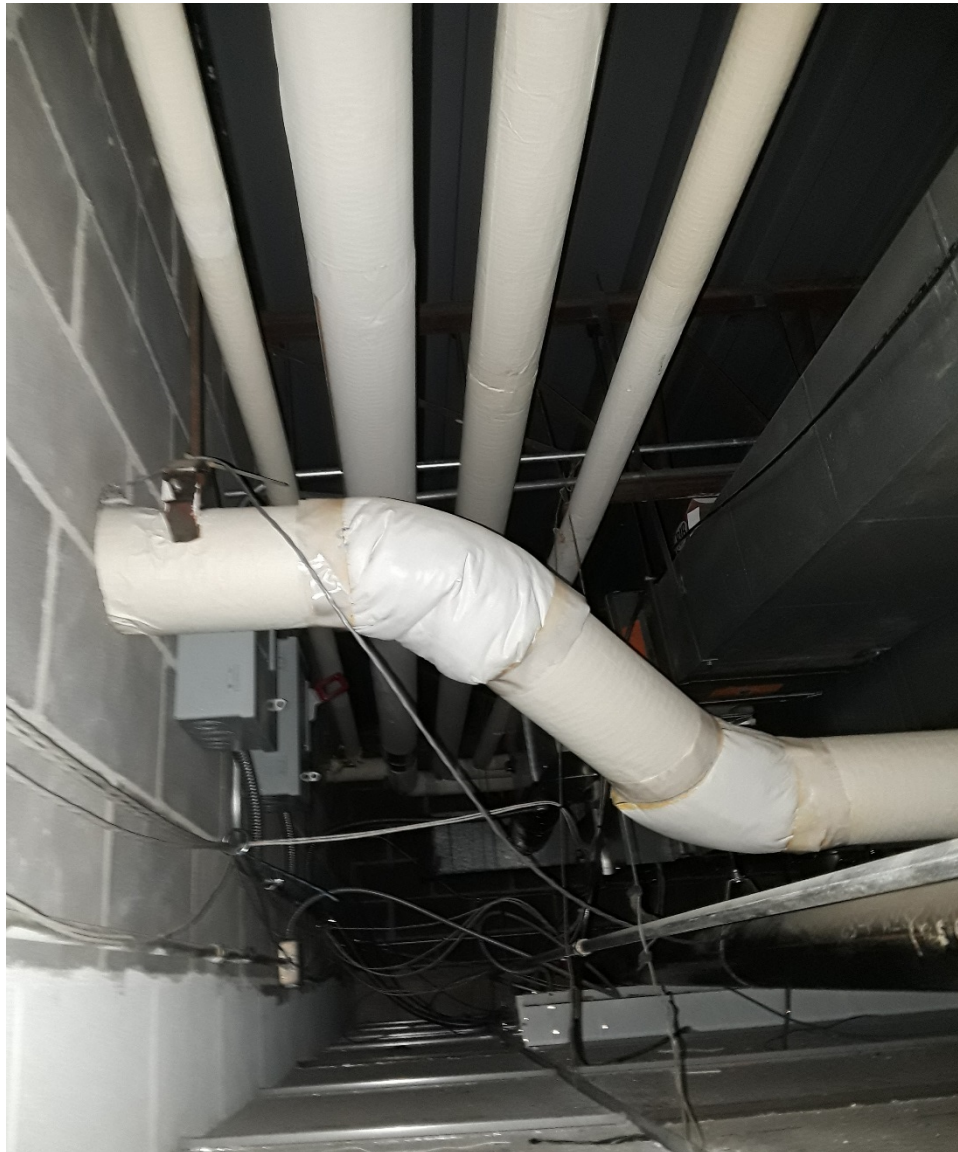
Photograph 10

Non-asbestos fiberglass pipe insulation and elbows above ceiling in jail hallway.

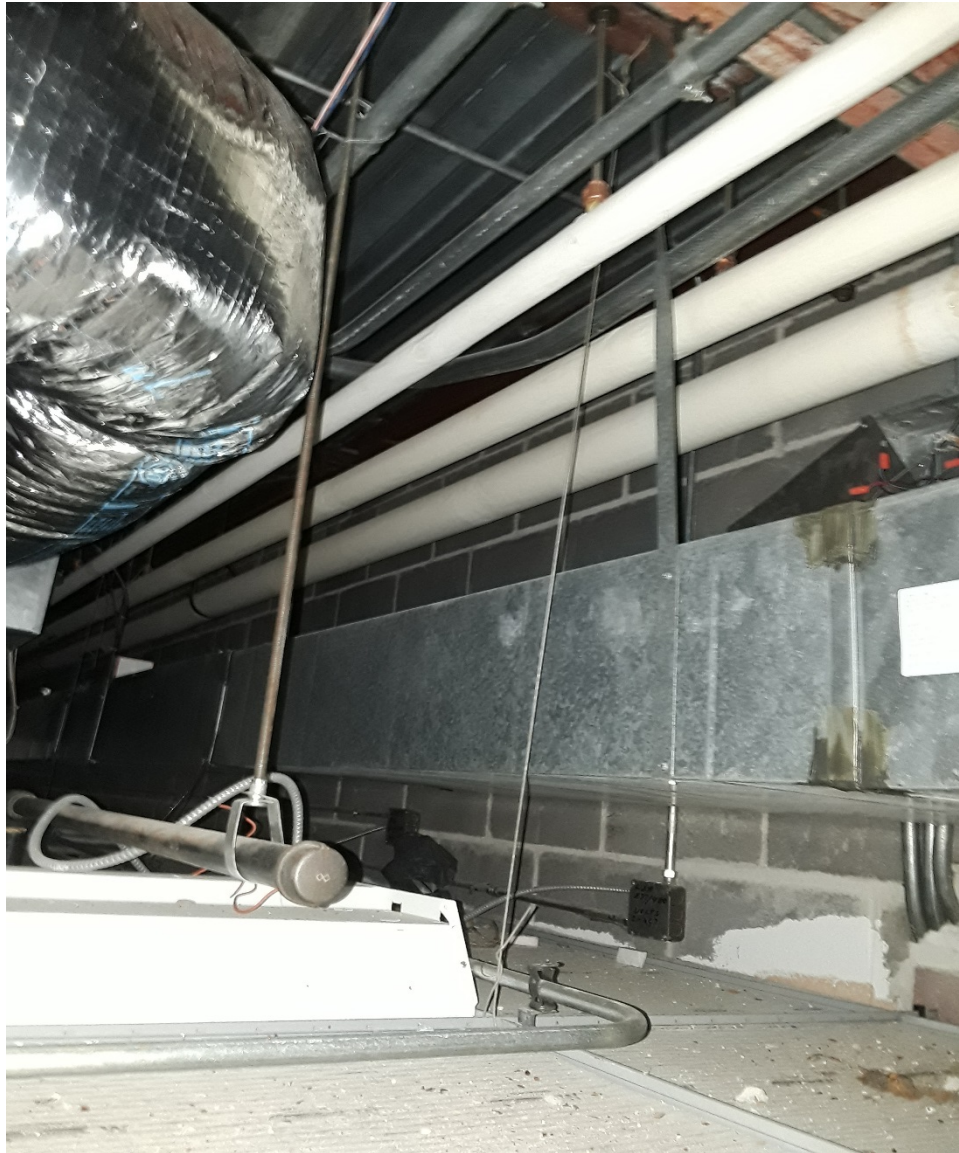
Photograph 11

Non-asbestos fiberglass pipe insulation and elbows in jail above hallway.

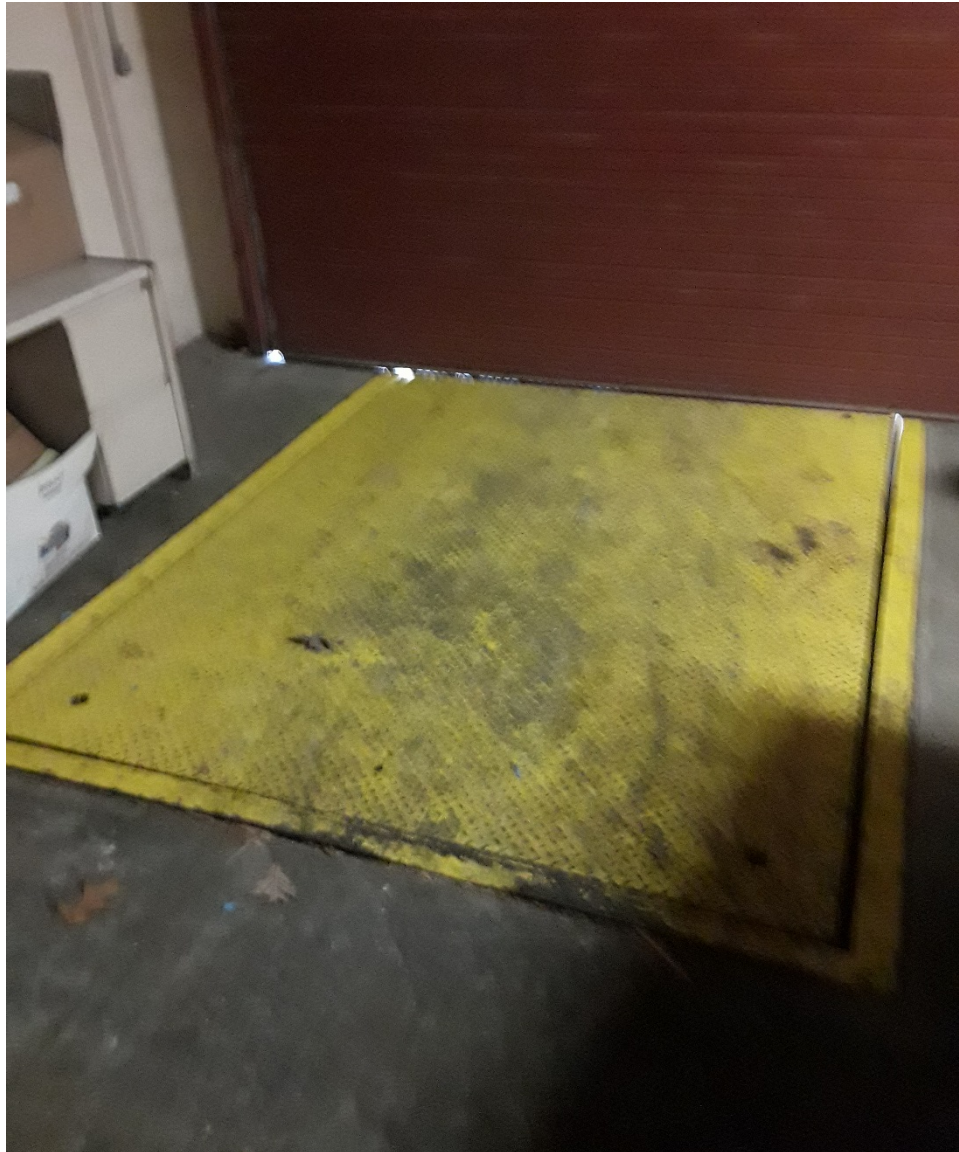
Photograph 12

**Lead-Based Paint (LBP) yellow lifting plastron and frame located in loading dock area
(Note: Next to Boiler Room).**

The following is a summary of the proposed lead stabilization remedial action plan. LBP stabilization should be done to minimize further damage and protect the identified LBP. The identified LBP is intact, however, a warning label and/or signs should be placed on the item to make building occupants and maintenance personnel aware of the presence of lead.

Work Area Location	Building Material	Action	Estimated Quantity
1 st Floor Loading Dock Area	LBP on Lift Platform and frame	Maintenance Personnel are required to have lead awareness training (if adopted 29 CFR 1910.1025). Stabilization of the painted is required to be performed by a licensed State of Missouri licensed lead abatement contractor using wet manual removal methods. Stabilization methods include removing any loose LBP using wet manual removal methods or approved chemical stripper. LBP can then be covered an industry approved non-lead paint. Grinding, sanding, scrapping or burning of LBP is strictly prohibited.	120 SF
