Project: M-0618-0201-5356 (Lorcom Lane)	Prepared By: Robb Lloyd	Date: 2018-06-21
City: Arlington	State: VA	Test Hole: 1 of

TEST HOLE FORM

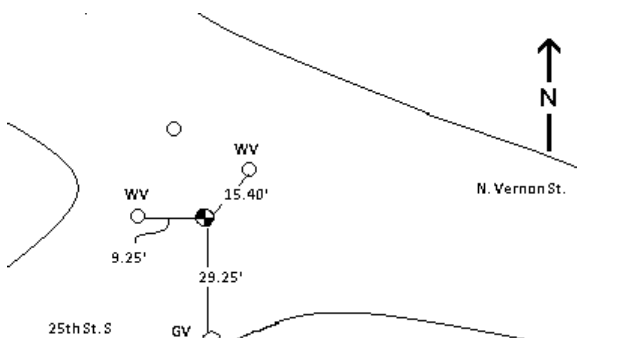
Utility Size: 7 1/2"	Material: Cast Iron	Good Condition: YES
Utility Type: Water		Utility Owner:

Utility Size: 30"	Material: Cast Iron	See Test Hole No.:
Utility Type: None		Utility Owner:

Top of utility field measurement: <u>A. 4.71'</u> Elevation:
	Bottom of utility field measurement: <u>B. 9.21'</u> Elevation: <u>None</u>

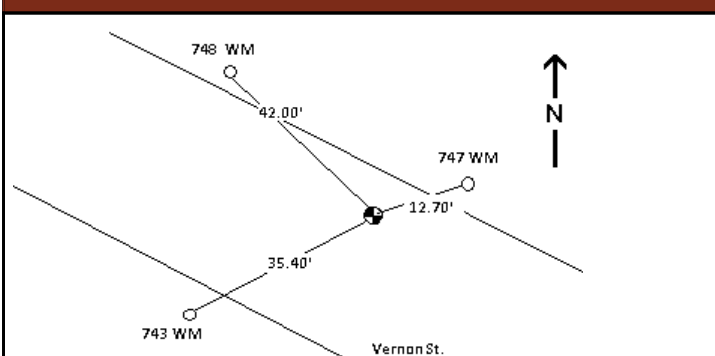
Utility Size: 2 1/2"	Material: Epoxy Coated Steel	Good Condition: YES
Utility Type: Unknown Function Pipe		Utility Owner:

Top of utility field measurement: <u>3.55'</u> Elevation:
	Bottom of utility field measurement: <u>None</u> Elevation: <u>None</u>

Northing:	Easting:
COMMENTS/NOTES	
<p>Crew notes that upon excavation that the unknown utility appears to be an abandoned gas line. Miss Utility has blacked out gas marks on ground as well.</p>

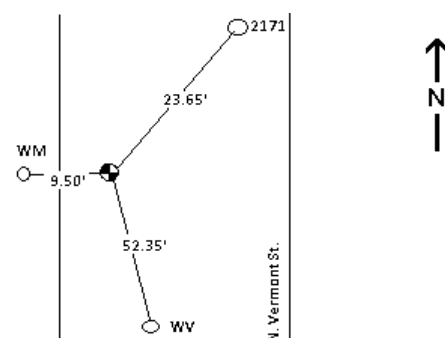
Utility Size: 1 1/4"	Material: Copper	Good Condition: YES
Utility Type: Water Line		Utility Owner:

Northing: Easting: COMMENTS/NOTES A=4.19' to the top B=4.69' to the top
-------------------------------------------------------------------------------------	----------------------------------------------------------------------------------------------------
